**AIRCRAFT ACCIDENT REPORT 1/2010**

**Air Accidents Investigation Branch**

**Report on the accident to  
Boeing 777-236ER, G-YMMM,  
at London Heathrow Airport  
on 17 January 2008**

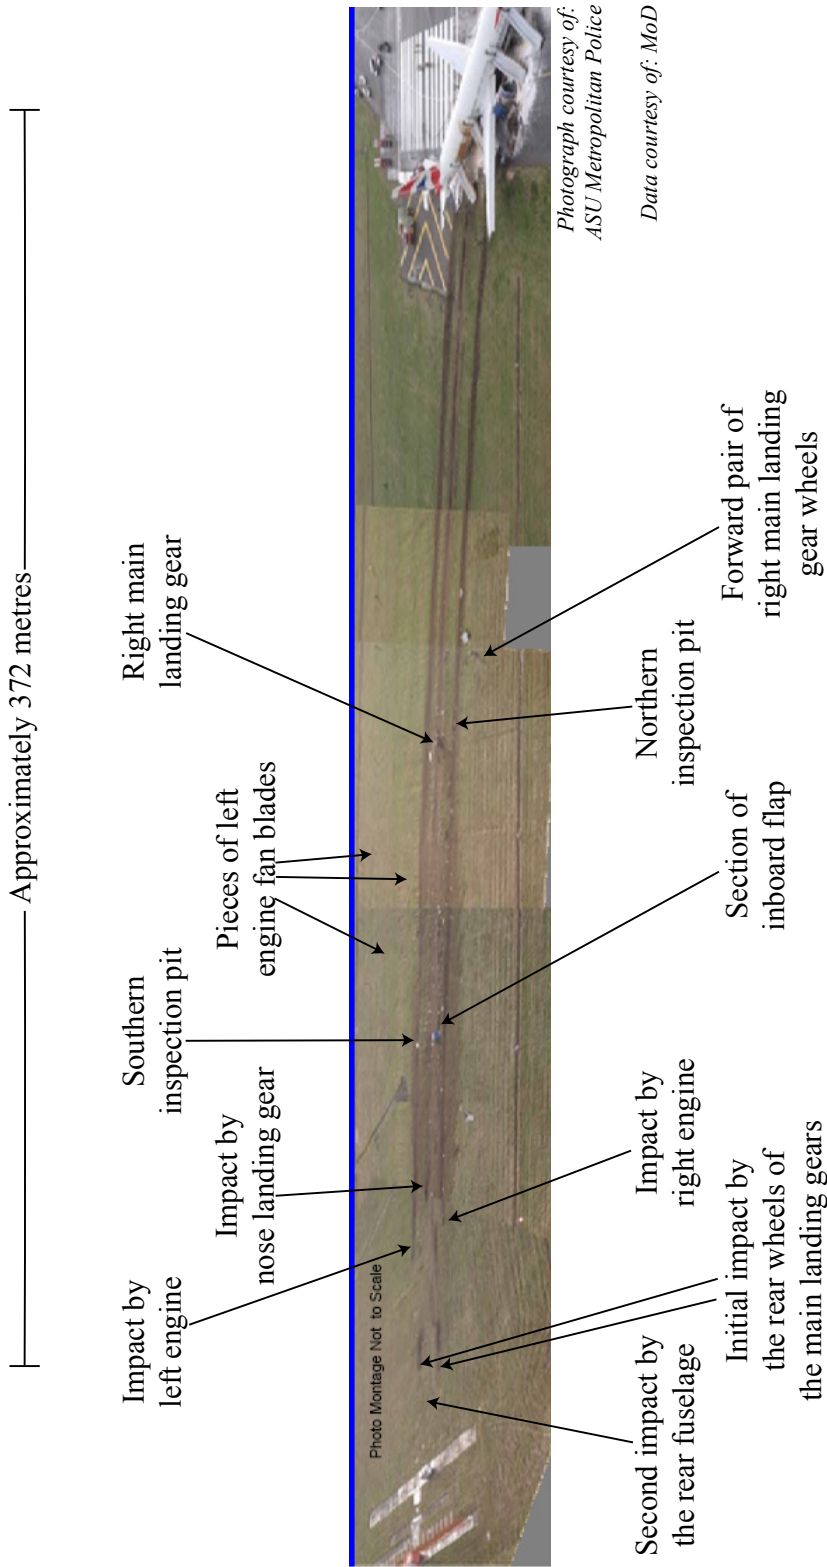
Figure 23

This caused damage to the lower part of the engine and assisted the deviation of the aircraft's ground slide to the right.

The aircraft came to rest on the tarmac area just to the north of the threshold of Runway 27L, approximately 372 m from the first impact point.

Ground impact marks and wreckage trail

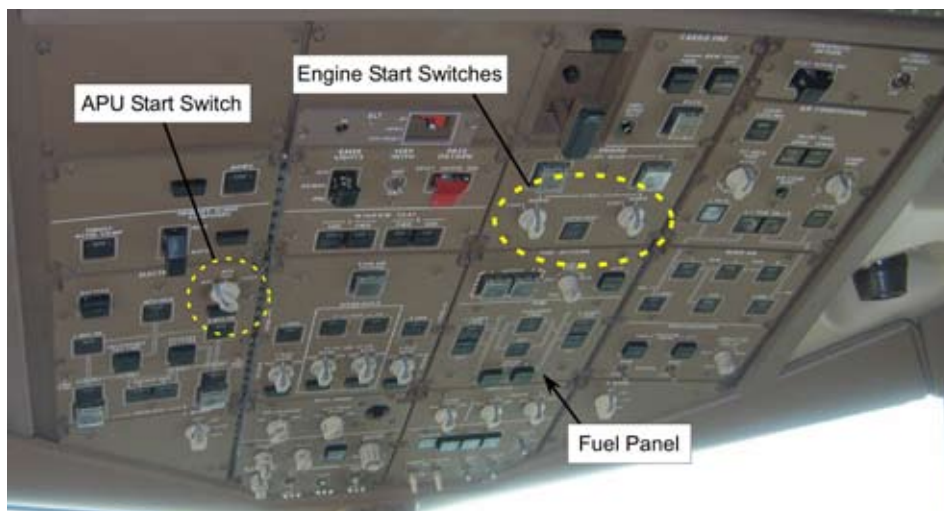
**Figure 24**

*Engine thrust levers* - Both engine thrust levers were in the full thrust position.

*Flaps* - FLAP 25 selected.

Overhead panel shortly after the accident

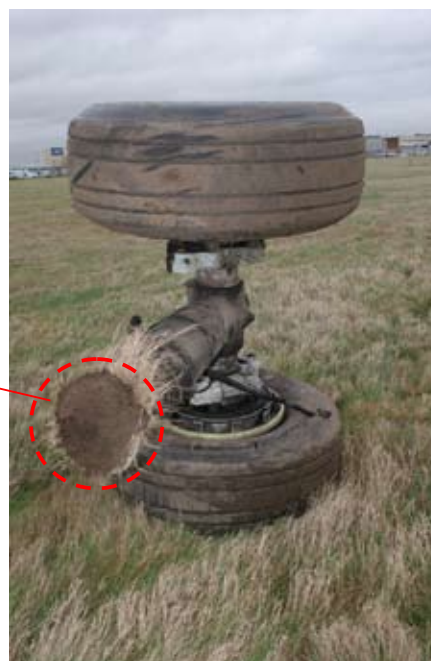
**Figure 31**

Forward portion of truck beam  
and two wheels

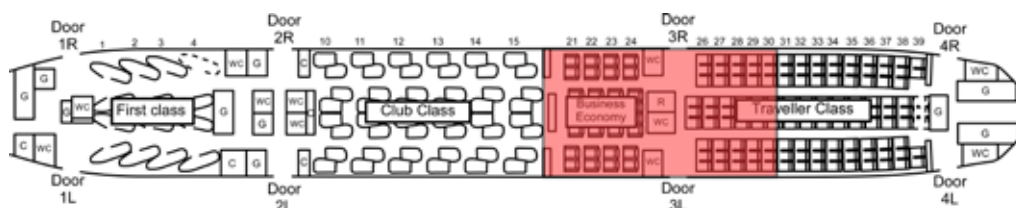
**Figure 35**

There were significant amounts of glass debris in the forward area of the Traveller cabin section, which was more extensive on the left side of the cabin in the region of Door 3L (Figures 35 to 37). The glass debris extended as far forward as Door 2L and 2R, and as far aft as seat row 31, with highest concentrations in the areas between rows 21 and 29.

Cabin layout showing location of glass debris

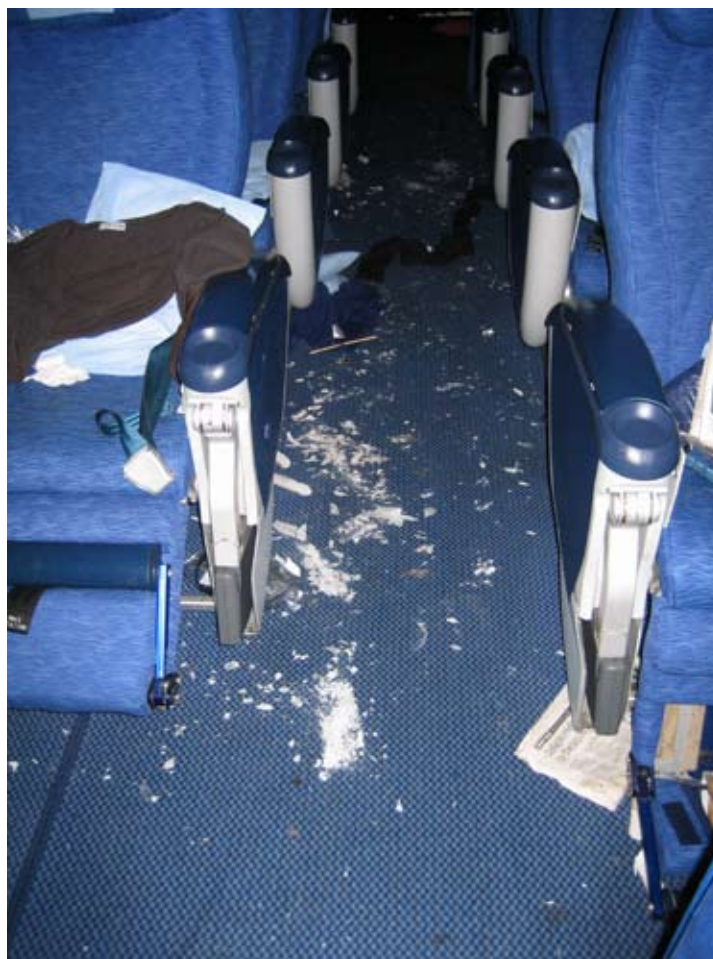
**Figure 37**

Debris on the floor from fluorescent tubes in area of Door 3L

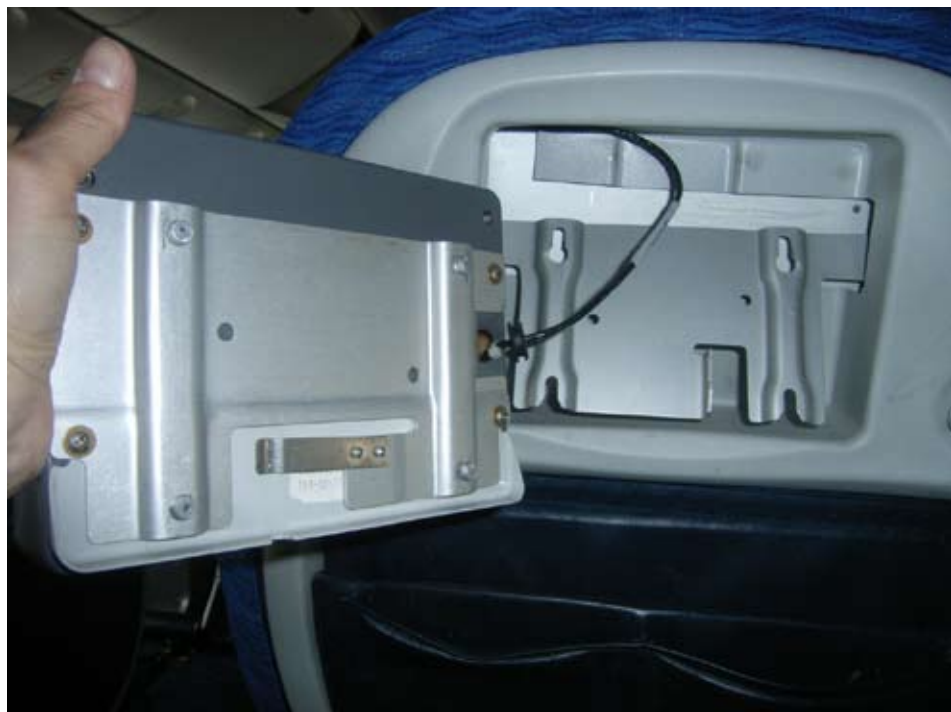
**Figure 40**

In the Business Economy section, nine of the 32 seat back video monitors had separated; of these, eight remained suspended by their electrical harness but one had separated completely and was found on the cabin floor (Figure 39).

Video monitor attachment fittings

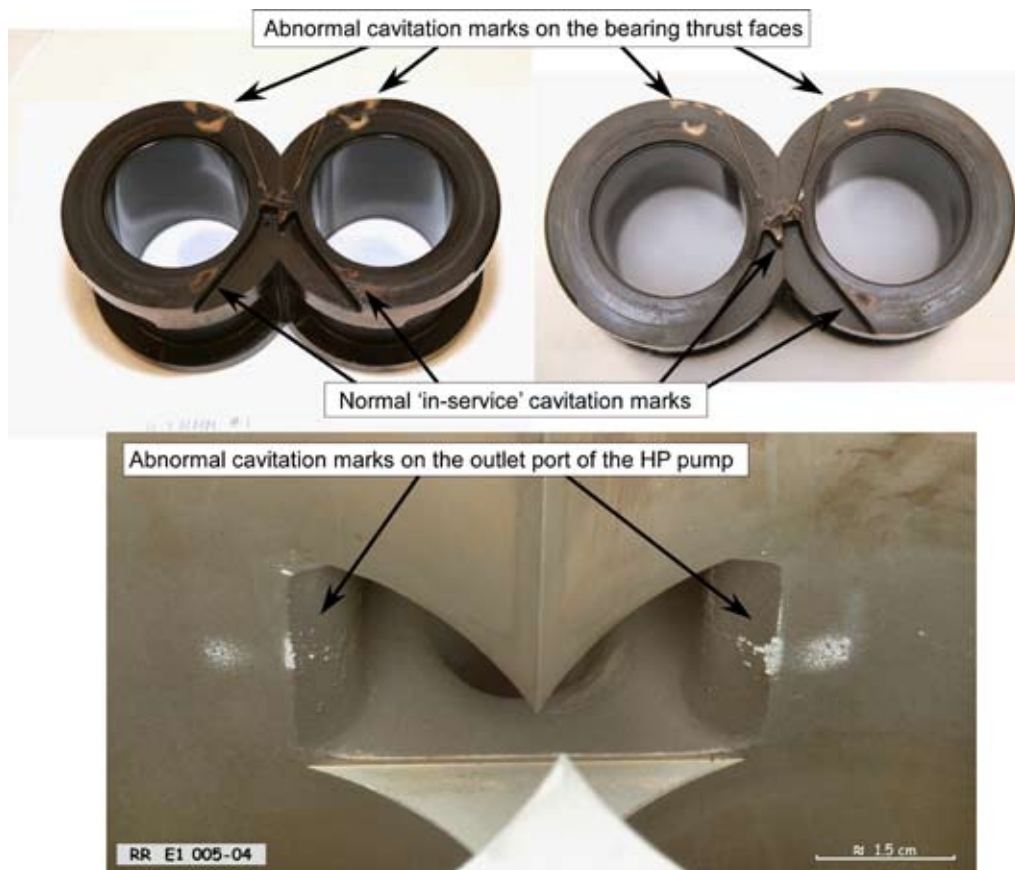
**Figure 41**

Strip of the HP gear pump did not reveal any mechanical discrepancies other than some unusual marks on the delivery sides of both pumps which the manufacturer described as being indicative of 'cavitation' (Figure 41). The marks comprised slight, but distinct, erosion of the dry film lubricant on the bearings and also of the outlet ports: they appeared fresh and bright.

Advice from the pump manufacturer was that these marks, at this location, were highly unusual. However, local cavitation erosion was to be expected at various known positions, mainly associated with the inlet side of the pump; the marks were hardly ever seen at the outlet ports. A series of tests had been carried out originally to certify the pump. Part of the tests involved running a pump at very low inlet pressures for several minutes. When the unit was stripped, marks were present which were almost identical to those which had been found on the pumps from G-YMMM. (Appendix E 'Explanation of Cavitation'.)

Apart from the marks, which would have had no effect on pump operation, no other abnormalities were found in either MEP from G-YMMM.

Cavitation markings on the HP pumps from G-YMMM

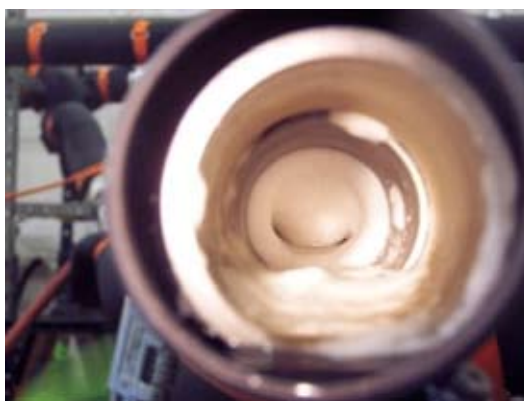
**Figure 50**

The only occasion when it appeared that there might be a sufficient quantity of ice to block a pipe occurred when approx 6 litres of water had been injected into the boost pump inlet over a period of 7 hours. During this period the flow rate was maintained at 6,000 pph and the water content varied between 100 and 150 ppm. On dismantling the system a large ball of soft ice was found just down stream of the spar valve on a coupling that is not used on the aircraft (Figure 50). Despite the presence of the ice, no pressure drop was detected across this section of tube whilst the fuel was flowing at 6,000 pph.

Ball of soft ice found in pipework in the fuel test rig assembled from steel components that are not used on the Boeing 777

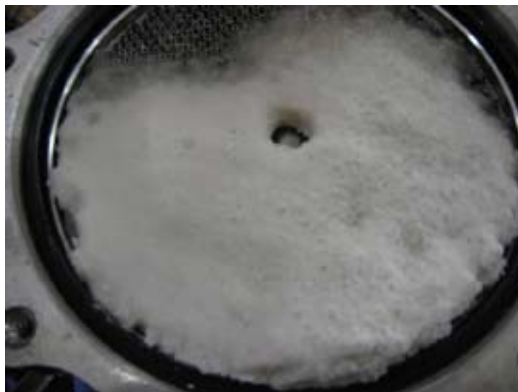
**Figure 52**

During the 'snowball' tests, with the fuel flow set at 6,000 pph, it took approximately 40 seconds for the water introduced at the boost pump inlet to reach the face of the FOHE. As the water flowed through the fuel system it turned into ice crystals and under certain conditions these crystals would collect on the face of the FOHE, restricting the fuel flow (Figure 52). However, during

Ice collected on the face of the FOHE

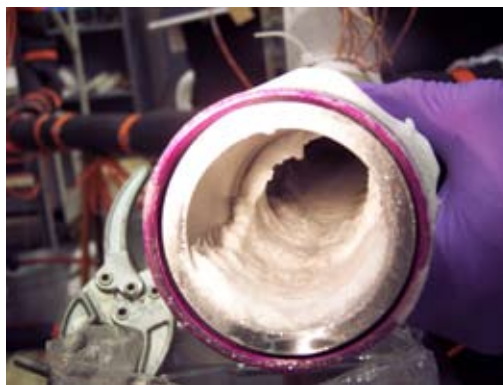
**Figure 53**

- The ice was soft and easy to move and there appeared to be no difference in the properties of the ice that accumulated at any of the cold test temperatures. However, in the test when the fuel temperature was cooled from -12°C to -33°C, the surface of the ice took on a 'pebbly' appearance.

Ice in the flexible hose located at the rear of the strut

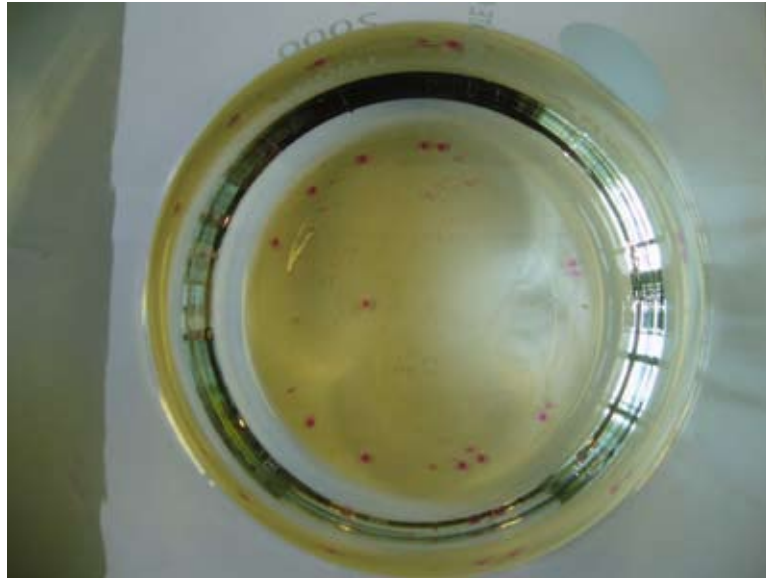
**Figure 59**

Small water droplets were observed in the fuel samples taken from the engine fuel filters and housings. The amount of water was too small to measure and so was classified by reference to the QinetiQ fuel appearance table as being 'small'. Figure 59 is a reconstruction of the QinetiQ description of 'small' using water coloured with food dye.

Reconstruction of a '*small*' amount of dyed water in aviation turbine fuel

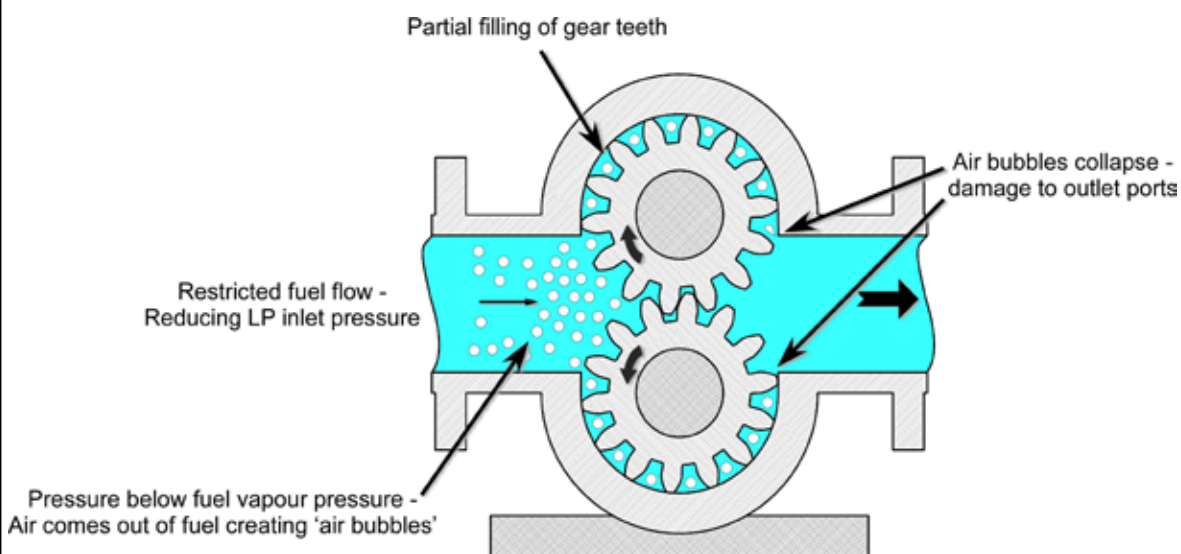
- Picture 4

Cavitation can occur with the presence of fuel vapour or air bubbles in the fluid and, given the low inlet pressure and high velocities, a certain amount of cavitation erosion is not unusual. The erosion is caused by the collapse of the bubbles which occurs violently and creates a shock wave of fluid. Striking a solid surface, the shock wave can cause progressive damage if it persists. In the case of the HP pumps fitted to G-YMMM, a degree of 'normal' cavitation damage is expected on the bearings where the teeth mesh and on the teeth themselves (Picture 4). The rate of erosion is a known quantity and does not affect operation of the pump within its overhaul life.

The inlet pressure to the pump should be maintained such that formation of air/vapour bubbles is minimised and, on most jet aircraft, this is achieved by the combination of aircraft booster and engine low pressure pumps. However, even if these are working correctly, a restriction in fuel flow upstream can result in the HP pump lowering its inlet pressure to the point at which a large quantity of air and vapour bubbles are formed. This gives rise to a mixture of fluid and gas bubbles filling the gear teeth. As these gear teeth open to the high pressure outlet port of the pump, the gas bubbles collapse and the high pressure fuel in the outlet port rapidly fills the available space. Both these actions result in shock waves being formed that cause damage to the outlet port and the delivery side of the bearing faces. This is the abnormal cavitation damage seen on both HP pumps from G-YMMM.

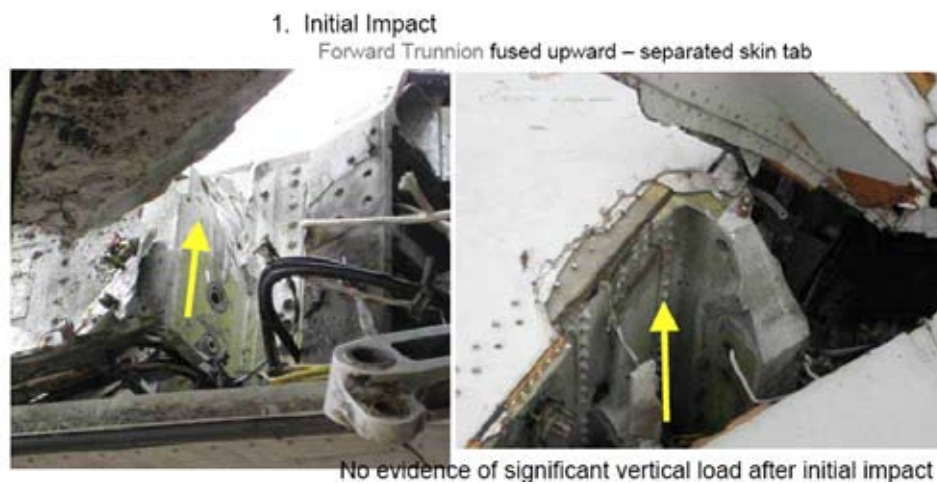
Forward trunnion upper and lower housing fuse pins failed

Drag brace fuse pin 'crankshafted'

Note the piece of upper wing skin removed by the separation of the upper and lower housings. This impact had pried open the wing tank.

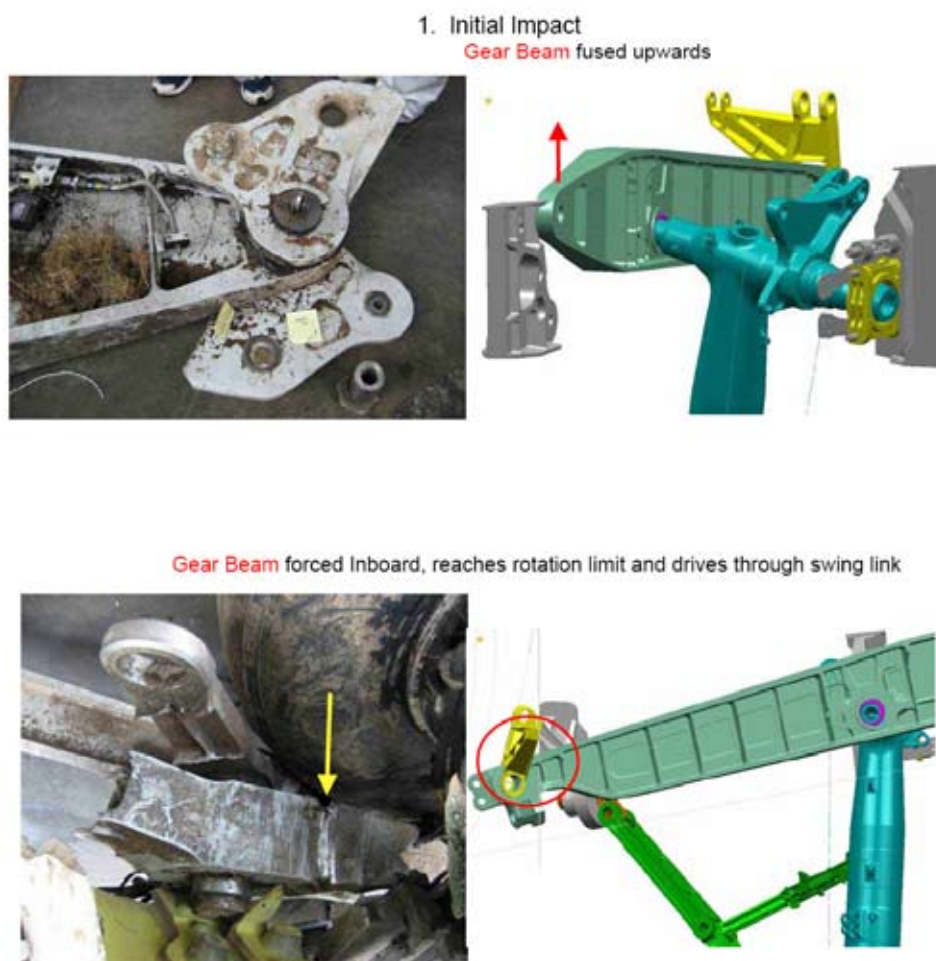
1. Initial impact: Gear beam outboard end fuse pins fail and gear beam forced upwards
- Side brace folded and gear beam forced inboard
- Gear beam rotated upwards and contacted the aft trunnion pin
- Forward trunnion lower housing (H block) fuse pins failed

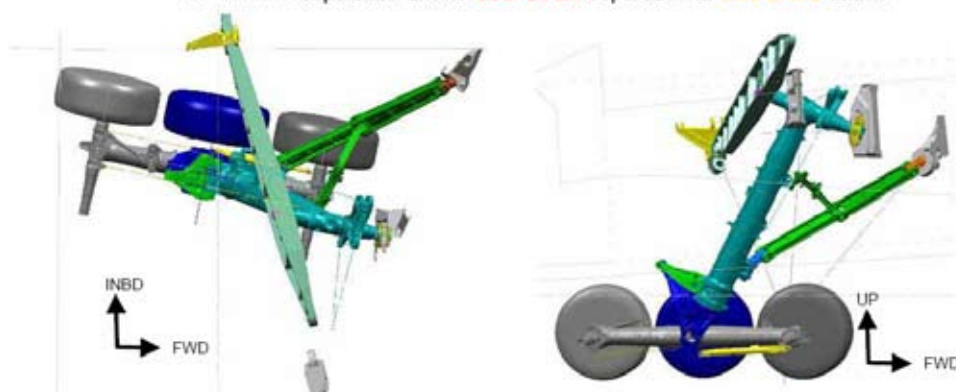
Aft Trunnion separation and/or Gear Beam separation at Side Brace attach

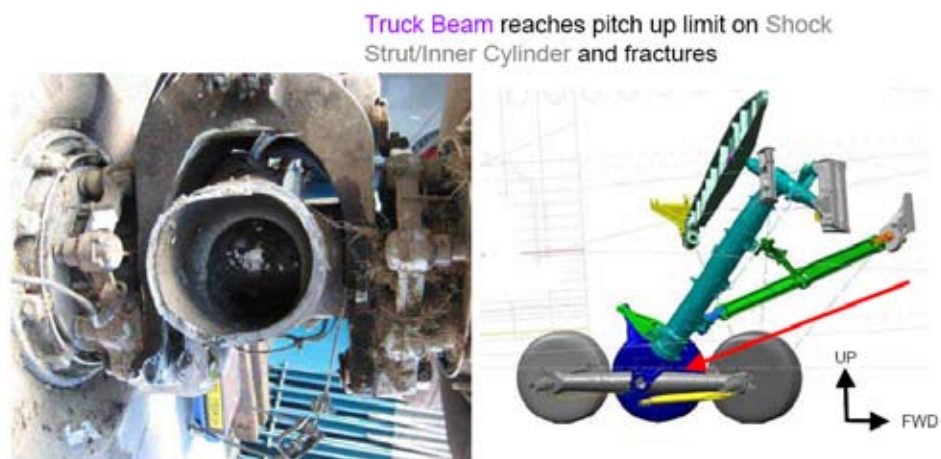
Rear spar web and backup fitting failure and drag brace separation

**3. Shock Strut / Retract Arm Jams on and destroys upper part of inboard Trunnion Support Fitting**

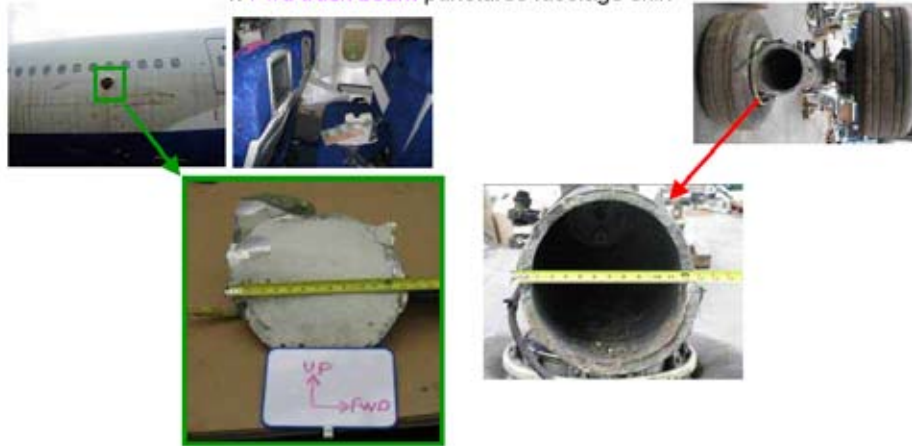
**Appendix J****4. Fwd truck beam punctures fuselage skin**

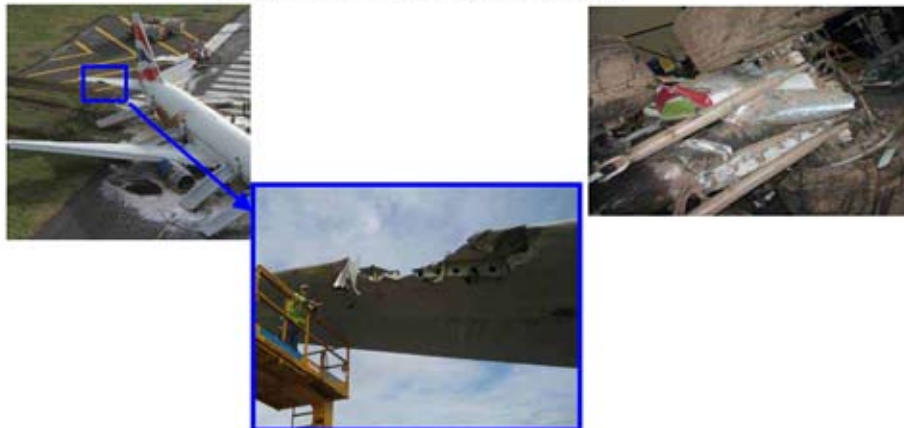
**4. Right MLG strikes horizontal stabilizer**

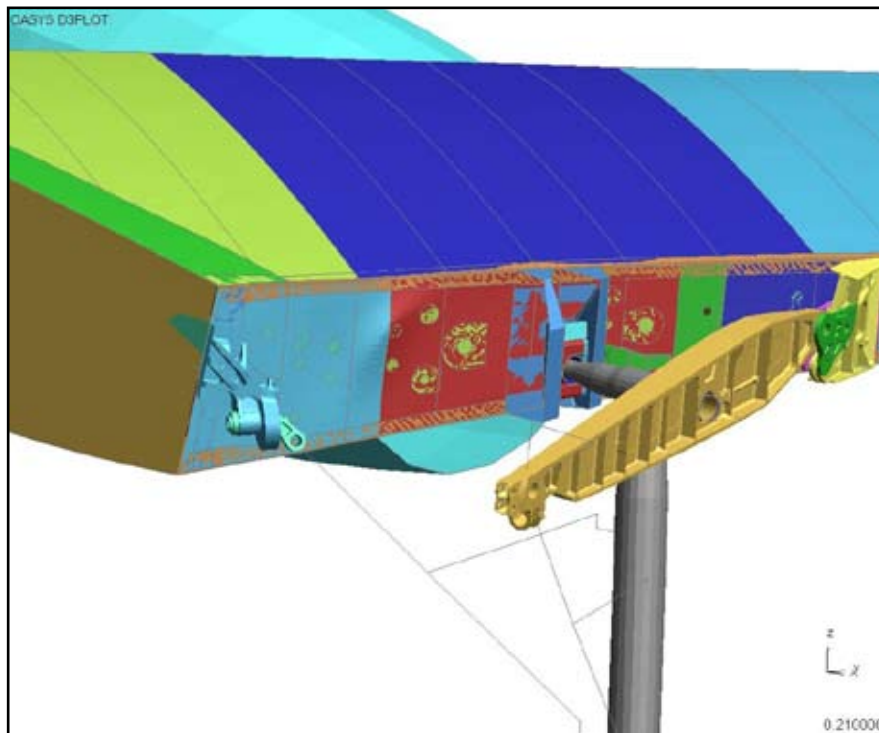
**Figure 67**

It was evident that the behaviour of the model on soft ground was different to that on a hard runway (Run B) in that only one fuse pin failed (the lower pin in the right outboard gear beam).

In the absence of any other fuse pin failures, loads could continue to be transferred into the rear spar. This led to distortion of both rear spars and is illustrated in Figure 67 which shows the right spar. A similar effect was seen in the left rear spar.

Right wing rear spar buckling – Run C (TIME = 0.21 SECS)

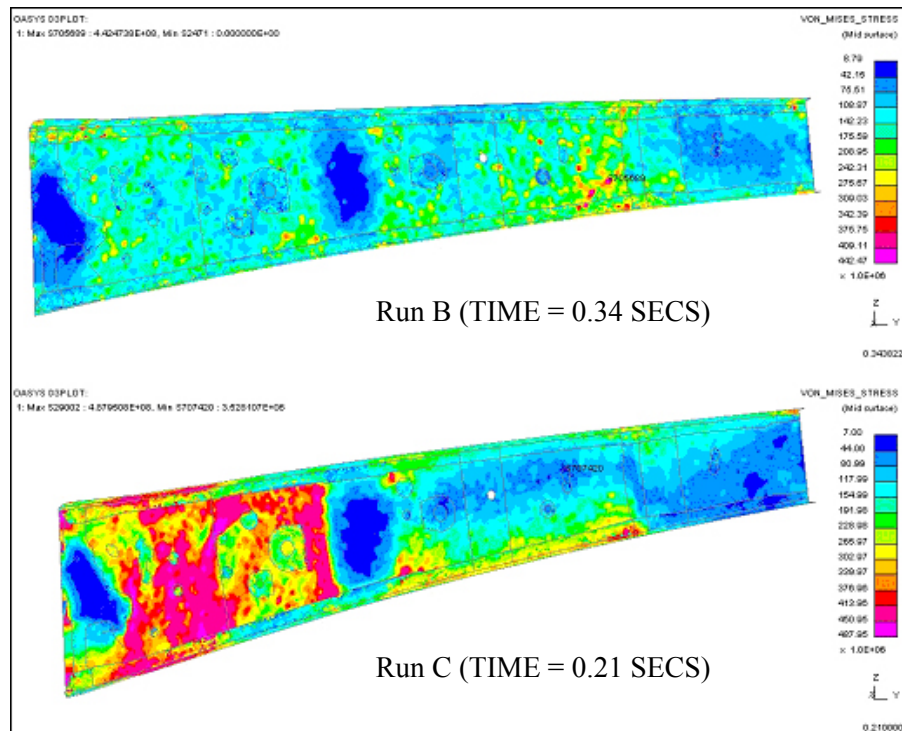
Figure 68 shows a comparison of the Von-Mises stress<sup>1</sup> in Run B (hard runway) and Run C; the red colours indicate higher stresses.

Right wing rear spar buckling Von-Mises stress

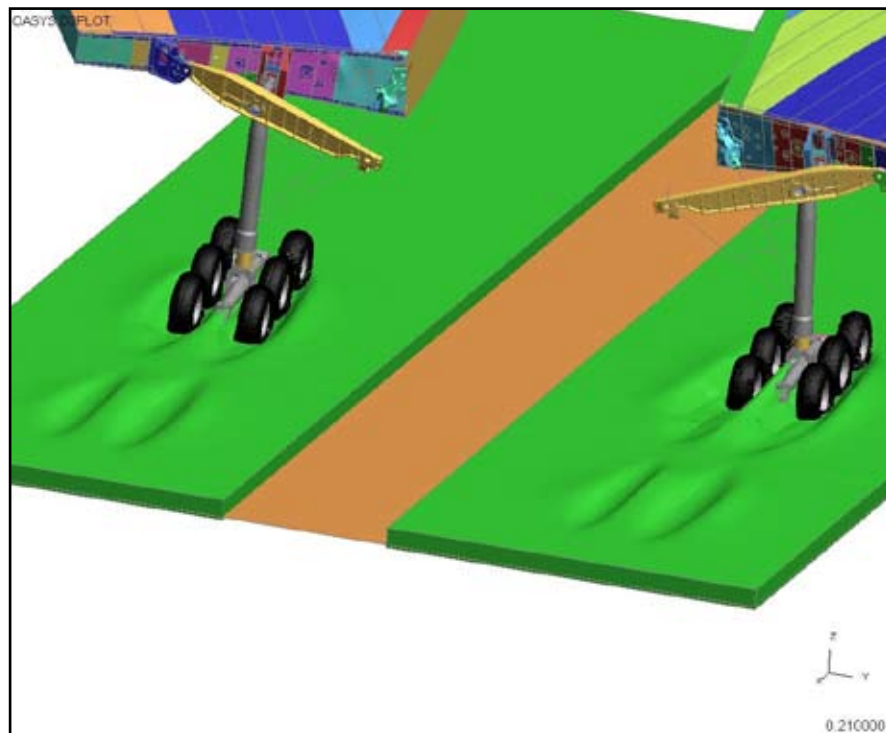
The Figure 69 shows the soft ground deformation.

Soft ground deformation Run C (TIME = 0.21 SECS)

The soft ground impact model (Run C), which was intended to most closely match the actual accident, showed a different behaviour. In this case the model indicated that all the fuse pins, except one in the outboard end of the gear beam, did not fail. This resulted in increased loads being transferred into the both wing rear spars. Review of force time history data from the fuse pins indicated that impact with soft ground delayed the build-up of shear forces in the pins (when compared to impact with hard ground) and prevented most of them from reaching their programmed shear failure trigger force. This delaying action allowed the fuse pins to continue transferring forces into the rear spars and resulted in distortion in the region of the drag brace attachment. It was concluded that the difference in outcome was due to the soil behaviour in the model under predicting the compression characteristics of the soil at the accident site.
