# BEA

*Accident  
on 25 July 2000  
at La Patte d'Oie  
in Gonesse (95)  
to the Concorde  
registered F-BTSC  
operated by Air France*

**REPORT translation**  
**f-sc000725a**

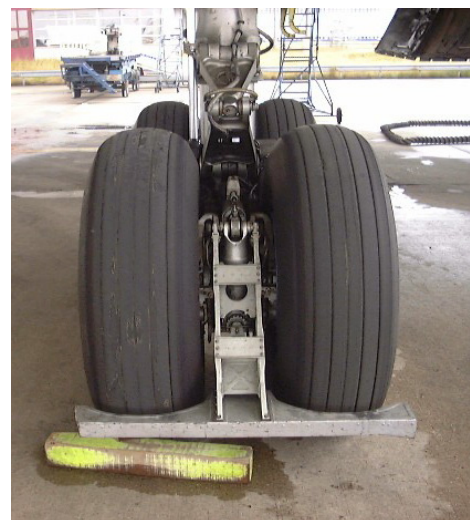
Figure 4: Water deflector

The deflectors are situated forward of each main landing gear. Their function is to deflect projected water so that it does not enter the engine air intakes. Weighing around four kilos, they are made of composite materials and fibre glass (to make them frangible) except for the bogie fasteners.

In 1995, these deflectors were the subject of an optional Service Bulletin (SST 32-103 of 12/01/95 modified on 28/02/95) which proposed the insertion of two cables in the leading edge in order to retain pieces of the deflectors in case of failure. Air France did not apply the aforementioned Service Bulletin.

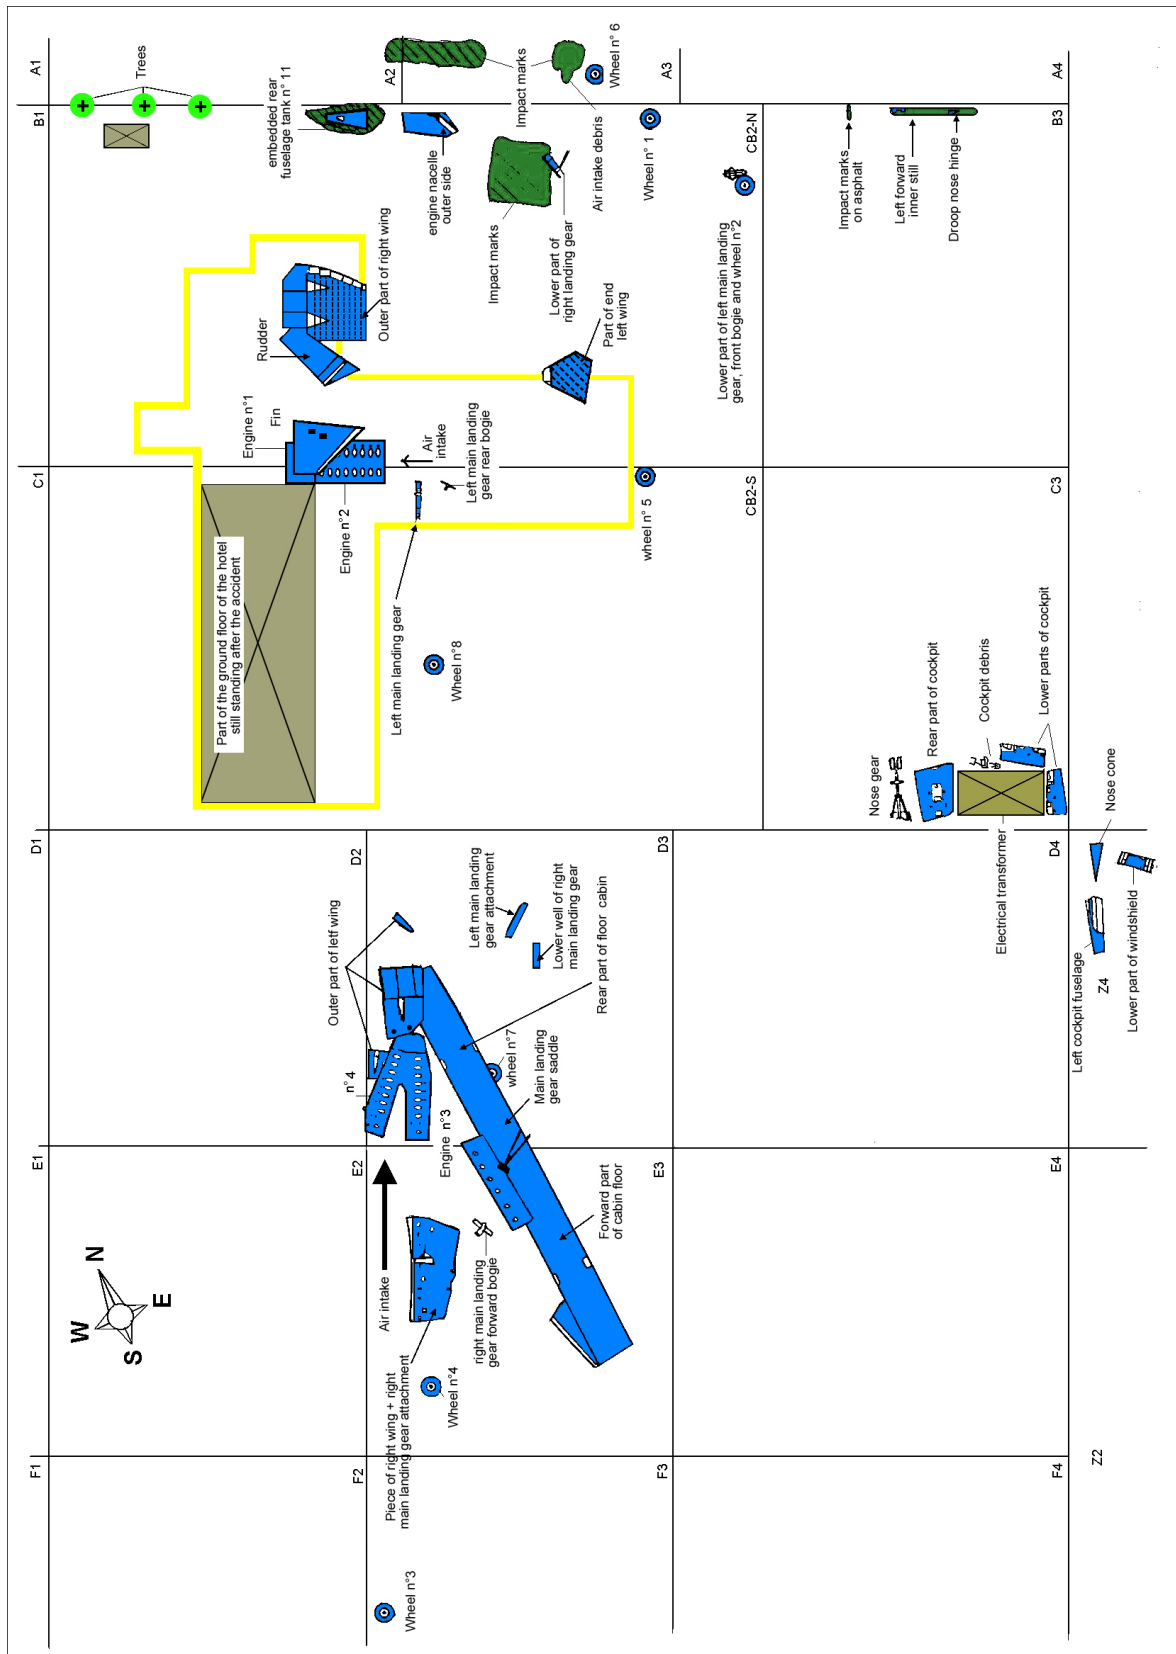
Figure 30: Wreckage distribution plan

The crash site was divided into a grid. The various areas were referenced to this grid.

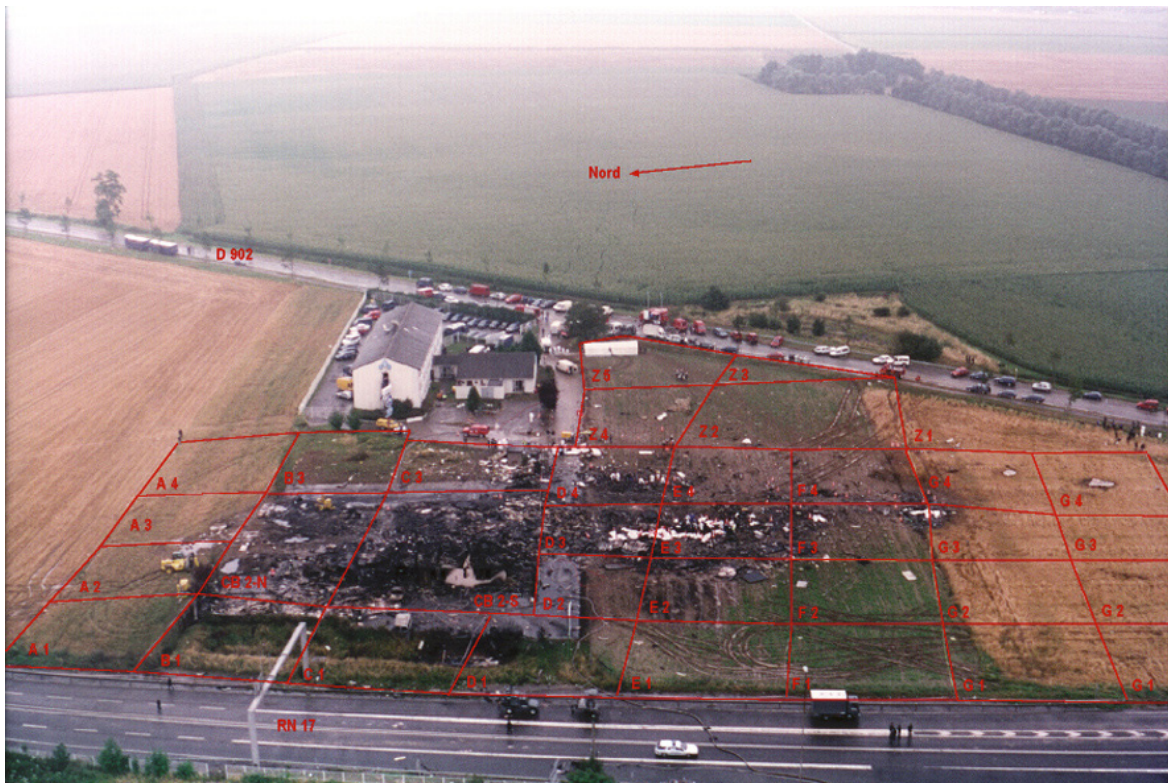
**Figure 31: Aerial view with indications of zones**

Examination of the site showed that the aircraft had struck the ground on heading 120° left, practically flat with little forward speed. After the impact, it broke and spread generally to the south, with the aircraft upright.

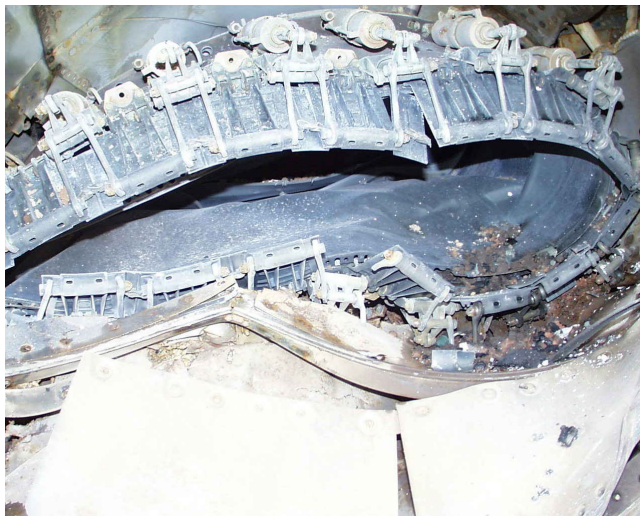
**Figure 36: Engine 2 exhaust nozzle**

The primary exhaust nozzle from engine 3 was separated from the structure of the secondary nozzle. The latter was torn away from the rest of the engine. The nozzles from engines 1, 2 and 4 were in place but flattened by the impact with the ground.

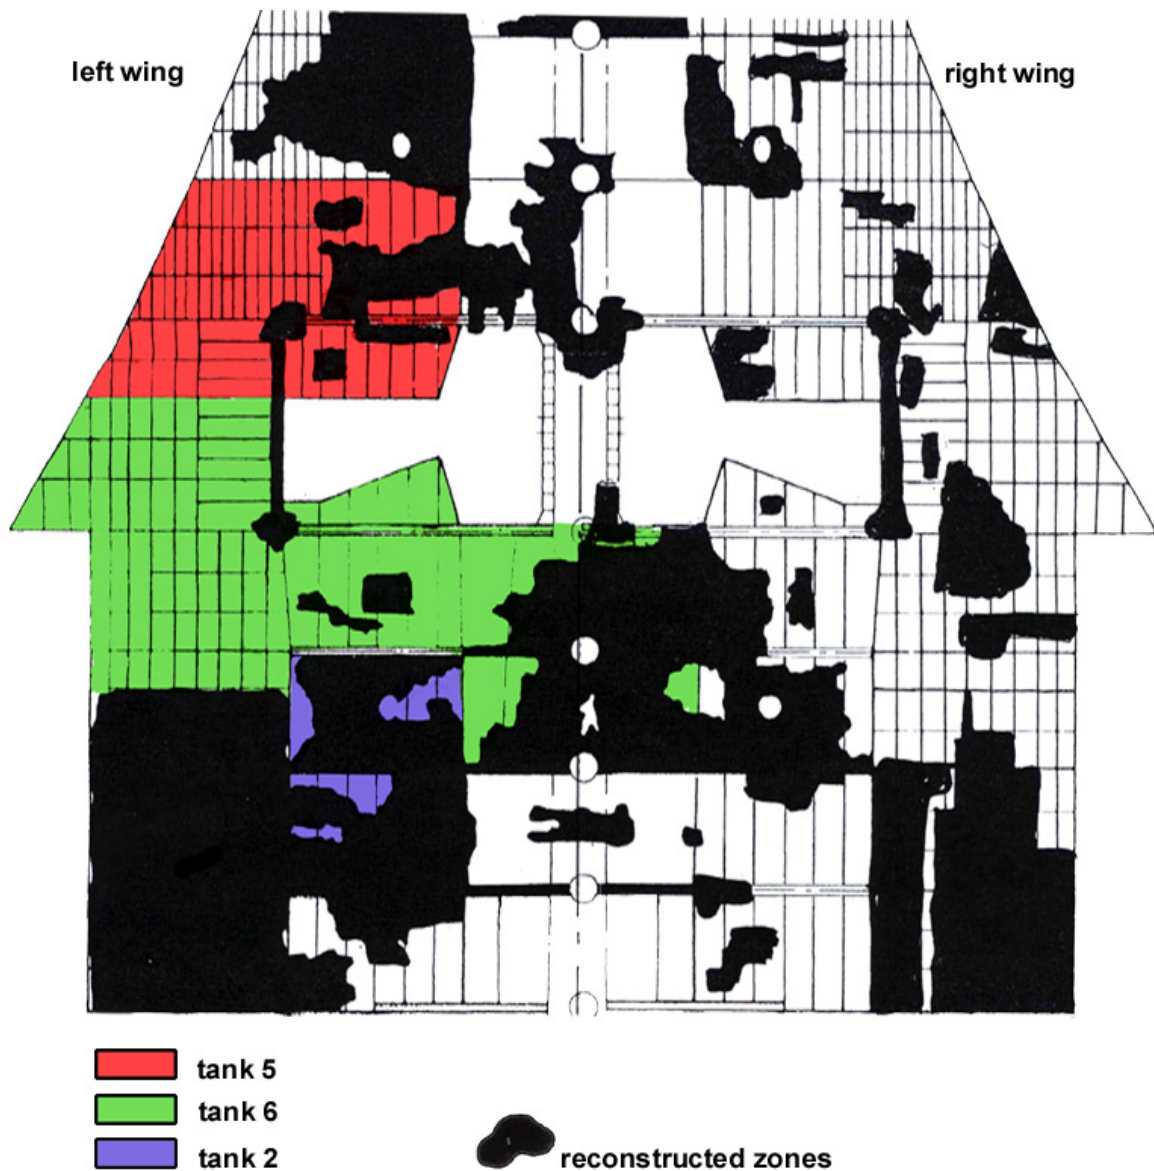
Figure 39: Computer reconstitution of upper wing

It was not possible to reconstruct the surfaces located near the landing gear well, nor the majority of the right wing. A melted piece appeared to have some small punctures.

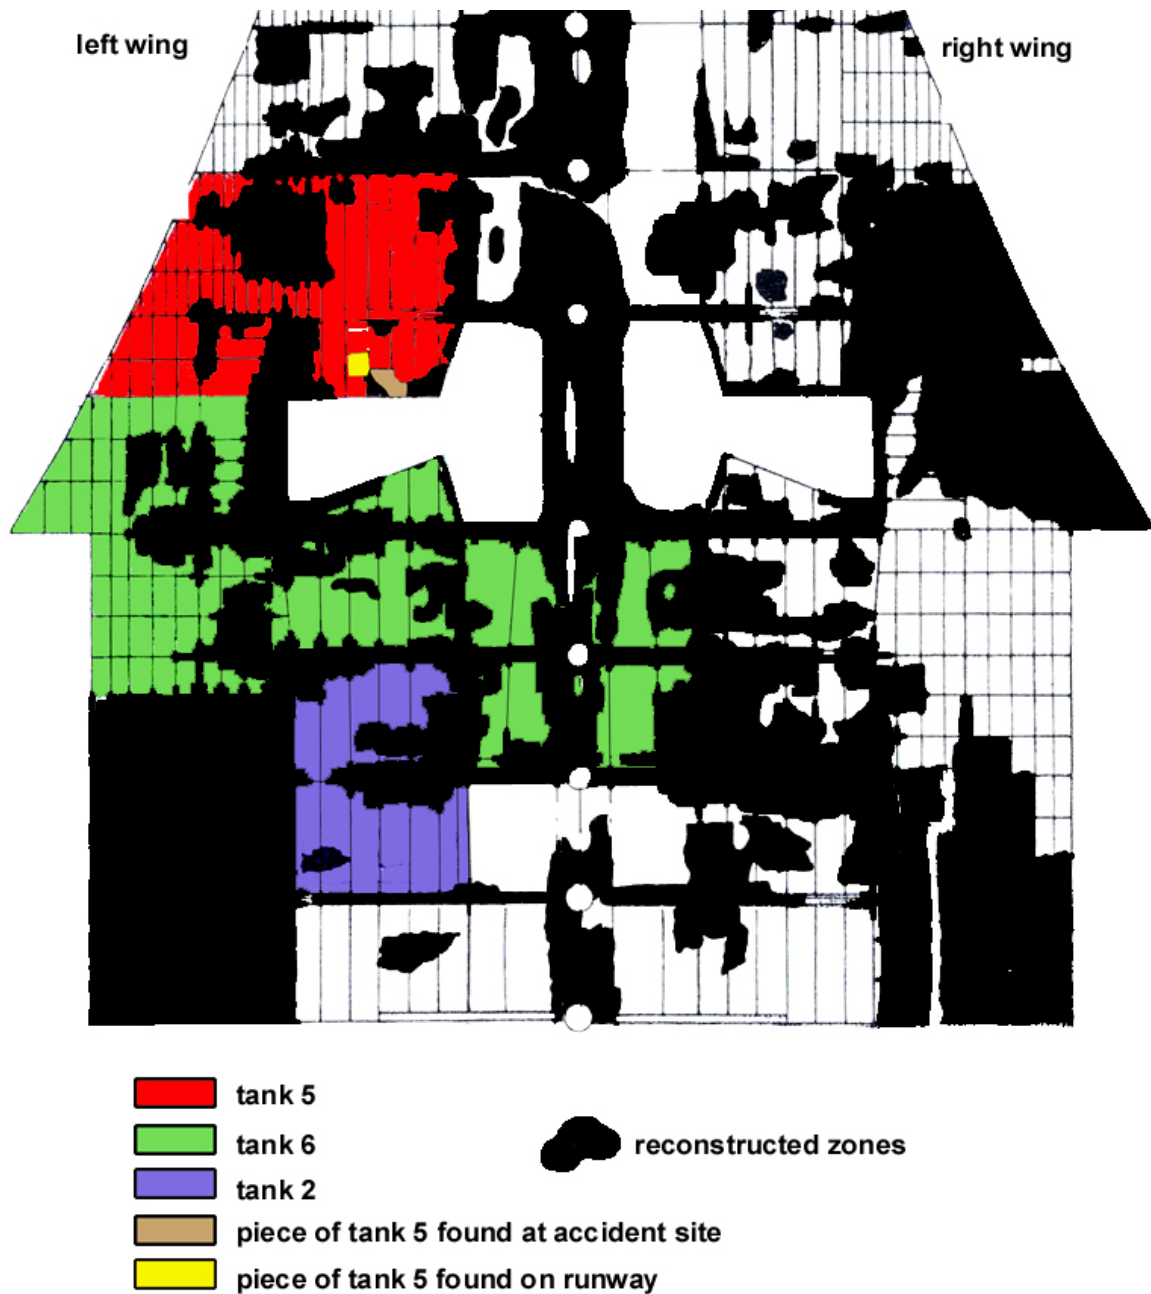
Figure 40: Computer reconstruction of lower wing

Almost nothing from tank 5 was recovered. Only one part of the edge of the landing gear well and two probe locations were still visible near the location of the piece found on the runway. These parts showed no puncture or impact marks, except on one of them.

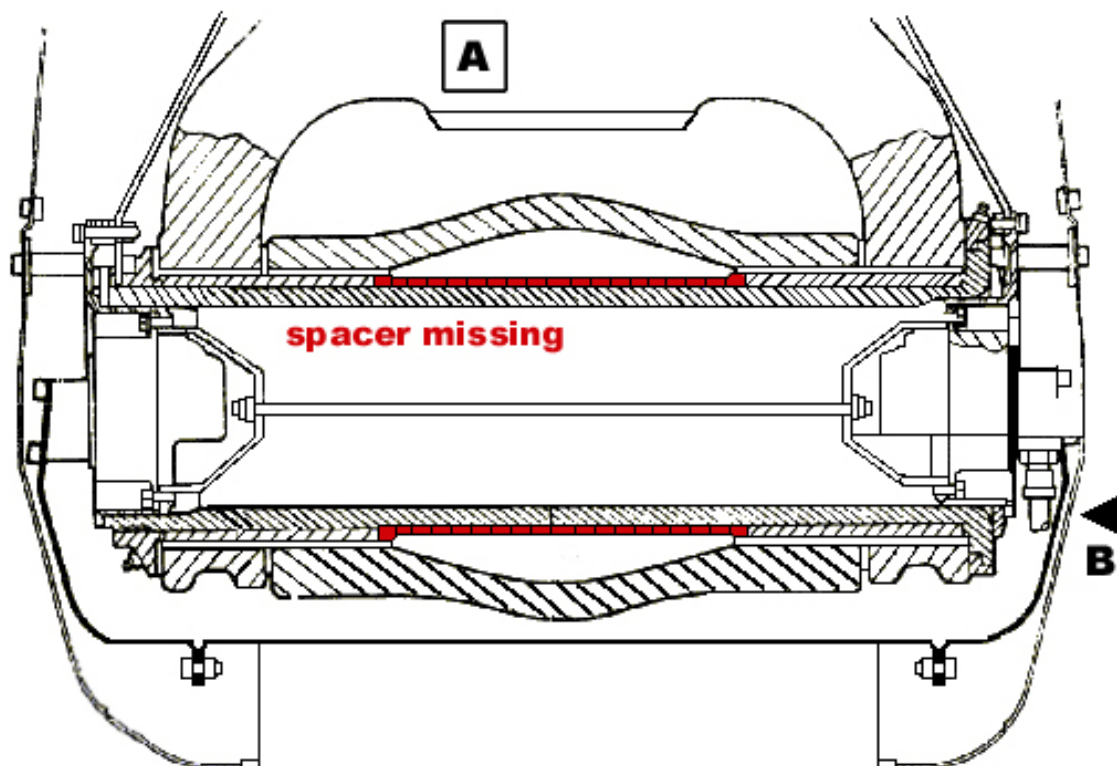
**Figure 42: Cross section of leg-bogie coupling**

- The forward and rear hinges of the right main landing gear inner door were identified.. The forward hinge was blocked in a position consistent with a closed door. The rear hinge was limited to a movement of about 20° around the normal closed position.
- A spacer, which holds two lateral rings in position, was missing from the oleo/bogie coupling on the left main landing gear. This retainer had not been re-installed during the A01 check performed from the 17 to the 21 July 2000.

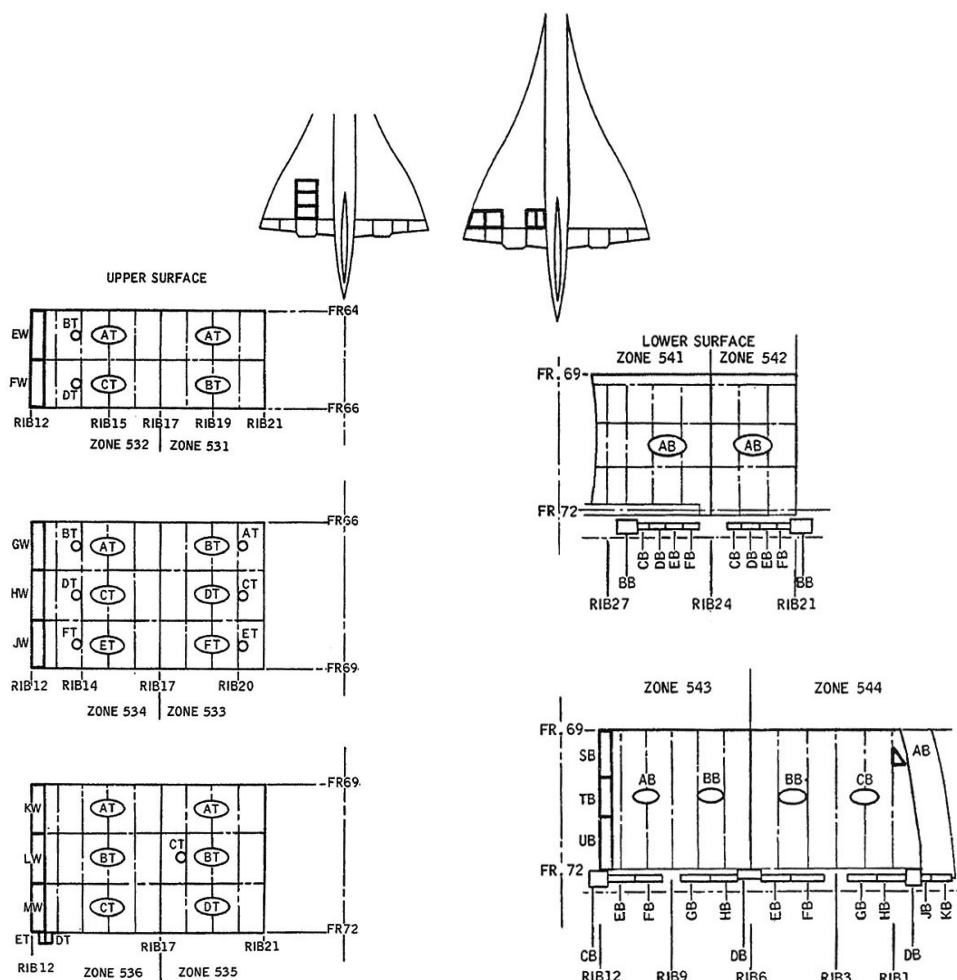
**Figure 43: Dry bays**

The dry bay located above engines 1 and 2 was examined by the BEA investigators and their advisors. At the time of impact, it was broken off between ribs 12 and 21. All of the lateral bulkheads were destroyed. The heat shield was generally intact except for an indentation on impact at the level of the engine 2 nacelle.

Examination of parts and of the wreckage found under the aircraft track showed that the aft part of the dry bay as well as the communicating areas suffered a very violent overpressure after takeoff, leaving no time for the overpressure valves to open. The door latches broke off as a result of this overpressure. The manufacturer estimates that a pressure of about 450 mbar on a door could lead to the rupture of the most loaded axis. Combustion of an air/kerosene mixture in the enclosed space of the dry bay could generate an overpressure which could reach a few bars in a few tenths of a second (stoichiometric mixture). Transition from combustion to detonation (propagation of a wave of combustion at supersonic speed) can generate a shock wave equivalent to pressure rise of several dozen bars.

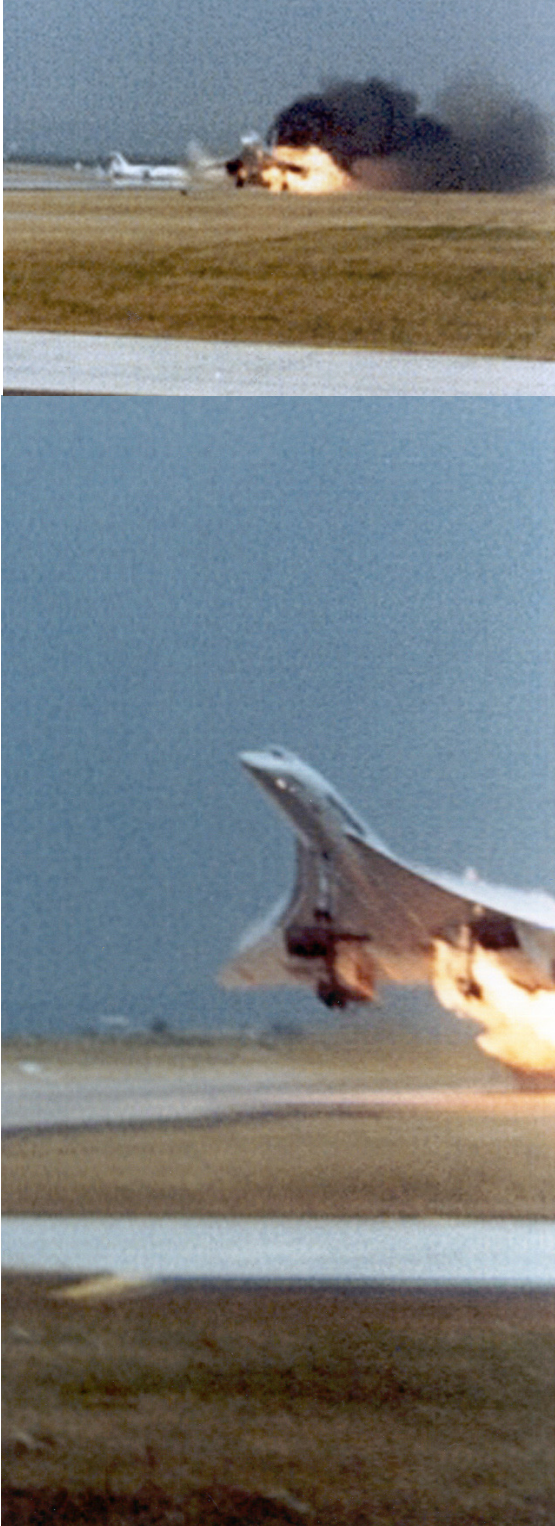
The general opinion was that the first phase of the takeoff was completely normal. The four jets from the reheats were perfectly visible. During the acceleration, several people heard explosions. The first was heard when the aircraft was in the vicinity of W6 and was followed by the appearance of a flame. The initial conflagration occurred under the wing, between the left engine nacelles and the fuselage, a few seconds before the beginning of the rotation, the aircraft being in the region of zone W7 or S5.

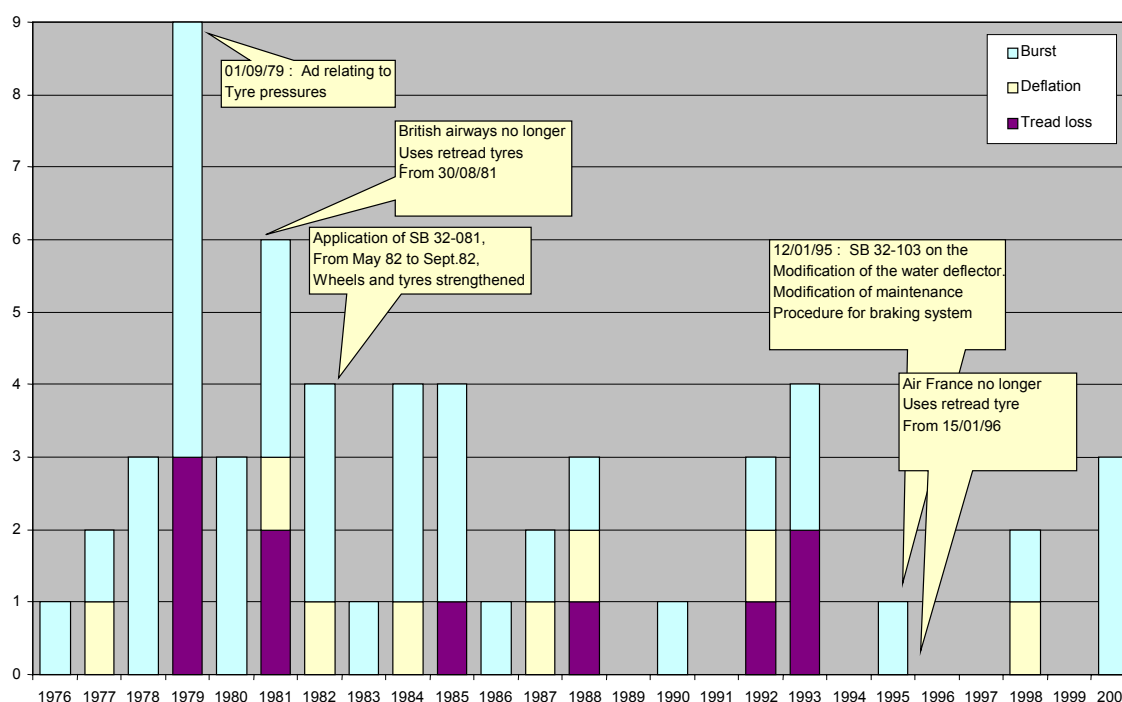
**Figure 45: History of Concorde tyre events**

- Twelve of these events had structural consequences on the wings and/or the tanks, of which six led to penetration of the tanks.
- Nineteen of the tyre bursts/deflations were caused by foreign objects.
- Twenty-two events occurred during takeoff.
- Only one case of tank penetration by a piece of tyre was noted.
- None of the events identified showed any rupture of a tank, a fire, or a significant simultaneous loss of power on two engines.

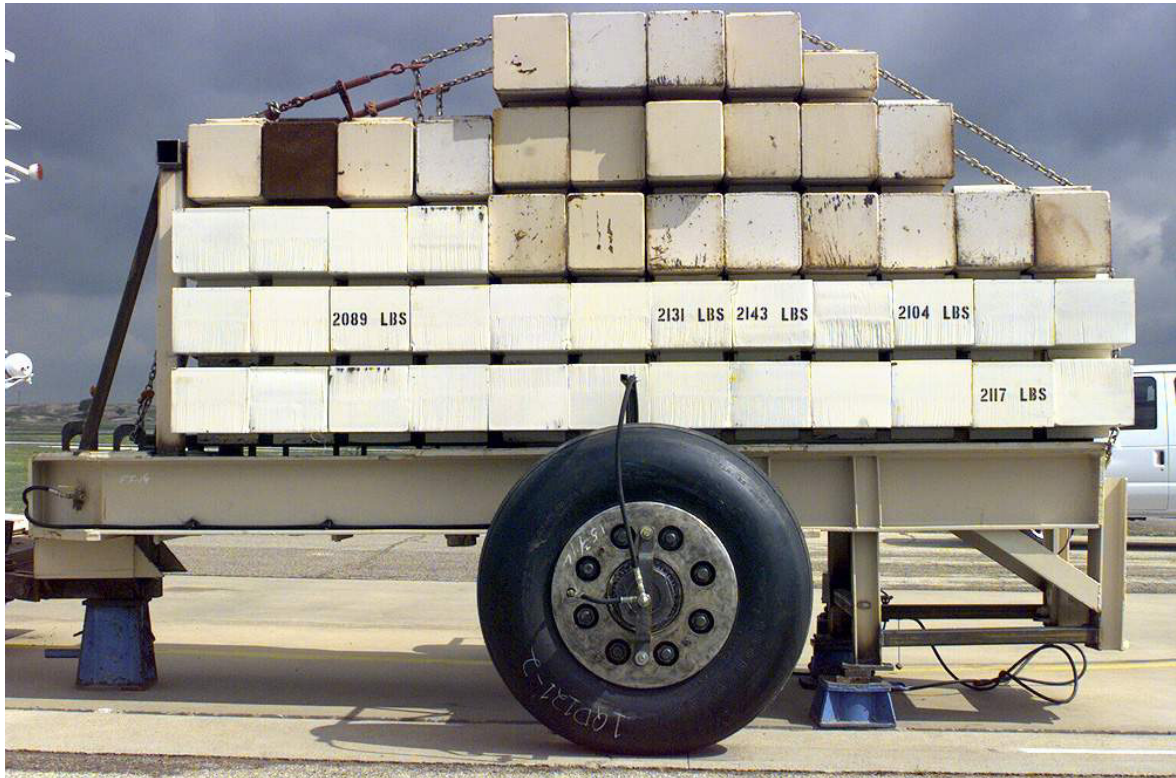
**Figure 47: Tyre Test Truck**

- an initial positioning of the strip, done with the titanium strip, resulted in its being flattened by the tyre,
- in a second position, the strip remained stable on its cutting side and the tyre was cut into,
- the tyre cut went right through its thickness, practically all across the width of the area in contact with the ground and in accordance with the shape of the strip,
- this cut continued as tearing onto the tyre shoulders and sidewalls through a static rupture in the direction of the reinforcing material of the tyre body,
- the static tear spread as far as the tyre beads, in other words slightly more deeply than the tear noted on the remains of tyre No 2 on F-BTSC.

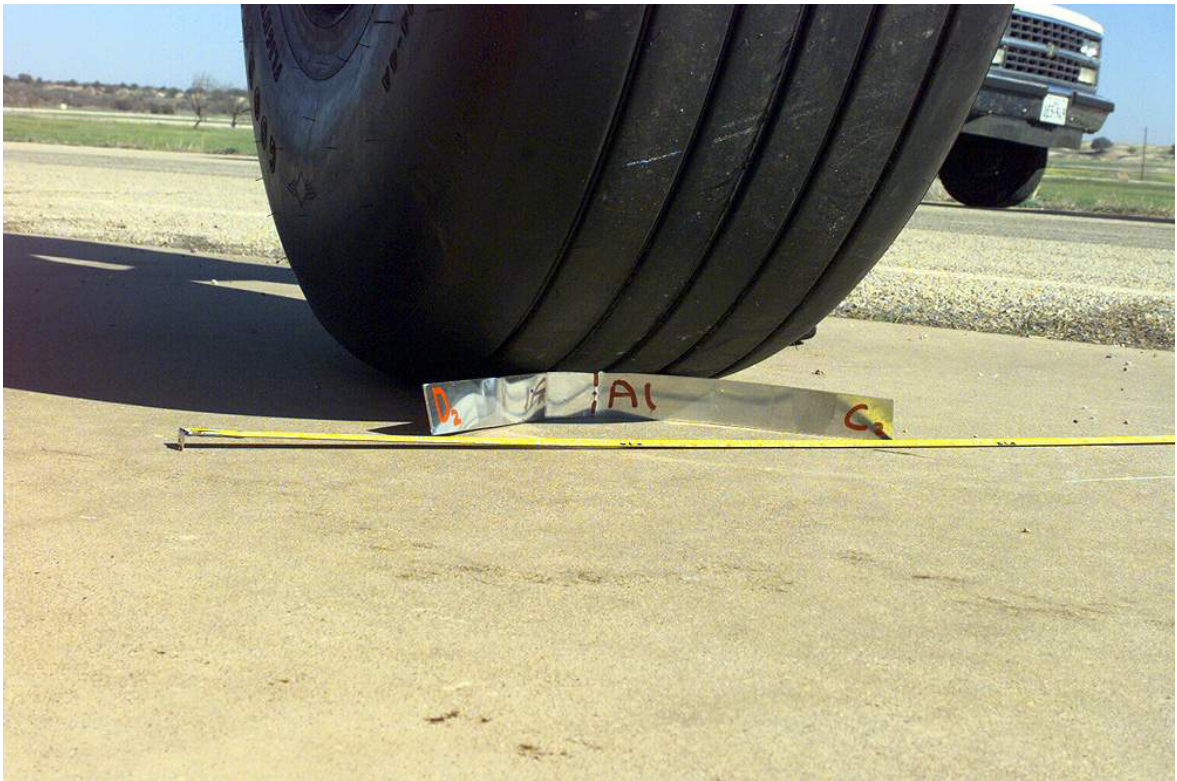
**Figure 48: Position of the metallic strip under the tyre**

Extension of the lines from the tear demonstrates that the piece that could be released was comparable to the piece of tyre found after the accident near to the strip.

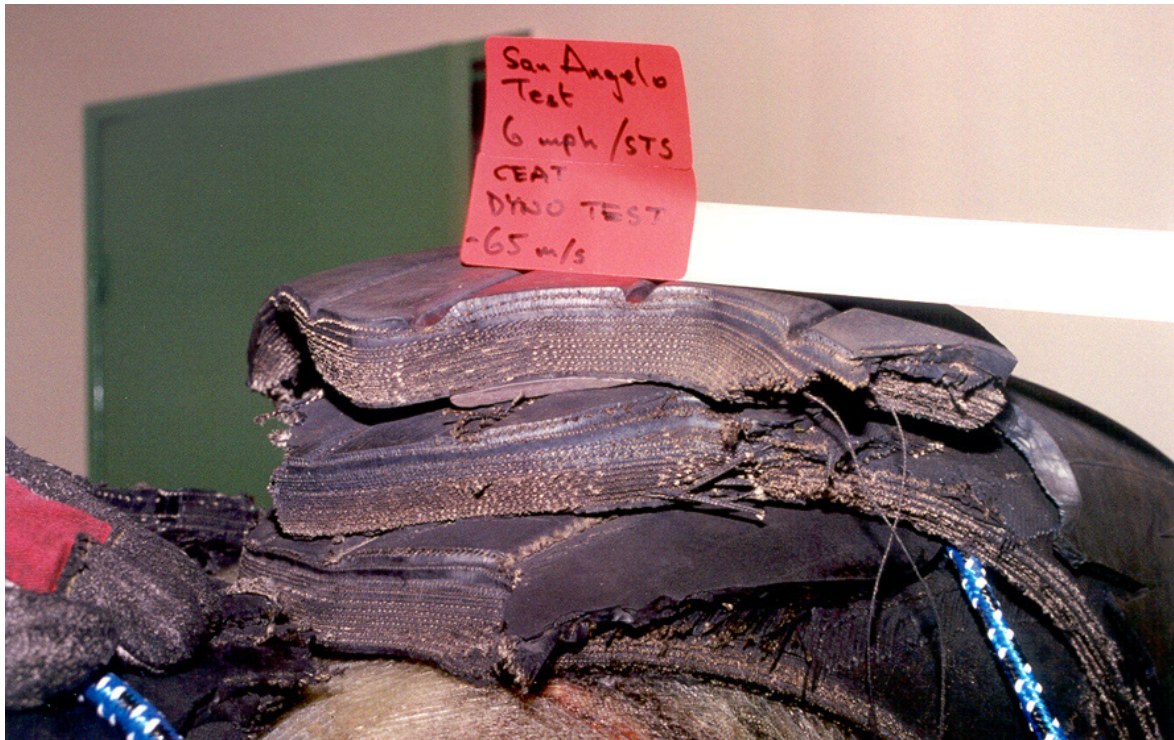
**Figure 50: Cuts in various Concorde tyres**

Various pieces of the tyre cut during the tests conducted in the USA and at the CEAT were examined at the LRCCP. Observation showed the resemblance of their rupture topography with that of tyre No 2.

The photo below shows the positioning of three pieces coming, from top to bottom, from tyre No 2 (speed of around 85 m/s), from a tyre tested at the CEAT with impact at 65 m/s and a tyre tried in the United States with impact at 2.5 m/s.

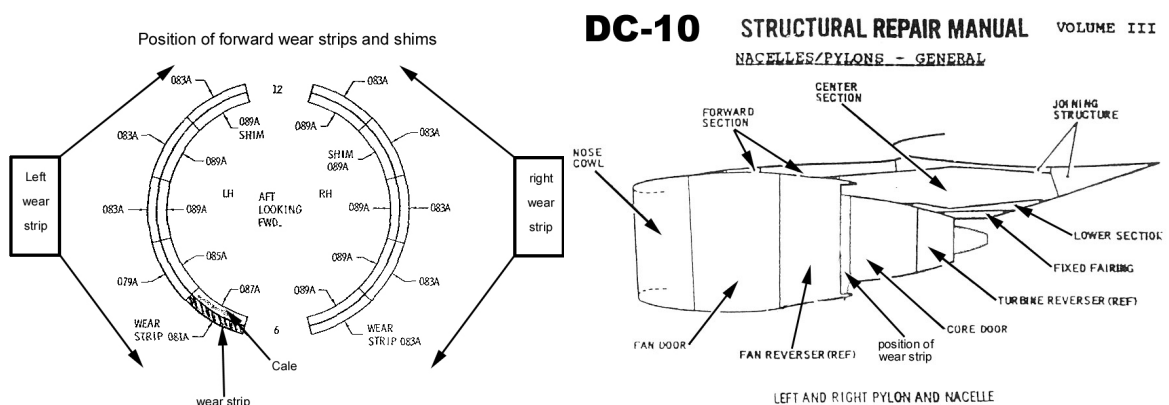
**Figure 51: Diagram showing the position of the wear strips**

The metallic strip found on the runway after the accident appeared to be an aviation part that did not belong to the Concorde. A search was therefore undertaken to identify the aircraft from which the part had fallen. This search was focused on the aircraft that had taken off from the same runway after 13 h 00. In addition, research on several types of aircraft showed that the part could be a wear strip from a CF6-50 engine fan reverser cowl.

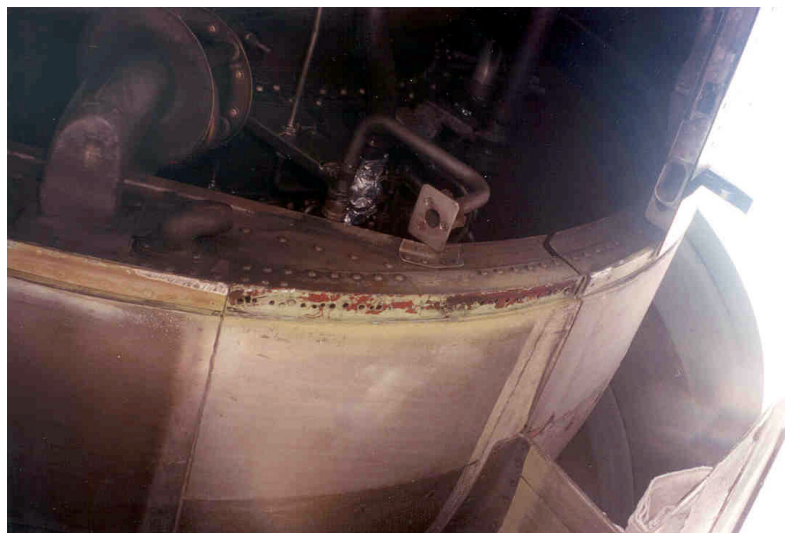
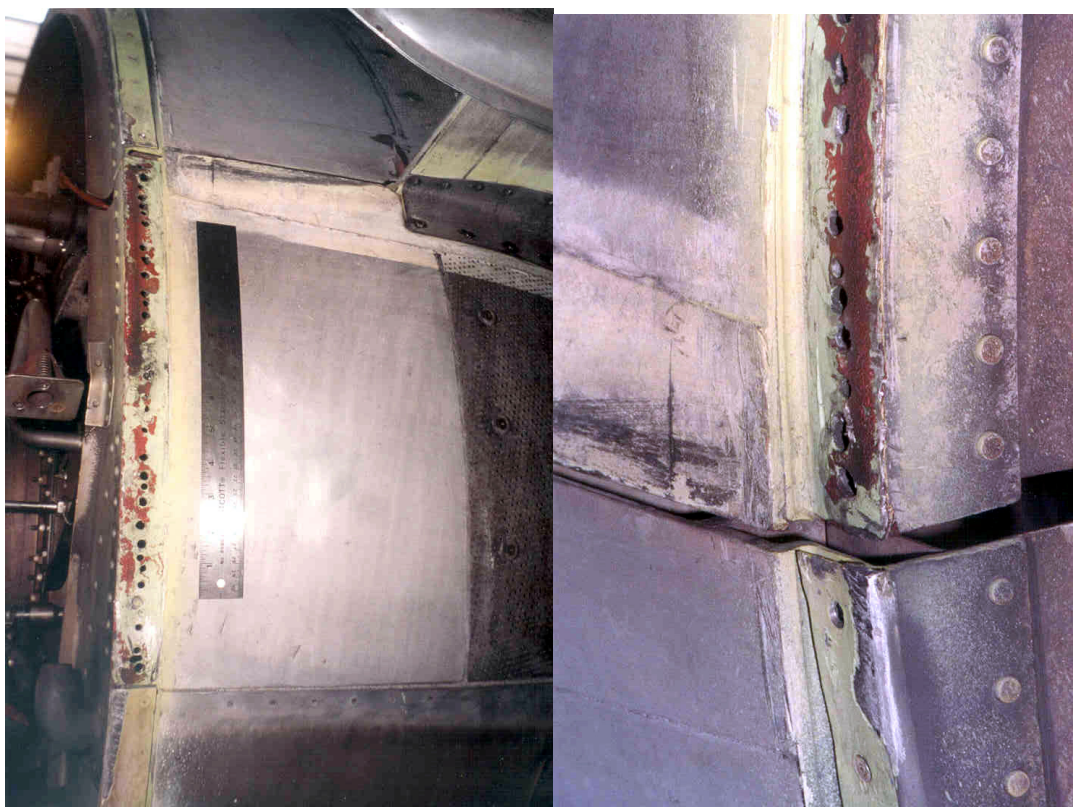
**Figure 52: Pictures showing the position of the wear strip**

- the lower left wear strip, about forty-four centimetres long, was missing. When closed, the forward part of the core door usually rests on the wear strip,
- the support was painted with green epoxy primer,
- in the position where the missing part would be, the support was covered in red type RTV 106 mastic,
- there was no trace of RTV 106 on the other parts of the support,
- there was no trace of RTV 106 on the wear strips which are in place,
- there were numerous paint runs on the support and on the wear strips and the paint,
- partially overlapped onto the fan reverser cowl,
- in the position of the missing part, the support still possessed several rivets,
- the support was drilled with thirty-seven holes, of which some had gaps between them,
- that were less than twice the diameter of the holes.

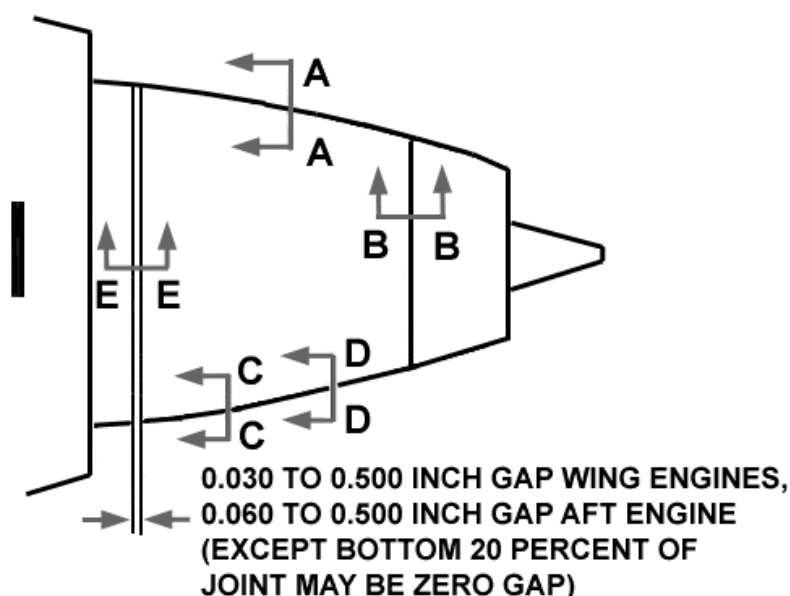
Figure 53: Diagram of cowl

During the investigation, it was noticeable on various aircraft that the play measured with engines stopped could exceed these values without touching the width of the wear strip. However, with the engine running, particularly when under takeoff thrust, the pressure inside the cowls is very high. Their deformation then seems to explain loss of a wear strip, which would no longer be attached to its support.

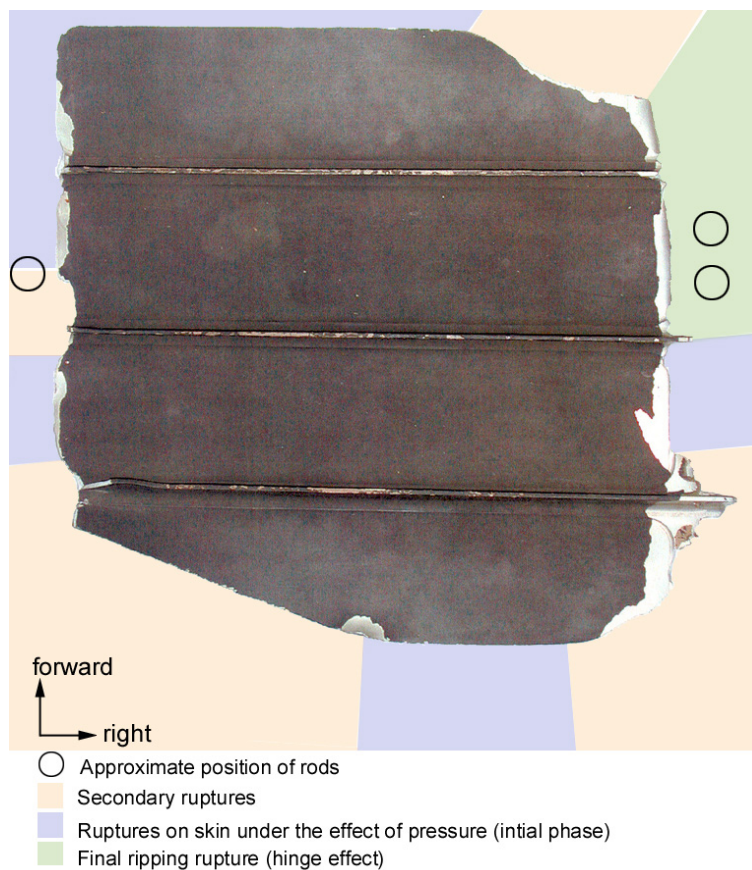
**Figure 56: Rupture sequence for piece from tank 5**

- some of the damage noted on the rear part was caused by impact with the ground,
- the cells possessed bulge deformations whose main line was perpendicular to the stiffeners. the radius of curvature measured in the areas away from the point of impact with the ground was of the order of 1.2 m,
- the ruptures in the thin skins were matt for the most part; the rupture face was angled at 45°, which indicates that these were static ruptures,
- the ruptures on the stiffeners displayed roughness characteristic of violent static ruptures following an abnormally high load.

The overall findings on this part show that it suffered pressure directed from the inside of the tank towards the outside, causing it to rupture in three phases as shown in the following figure:

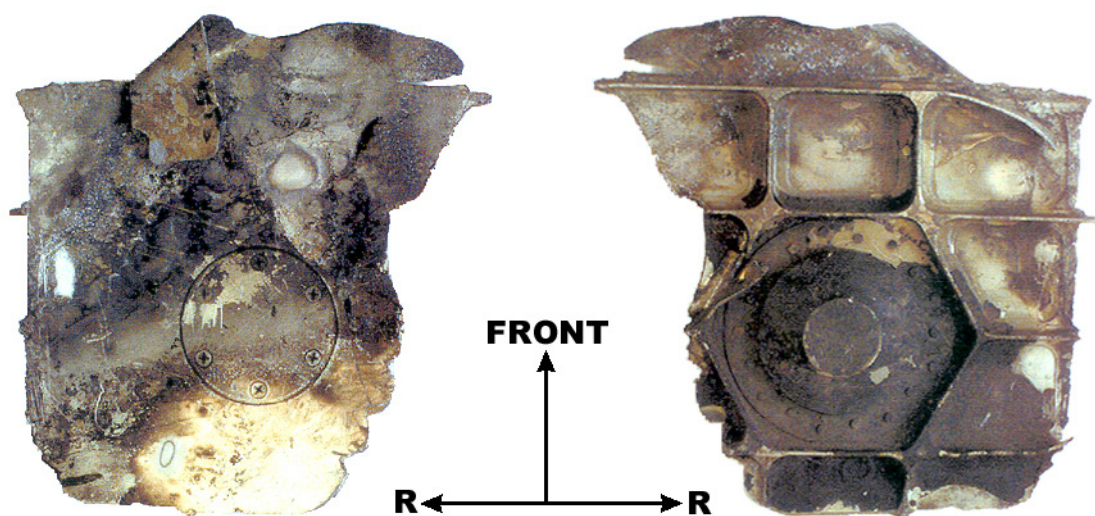
**Figure 57: Piece of tank 5 found at site**

A part found at the site was identified as coming from the underside of tank 5. It was located along spar 56 between ribs 24A and 24B.

The piece had not melted but the external paint and the internal black mastic were damaged on three-quarters of their surface and the material was overheated in this area. Only the remaining quarter, in the rear part, was intact.

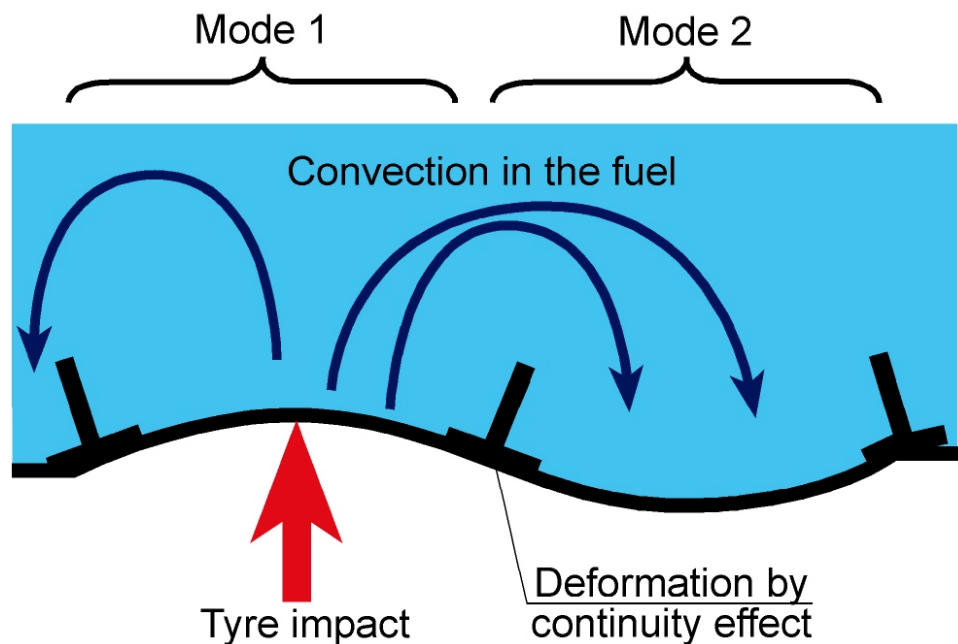
Figure 59: Effect of impact on wing box filled with fuel

- When the box contains liquid, a secondary effect can appear which contributes to the indirect mode, an effect due to:
  - o the wave of pressure that is propagated in the liquid at the speed of sound, that is to say at about 1,400 m/s. This wave diminished rapidly and after an initial pressure of two hundred bars, it was only about ten bars in the area where the indirect mode was expected;

- o the successive displacements of the liquid itself, at a speed of a few dozen metres a second. Because of the incompressibility of liquids, and in as much as the tank is “full”, that is to say there is no free surface too near the impact area that disturbs the phenomenon, this displacement tends to push the tank structure towards the outside, first of all in the nearest areas.

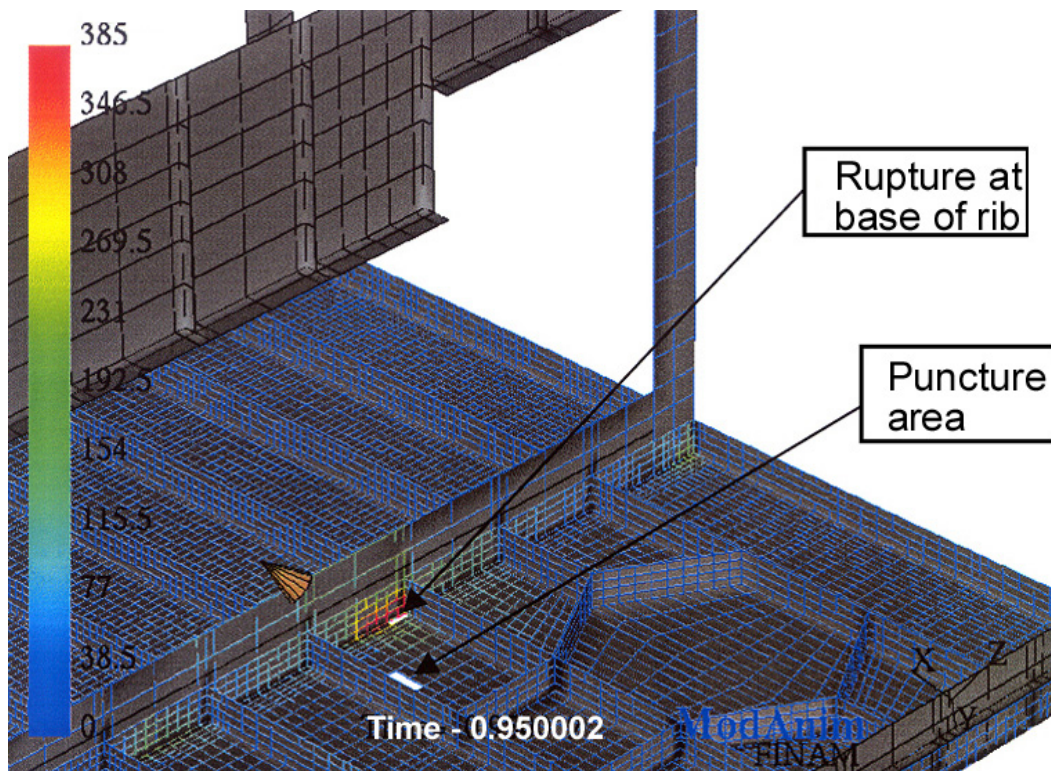
**Figure 61: Position of the rupture areas on the lower skin**

- the calculations for each simulation took place normally, without any accumulation of energy errors or numerical instability, which shows that the method was reliable;
- a hydrodynamic pressure surge phenomenon was observed following penetration and turning of the projectile in the tank;
- the loads transmitted to the structure did not lead to a rupture in the area affected by the pressure surge. However, they can lead to structural damage in the connection areas : the shock wave created overpressure that loaded the rib laterally and the resulting bending could initiate a local rupture at the base of the rib;
- the crack did not initiate in the puncture area itself.

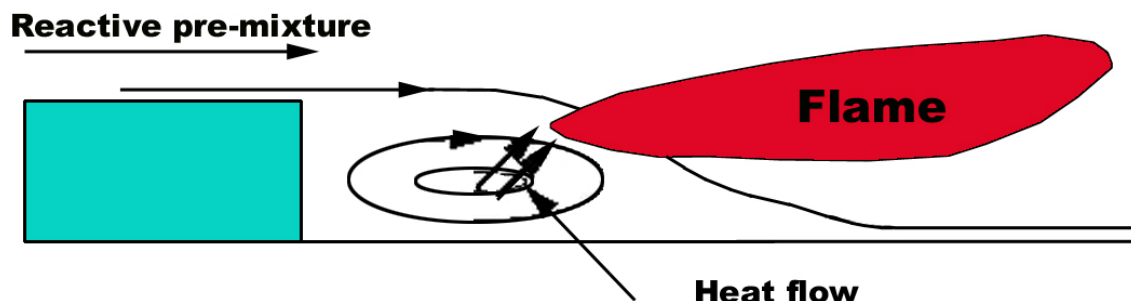
Figure 62: Re-circulation zone

- the re-circulation generates an area of low speeds,
- the re-circulation zone contains burnt gases and acts as a reservoir for hot gases that contribute to the ignition, slightly downstream, of the fuel-air mixture.

These mechanisms may explain the stabilisation of the flame in the left landing gear bay, as can be seen on photos of the aircraft on takeoff. Indications of stabilisation of the flame are not therefore necessarily apparent on the gear leg, partly because the flame is slightly stabilised downstream and in part because the leg is continuously cooled by the flow from upstream.

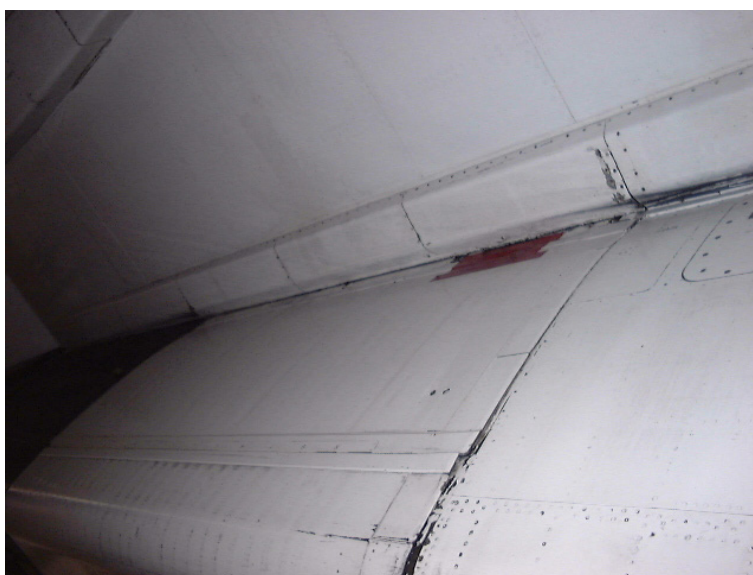
**Figure 65: In red, the lateral air conditioning air bleed door used for the air conditioning**

After the rupture of the tank, kerosene ingestion through the nacelle/engine assembly could have occurred through:

- the auxiliary air intake and/or the ventilation door,
- the air conditioning air bleed exchangers.

The kerosene ingested could have ignited on contact with the hot walls of the engine or on contact with the gas coming from the reheat, at the level of the thrust nozzle. In this area, many obstacles allow the development of re-circulation zones and ensure retention of the flame in the rear part of the engine. It should, however, be noted that no traces of fire were discovered during the examination of the engines.

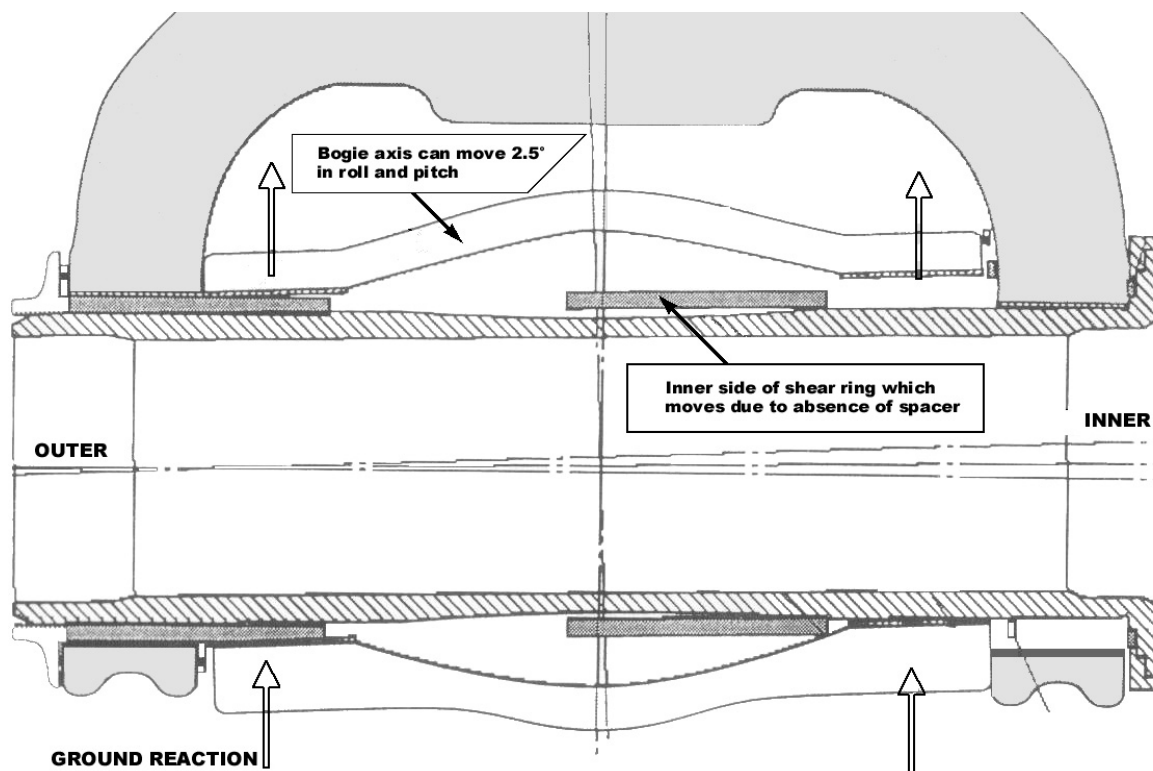
**Figure 68: Cross-section of landing gear bogie beam coupling**

During removal of the bogie, the extractor tool was not used. Only the bushes were extracted after removal of the axle. The spacer remained on the bogie. Because they were using the tool reference in their working document, the AMM, the personnel did not find the extractor in the store. A check carried out after the discovery of the anomaly on 23 October 2000 confirmed, however, the presence of two extractors.

During reinstallation, the shear rings were positioned directly in their end bogie beam shock strut bores, before the axle was reinstalled. This made it impossible to detect the absence of the spacer on the new bogie.

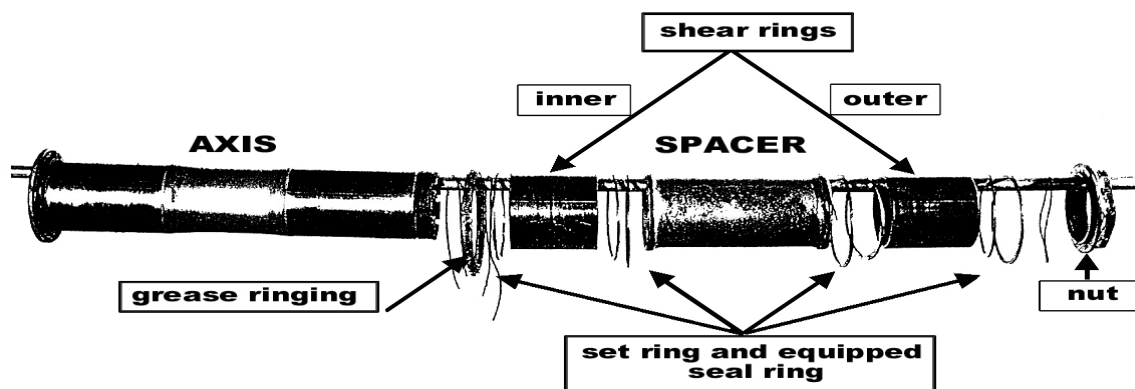
**Figure 69: Landing gear, parts of the bogie beam**

The checks and tests carried out before reintroduction into service brought no anomalies to light. These included manoeuvring the landing gear so as to extend and retract it. It should however be noted that, since the landing gear is not in contact with the ground, any possible alignment problems would not be noticeable.
