# BEA

*Accident  
on 25 July 2000  
at La Patte d'Oie  
in Gonesse (95)  
to the Concorde  
registered F-BTSC  
operated by Air France*

**REPORT translation**  
**f-sc000725a**

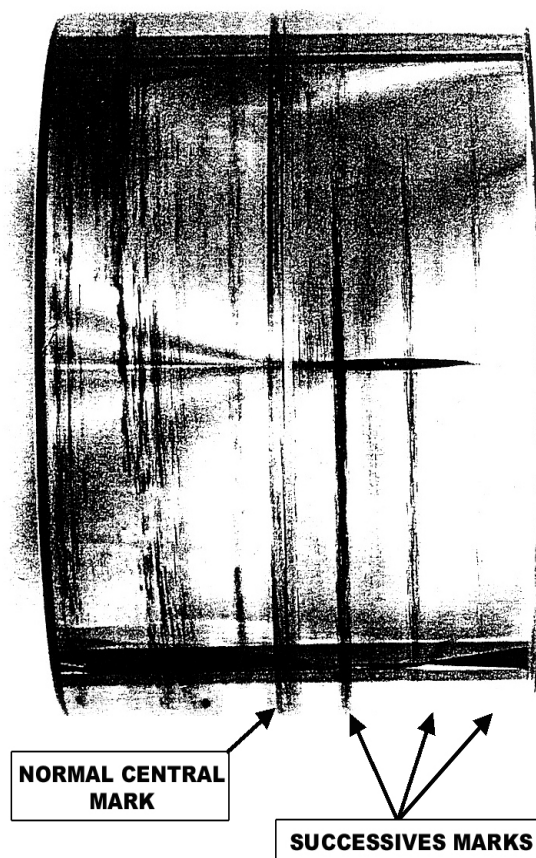
**Figure 70: Left landing gear, inner shear ring**

The condition of the various pieces (shear rings, bronze bearings, seals) show that the inner shear ring had moved from its position incrementally during the last few flights. The marks indicate that the mechanism was operational although the shear ring was no longer in its position on the bronze bearings of the shock absorber and bogie.

The exact chronology of this displacement is, however, difficult to determine since the ring was not new and certainly bore marks related to its previous usage. The only marks observed on the mechanical parts correspond to movements in the vertical plane alone or to normal oscillations of the bogie.

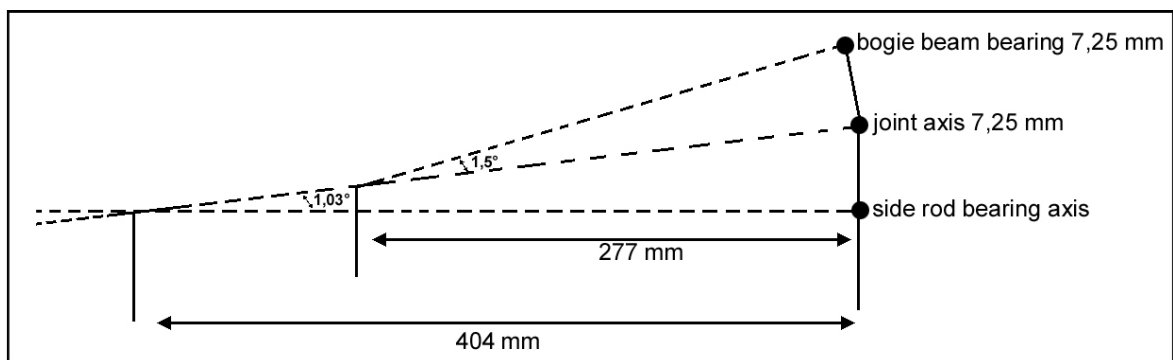
Figure 71: Effect of the lack of ring on the axle geometry

The bogie beam can move by the same amount in relation to the axis of the shaft, disregarding the residual guidance provided by the outer shear ring.

Maximum displacement of the geometrical axis of the bogie beam results from the combination of the two movements described above, which corresponds to 14.5 mm at the radius, thus a cone angle at the apex of  $5^\circ$ , the tip of the cone being located at the centre of the outer bearing.

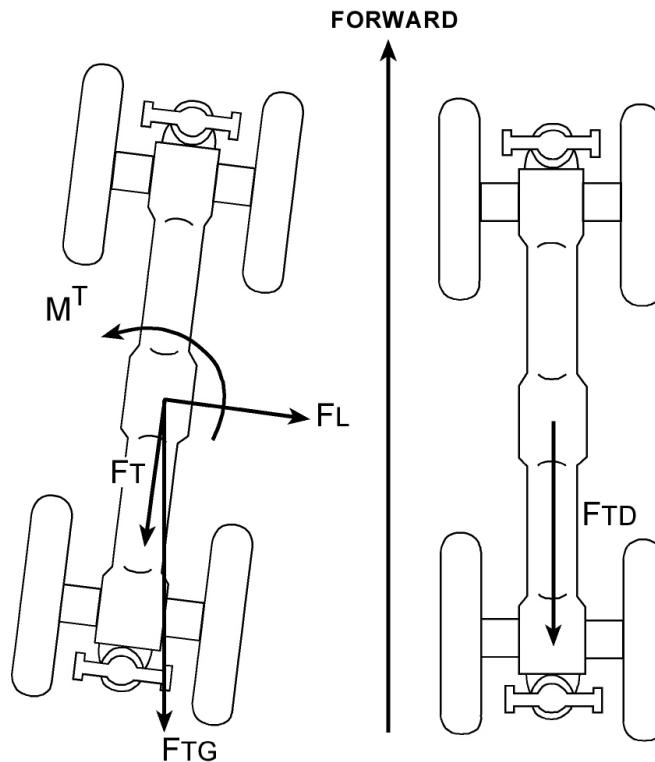
**Figure 73: Loads in sideslip situation**

Overall, the balance of forces at the centre of the bogie would result in self-aligning moment and two loads whose resultant is increased drag, that is to say a tendency to make the aircraft yaw to the left. The level of this drag would be at most around 1000 daN, very low in relation to the thrust of the engines. The influence of possible sideslip on the trajectory is thus very low or negligible.
