**AIR ACCIDENT INVESTIGATION
& AVIATION SAFETY BOARD
(AAIASB)**

AIRCRAFT ACCIDENT REPORT

**HELIOS AIRWAYS FLIGHT HCY522
BOEING 737-31S
AT GRAMMATIKO, HELLAS
ON 14 AUGUST 2005**

Accident of the a/c 5B-DBY of Helios Airways,
Flight HCY522 on August 14, 2005,
in the area of Grammatiko, Attikis,
33 km Northwest Of Athens International Airport

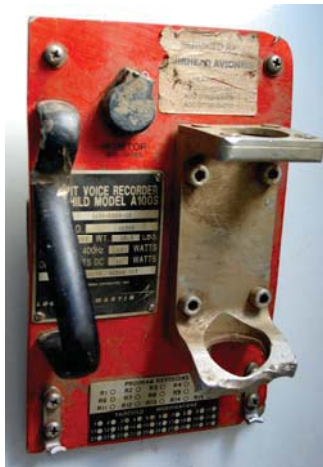
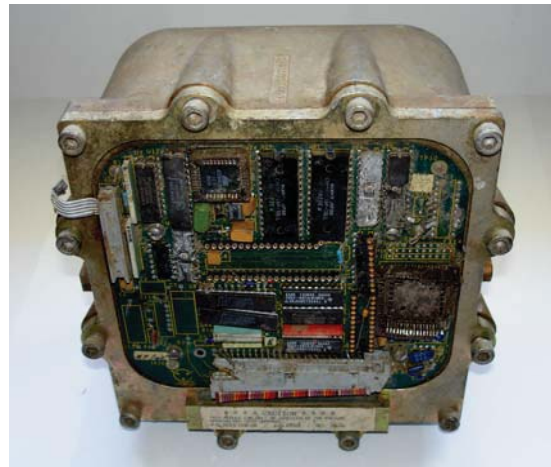
Photo – CVR

The CVR was taken to be transcribed at BEA (Bureau d’ Enquêtes et d’ Analyses) in France. The Flash Card Survivable Store Unit (FCSSU) was opened and the memory board was extracted. The memory board was connected to the acquisition part of the Solid State CVR by a cable from the FCSSU (memory-protected module). The cable was found in good condition; a new connector was plugged into the cable, which was then connected to BEA’S A100S unit, which was used as a reader. After the data extraction was completed, the last 30 minutes of the recording was obtained.

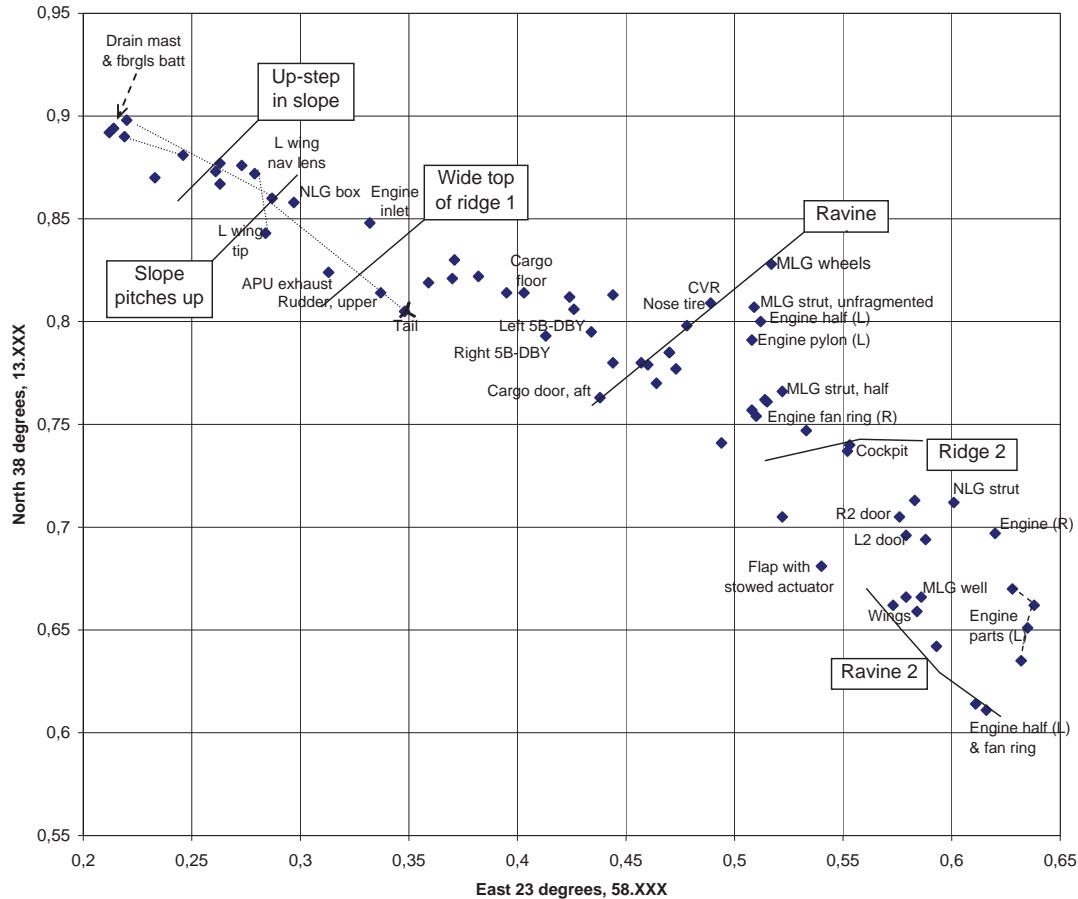
Diagram – Wreckage Distribution Map

The wreckage was distributed generally from west to east, over two rocky hills for a straight-line distance of about 800 m (Diagram - Wreckage Distribution Map and in Appendices the Wreckage Distribution Position Data). The first component found was a drain mast where the fuselage first impacted the ground. Tufts of fiberglass thermal-acoustic insulation batting were in the immediate area.

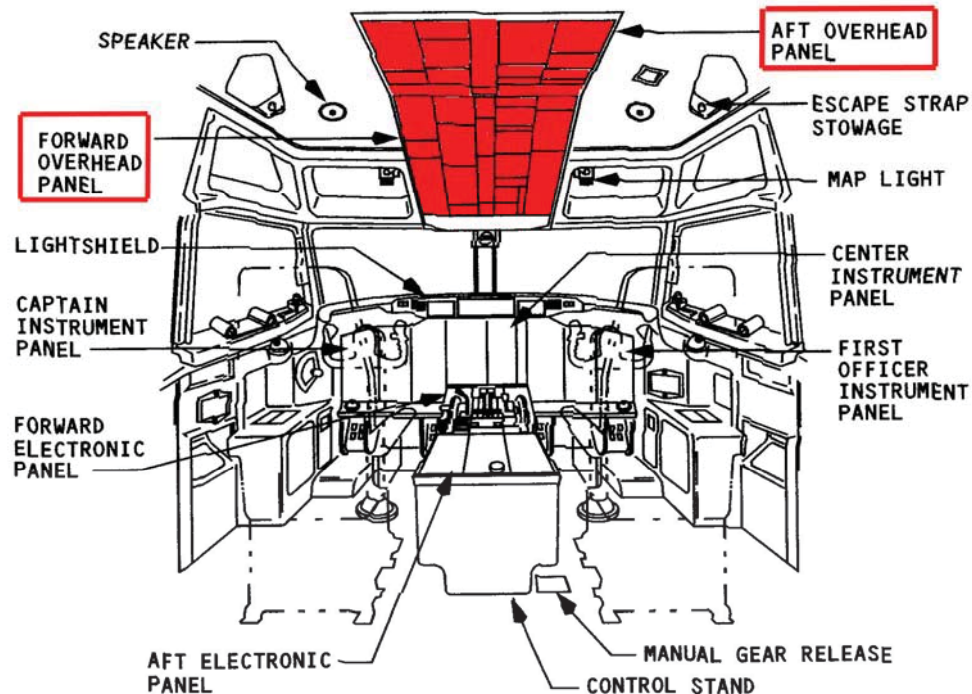
Diagram – Position of overhead P5 panel (marked in red)

The forward overhead P5 panel was located in the area of the cockpit within the wreckage at the accident site. The panel was accessed by removing the surrounding wreckage. Once the panel was located, low air pressure was used to remove the accumulated dirt, dust and light debris in order to visually examine the controls. The entire P5 panel was photographed and the position of the controls (toggle switches, selectors, switches, and indicators) were visually examined and documented. The controls were not activated.

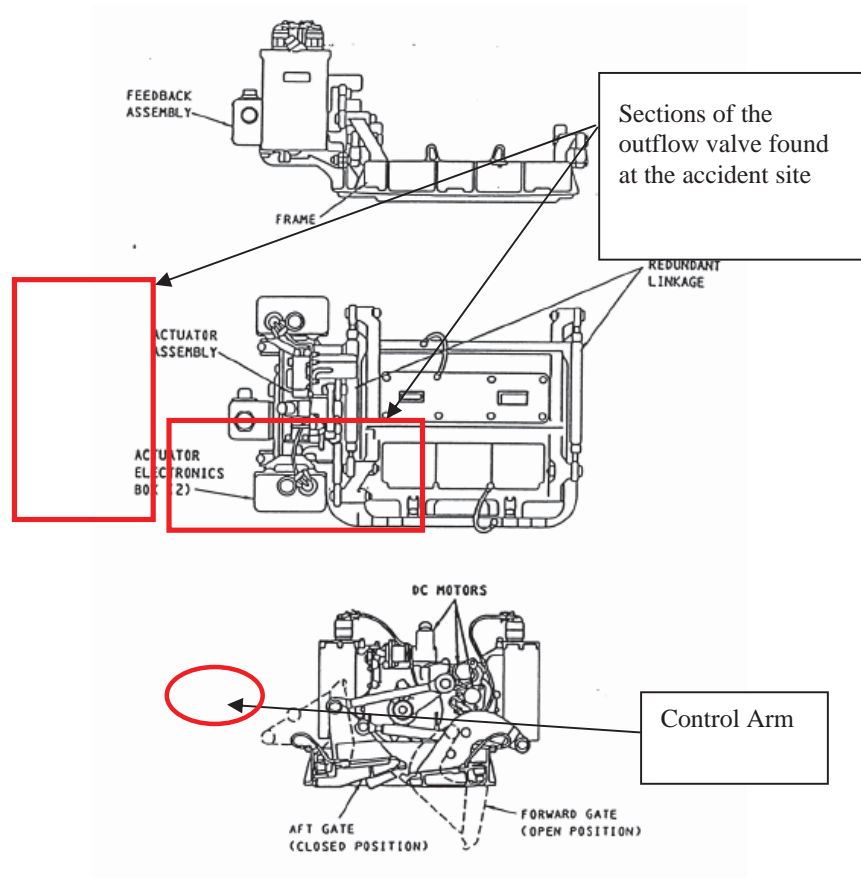
Diagram - Aft Outflow Valve

The actuator/motor assembly and both the forward and aft door gates of the aft outflow valve (AOV) were found at the accident site (see diagram and photos below and next page). The actuator/motor assembly was separated from each of the door gates. The condition of the actuator/motor assembly was documented and photographed at the accident site. The control arm and position indicator remained attached to the motor assembly. Using hand pressure, a small force was applied to the control arm; it was physically locked in place and not able to rotate freely. At the storage facility, a measurement was taken between the closed position stop and the control arm position lever; the distance between the two was 8.0 mm (see photo in the next page).
