# **NATIONAL TRANSPORTATION SAFETY BOARD**

**CONTROLLED FLIGHT INTO TERRAIN  
KOREAN AIR FLIGHT 801  
BOEING 747-300, HL7468  
NIMITZ HILL, GUAM  
AUGUST 6, 1997**

**National Transportation Safety Board. 2000. *Controlled Flight Into Terrain, Korean Air Flight 801, Boeing 747-300, HL7468, Nimitz Hill, Guam, August 6, 1997. Aircraft Accident Report NTSB/AAR-00/01. Washington, DC.***

NTSB/AAR-00/01  
PB00-910401  
Notation 6952B  
Adopted January 13, 2000

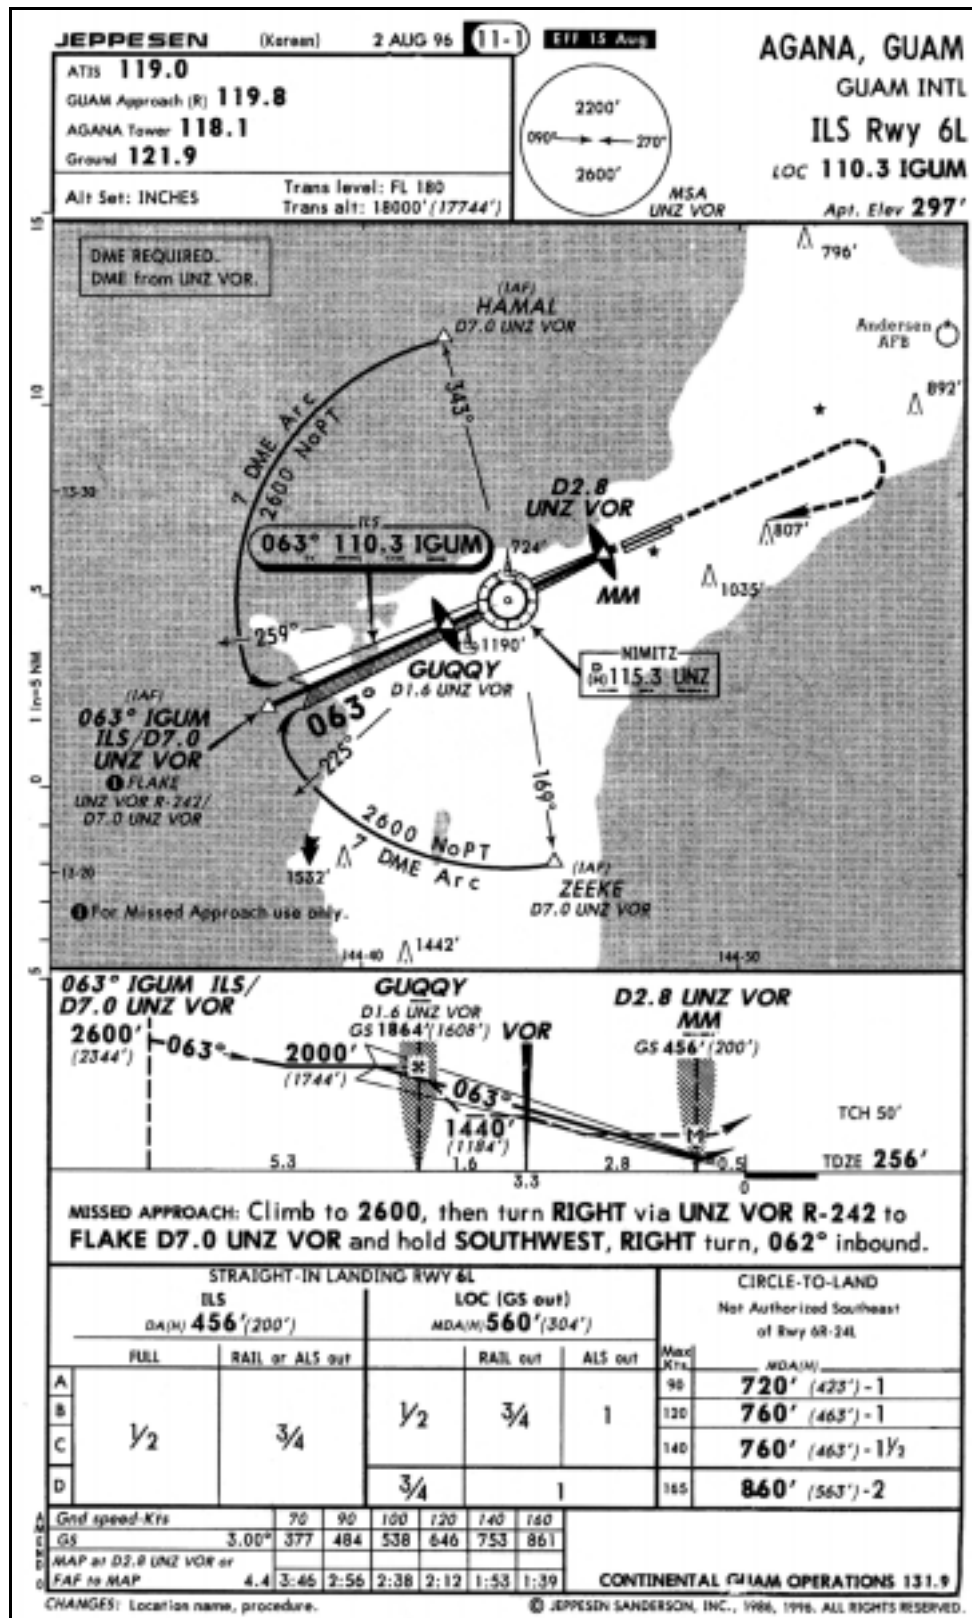
**Figure 1.** Instrument approach chart for the Guam International Airport runway 6L ILS procedure.

Figure 1 shows the instrument approach chart for the Guam runway 6L ILS procedure that was in effect at the time of the accident. Figures 2 and 3 show FDR information for the last 5 ½ minutes of flight, along with CVR comments and sounds and air traffic control (ATC) data.

The instrument approach charts for Guam International Airport in effect at the time of the accident were issued on August 2, 1996 (with an effective date of August 15, 1996). Changes incorporated in the August 2, 1996, 11-1, ILS runway 6L approach chart (shown in figure 1) included the location names, crossing altitudes, and the missed approach procedure. Table 2 details the specific differences between the January and August 1996 instrument approach charts.

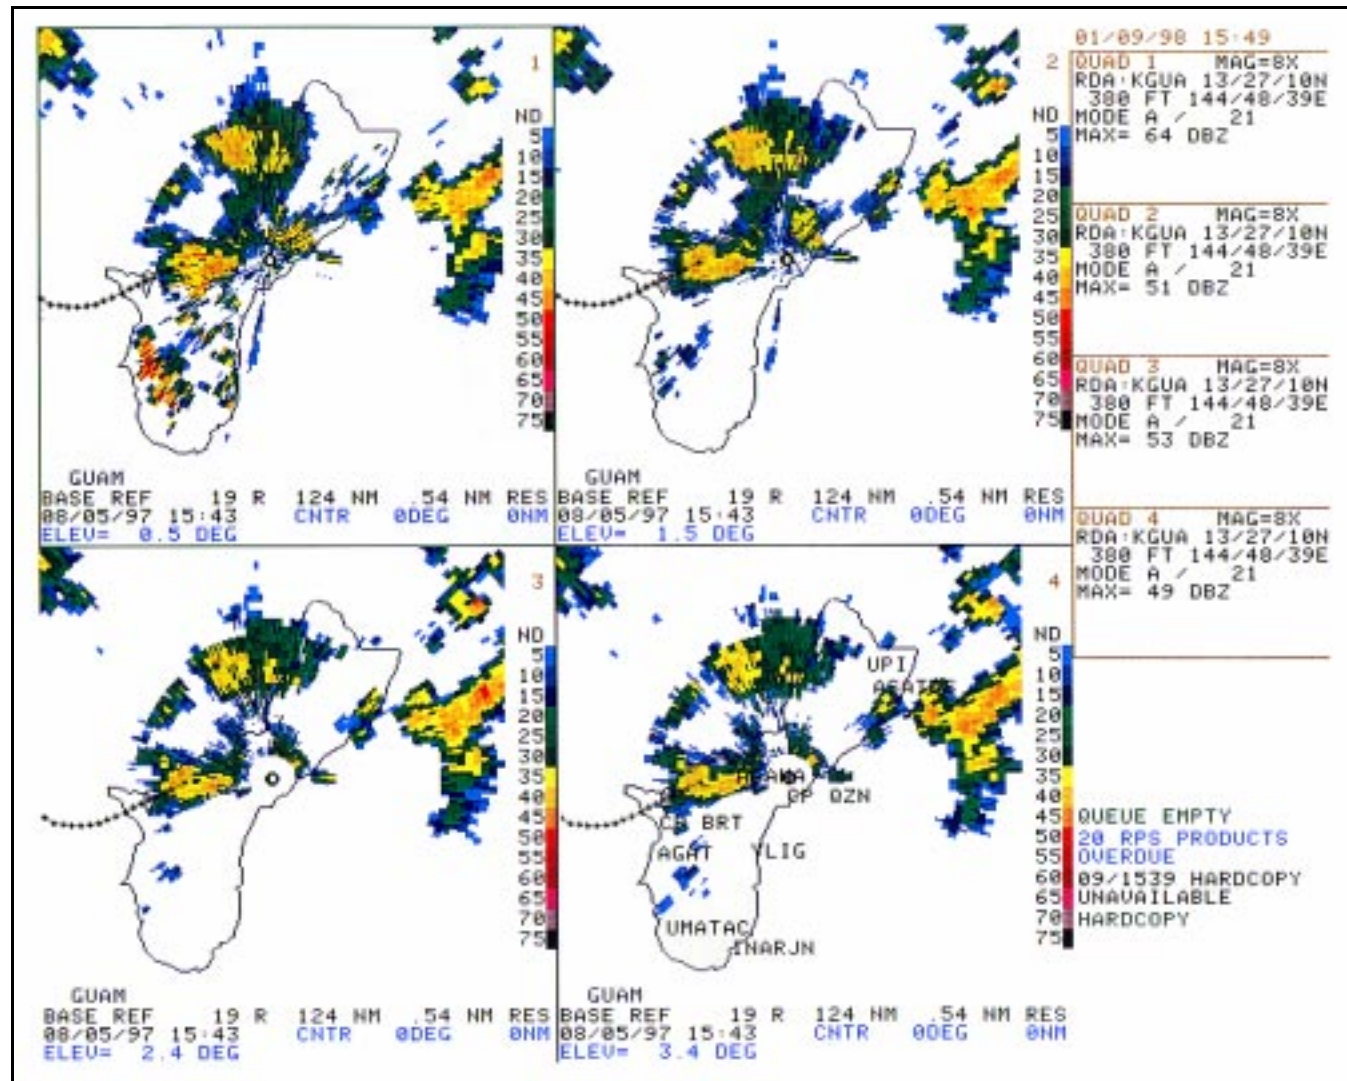
Figure 6. WSR-88D four-panel base reflectivity product for Guam.

The radar antenna of the Guam Weather Surveillance Radar-1988, Doppler (WSR-88D) was located about 5 nm east of the accident site. Data recorded about 0143 on August 6 (1543 UTC time on August 5, 1997) indicated an area of precipitation over higher terrain about 4 nm southwest of the airport, including Nimitz Hill. The precipitation was oriented east to west, about 7 to 8 nm long and 3 to 4 nm wide, and was moving toward the west. Figure 6 shows the WSR-88D four-panel base reflectivity product for 0143.
