Attempted Takeoff From Wrong Runway  
Comair Flight 5191  
Bombardier CL-600-2B19, N431CA  
Lexington, Kentucky  
August 27, 2006

NTSB/AAR-07/05

# Aircraft Accident Report

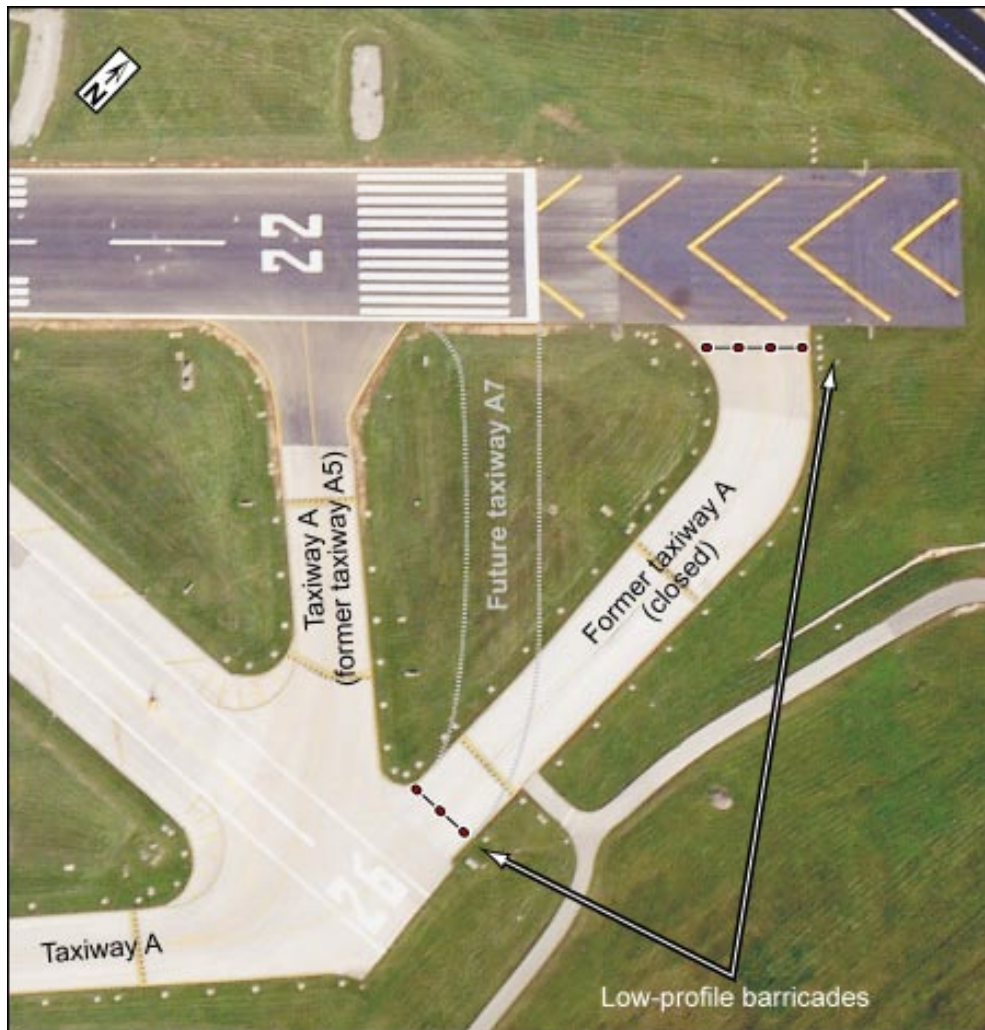
**Figure 3.** Taxiways Leading to Runways 4/22 and 8/26

From August 18 to 20, 2006, LEX was closed to resurface and paint new markings on runway 4/22 and change taxiway connector signage. On August 20, the airport was reopened at 1800, a local NOTAM was issued to announce the closure of taxiway A north of runway 8/26,<sup>61</sup> and low-profile barricades with flashing red lights were placed on that part of the taxiway. Former taxiway A5 was redesignated as taxiway A and was used by airplanes to access runway 22 before the construction of the new taxiway A7, which was planned to be completed about 30 to 45 days after the completion date of the repaving project (August 20). Figure 3 shows the locations of the existing (A), planned (A7), and former (A5 and A north of runway 8/26) taxiways.

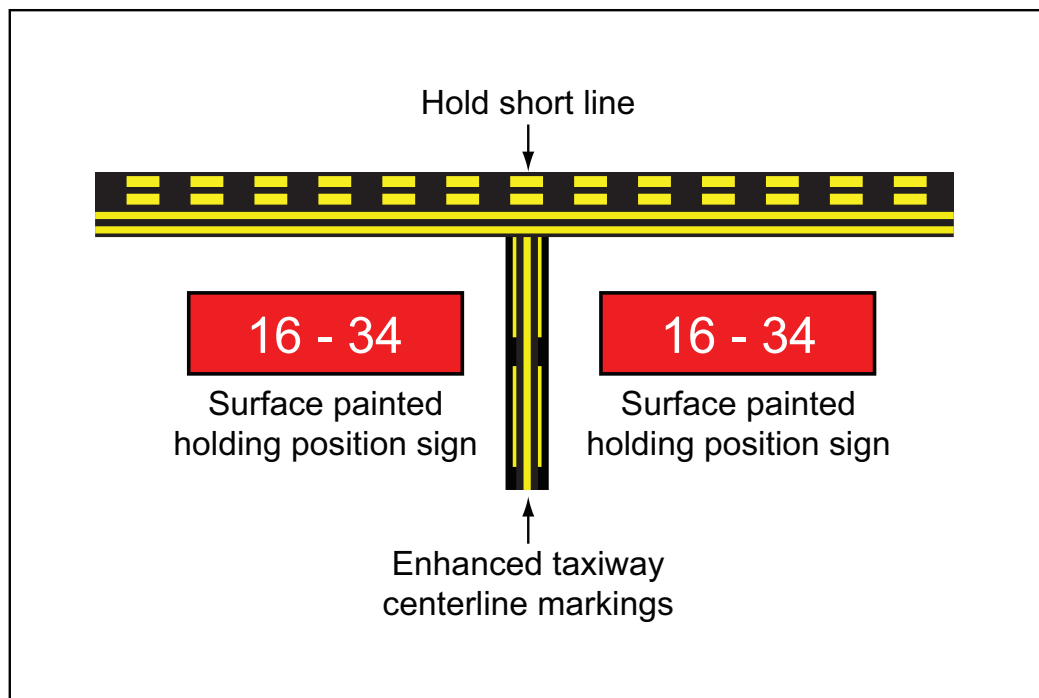
**Figure 5.** Enhanced Taxiway Centerline Markings and Surface Painted Holding Position Signs

Figure 5 shows an example of enhanced taxiway centerline markings and surface painted holding position signs. Enhanced taxiway centerline markings are not currently required, but, by June 30, 2008, all Part 139 airports with 1.5 million or more annual passenger enplanements will be required to have these markings before each runway holding position. Surface painted holding position signs are currently required only where the width of the holding position on the taxiway is greater than 200 feet.

In 2002, the FAA sponsored a study to determine whether paint markings would improve the situational awareness of pilots taxiing on an airfield. The study, which was undertaken by the Mitre Corporation, found that enhanced taxiway centerline markings and surface painted holding position signs (see figure 5) were effective in increasing runway awareness among transport-category pilots.

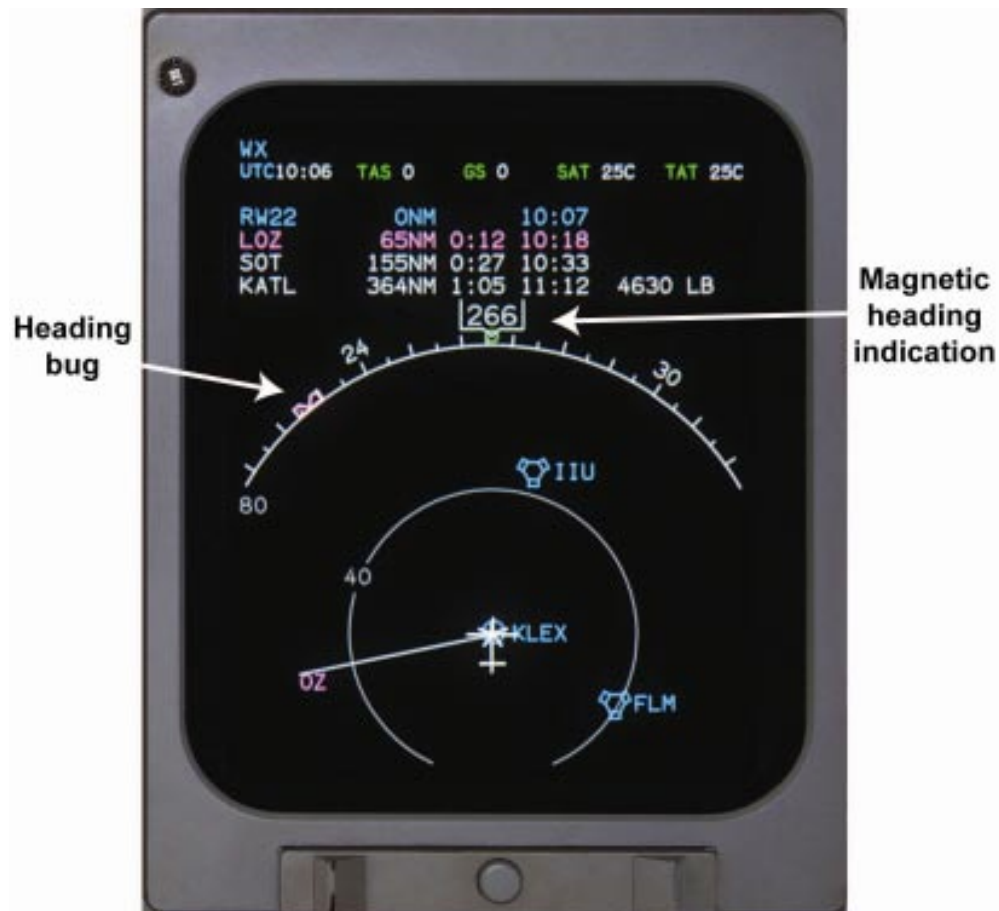
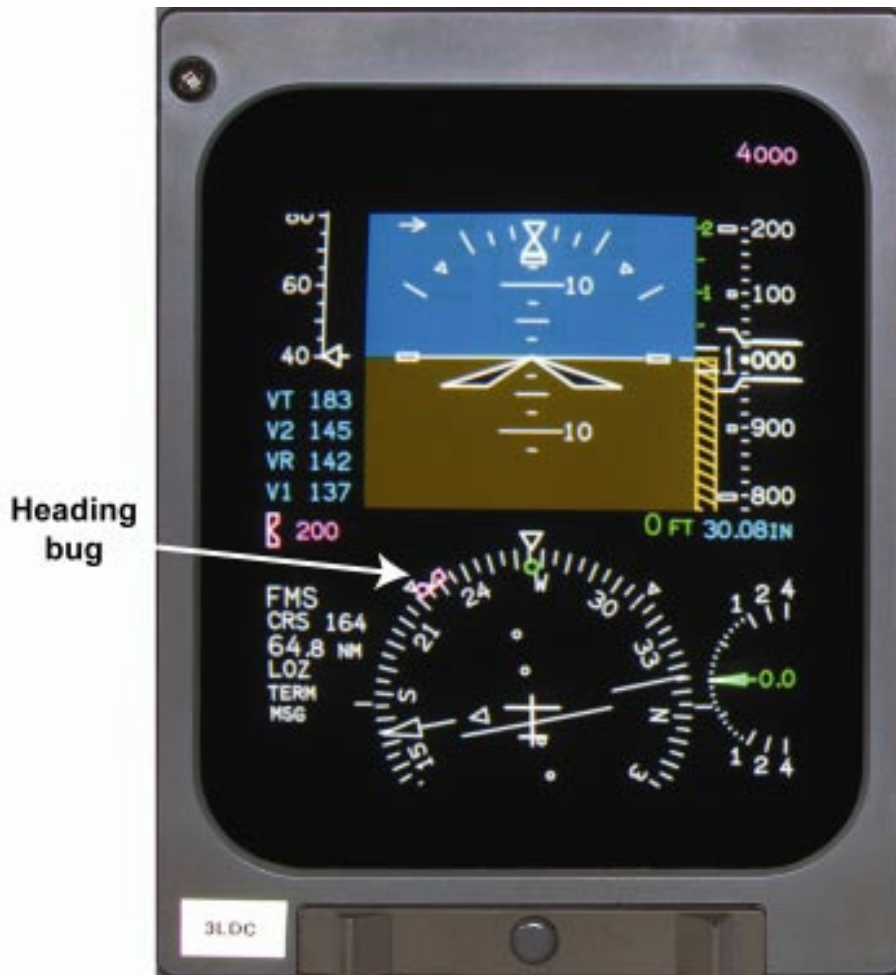
At the time that the first officer began to increase thrust for takeoff, FDR data showed that the magnetic heading of the airplane was about 266°, which corresponded to the magnetic heading for runway 26. Figures 6 and 6a show the approximate configuration of the captain's MFD and PFD, including the heading bug setting and magnetic heading indication, when the airplane was lined up on the runway 26 centerline. As shown in the figures, the heading bug was offset by 40°, providing a salient cue that the airplane was not lined up on the correct departure runway. The CVR did not record any awareness by the flight crewmembers about this offset.

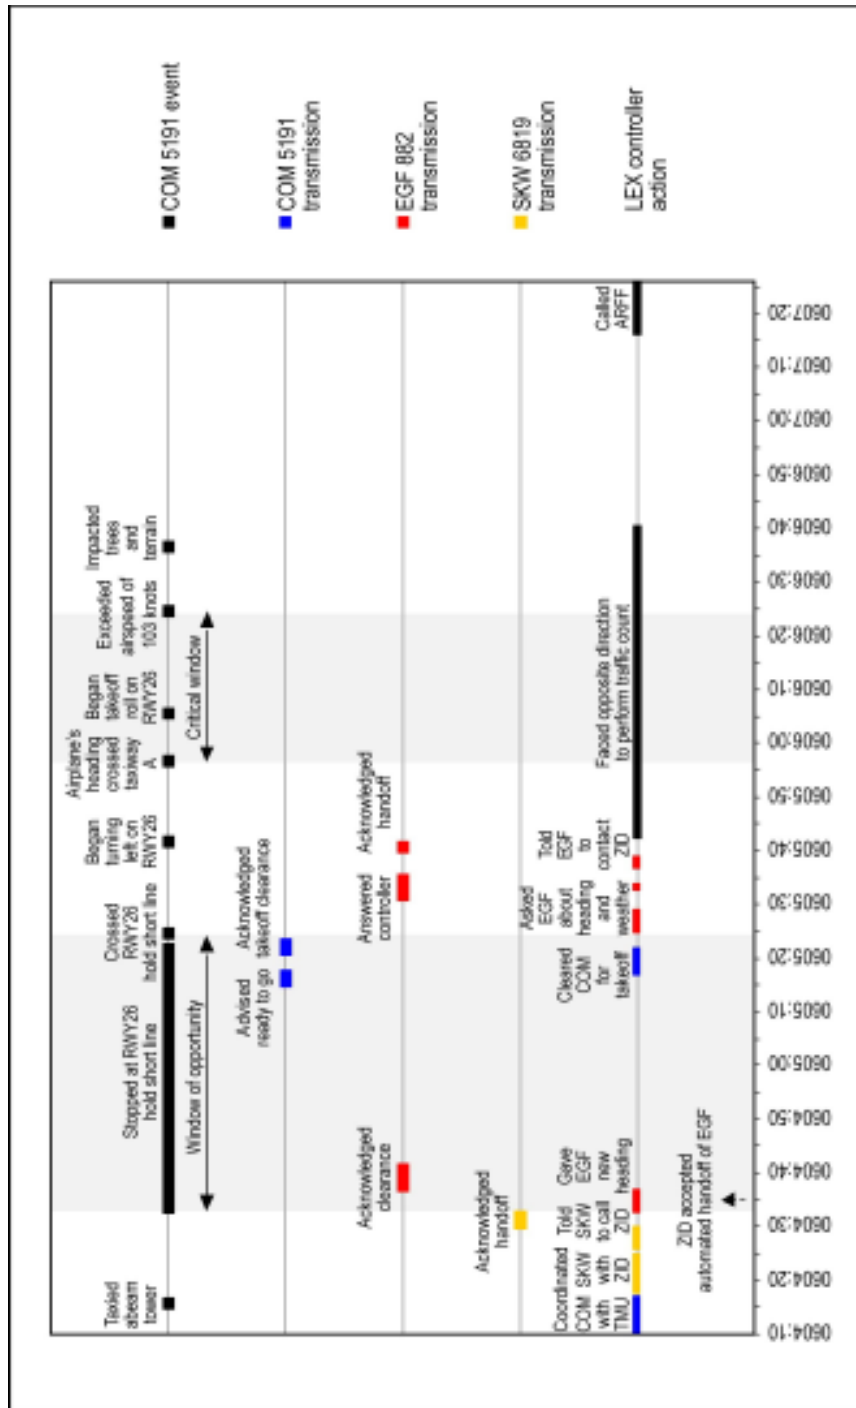
Figure 7. Air Traffic Control Event Timeline

The Safety Board examined possible reasons why the controller did not notice indications of the flight crew's surface navigation error either during the 50-second window of opportunity, which began about 2 minutes before the accident, or during the 28-second critical window, which began about 39 seconds before the accident. Figure 7 shows a detailed timeline of communications and events that occurred in the 2 minutes before the accident.
