AIRCRAFT ACCIDENT REPORT

IN-FLIGHT ICING ENCOUNTER AND LOSS OF CONTROL
SIMMONS AIRLINES, d.b.a. AMERICAN EAGLE FLIGHT 4184
AVIONS de TRANSPORT REGIONAL (ATR)
MODEL 72-212, N401AM
ROSELAWN, INDIANA
OCTOBER 31, 1994

VOLUME 1: SAFETY BOARD REPORT

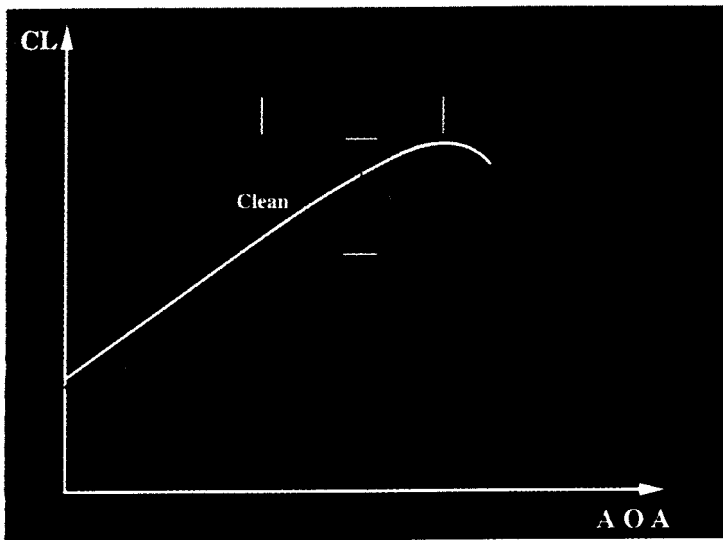
Fig. 3- Effect of certified ice shapes on lift curve - Flaps 30°, gear down standard de-icers

The lift curves are substantially modified compared to clean aircraft (fig. 3):

When the maximum lift capability of the wing decreases by 25%, the actual stall speed is 12% higher than the basic stall speed (aircraft clean). So an iced aircraft (fig. 3) flying at a given speed (and thus at a given CL) will have stall margin reduced either looking at angle of attack (6°5 less margin) or looking at stall speed (12% less margin).

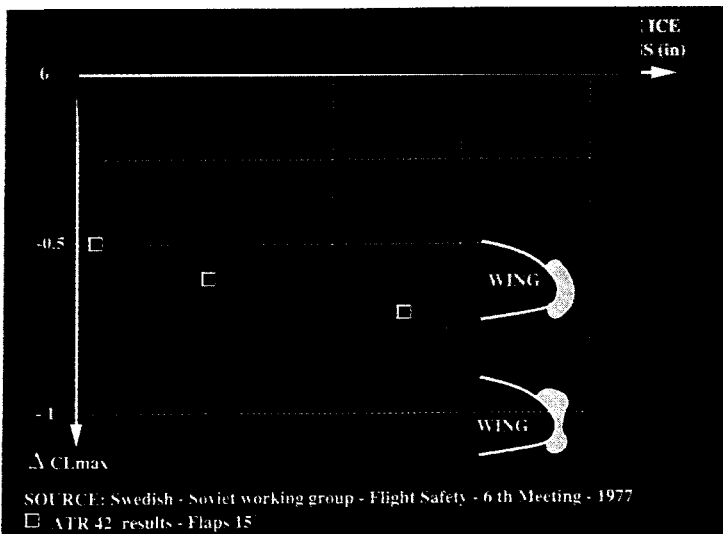
Fig. 4 Effect of ice shape on CL_{max} - Wind tunnel tests - Flaps 15°

More surprising is the fact evidenced by fig. 4: the bulk of the maximum lift degradation is already there for accretions as small as a few millimeters.

A CL_{max} decrease of 0.5 typically means a stall speed increase of 10 kt for an ATR 42 with

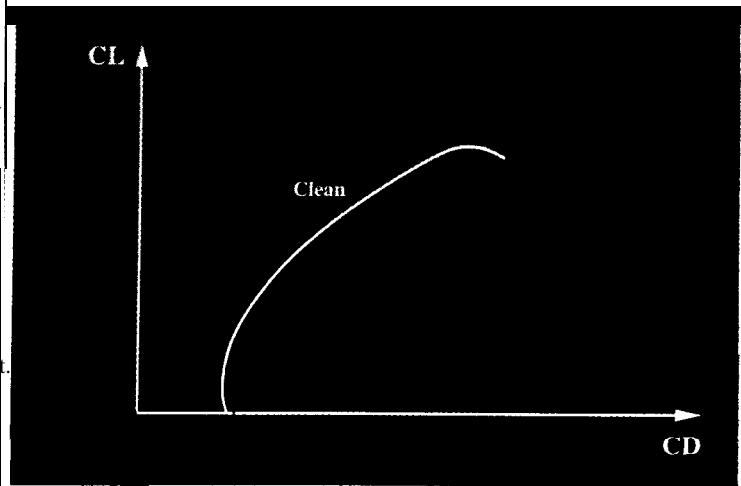
Fig. 5- ATR 72- Effect of certified ice shapes on drag polar. Flaps 0°. Standard de-icers

The drag polar is also heavily affected (fig. 5)

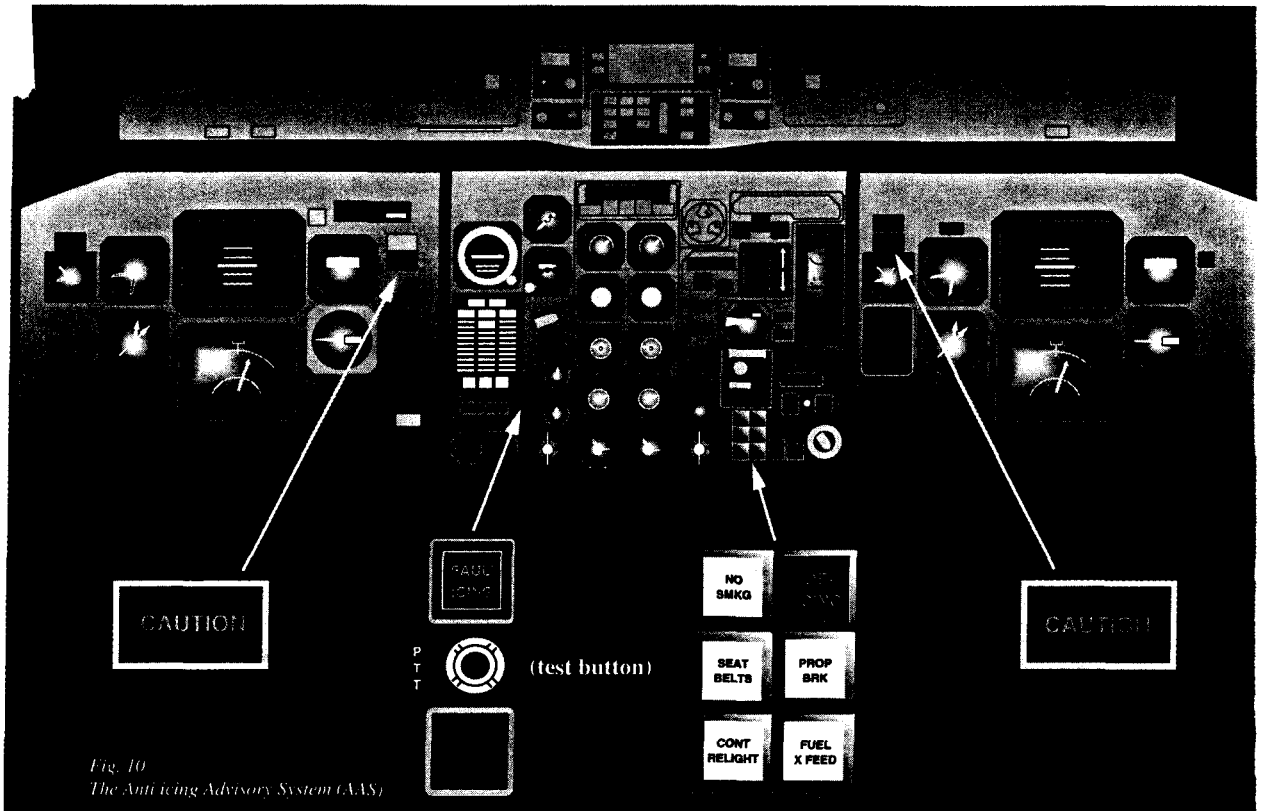
Fig. 10
The Anti Icing Advisory System (AAS)

The electronic ice detector is located under the left wing and alerts the crew as soon as and as long as ice accretion develops on the probe. Aural and visual alerts are generated (amber ICING light on the central panel and single chime).

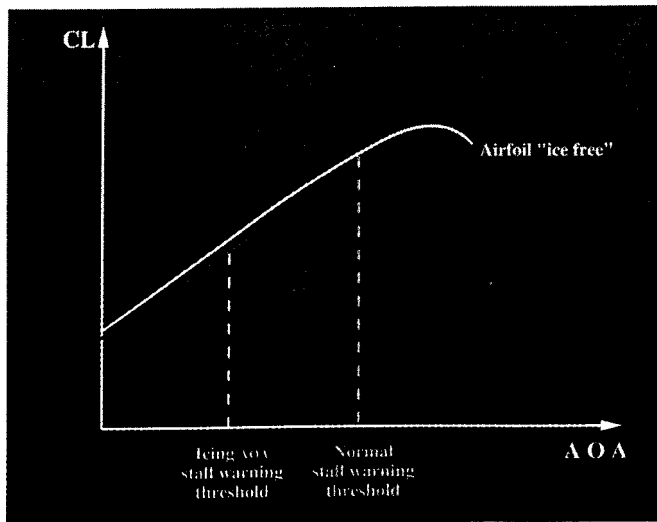
Fig. 12

Stall occurs at higher speeds (fig. 12) when ice accretion spoils the airfoil, therefore the stall warning threshold must be reset to a lower value of angle of attack.

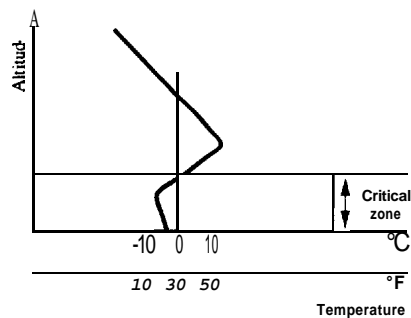
Fig. 13- Temperature in inversion is a zone where temperature increases with altitude.

Freezing rain normally occurs as a result of weather conditions where temperature increases with altitude (temperature inversion, ref. fig. 13). Warm rain falls from or passes through this warm layer into a region of subfreezing temperature and typically becomes supercooled. These supercooled large rain drops will then freeze upon impact with an object.
