AIRCRAFT ACCIDENT REPORT

IN-FLIGHT ICING ENCOUNTER AND LOSS OF CONTROL
SIMMONS AIRLINES, d.b.a. AMERICAN EAGLE FLIGHT 4184
AVIONS de TRANSPORT REGIONAL (ATR)
MODEL 72-212, N401AM
ROSELAWN, INDIANA
OCTOBER 31, 1994

VOLUME II: RESPONSE OF BUREAU ENQUETES-ACCIDENTS
TO SAFETY BOARD'S DRAFT REPORT

COMMENTS OF THE BUREAU ENQUETES ACCIDENTS (FRANCE)

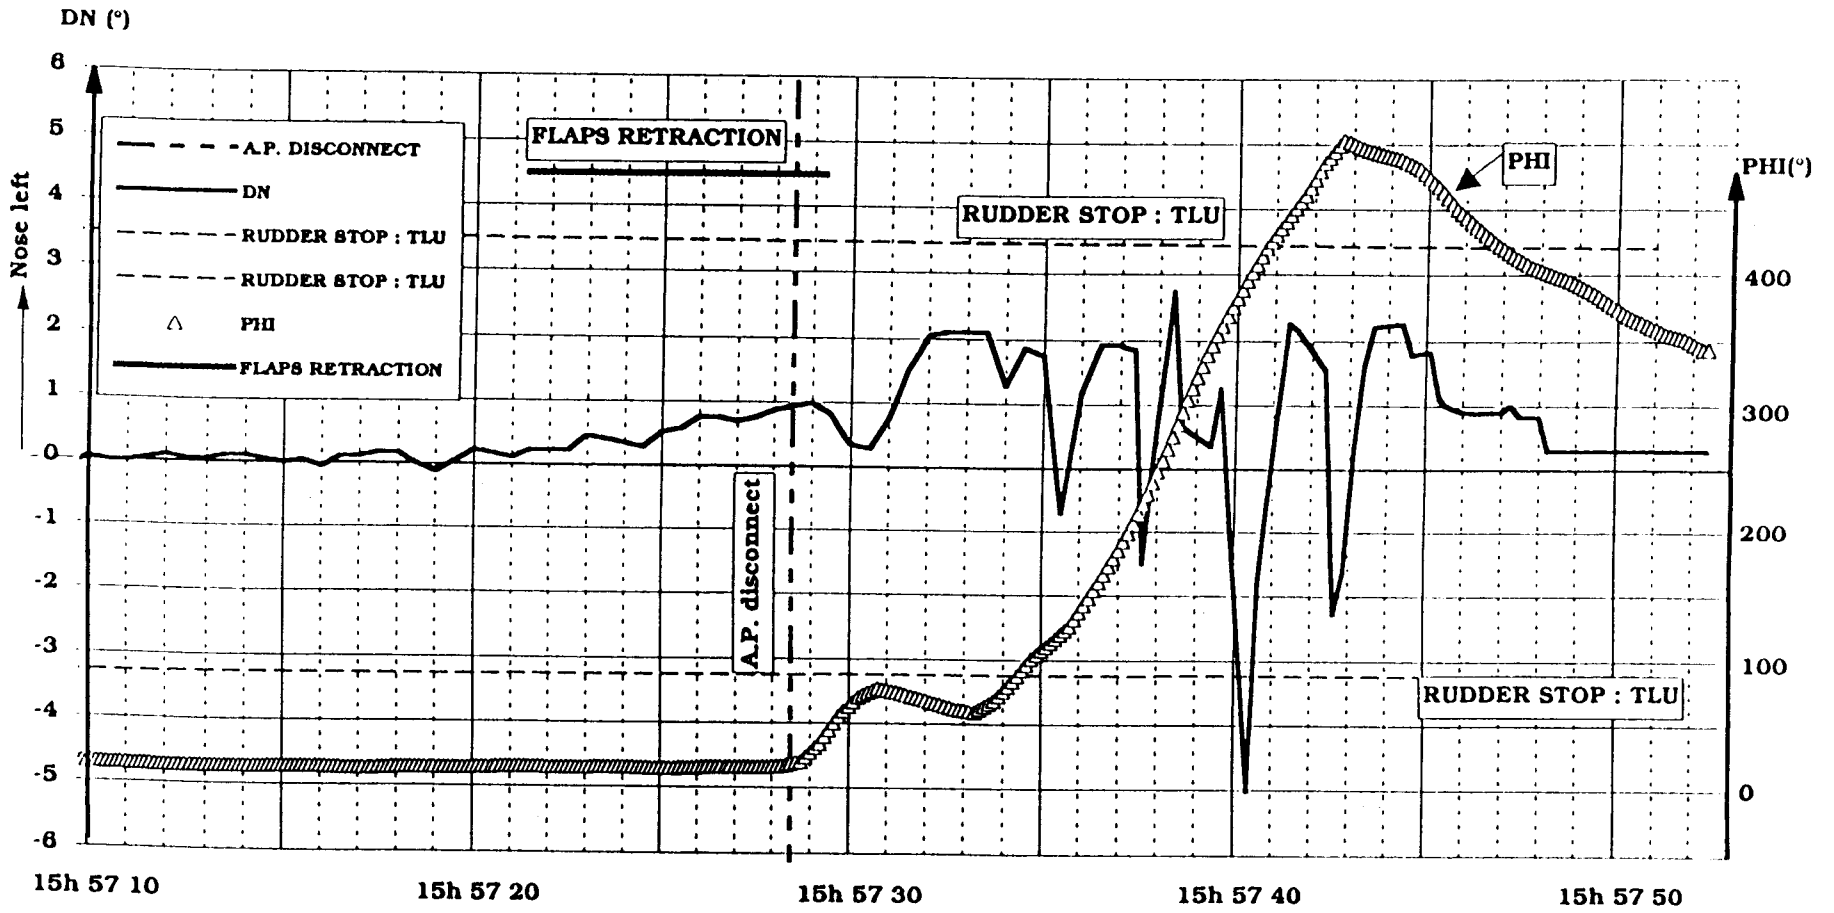
FIGURE 17 : YAW CONTROL INPUTS / ACTIVITY AFTER ROLL UPSET

A limited control activity mainly during inverted flight

In addition, the CVR transcript shows that there was almost no discussion between the flight crew in respect to how to respond to the roll upset. Following the initiation of the roll, there was no discussion between the flight crew members regarding the aircraft's attitude or airspeed, nor was there any conversation between them in respect to how to respond to the aircraft's attitude. Further, the First Officer never asked for any help in controlling the aircraft or in responding to the event, nor is there any indication that the Captain exercised his command authority to take over the controls, nor to identify the unusual attitude of the aircraft or to appropriately comment the First Officer's inputs. This shows that the flight crew, probably disoriented, did not identify the unusual attitude nor understood the fast moving evolutions of the aircraft.

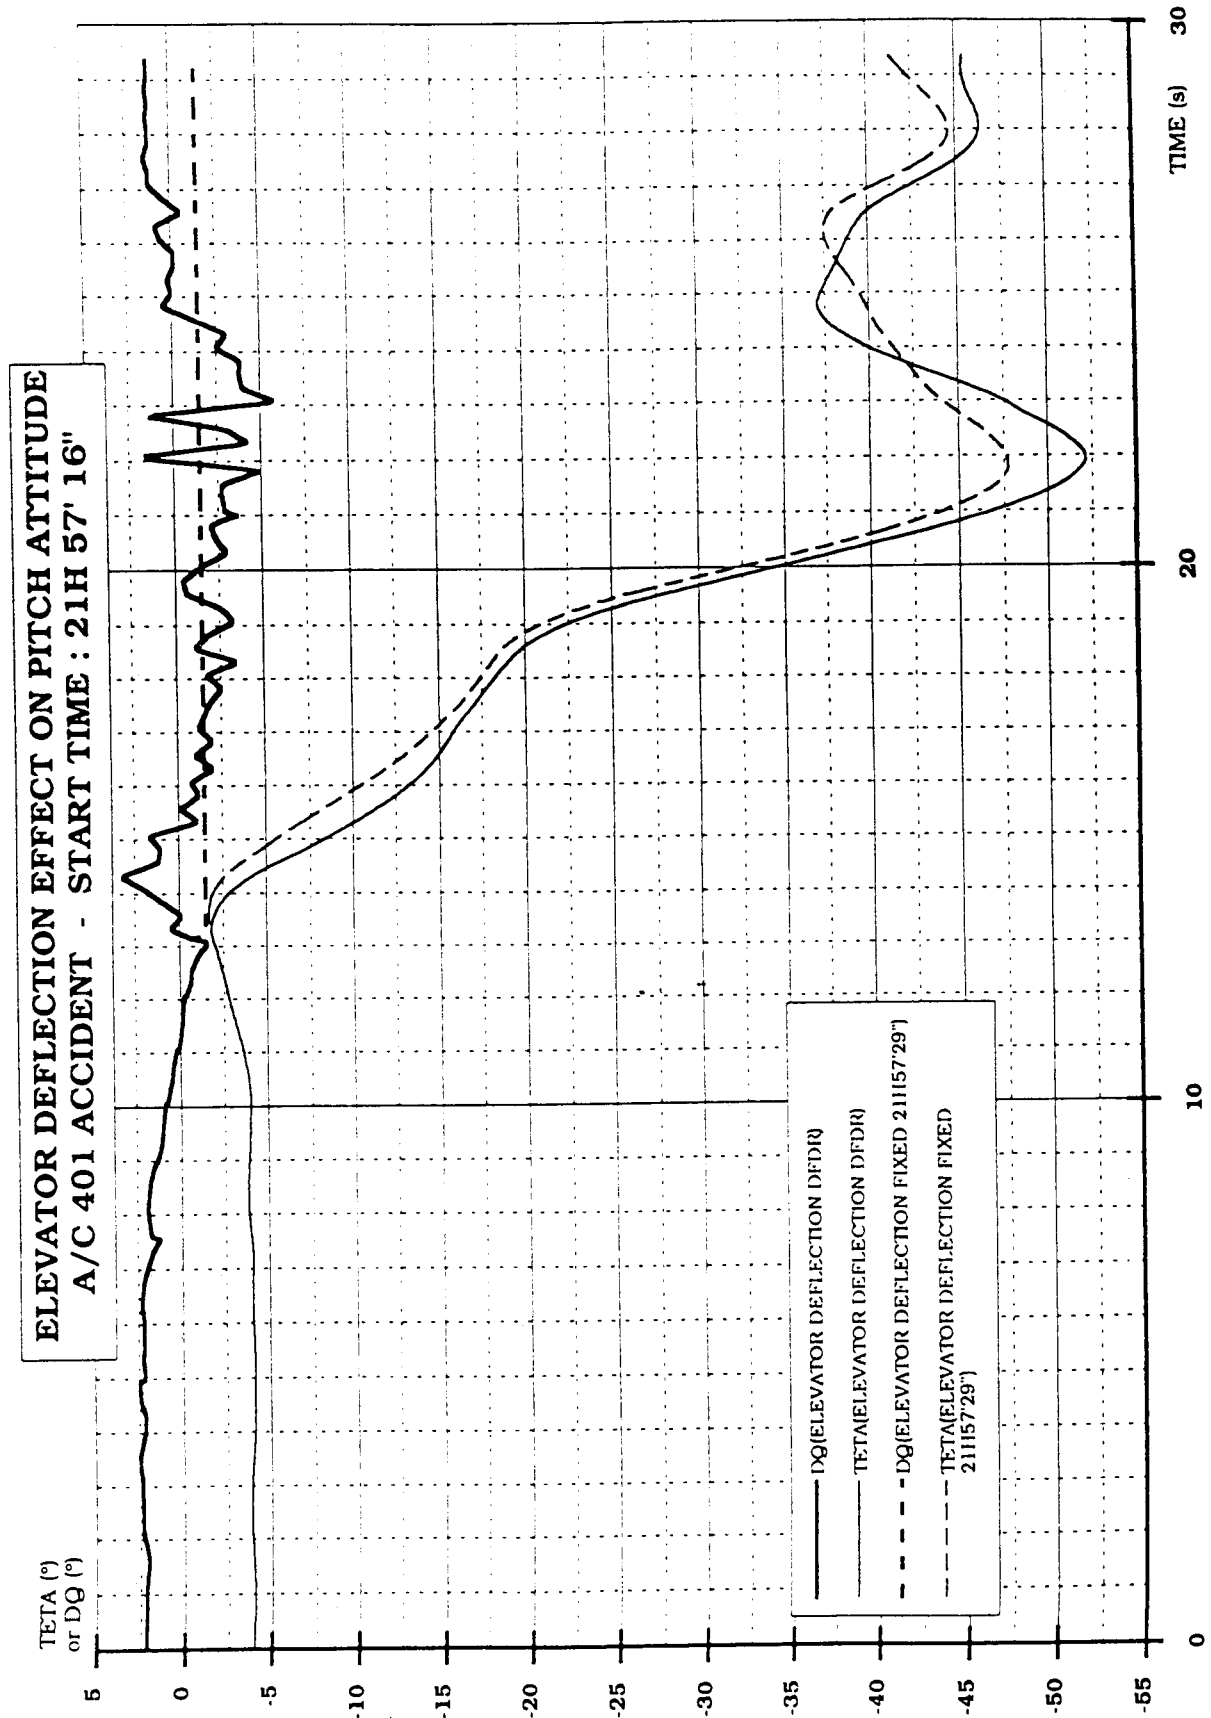
FIGURE 18 : EFFECT OF A CONSTANT PITCH INPUT ON RECOVERY

It also allows to predict the Flight path resulting from different control surface deflections. It is thus possible to determine (fig. 18) that the deflection of the elevators contributes only marginally to the longitudinal movement whose amplitude is mainly due to roll initiation.

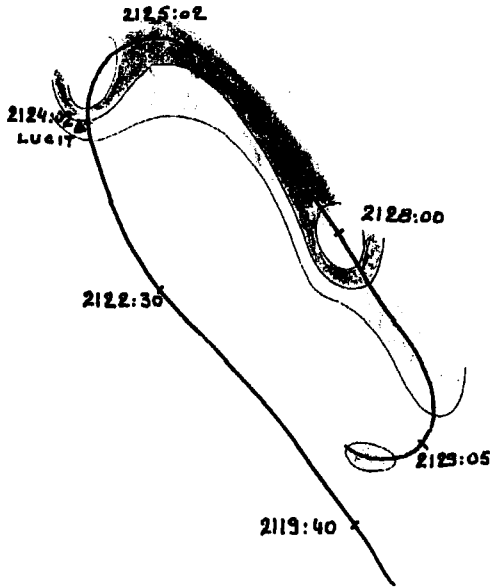
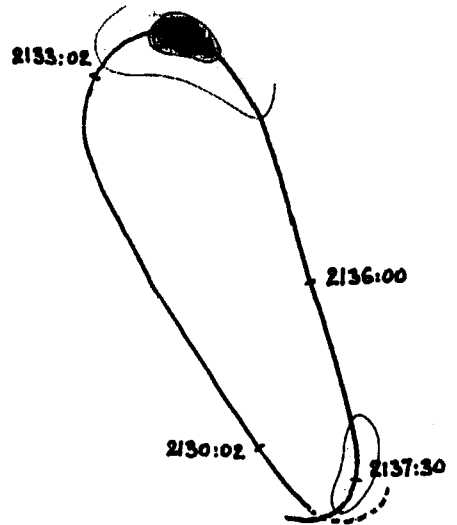
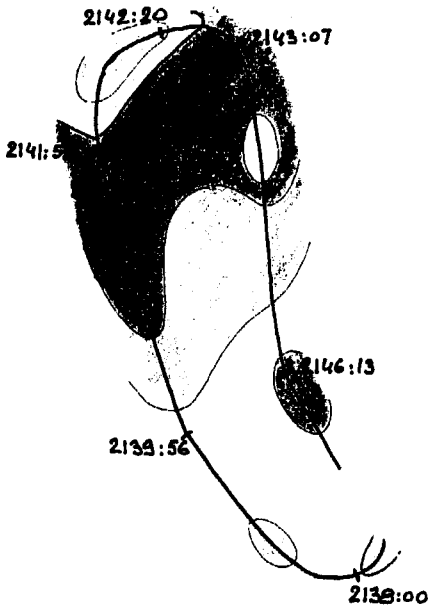
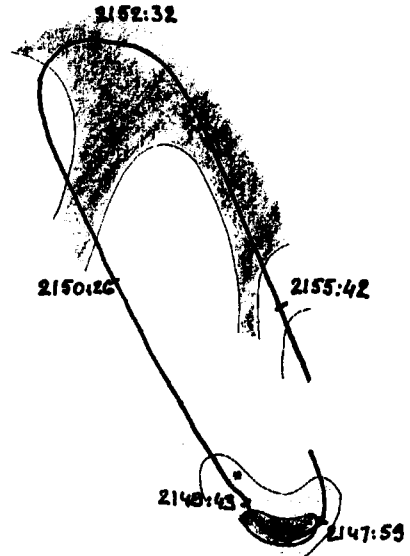
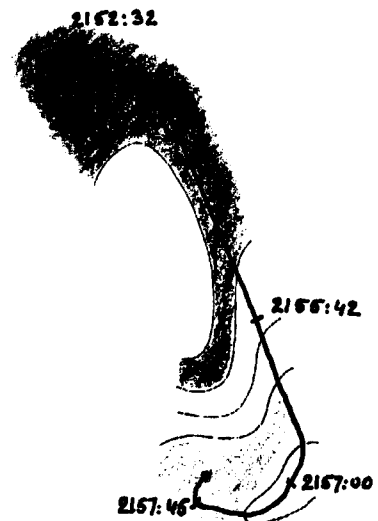
APPENDIX 14

PRECIPITATION ECHOES IN THE HOLDING PATTERN (WEATHER RADAR REFLECTIVITIES)

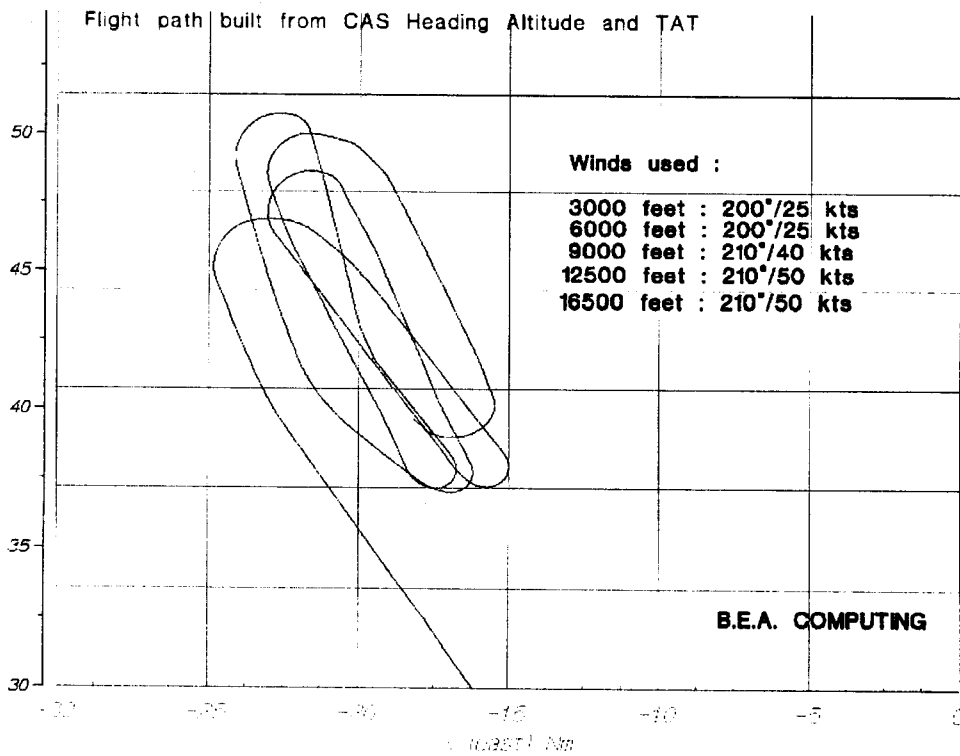
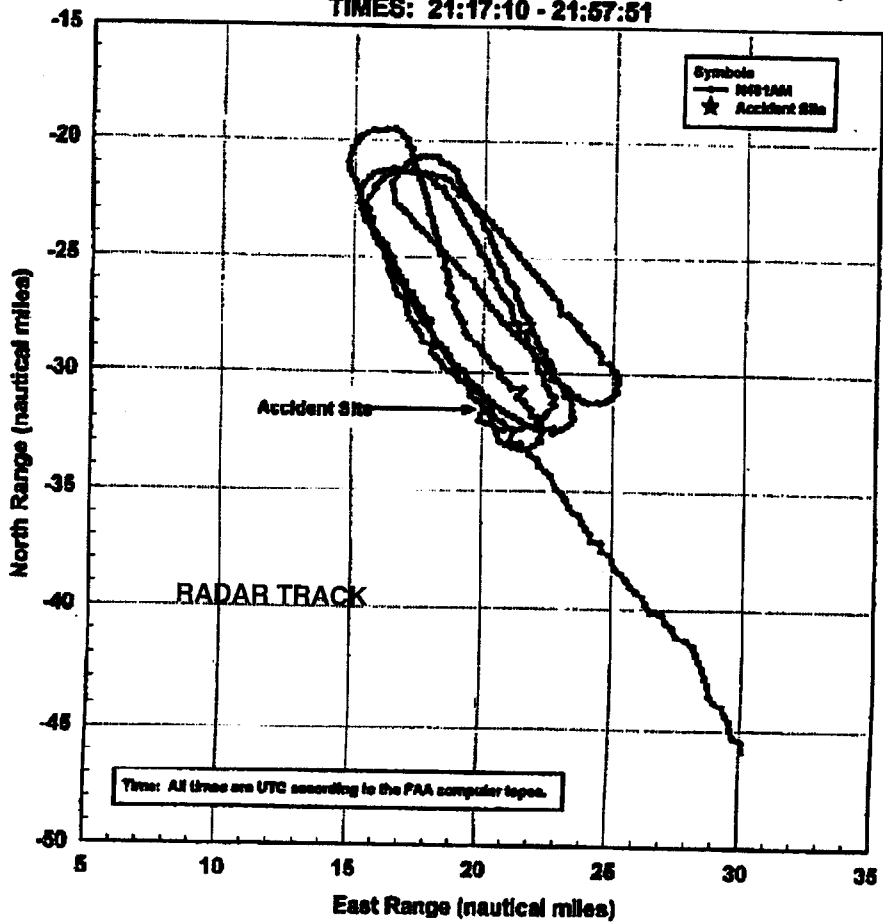
APPENDIX 15

COMPARISON BETWEEN B.E.A. COMPUTING AND RADAR TRACK

North Range vs. East Range
(DCASMA001, 10/31/94, Roselawn IN, ATR-72-210, N401AM)
TIMES: 21:17:10 - 21:57:51

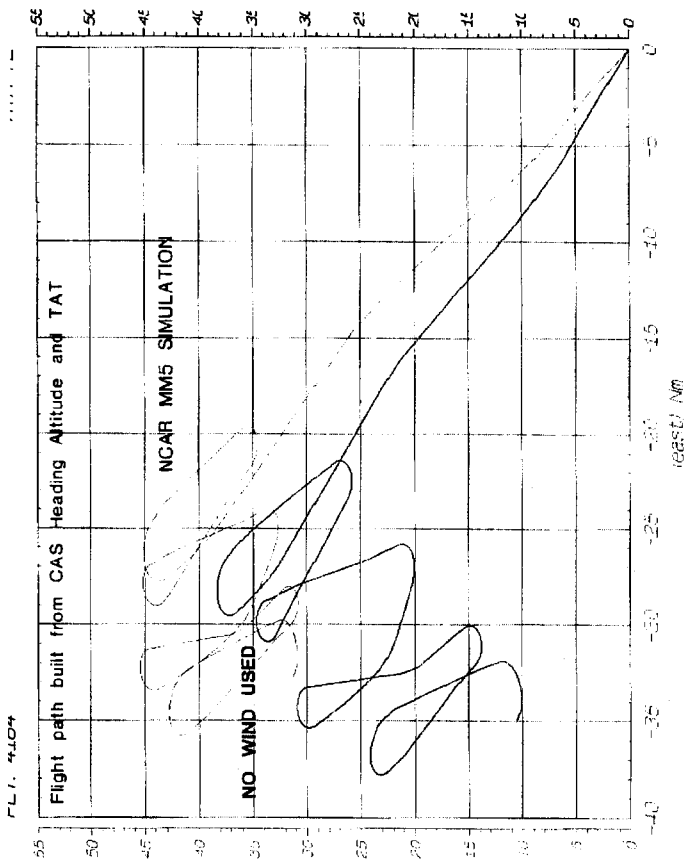
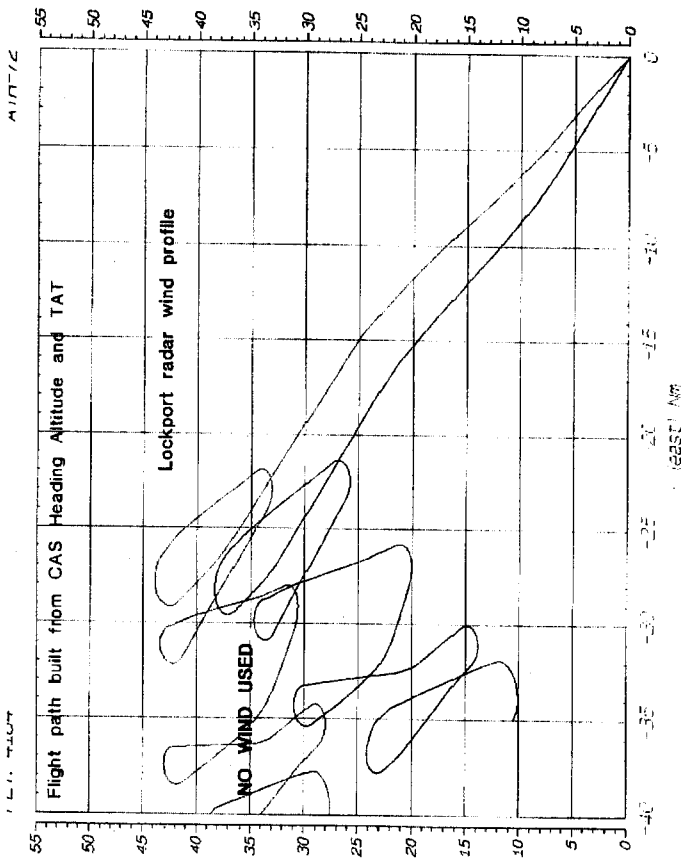
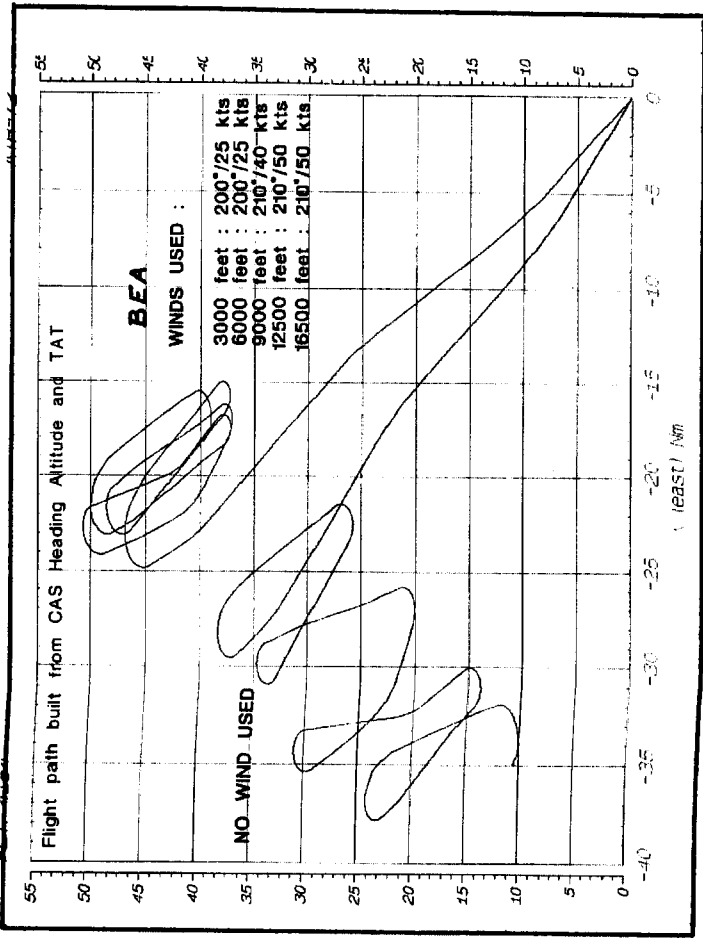
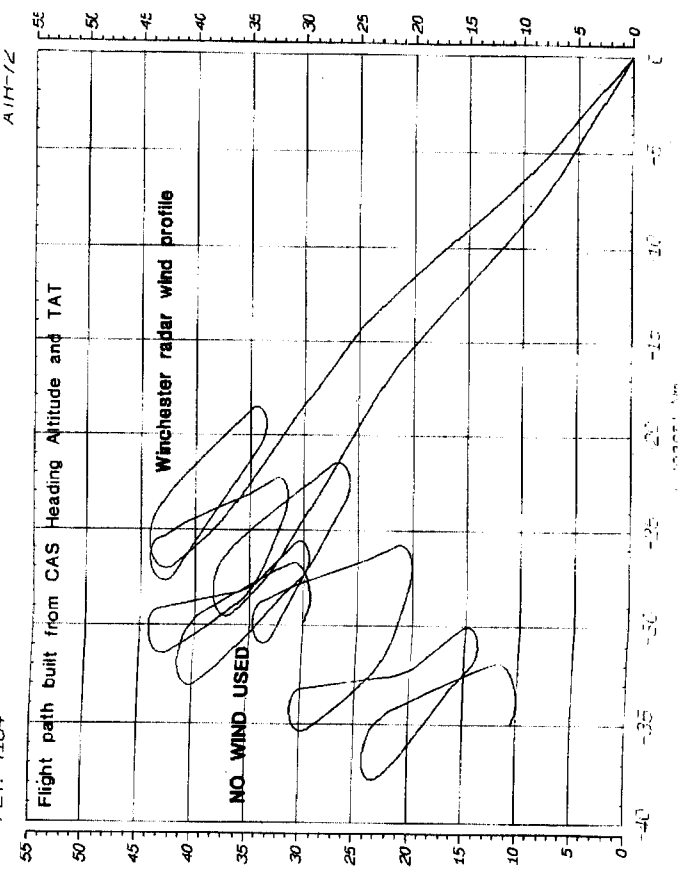
APPENDIX 16

COMPARISON BETWEEN BEA COMPUTING AND RESULTS PROVIDED BY THE NTSB
