*REPORT C 1993:57*

**Air Traffic Accident  
on 27 December 1991  
at Gottröra, AB county**

*Case L-124/91*

The Board of Accident Investigation (SHK) has investigated an aircraft accident which occurred on 27 December 1991 at Gottröra, AB county, involving an aircraft with registration OY-KHO.

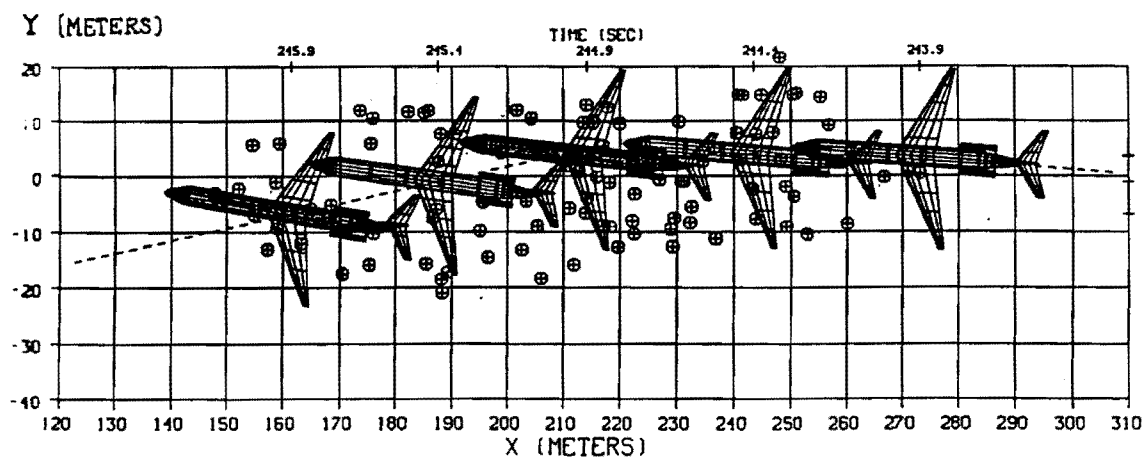
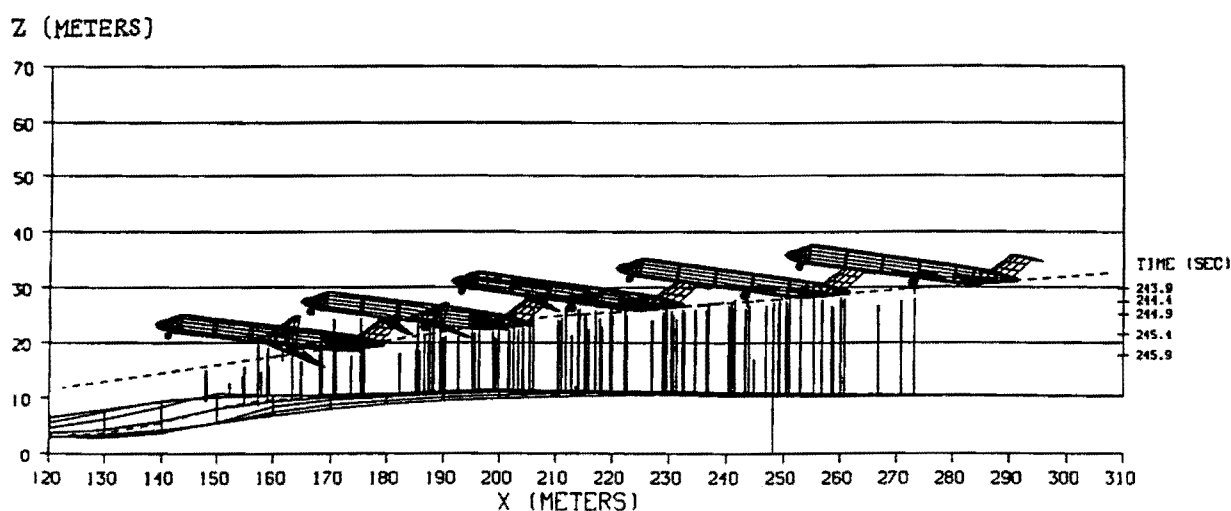
### *The final phase of the flight*

Four minutes and seven seconds after rotation the aircraft hit sloping ground, first with the tail. On impact, a right bank of  $40.1^\circ$  was recorded. After impact the aircraft slid along the ground about 110 m before stopping. The fuselage was broken into three on impact and during the subsequent braking along the ground. There was no fire. All 129 on board survived. Except for four persons, all made their way out of the aircraft themselves.

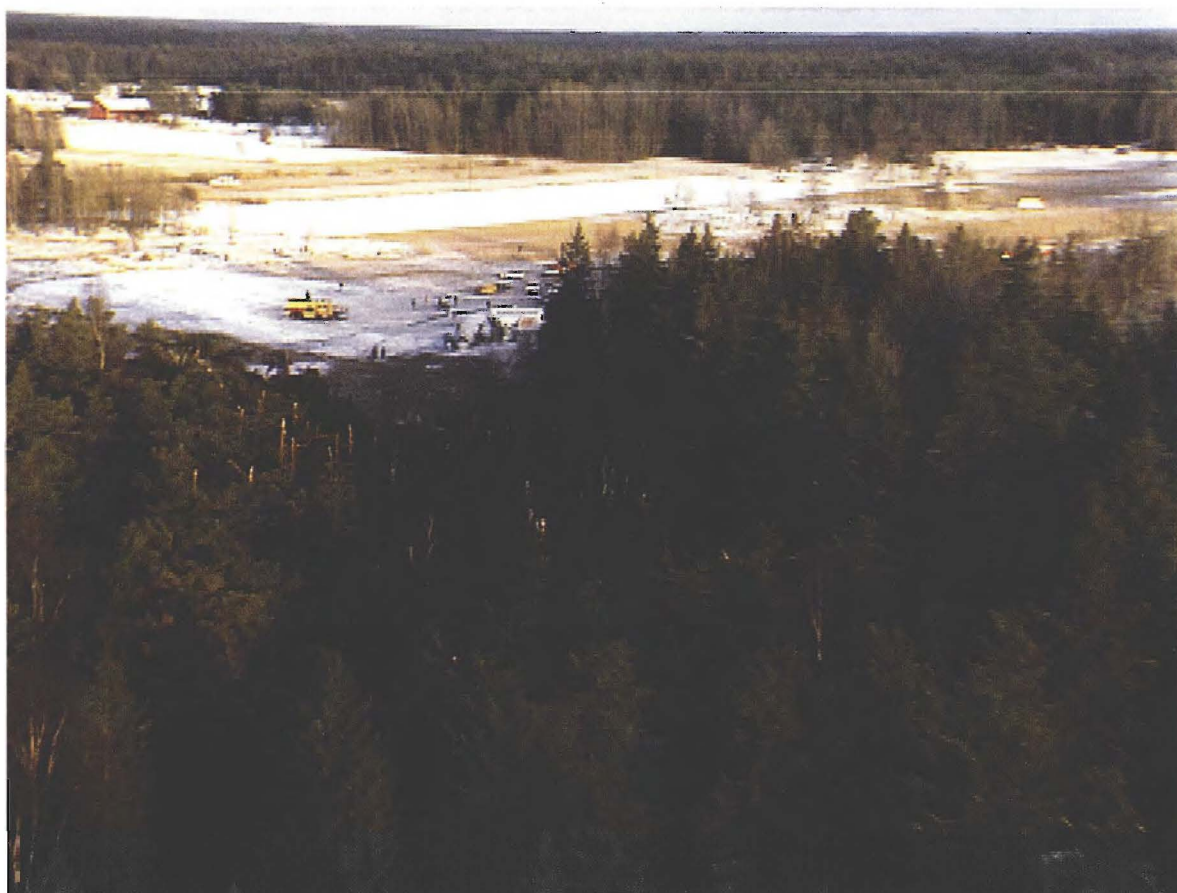
*Approach to accident site*

Shortly before striking the ground the aircraft collided with a number of large coniferous trees. Over an area of about 125 m in length and in breadth corresponding to the aircraft's wingspan, trees were broken.

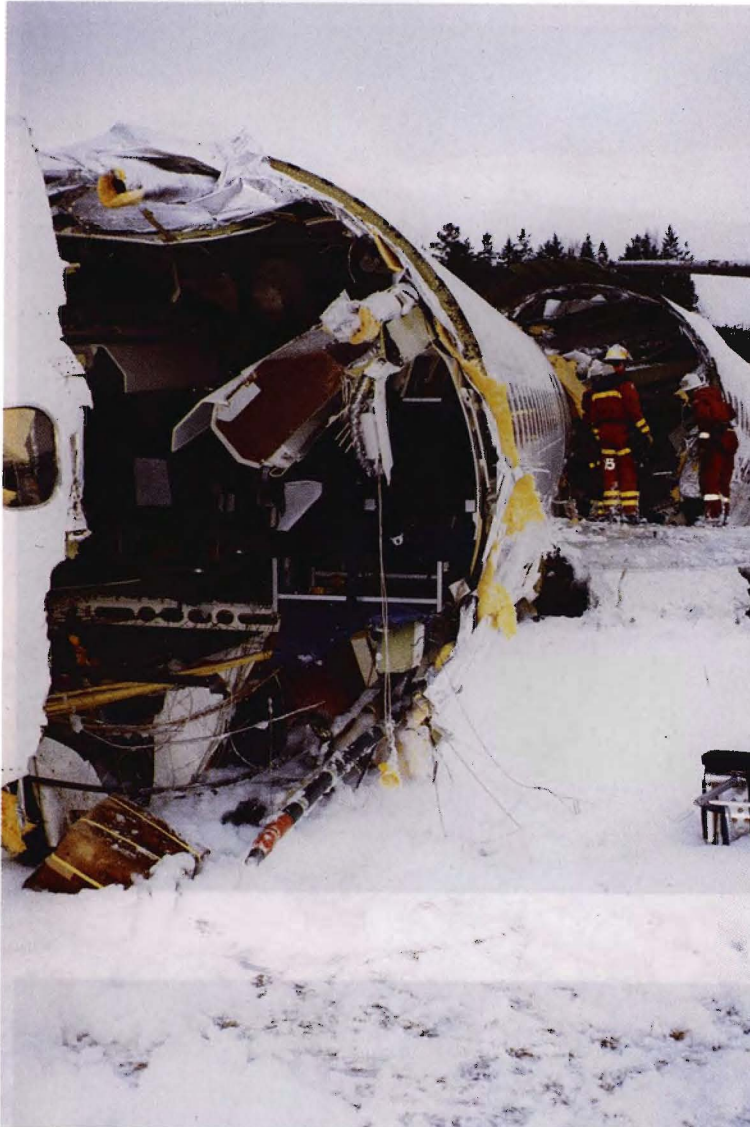
### *Openings in the fuselage*

Both forward emergency exits were open. The entrance door slide had not inflated. The service door slide had inflated but was punctured. The slides had been detached and used as somewhere for people to lie down. Both rear emergency exits were shut. According to information from the crew it was impossible to

open them immediately after the crash. The rear service door could be opened later. Three of the four emergency exit windows were open. According to information from witnesses, the rear right exit was blocked with loose seats, cabin luggage etc.

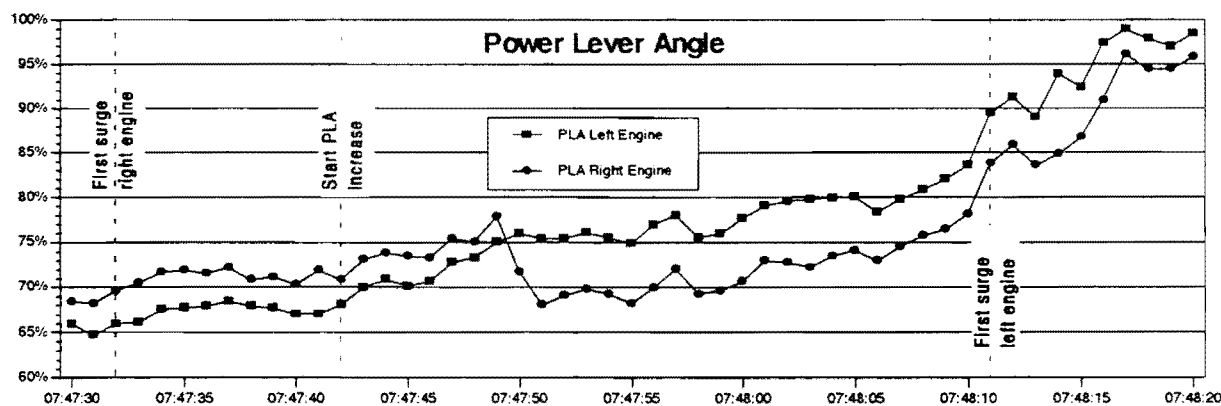
#### *Automatic PLA increase*

As the ATS went over to G/A it started to increase the throttle to enable engine thrust to attain the new higher EPR that applied for G/A. Since this EPR rose with increasing flight altitude, the throttle increase for both engines increased successively during the climb.

As will be shown under 2.3.2 the damage to the engines' fan stages caused aerodynamic disturbance which led to the engines' EPR decreasing somewhat in relation to the other performance parameters. This meant that more throttle than normal was required for the engines to attain G/A EPR.

Engine surging is normally stopped by throttle cutback. As opposed to this, an increase in throttle results in the surges continuing with increased intensity. What

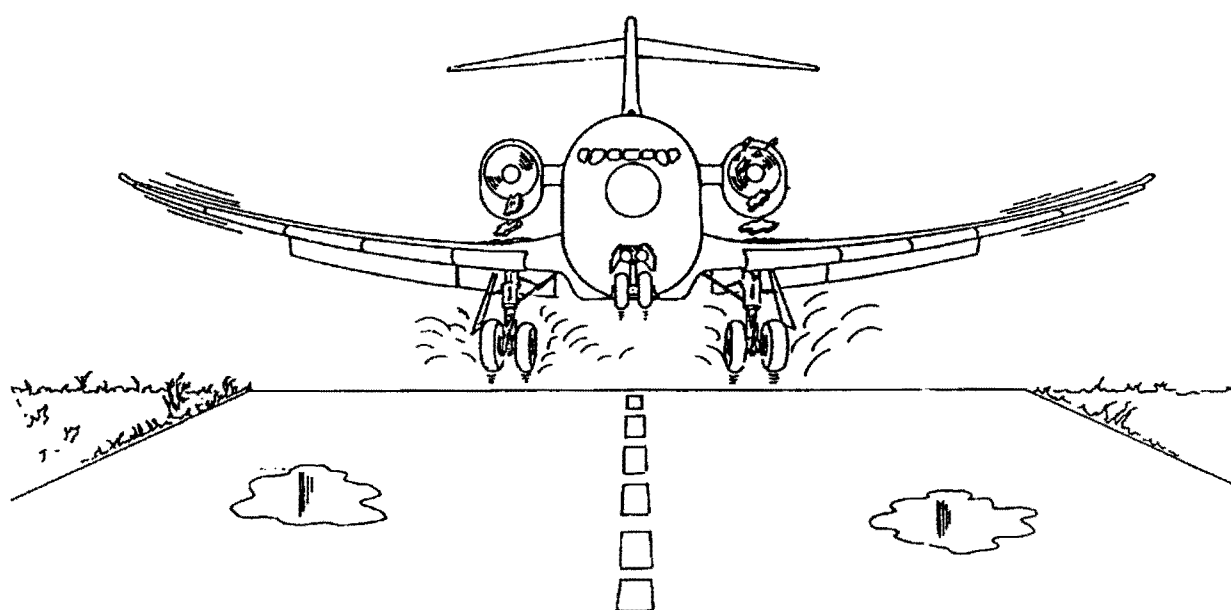
“CLEAR-ICE”.

**WHEN THE AIRCRAFT ROTATES, THE  
ICE WILL BREAK LOOSE DUE TO THE  
NATURAL FLEXING OF THE WINGS,  
AND WILL BE SUCKED INTO THE  
ENGINES AT THE MOST CRITICAL  
PHASE OF THE FLIGHT!**
