## Aviation Investigation Report

### In-Flight Fire Leading to Collision with Water

Swissair Transport Limited  
McDonnell Douglas MD-11 HB-IWF  
Peggy's Cove, Nova Scotia 5 nm SW  
2 September 1998

Report Number A98H0003

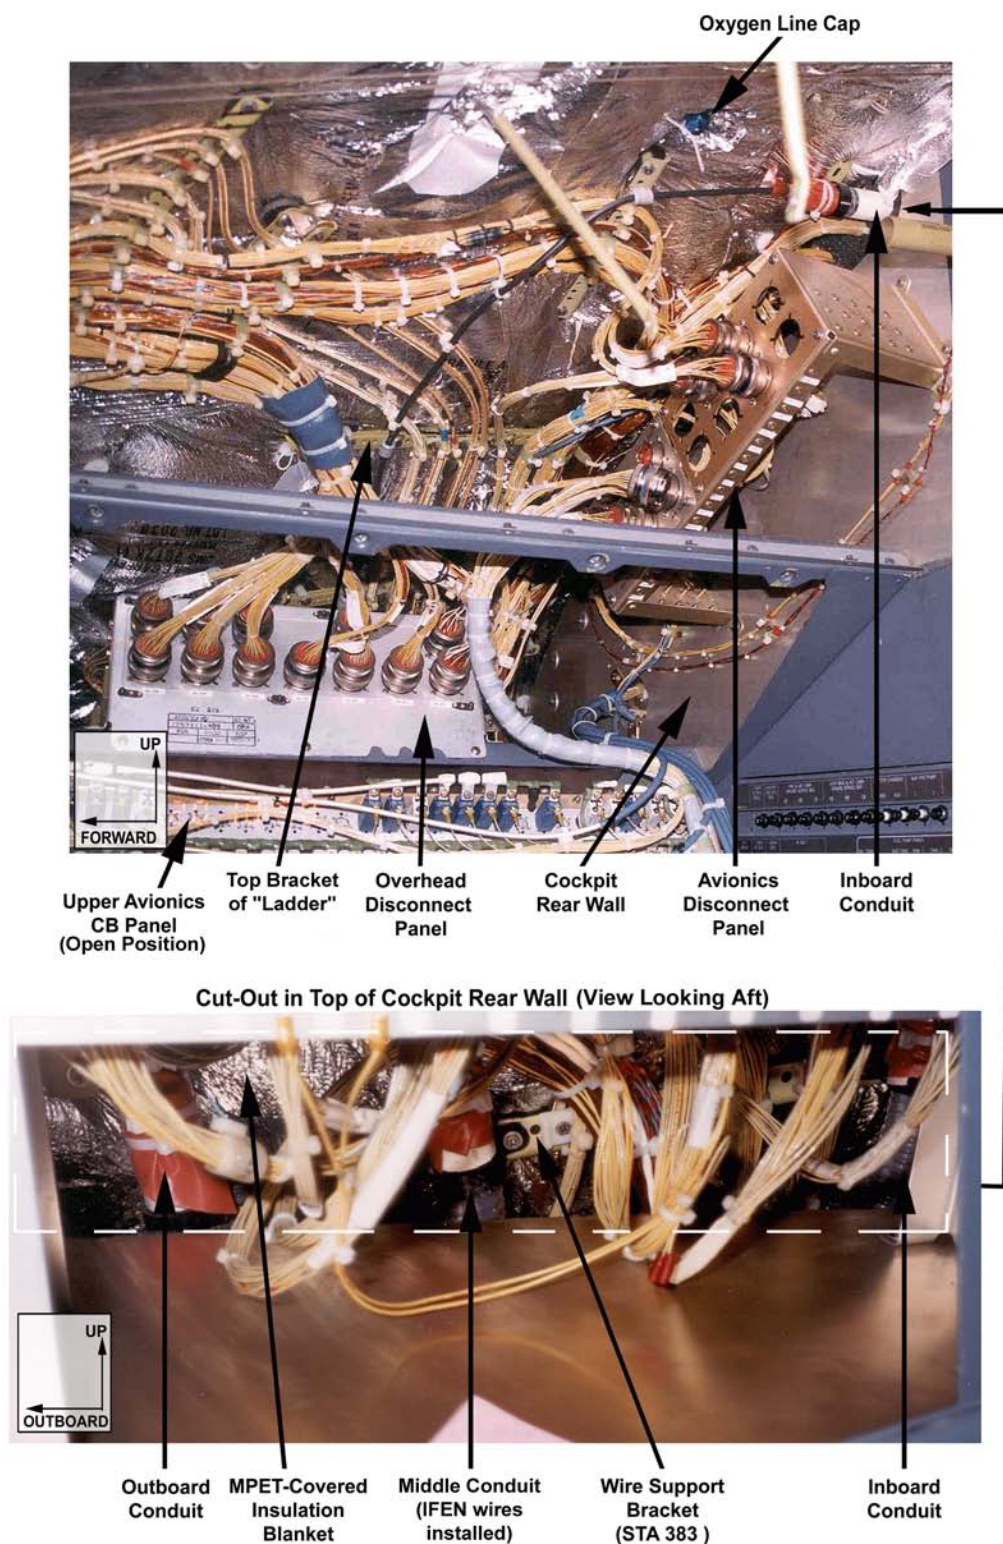
Figure 5: Cockpit attic area and cut-out above cockpit rear wall

Examination of other Swissair MD-11 aircraft in the Swissair fleet disclosed that openings existed in the smoke barriers, and in areas adjacent to the barrier. Some of these openings were located at conduit and wire run locations that pass through or above the cockpit rear wall. The top edge of the rear, right cockpit wall near STA 383 has a cut-out in it to permit the passage of wire bundles and conduits. (See Figures 4 and 5.)

Several of the wire segments in Exhibit 1-4372 were identified as belonging to one of three aircraft wire runs (FAC, FBC, and FDC) (see Figure 7). As installed, these three wire runs, along with wire runs AAG, ABG, and the IFEN wire bundle, ran parallel to each other on the right side of the fuselage over top of Galley 2, between the cockpit rear wall at STA 383, and the aft end of Galley 2 at approximately STA 420. Just forward of the aft cockpit wall, the IFEN wire bundle entered one of two spare 102-cm (40-inch) long conduits that were installed between STA 383 and STA 420 (see Figure 5).

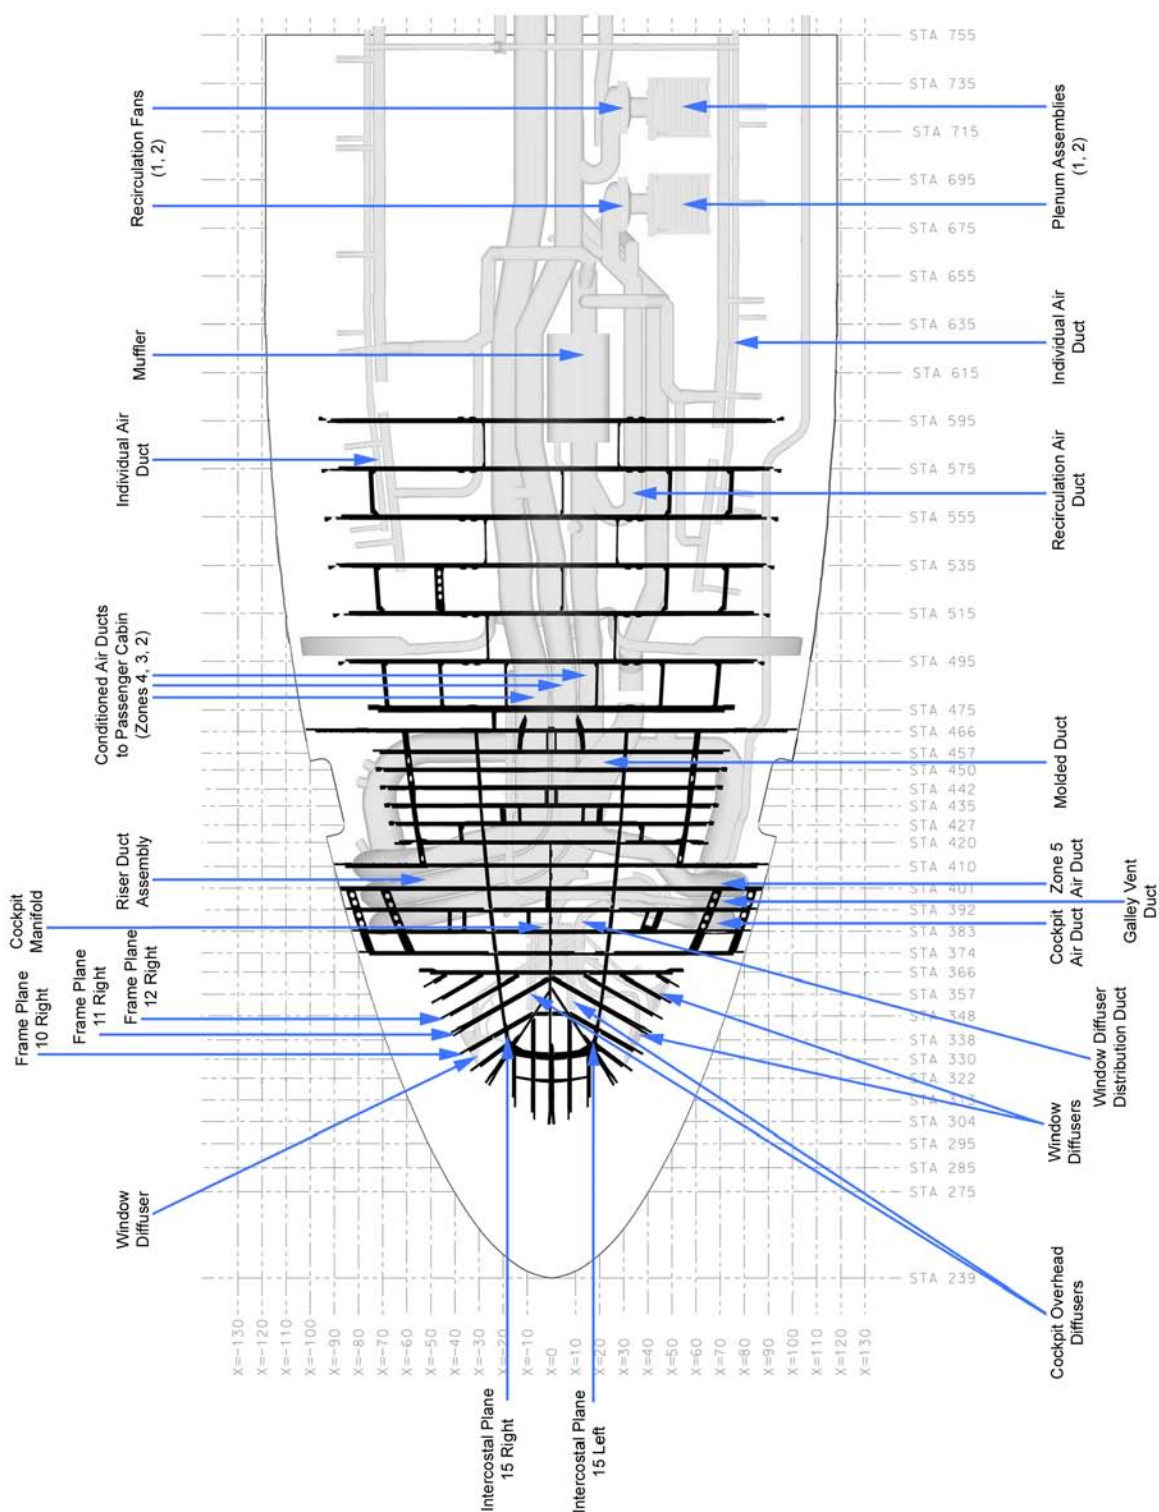
**Figure 24:** Airframe structure and air distribution system

There was bare-metal heat damage on the ducts behind the cockpit air diffusers from STA 350 aft to STA 402, primarily between the plane 15 left and right intercostals. The exception was the window diffuser distribution duct, which had bare-metal heat damage along STA 392 to  $X = 32$ . The heat damage to the recovered portions of the diffusers varied, with higher heat on the upper surfaces and lower heat on the lower surfaces adjacent to the cockpit ceiling liner.

Damage to the riser duct assembly ranged from no heat damage to bare-metal heat damage. The vertical portion of this assembly had no heat damage. The first area of bare-metal damage to the riser duct assembly started at intercostal plane 15 right, where the lower surface had a region of bare-metal heat damage from  $X = -30$  inboard to the joint at  $X = -20$ . This was in the vicinity of the Galley 2 vent end cap. There was bare-metal damage from approximately STA 395 to STA 442 between  $X = 25$  and  $X = -10$ . A section of molded duct was installed in that area from STA 420 to STA 442 between  $X = 5$  and  $X = 25$ . No portions of this molded duct were identified in the wreckage.
