AAIS Case Reference: 13/2010

AIR ACCIDENT INVESTIGATION REPORT

**Uncontained Cargo Fire Leading to Loss of Control
Inflight and Uncontrolled Descent Into Terrain**

Boeing 747-44AF
N571UP
Dubai
United Arab Emirates
03 September 2010

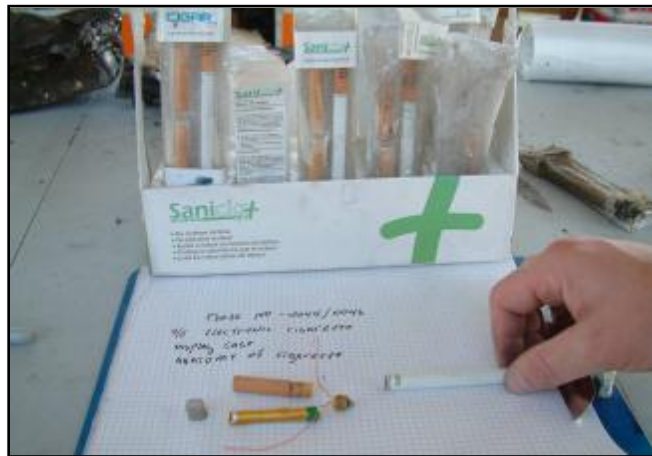
Electronic cigarettes containing lithium primary batteries⁵⁵

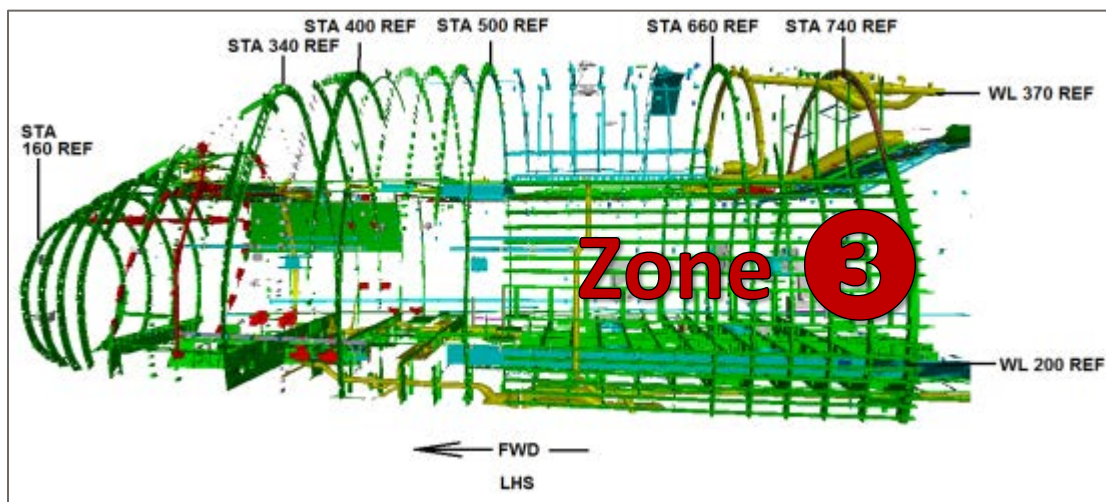
Figure 57- Cutaway Forward Fuselage and Main Deck Cargo Compartment

Conclusion: Based on the ACAR/AHM analysis the cargo fire occurred in Fire Zone 3 at 15:13 UTC

Zone 3 is approximately defined by the volume between STA 580 and STA 700, where the ceiling begins sloping up at the cargo liner transition point. This immediately below the LH and RH truss assemblies supporting the flight control cables

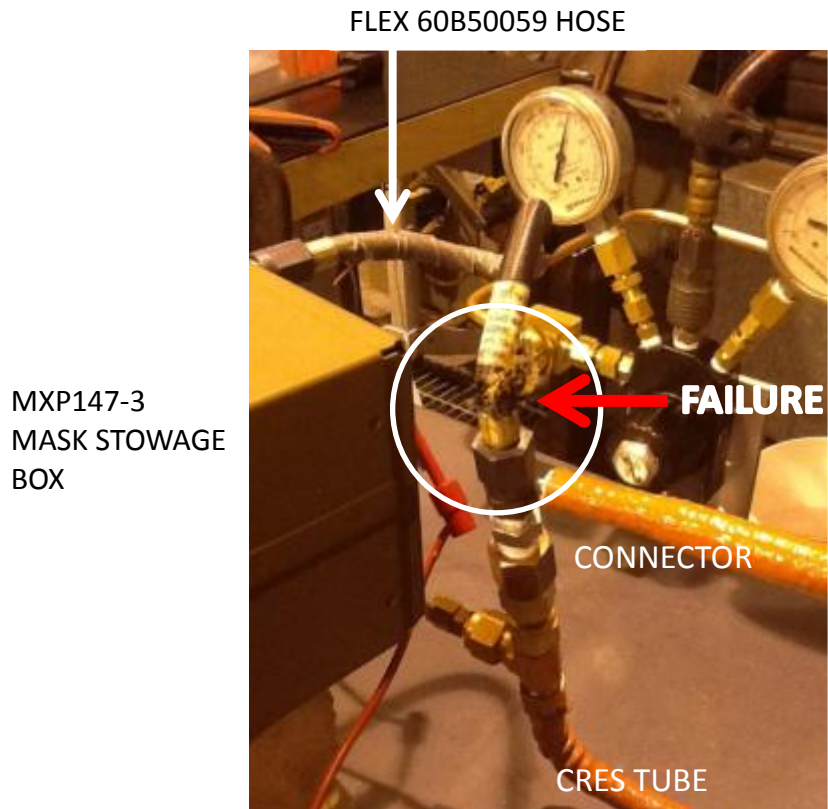
Mask Test #2 Flex Hose 60B50059 hose failure

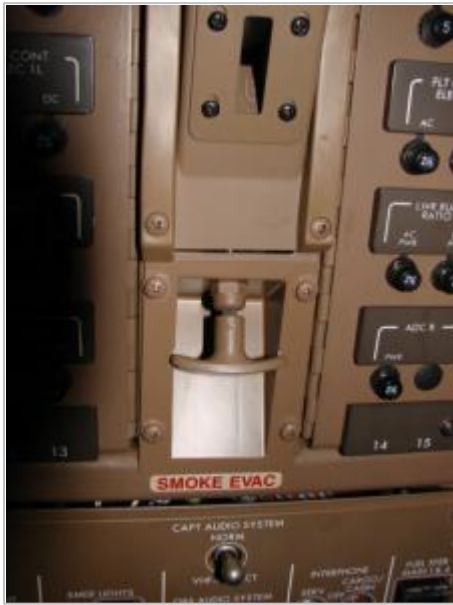
captain called for the fire main deck checklist. No emergency was declared and no turn was initiated. The FIRE MN DK FWD checklist was begun at about 1:32 (1 minute and 32 seconds into the scenario). When pilot #1 removed his oxygen mask from its container, the cord was tangled and delayed donning. Two minutes and 15 seconds into the scenario, an emergency was declared with ATC (air traffic control). The flight was cleared to descend to FL250 and initiated a right turn toward ANC. Although “smoke” was declared by the instructor, it was not heard by the flight crew and no acknowledgement was made. When the main deck cargo fire arm switch was armed, packs 2 and 3 were automatically turned to ‘off’. It was unclear to the observers who was designated the PF because pilot #1 switched the altitude in the mode control panel. The flight crew was again informed that the cockpit was full of smoke at 4:18 into the scenario. The flight crew donned smoke goggles. It took about 16 seconds for the crew to don their smoke goggles. The flight crew descended to FL100. At time 5:30, the flight crew was unable to see their instruments due to smoke in the cockpit. This was simulated by failing the displays and covering the backup display. The captain pulled the smoke handle, however, no checklist was used to make this decision.

Figure 97: Smoke Evacuation Handle

Figure 98: Smoke Evacuation Handle (pulled)

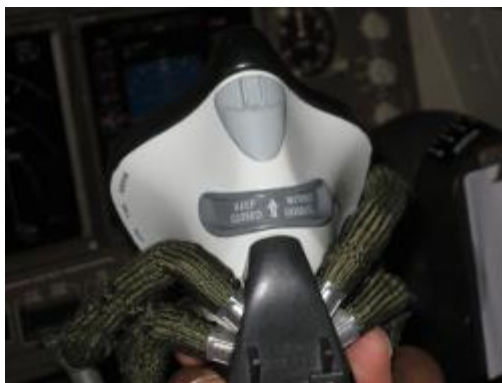
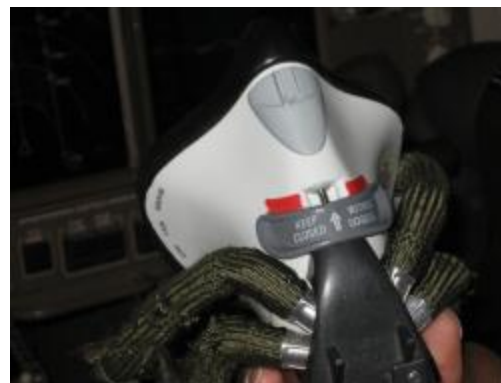
Figure 101: Smoke vent valve selector (closed) Figure 102: Smoke vent valve selector (open)

The pilots involved in the exercise indicated that with the smoke goggles donned, it was difficult to find the switch to clear the goggles of smoke (see figures 9 and 10) and one stated “it was “awkward”.

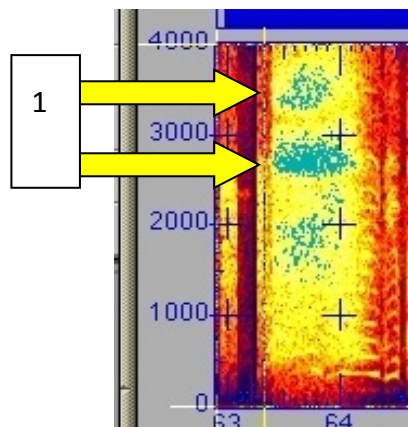
Figure 110 – Spectrogram of Inspiratory Noise from Mask Microphone Audio

The auditory review of the mask microphone audio revealed that the breath noises did not sound significantly different between the two mask modes. However, the sound spectrum analysis found a unique characteristic in the audio that differentiates one mask mode from the other. Figure 109 shows a spectrogram of the inspiratory noise from a single breath, as recorded from the oxygen mask microphone.

The audio from the mask microphones exhibits characteristic “bands” of energy during inspiratory breaths (light blue regions labeled 1 and 2 in Figure 109). These bands are a concentration of relatively higher sound energy within certain frequency ranges. The height of the bands (range of frequency) and total number of bands seems to vary, and may be affected by the overall loudness of the breath sound itself. However, two of these bands are present in all segments of audio that were examined (labeled 1 and 2 in Figure 109). The unique characteristic is the “center” frequency of Band 2. The band height (total frequency range) can vary, but the center of the band appears to be unique to the mask mode. In
