## SPECIAL AIRWORTHINESS INFORMATION BULLETIN

SAIB: NE-16-19

**SUBJ:** Turbine Engine Compressor Section – Stator Nozzle Distress

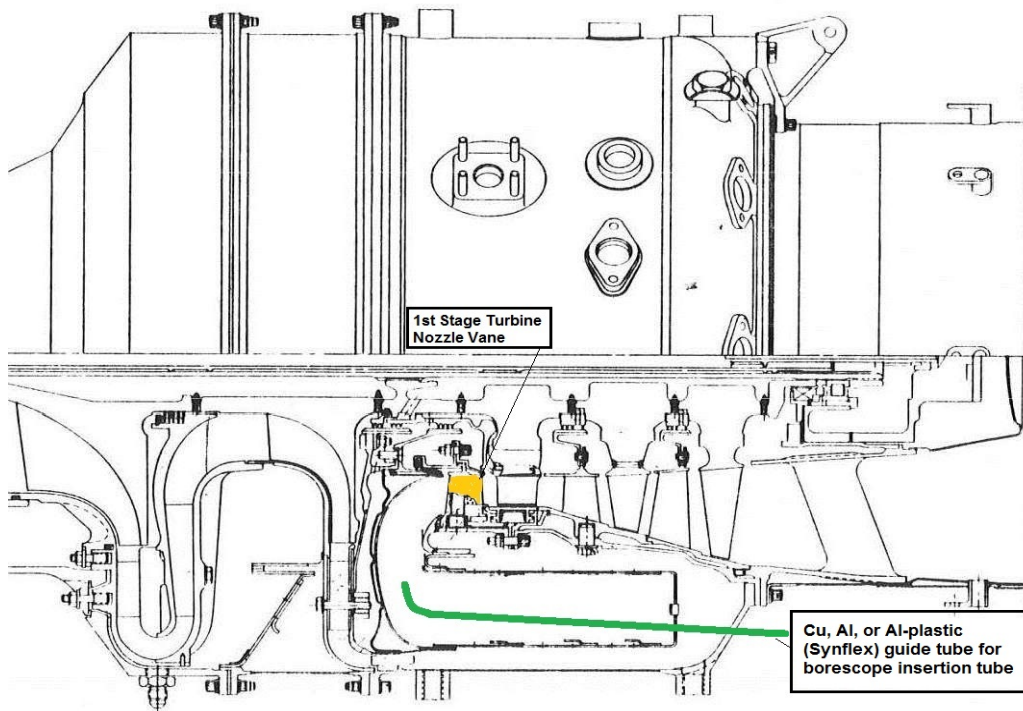
**Figure 1. Cross-section of TPE331-11U Engine Power Section with Borescope Guide-Tube in Combustor**

The flex insertion tube must be used with an appropriately sized guide tube as shown in Figure 1 below. When selecting a flex insertion tube, it is important to note that larger diameter tubes allow more light at the inspection site, but will have less flexibility. Synflex guide tubing provides the strength and flexibility of aluminum tubing and can be bent by hand. Some borescope suppliers may provide properly-sized Synflex tubing.
