Air Accidents Investigation Branch

Report on the accident to Aerospatiale (Eurocopter) AS332 L2 Super Puma, registration G-REDL 11 nm NE of Peterhead, Scotland on 1 April 2009

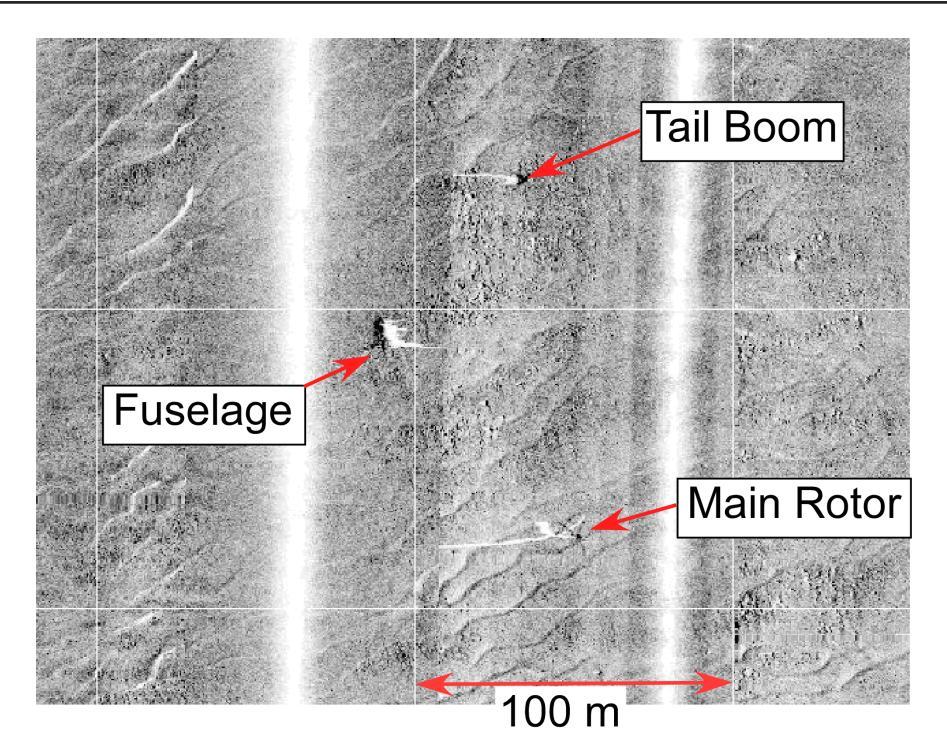
Figure 2 Sidescan sonar picture of main wreckage items

Radar data, and the information given by the eyewitness on the Normand Aurora, identified the probable location of the wreckage. On the afternoon of 1 April 2009, floating debris was recovered by several vessels which had positioned to the area. During the evening of 2 April a survey vessel, which had been operating in the area on behalf of the Maritime and Coastguard Agency, was tasked to survey the seabed using its high definition sonar system. By the morning of 3 April 2009, the ship had identified the location of three main items of wreckage, (see Figure 2).

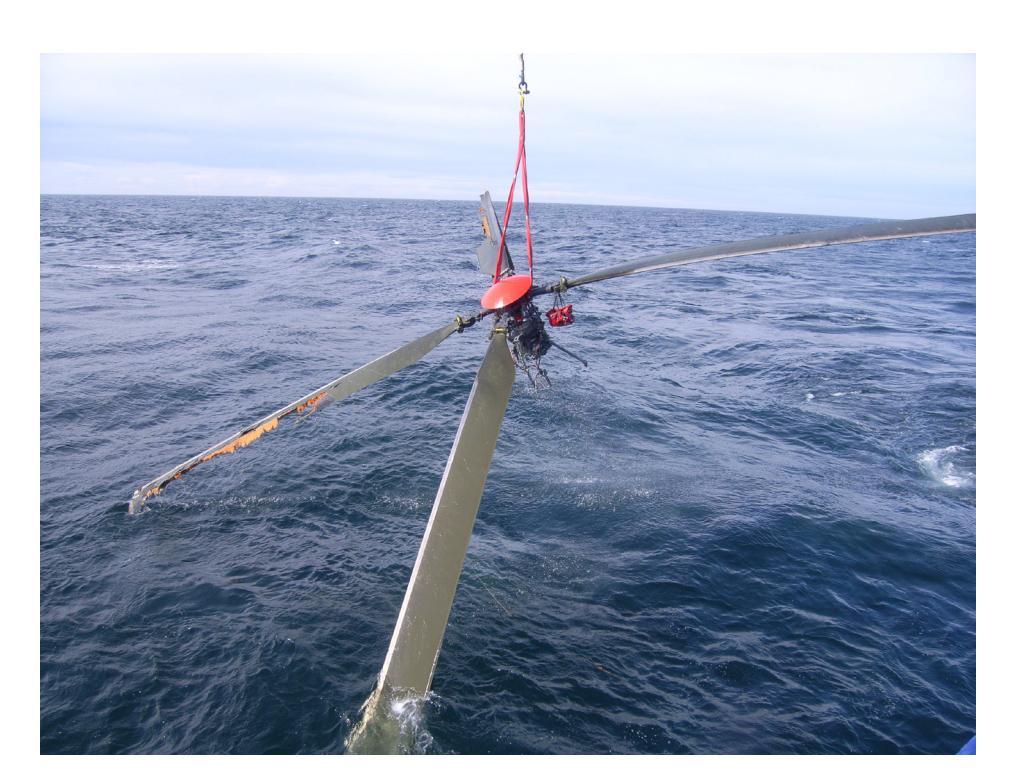
Figure 3 Main rotor head recovery

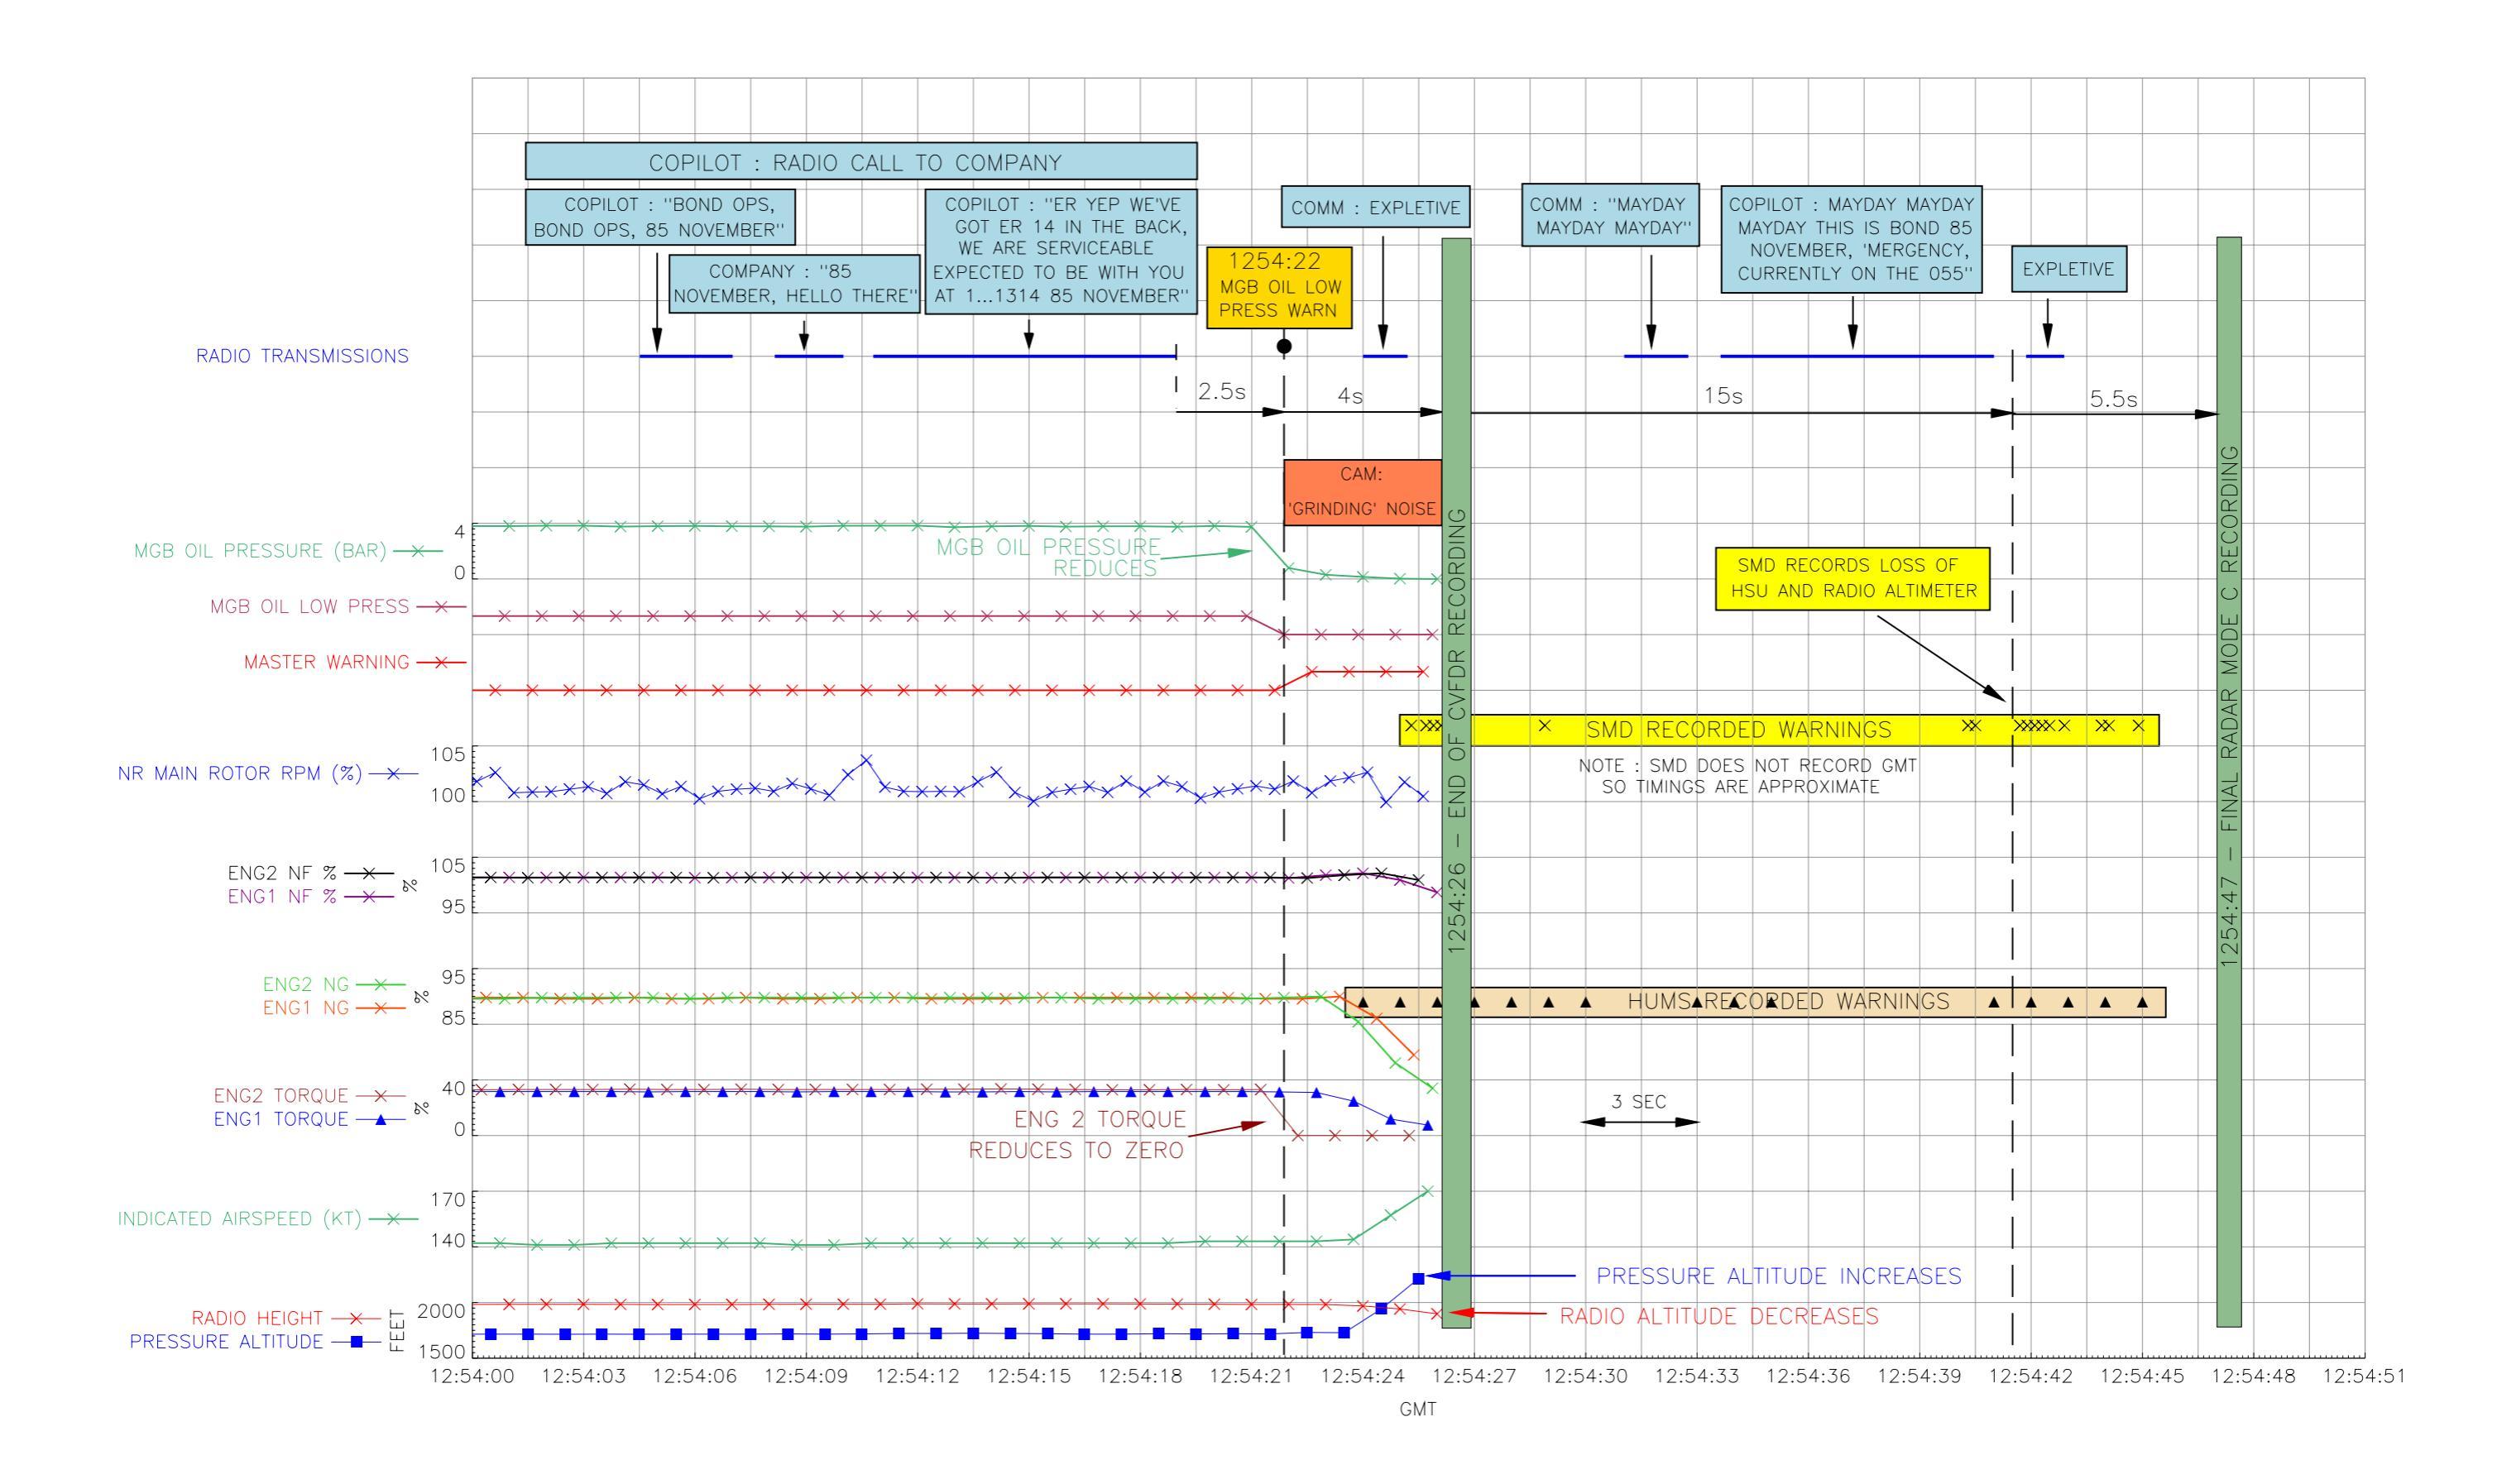
Figure 17 G-REDL recorded flight data

The recorded MGB oil pressure reduced from 3.8 bar to 0.8 bar within one second and the data confirmed that the helicopter immediately deviated from cruise flight conditions. Half a second later, the recorded right engine torque reduced from 33% to zero, (see Figure 17). Apart from this recorded loss of torque, engine operation during the final part of the recording was normal, and the recorded main rotor rpm remained at between 100% and 103%.

The final two seconds of the CVFDR recording suggested an indicated airspeed increase to 170 kt, radio altitude decrease to 1,898 ft but the pressure altitude increased to 2,215 ft. This represented a pressure altitude rise of 14,500 fpm which is beyond the capabilities of this helicopter.

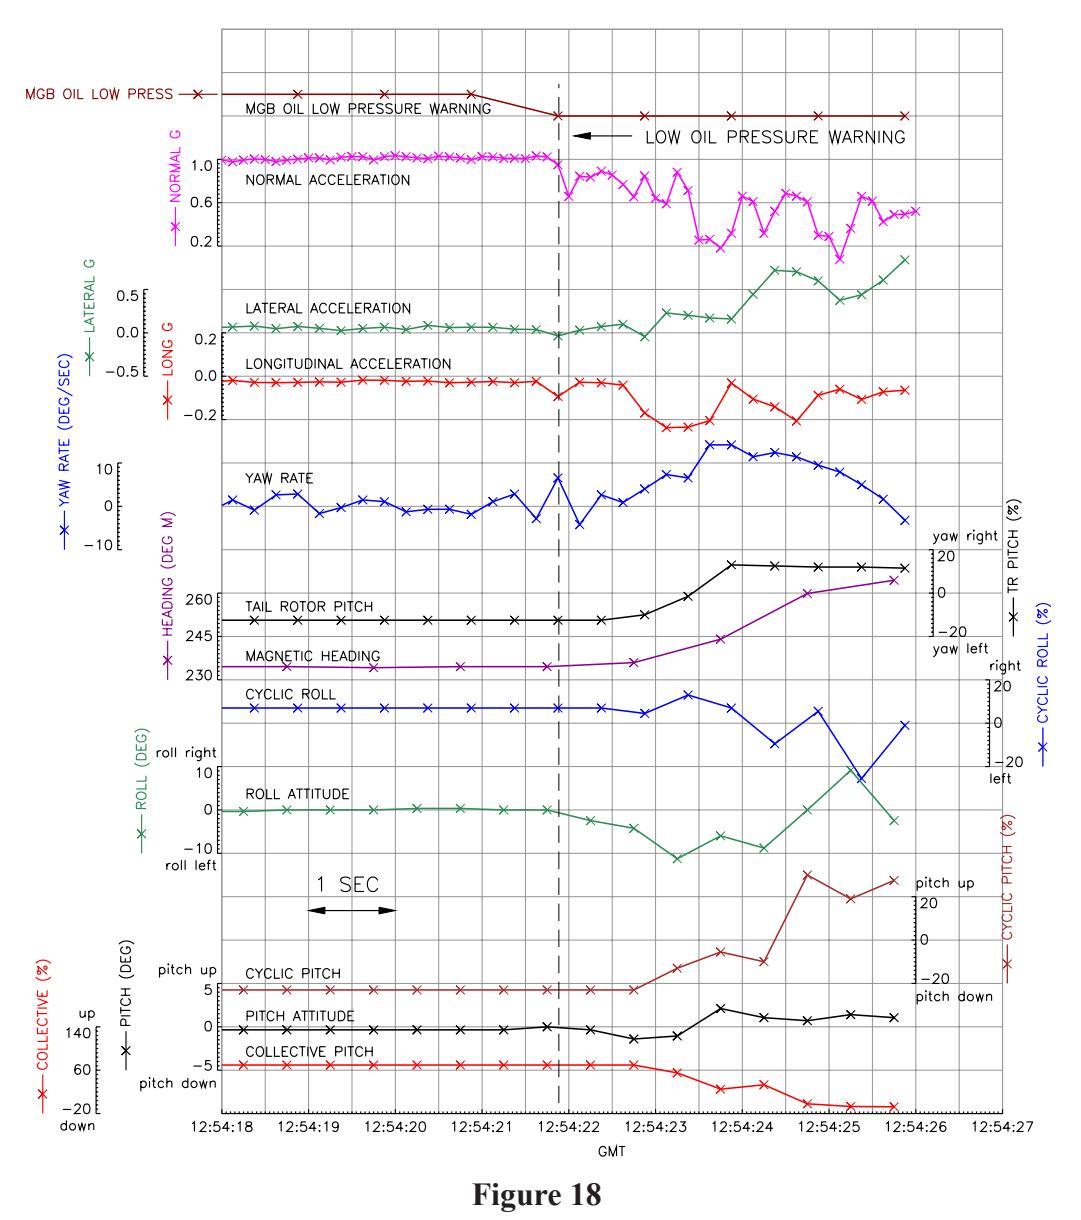
Flight control inputs and helicopter response

The recorded flight data was provided to the manufacturer who ran a simulation to analyse the consistency between flight control inputs and the helicopter response during the final seconds of operation, see Appendix F. The analysis was performed in two stages. The first was to input the recorded flight control commands and analyse the simulated helicopter response. The second was to use the recorded helicopter attitudes and determine the required flight control inputs to achieve them. The results indicated that, two seconds after the MGB oil low pressure warning, the helicopter was no longer responding normally to flight control inputs.

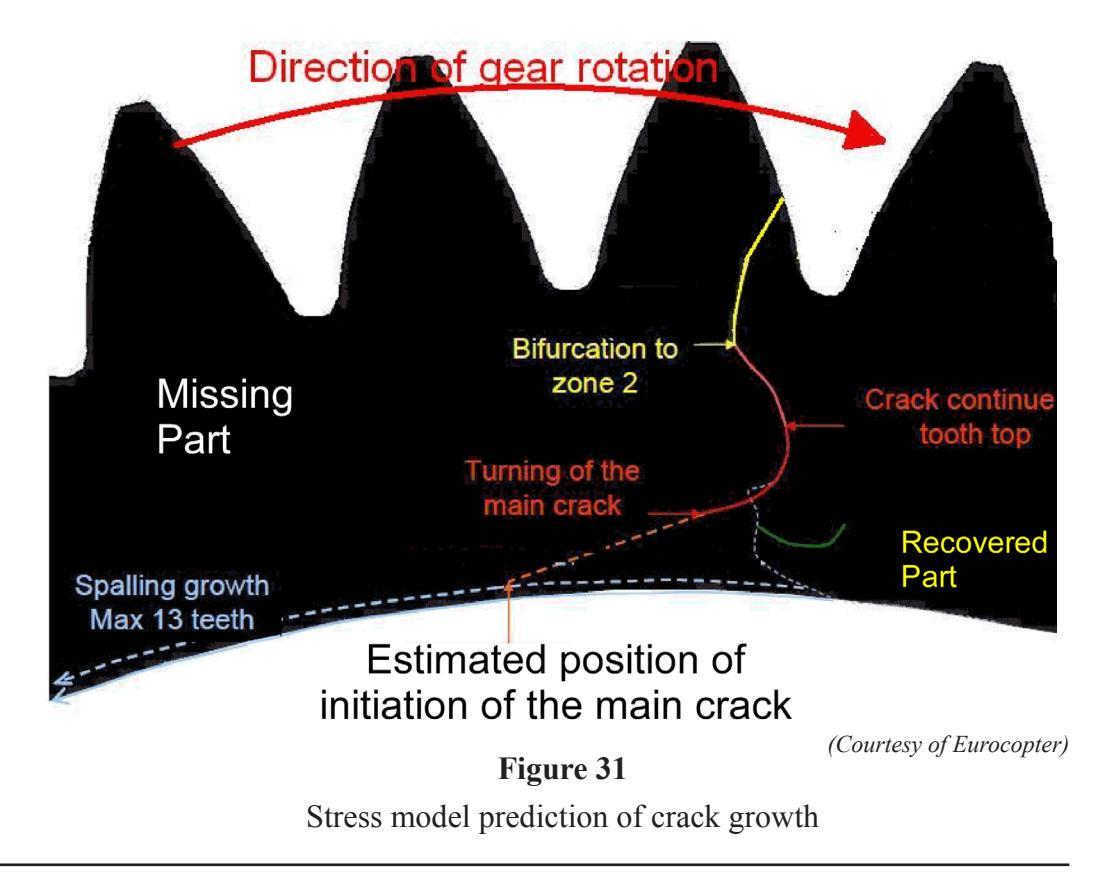
The crack was predicted to progress initially approximately tangentially to the raceway surface, (see Figure 31) but also moving inwards. As it leaves the carburised layer, the increasing tensile stresses cause the crack to turn and follow the line of maximum tensile stress. This was predicted to create a 'dished' shape similar to that seen in Zone 1 of the fracture surface of the 9-tooth section.

As the crack progresses, theory suggests that it should propagate towards the tooth root. However, the model showed that this area, and the tooth flanks, has significant compressive stresses, so the crack tends to follow the tensile stresses in the middle of the tooth, until the gear fractures in overload. The possibility of a bifurcation of the crack was also predicted, creating a feature similar to that observed in Zone 2 of the actual failure.

The conclusion of the stress analysis was that it could explain most of the features of the fatigue morphology observed on the fatigue fracture face of the failed second stage gear. It also suggested that the origin of the fatigue would have been several millimetres away from the fracture face (ie on a segment of the gearwheel which was not recovered).

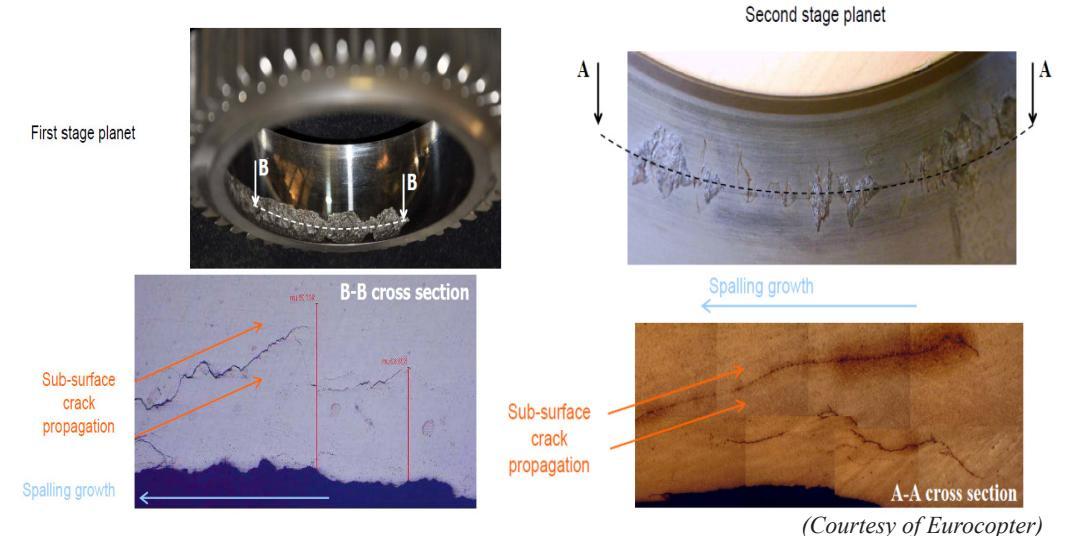
Figure 33

A first stage planet gear with spalling on one bearing track over 190° of its circumference had been removed in 2009. A second stage planet gear which had near-continuous spalling around 360° of one bearing track, had been removed in 2005. Photographs of sections cut through the spalling damage revealed

sub-surface cracks propagating tangentially inwards, extending beyond the carburised layer, in a manner which the stress analysis had suggested the crack path could follow in its early stages.

Spalled gears exhibiting cracking within the carburised layer

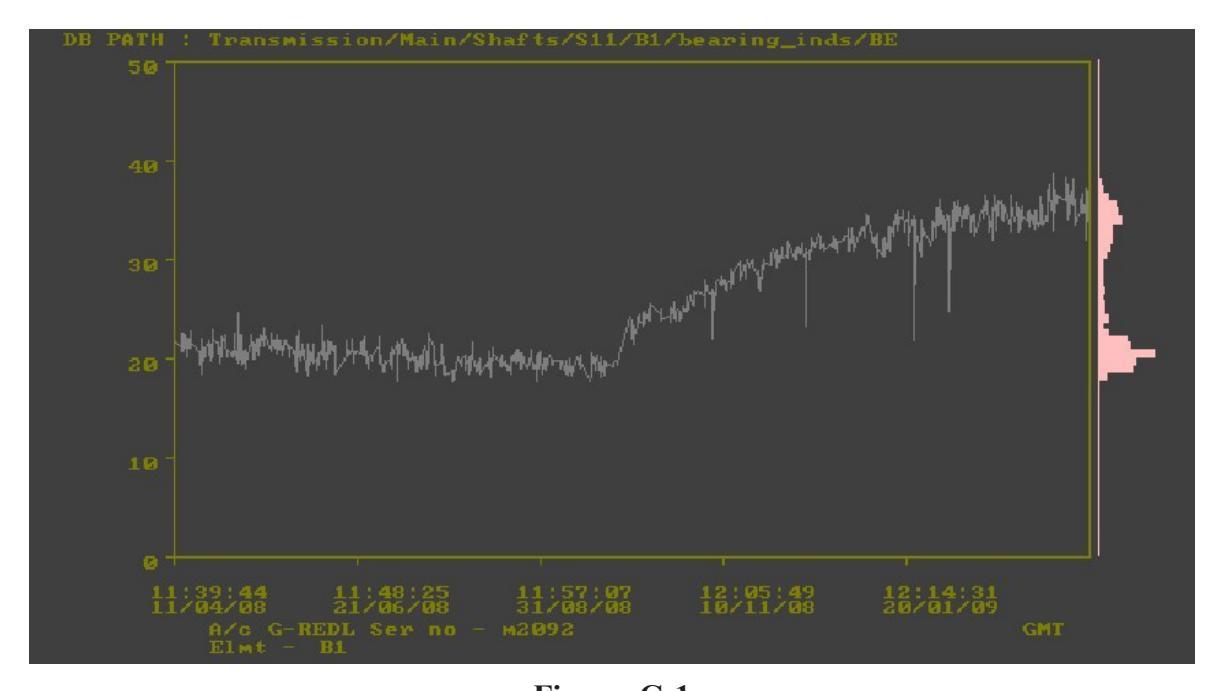
Figure G-1 G-REDL HUMS lower planetary bearings Band Energy

Lower epicyclic planet gear bearings HUMS Condition Indicators

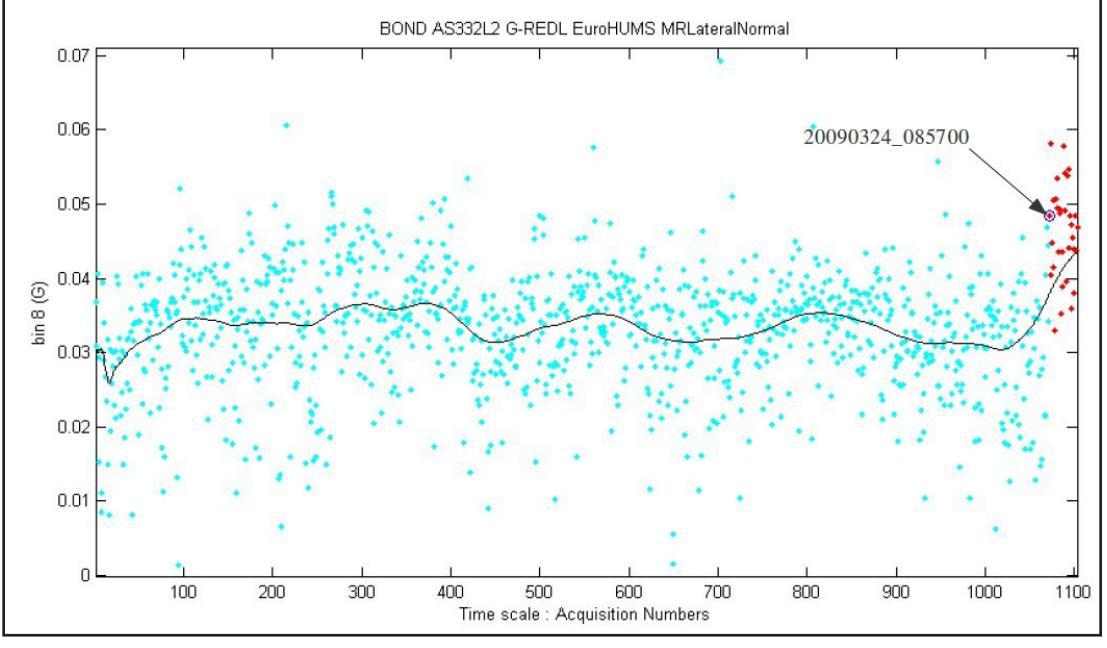
Figure H-1

Upper epicyclic ring gear eight-per-rev CI, calculated from the main rotor accelerometer Y-axis accelerometer measurements. Arrow points to operations of 24 March 09 (Source: Eurocopter)

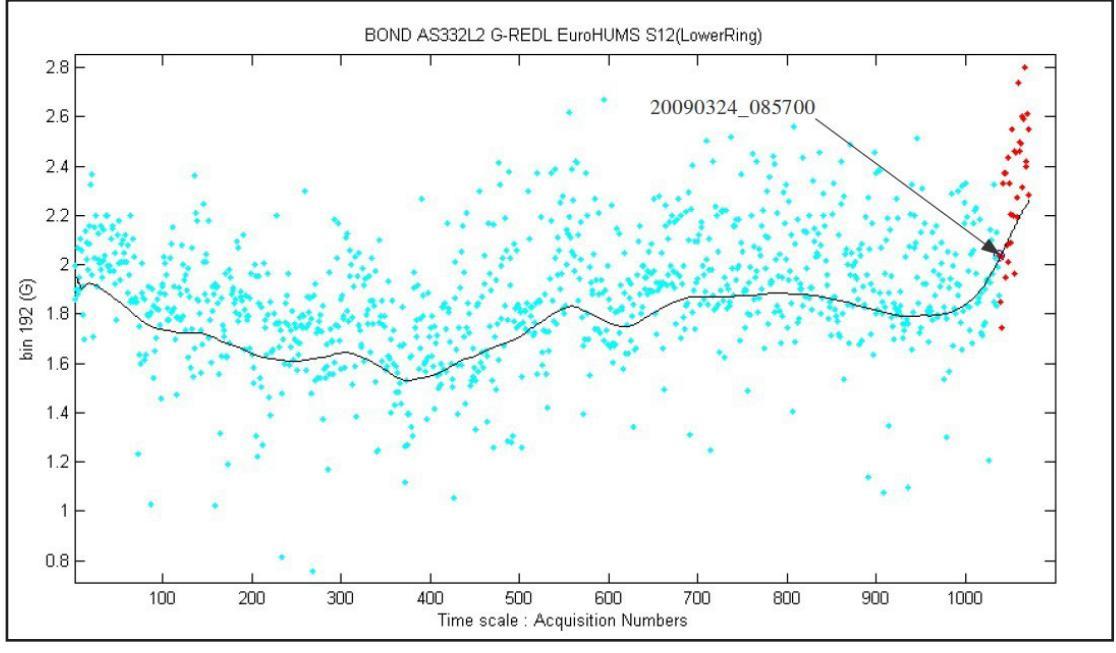
Figure H-2

Lower epicyclic ring gear, lower sideband mesh CI. Arrow points to operations of 24 March 09 (Source: Eurocopter)
