AIRCRAFT ACCIDENT REPORT 2/2014

Report on the accidents to Eurocopter EC225 LP Super Puma

**G-REDW
34 nm east of Aberdeen, Scotland
on 10 May 2012**

**G-CHCN
32 nm southwest of Sumburgh, Shetland Islands
on 22 October 2012**

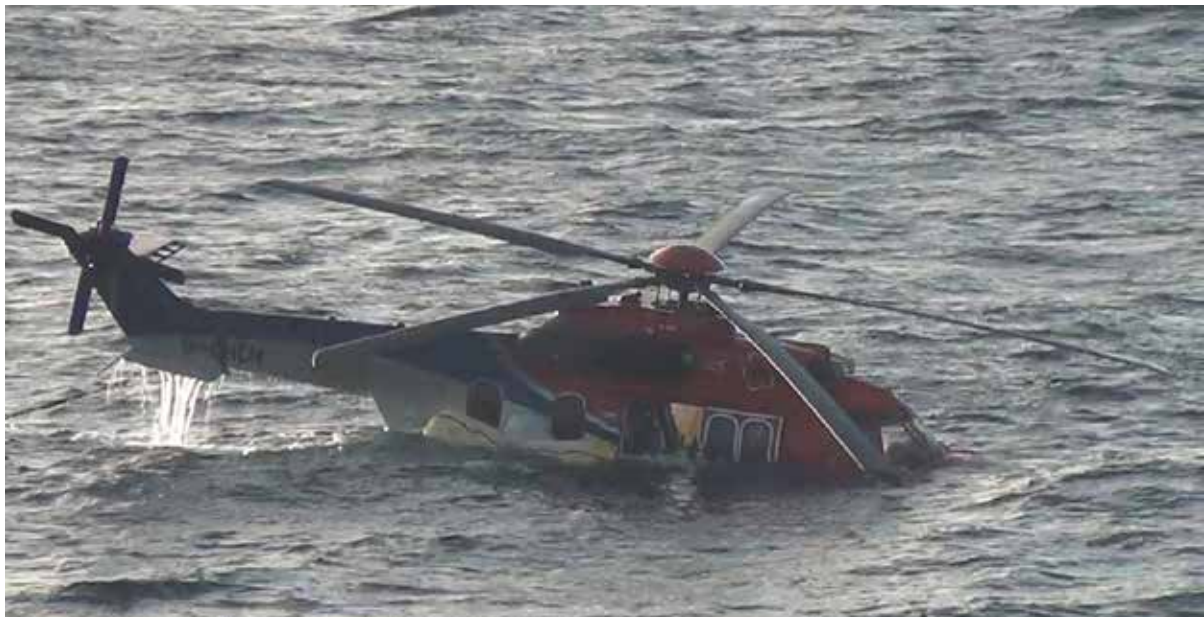
Figure 1

G-REDW afloat, approximately 8 hours after ditching

G-REDW remained upright and was salvaged onto a recovery vessel approximately 22 hours after it ditched (Figure 1). Whilst afloat the sea state increased to a Force 5 and waves were seen to break over the windshields, the tail boom dipped into the water and the main rotor blades caught the top of the waves.

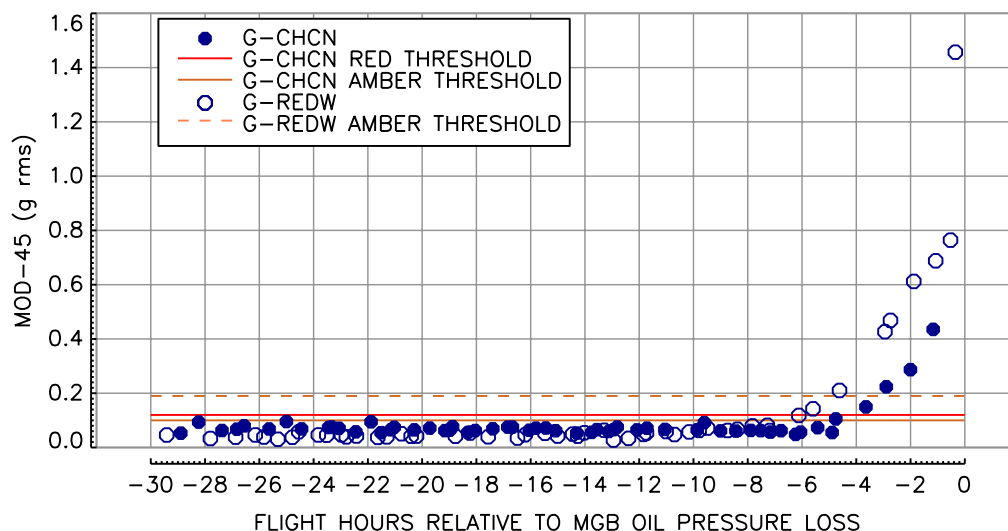
**Figure 22**

Comparison MOD-45 condition indicator between G-CHCN and G-REDW

For G-REDW the MOD-45 indicator exceeded its learned amber threshold (0.19) 4.62 flying hours before the loss of the MGB oil pressure. No red threshold existed at the time of the accident involving G-REDW. The MOD-45 indicator for G-CHCN exceeded its learned amber threshold (0.10) 4.75 flying hours and its learned red threshold (0.12) 3.63 flying hours prior to the loss of oil pressure (Figure 22).

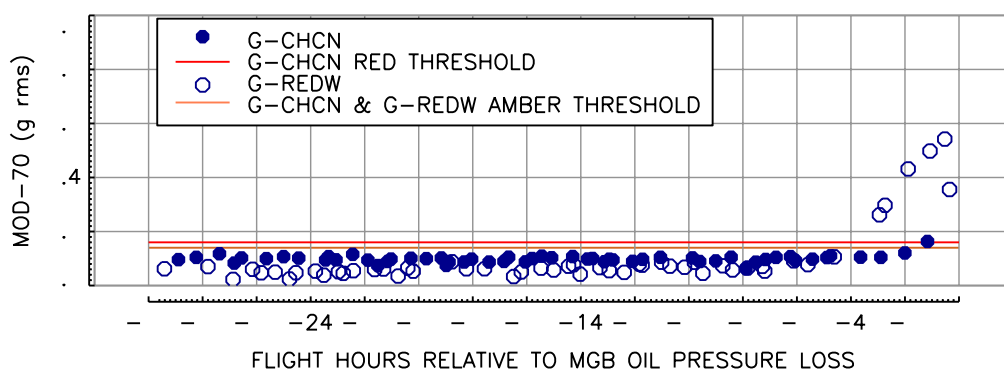
**Figure 23**

Comparison MOD-70 condition indicator between G-CHCN and G-REDW

For the MOD-70 indicator, the first instance that it exceeded the learned amber threshold (0.14) for G-REDW was 2.95 flying hours before the loss of MGB oil pressure (Figure 23). However, for G-CHCN only the last recorded value of this indicator, which was captured 1.17 flying hours before the loss of the MGB oil pressure, exceeded both its amber (0.14) and red (0.16) learned thresholds.

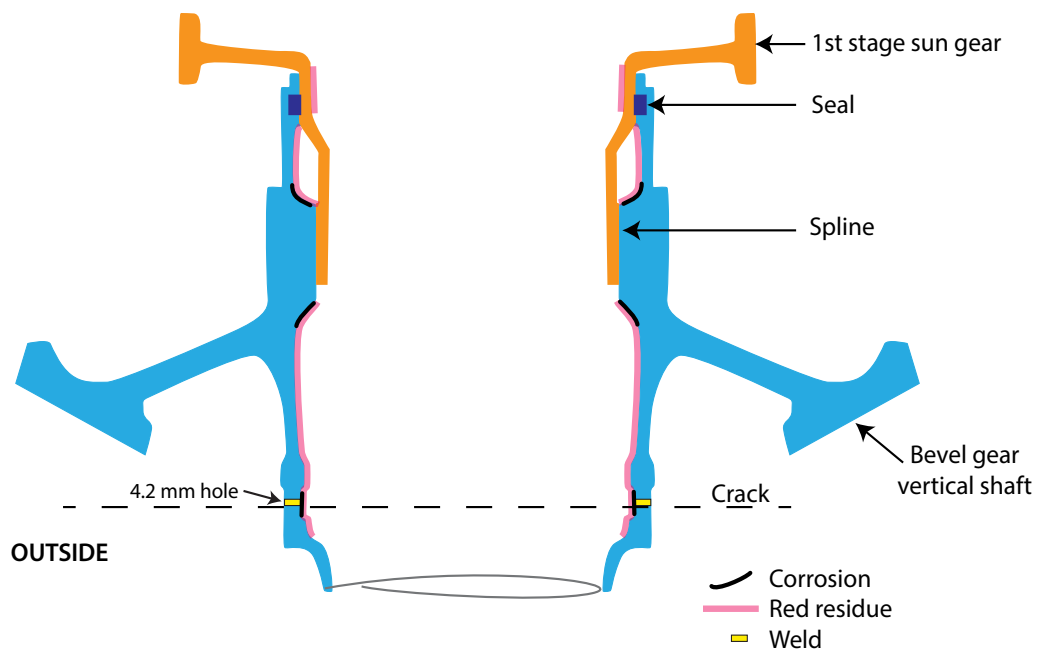
**Figure 29**

When the deposit was removed, corrosion was observed visually on the shaft, in the areas above and below the splines. Small areas of corrosion pits and machining marks were also present around the inner flange that had been machined to remove the root of the weld (Figures 28 and 29).

Location of corrosion on bevel gear vertical shaft G-CHCN

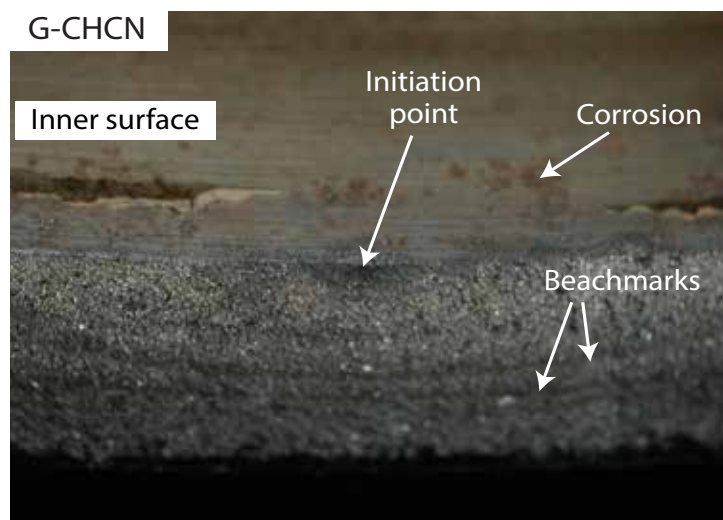
**Figure 35**

On G-CHCN, the principle crack initiated at a corrosion pit 60µm deep located on the inner radius in the parent material (Figure 34). The initiation point was approximately 45° around the circumference of the shaft from the 4.2 mm hole. The crack then propagated in both directions in the parent material in the lower³⁰ part of the shaft, into the 4.2 mm hole, before it re-initiated on the other side of the hole. As the crack extended around the circumference of the shaft it changed planes a number of times, but always remained in the parent material. In addition, multiple crack initiation sites were identified on the inside of the shaft with small semi-elliptical cracks propagating from the surface. It was assessed that these small cracks initiated and grew as a result of the increase in stress caused by the two major cracks extending around the circumference of the shaft. Both major cracks exhibited evidence of striations and beachmarks, which are associated with fatigue cracking (Figure 35).

Location of crack initiation on G-CHCN

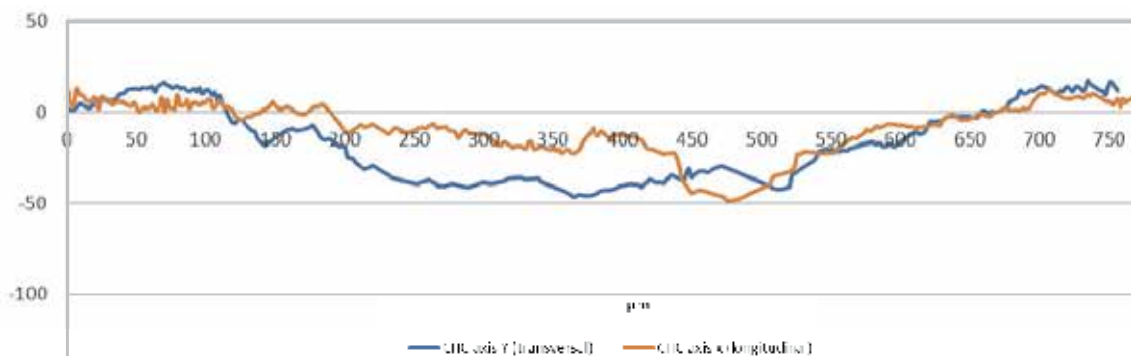
**Figure 38 (b)**

Profile of corrosion pit on the shaft fitted to G-CHCN
(using the same scale on the horizontal and vertical axis)

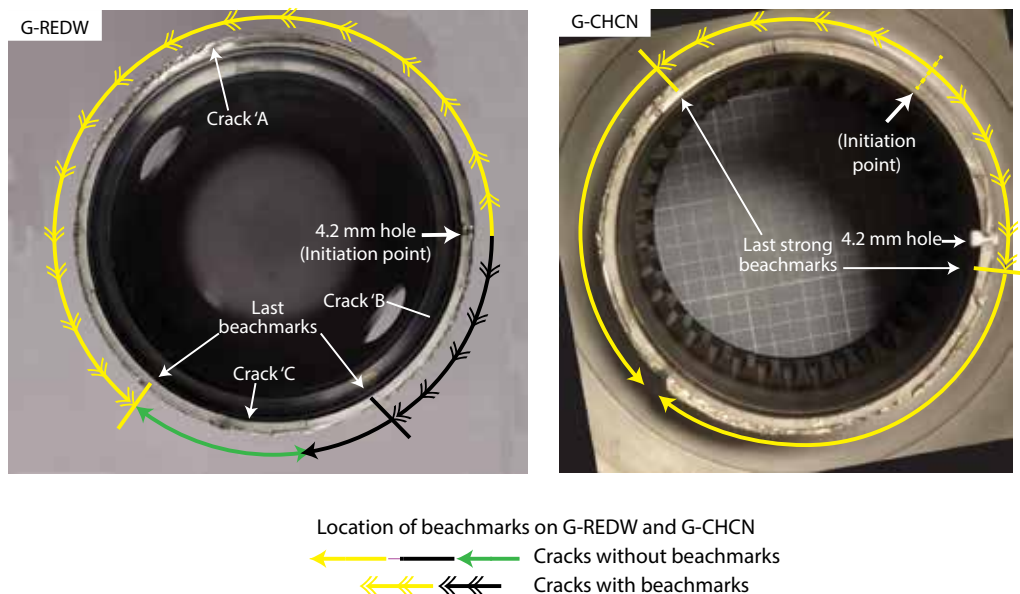
**Figure 39**

The fracture surfaces of the shafts on G-REDW and G-CHCN both displayed beachmarks, which can be formed when an event such as an engine start or significant change in torque has taken place (Figure 39). Beachmarks may be difficult to identify and can be interpreted in a number of ways.

Fracture surfaces on shafts fitted to G-REDW and G-CHCN

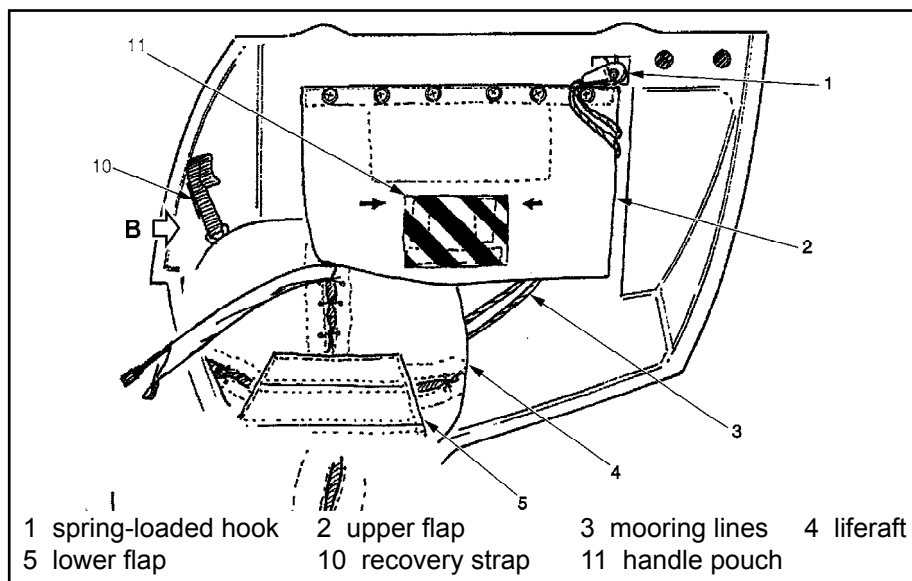
**Figure 40***(Courtesy of Eurocopter)*

The EC225 LP aircraft maintenance manual (AMM) contains a procedure in workcard 25-66-01-061 (version 2012.06.14) for installing the liferaft, inflation bottle and rescue pack. The procedure calls for the liferaft to be installed first and then it states to '*Attach mooring lines (3) to spring-loaded hook (1) and bind them to upper flap (2) using Commercial Adhesive tape.*' These items are shown in Figure 3 of the procedure, reproduced in Figure 40 of this report. There is a spring-loaded hook secured to the end of the mooring lines and the intention of this instruction is for this hook to be attached to the bracket fixed to the sponson at position (1) in Figure 40. The figure does not show how to tape the mooring lines to the upper flap and the lines are shown to pass in front of the flap, when they should pass behind it as shown in Figure 41. This tape is removed after the inflation bottle is installed. The rescue pack is installed last. Figure 40 also shows the mooring lines (3) routing behind and below the liferaft which is different from the routing of the lines in an installation test carried out by the helicopter manufacturer (Figure 41).

Extract from Figure 3 of
workcard 25-66-01-061- liferaft installation procedure

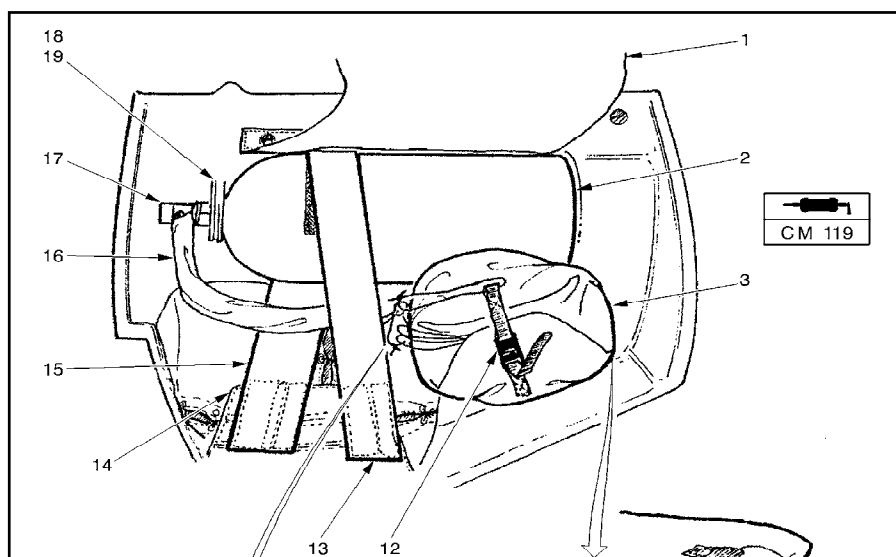
The liferaft installation procedure contains a Caution which states that the mooring lines, recovery strap and rescue pack lines 'MUST NOT CROSS EACH OTHER', but the actual routing of these lines is not shown. An additional installation diagram, Figure 42 (Figure 2 in the workcard), shows the inflation bottle, rescue pack and liferaft installed, although the liferaft is not easily visible in the lower left part of the image, and the mooring lines are not shown.

Extract from Figure 2 of
workcard 25-66-01-061- liferaft installation procedure

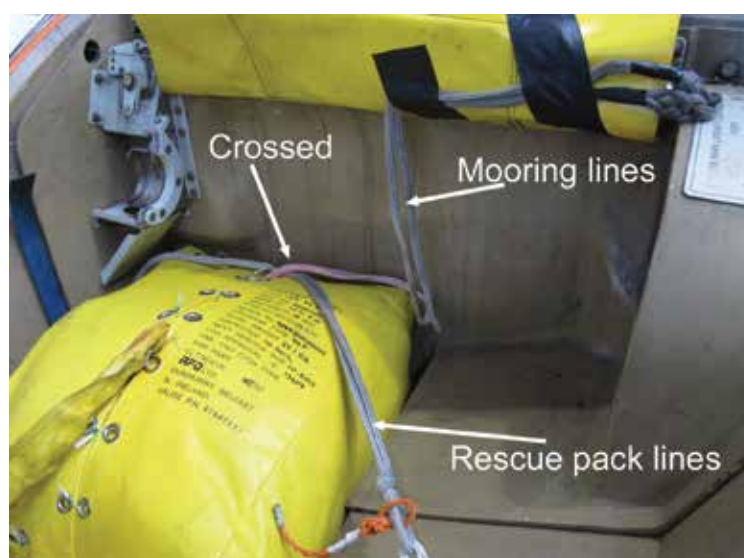
Although the instructions state clearly that the mooring lines and rescue pack lines must not cross, whether this is achievable or not depends upon how the lines exit the liferaft pack. In the liferaft installation shown in Figure 43 it was not possible to route the lines without crossing them because the mooring lines exited the liferaft pack forward of the rescue pack lines. The liferaft packing instructions do not specify if one set of lines needs to be forward of the other – for more detail on packing see section 1.15.6.3.

Liferaft installation showing crossed mooring and rescue pack lines

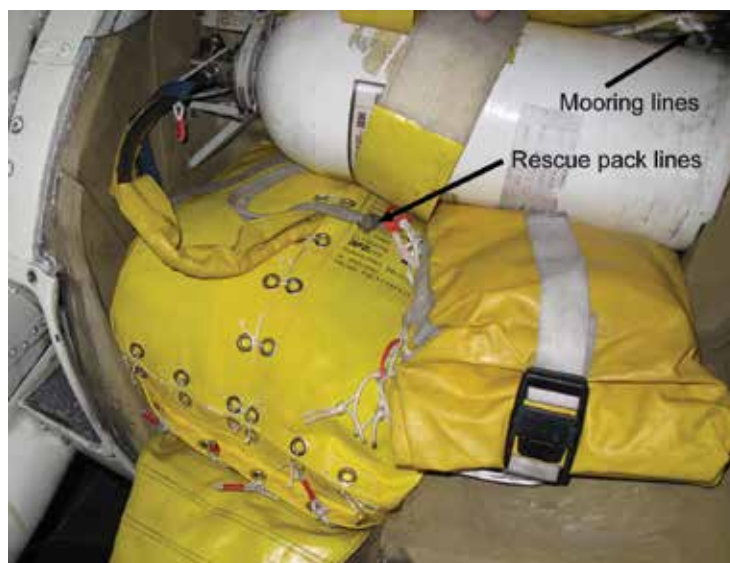
Figure 44

On four of the installations the mooring lines and rescue pack lines were routed correctly, that is they were not crossed and the mooring lines were routed behind the inflation bottle as shown in Figure 44. However, since the exact routing of the rescue pack lines is not specified in the manual, it is not possible to be certain that they were routed as intended by the helicopter manufacturer.

Mooring lines shown correctly routed behind the inflation bottle

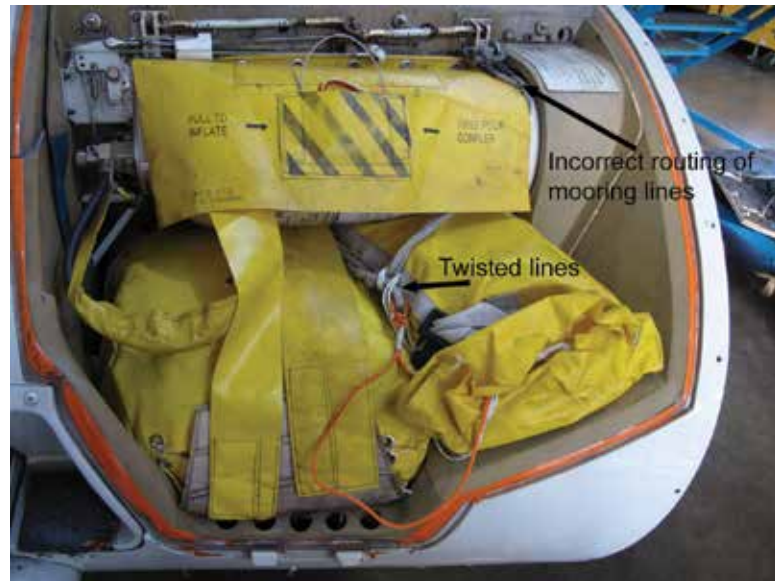
Figure 45

In the left compartment of G-WNSO the mooring lines were routed in front of the inflation bottle instead of behind it and the rescue pack lines were twisted around the mooring lines (Figure 45). The engineer who installed this liferaft was interviewed several months later and could not recall fitting the liferaft. He was aware that the mooring lines should be routed behind the bottle. He stated that sometimes it was difficult to install the bottle with the mooring lines behind it, which may have been the reason why he routed the mooring lines in front of the bottle. He could not explain why the mooring and rescue pack lines were left in a twisted state.

G-WNSO left compartment - incorrect routing of mooring lines in front of the bottle and rescue pack lines twisted around mooring lines

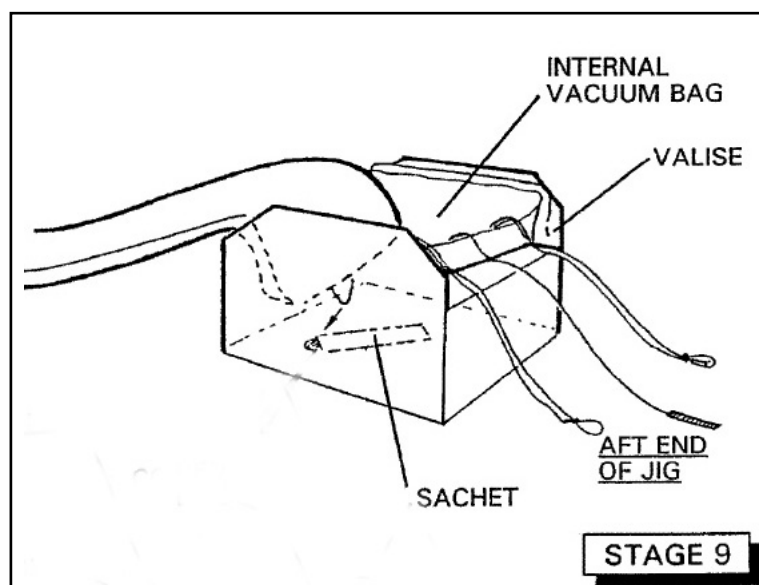
Figure 46

The instructions in the CMM contain diagrams for how to fold the liferaft, but do not depict the rescue pack line, mooring lines or the retrieval line. The first diagram to show these lines is CMM Figure 712, reproduced here in Figure 46, where the liferaft is already packed in the valise.

Figure 712 from liferaft CMM showing mooring, rescue pack and retrieval lines

The retrieval line, which has a strap on the end, can be identified in the centre, but the other two lines are difficult to identify. The liferaft manufacturer stated that the lines furthest away in the diagram are the mooring lines and the ones closest are the rescue pack lines. In a later diagram, Figure 47 (CMM Figure 714), the lines appear in a different order but there is no explanation in the text for this.

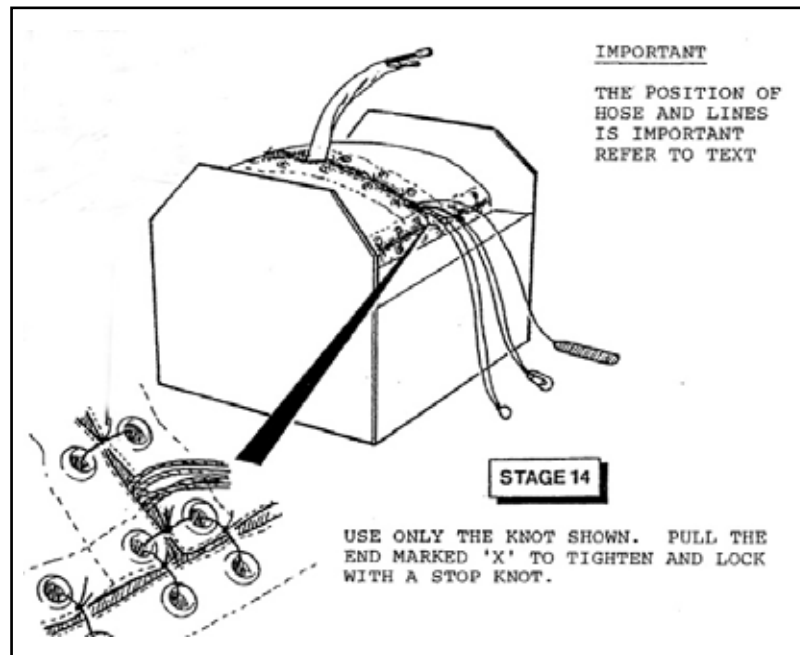
Figure 47

Figure 714 from liferaft CMM – lines shown in different order
from Figure 712

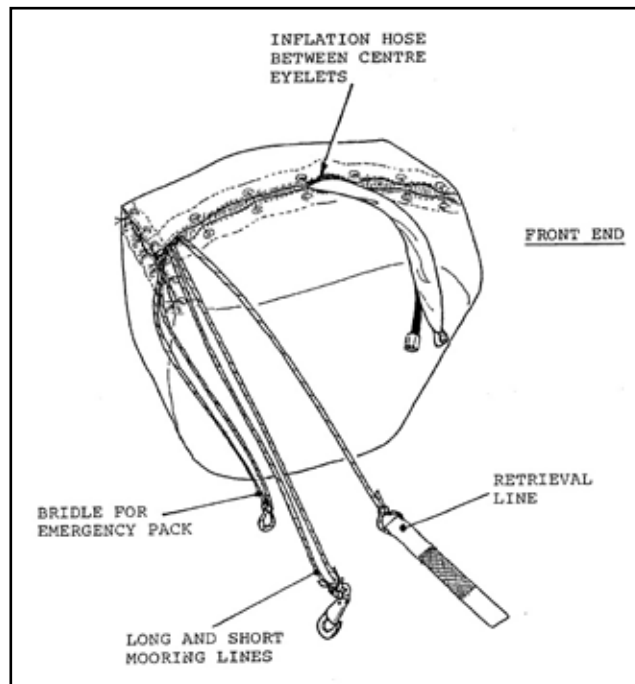
The final diagram in the packing instructions, Figure 48 (CMM Figure 715), shows the rescue pack line⁴⁰ emerging at the back of the valise and the mooring lines forward of these. This orientation will result in these lines crossing when the liferaft is installed in the sponson because the rescue pack line is routed forwards while the mooring lines are routed rearwards. The instructions in the text relating to the lines state (note: the 'bridle' is the rescue pack line):

There are no further instructions detailing how to pack the lines and there are no notes of caution about not crossing the lines.

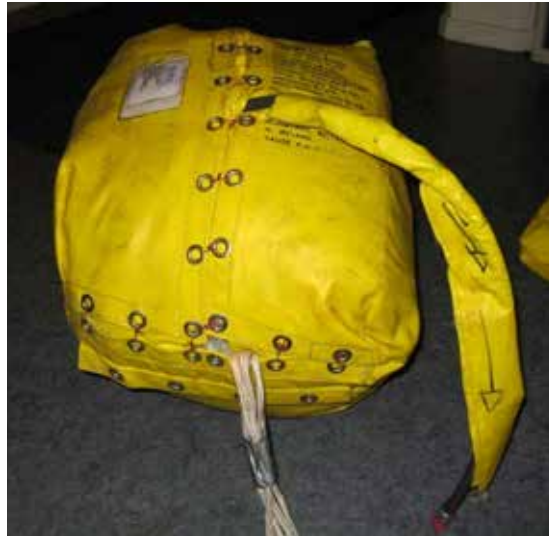
Figure 49

The Part 145 AMO that serviced the left liferaft on G-CHCN was asked if they were aware of any packing issues. A search of their database revealed four reports of incorrectly packed liferafts between May 2008 and September 2013. These were discovered when the liferafts were sent to them for their annual service. In all four cases the mooring, rescue pack and retrieval lines exited the valise at its forward end rather than its aft end (Figure 49). This would have resulted in incorrect inflation of the liferaft, causing the lines to twist, and would also have posed a risk of puncture. In two of the cases the liferafts had been packed by organisations in Brazil and Australia that were not registered with the liferaft manufacturer and therefore would not have had access to official copies of the CMM or updates.

Incorrectly packed liferaft with the lines exiting at the front instead of the rear
– discovered during servicing

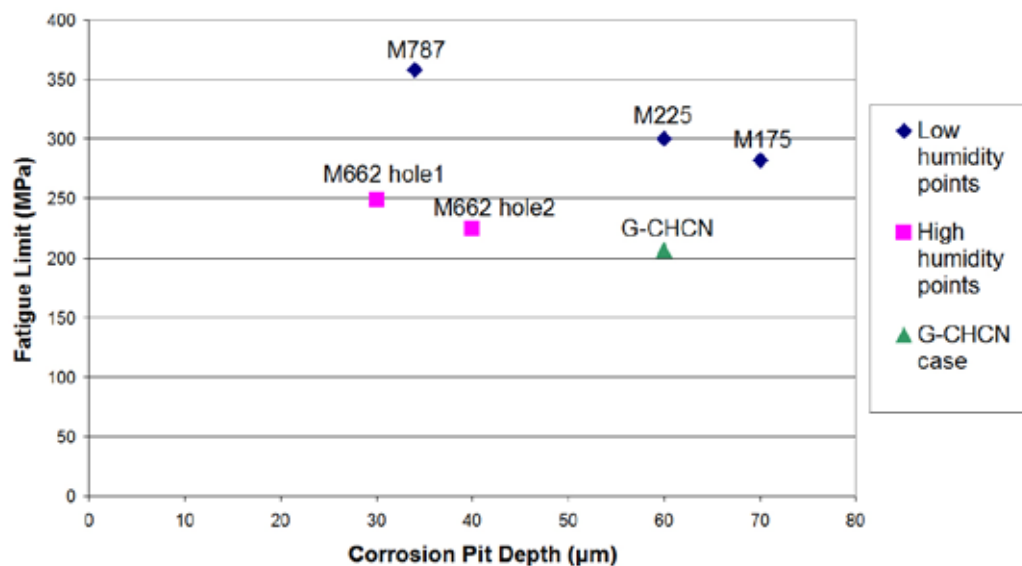
Data points from the bending fatigue tests carried out on shafts M787, M225, M175 and M662 are plotted in Figure 52 as a function of the calculated fatigue limit versus the corrosion pit depth. These data points are all for cracks that initiated from corrosion pits in the inner radius. Points M787, M225 and M175 were considered to be low humidity points and the data points from shaft M662 were considered to be high humidity points caused by water being dropped onto the surface at a temperature of 85°C. The G-CHCN failure is plotted for comparison using the stress level produced at Takeoff Power (TOP).

Effect of corrosion pit depth and humidity on the manufacturer's calculated fatigue limit for the inner radius

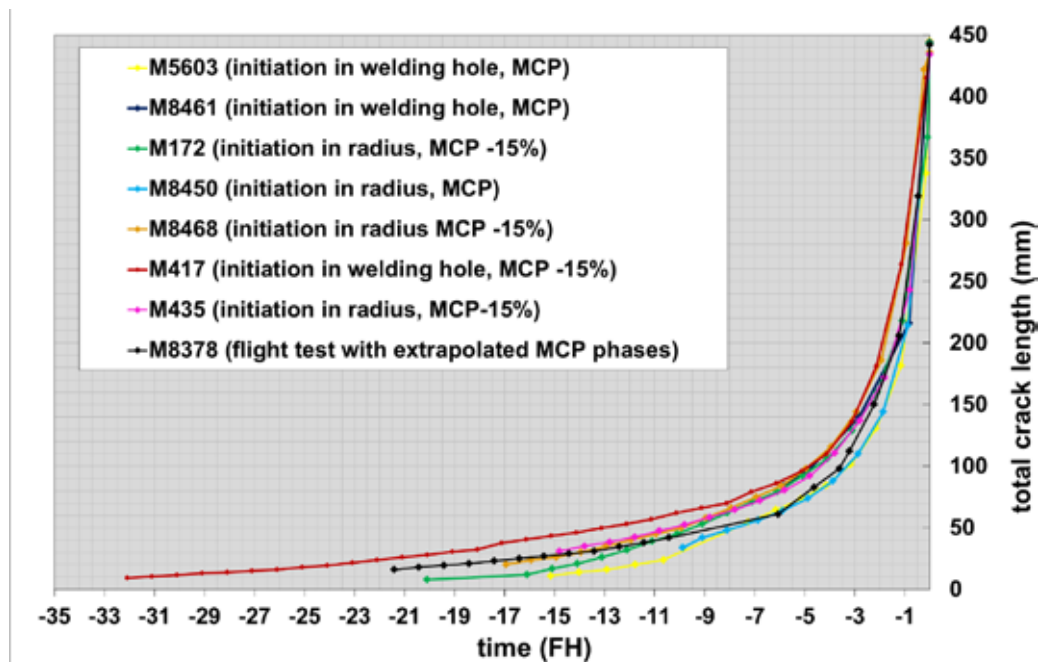
Figure 56

The manufacturer carried out dynamic testing of seven shafts to determine the rate that a circumferential crack would propagate at a power setting of MCP and MCP-15%. Decreasing the engine power by 15% should decrease the rate the crack grows by 33%. (Appendix G). Cracks were initiated at the 4 mm hole, weld and inner radius and the shafts were then subjected to the engine power spectrum similar to that experienced on G-REDW and G-CHCN. At the end of the tests the manufacturer carried out beachmark counting to determine the rate of crack propagation. A similar test was carried out, in flight, on a shaft fitted to an EC225 LP. As the tests were carried out on shafts and not coupons, the results included the effect of residual stress⁵³ and the position of the 29 mm lubrication hole, on the local stress at the 4.2 mm hole and inner radius. The results of the test are at Figure 56.

Results of manufacturer's crack propagation tests

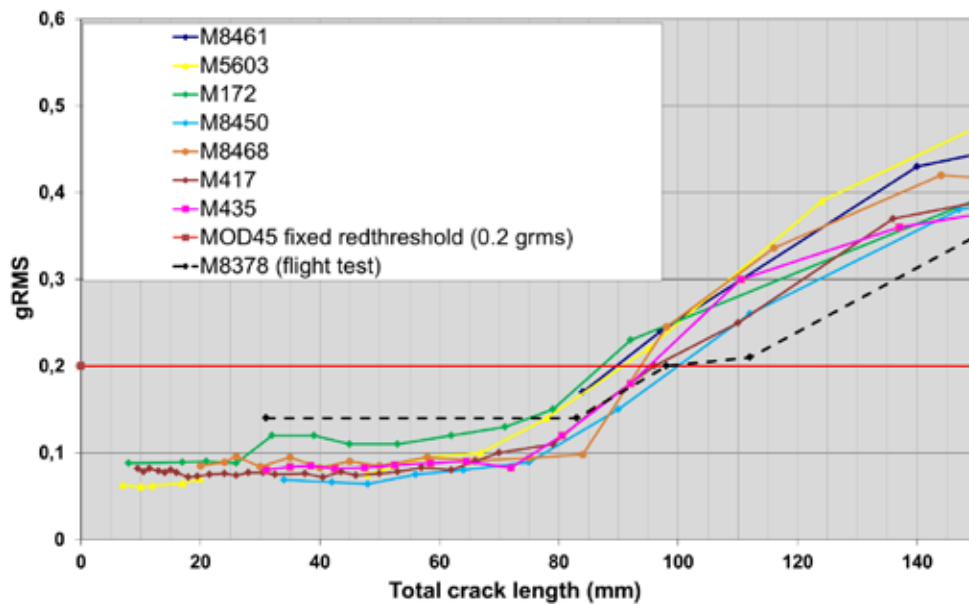
These tests also explored the response of the HUMS MOD-45 indicator as the crack grew in length. The results of these tests are at Figure 57 and show that HUMS indicator MOD-45 exceeded the red threshold of 0.2 g rms when the crack length was between 87 mm and 100 mm.

Results of manufacturer's crack propagation tests

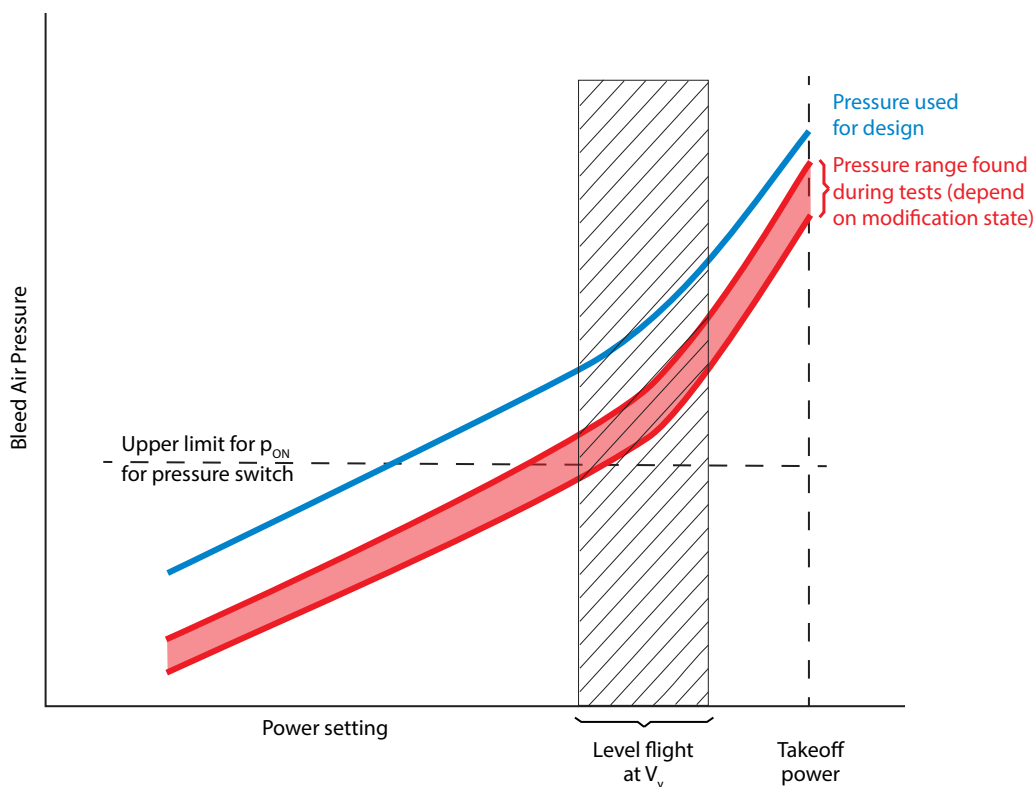
Figure 62 is an indicative graph. For a given pressure altitude and power setting, it was found that the bleed-air pressure (red band) is always lower than that used in the design and certification of the system (blue line).

Variation of bleed-air pressure with engine power setting

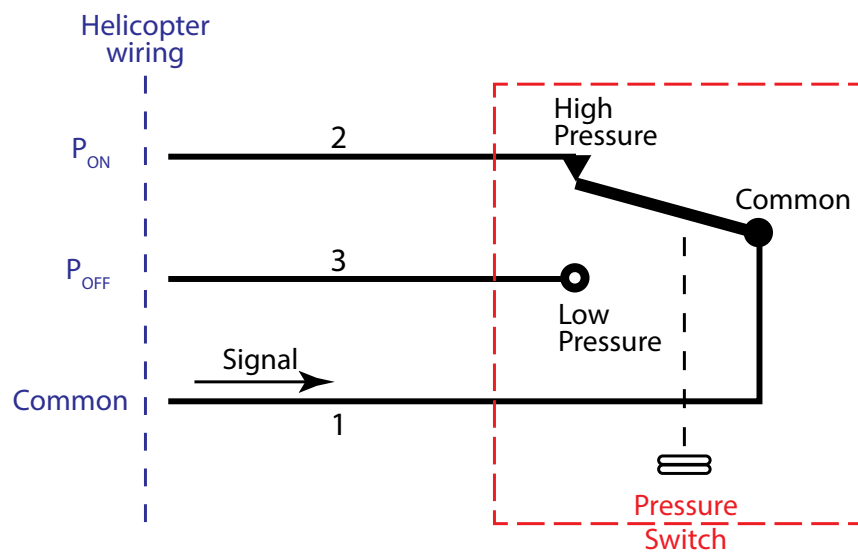
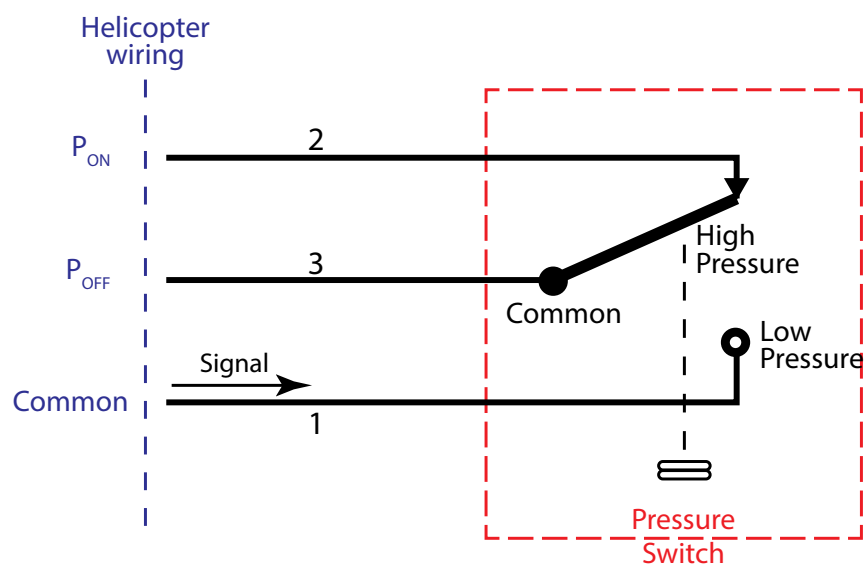
Owing to obsolescence, the helicopter manufacturer issued a specification for new pressure switches, requiring them to be interchangeable with the original switches. It included the original specification for the internal wiring of the pins. Therefore, the replacement pressure switches were developed with Pin 3 as the common pin. The helicopter wiring, however, remained configured for a common Pin 1. The new pressure switches, manufactured by a different supplier, were fitted to helicopters as part of a modification in 2010 (MOD 0752520). The wiring and internal schematic for the switches before and after MOD 0752520 is shown in Figure 63. The schematic is valid for both the Hydrosafe 620 and bleed-air switches.

The terms 'p_{on}', 'p_{off}' and 'Common' in Figure 63 reflect the helicopter wiring identification. The figure illustrates that changing the internal architecture to Pin 3 as 'common' on the replacement switch meant it now fed the p_{off} signal wiring on the helicopter.

In summary, the MGB EMLUB caption will illuminate for any of the three possible states - high pressure, low pressure or an erroneous signal - when the system is activated. These are the only three possible states for the system and hence for all helicopters with MOD 0752520 the MGB EMLUB caption will illuminate after the 30-second delay following system activation. Both G-REDW and G-CHCN had MOD 0752520 embodied.

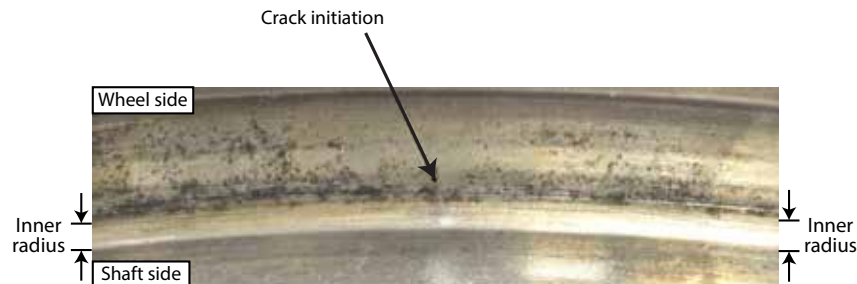
Figure 67

Red deposits were found on the inside of the bevel wheel part of the shaft fitted to G-CHCN (M122). Whilst the deposits covered all of the top part of the inside of the shaft, it was particularly concentrated in three distinct bands where there are features in the shaft. One of these bands was located in the area of the inner radius, a design feature that was not present on the AS332 shaft. On removing the deposit, corrosion pits were found under each of these bands and it was from one of these corrosion pits, located on the inner radius (Figure 67) that the fatigue crack on the shaft fitted to G-CHCN initiated. Apart from these areas, and in the 4.2 mm hole and countersink, corrosion was not

found anywhere else on the shaft or on any other components in the MGBs fitted to G-REDW and G-CHCN.

Corrosion pits at the inner radius on G-CHCN

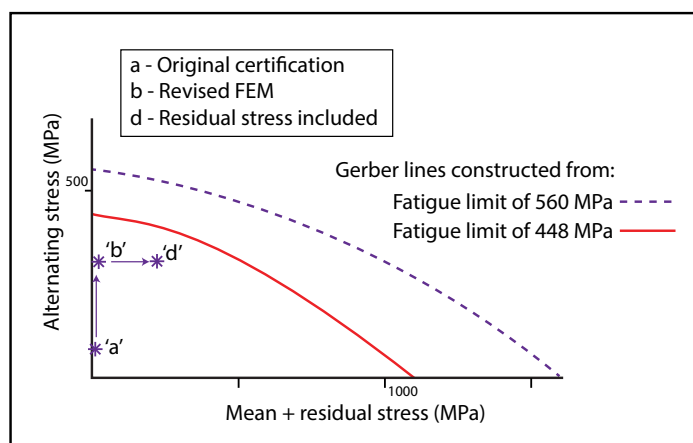
- The first condition is shown at Figure 68 which represents the understanding during the EC225 LP certification process of the stresses at Critical Area 2: the 4.2 mm hole in the weld. The Gerber line (solid line) is constructed from a fatigue limit of ± 448 MPa, based on a surface roughness of $3.2\text{ }\mu\text{m}$, and the parent material UTS of 1,200 MPa. Point 'a' is the maximum stress, calculated during the original certification, at the 4.2 mm hole and the safety factor is approximately 5.4. The actual safety factor is more conservative as the design drawing specifies the surface roughness of the 4.2 mm hole as $1.6\text{ }\mu\text{m}$. This would give a fatigue limit of ± 560 MPa. This is shown by the dotted Gerber line which uses this fatigue limit and the UTS for the weld material of 1,600 MPa.

Safety factor at Critical Area 2, 4.2 mm hole in the weld

- The second condition represents the stress after the revision of the FEM following the accidents to G-REDW and G-CHCN. As can be seen at Figure 68, the maximum stress at the 4.2 mm hole has moved from point 'a' to 'b'. The maximum stress at the inner radius is plotted as point 'c' on Figure 69, where the Gerber line is constructed from the parent material fatigue limit of ± 480 MPa obtained for a surface roughness of $3.2\text{ }\mu\text{m}$. The safety factors are approximately 1.9 for the 4.2 mm hole, using the dashed Gerber Line, and 2.1 for the inner radius.

- The third condition shows the effect of including the residual stress. The Gerber lines are unchanged, but as can be seen at Figure 68, the maximum stress at the 4.2 mm hole has moved from point 'b' to point 'd'. On Figure 69 it can be seen that the maximum stress at the 'inner radius' has moved from point 'c' to point 'e'. The safety factors are now approximately 1.7 for the 4.2 mm hole, using the dashed Gerber Line, and 1.6 for the inner radius.

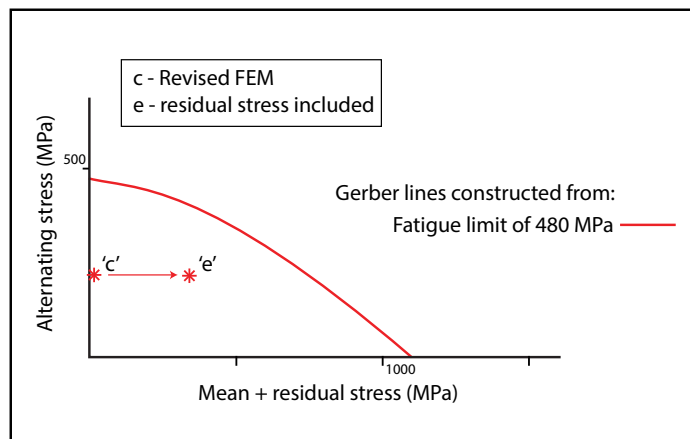
**Figure 69**

Safety factor at inner radius

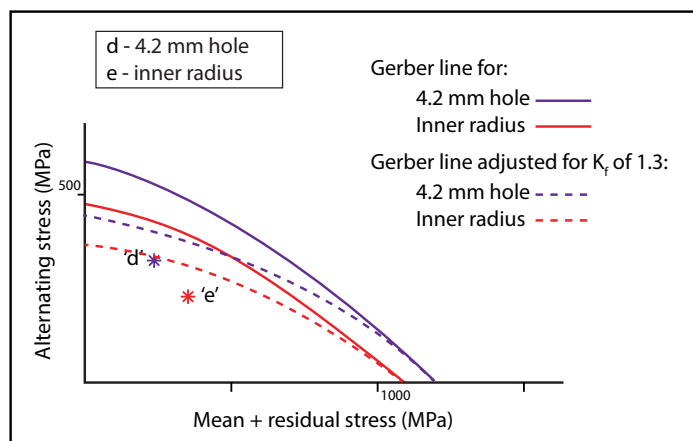
**Figure 70**

- The results of the first method, using an experimental K_f of 1.3 for a corrosion pit 60 μm deep, are shown at Figure 70. The fatigue limit is decreased by a factor of 1.3 and the Gerber lines for the weld material and parent material move downwards. Consequently, the safety factors are now approximately 1.4 for the 4.2 mm hole and 1.3 for the inner radius.

Effect of a corrosion pit 60 µm deep and K_t of 1.3 on the factor of safety

The above analysis does not take into account the variation in the material properties that will affect the fatigue limit, or the tolerance on the estimated stress concentration factor for the corrosion pit. The K_t of 1.3 was based on an R ratio of -1 and it was not established during this investigation if the residual stress would change the R ratio and hence K_t . Moreover, the fatigue limit on the weld fusion line may be lower than on other areas of the weld; this was demonstrated by QinetiQ's coupon testing. Increasing the stress concentration factor K_t of the corrosion pit from 1.3 to 1.8 for the 4.2 mm hole and to 2 for the inner radius would move points 'd' and 'e' onto their respective Gerber lines. The work undertaken by Cranfield University, in support of this investigation, indicated that stress concentration factors of this level are possible and cites some of the manufacturer's data that indicated that the stress concentration factor, taking into account tensile residual stress, could be around 2.

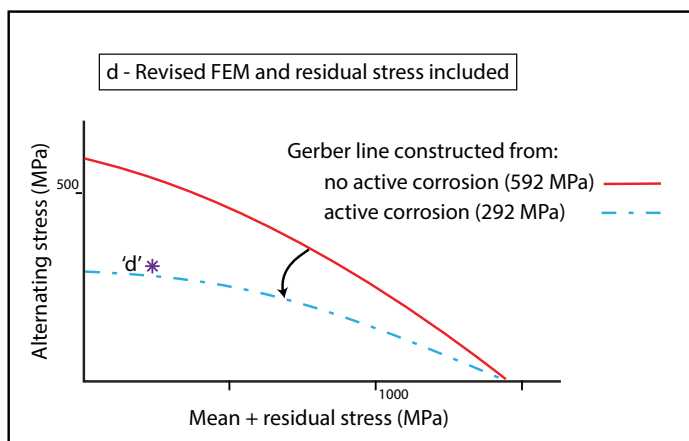
**Figure 71**

Figure 71 shows the effect of 'active corrosion' on a crack initiating from a 40 µm corrosion pit on the 4.2 mm hole in the weld. An estimated fatigue limit of ± 292 MPa was obtained from the testing of shaft M041. The stress at the 4.2 mm hole is unchanged at point 'd'. The effect of corrosion fatigue is to move the Gerber line downwards such that the safety factor is reduced to 0.9.

Effect of a corrosion pit 40 µm deep and corrosion fatigue on the factor of safety at the 4.2 mm hole

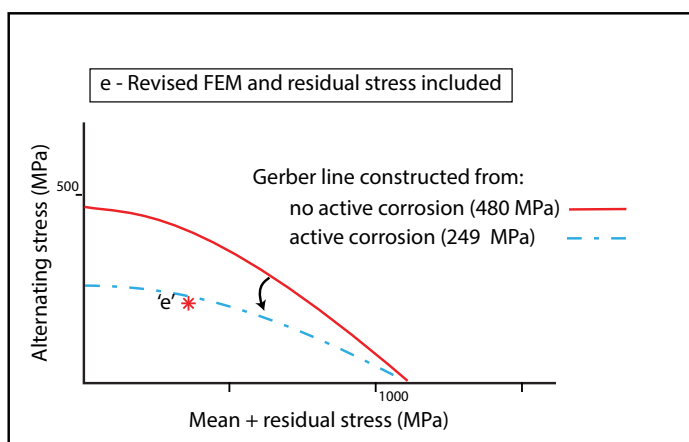
**Figure 72**

Figure 72 shows the effect of 'active corrosion' on a crack initiating from a 40µm corrosion pit on the inner radius. An estimated fatigue limit of ± 249 MPa was obtained from the dynamic testing of shaft M662. The stress at the inner radius remains at point 'd'; however, the Gerber line has now moved downwards to an extent that the safety factor is now 1.1.

Effect of a corrosion pit 40 µm deep and corrosion fatigue on the factor of safety at the inner radius

While the use of safety factors and the Gerber line is an analytical approach, it demonstrates that the stress levels, residual stress and corrosion pits and/or 'active corrosion' could explain the fatigue failures of both shafts.

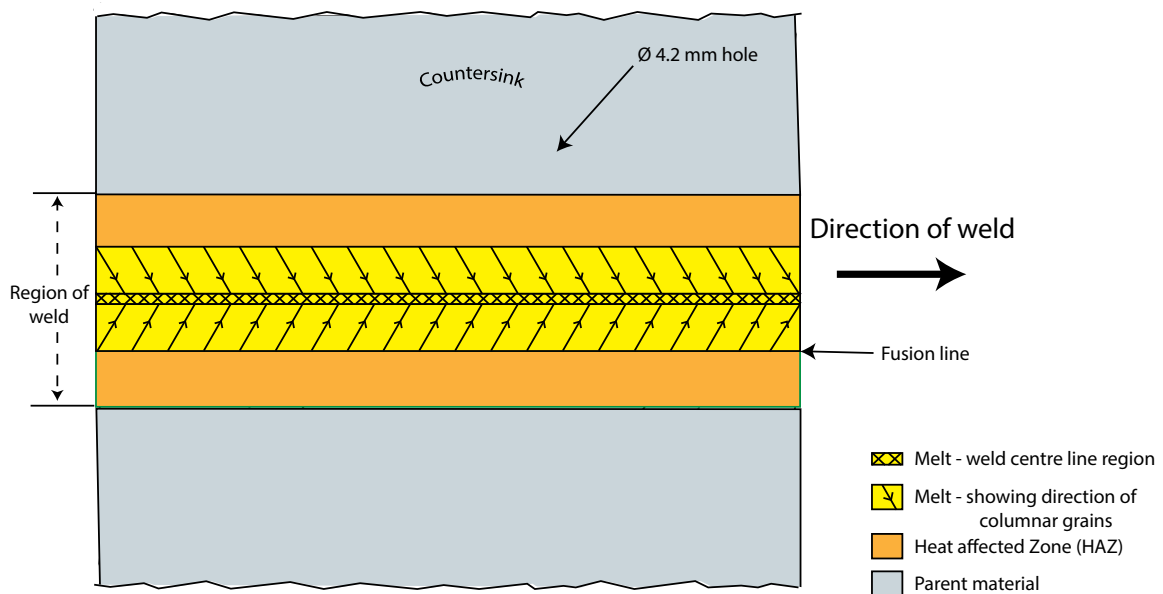
Figure B-1

The region of the weld consists of two areas, the Heat Affected Zone (HAZ) and the melt; the transition between the two areas is called the fusion line. The design definition specifies the width of the melt and HAZ on the inside surface of the EC225 shaft as 2 ± 0.5 mm. The surface hardness, which is an indication of the strength of the material, reduces slightly between the parent material and HAZ and then increases by approximately 25% across the melt (Figure B-1).

Features of the weld on the bevel gear vertical shaft

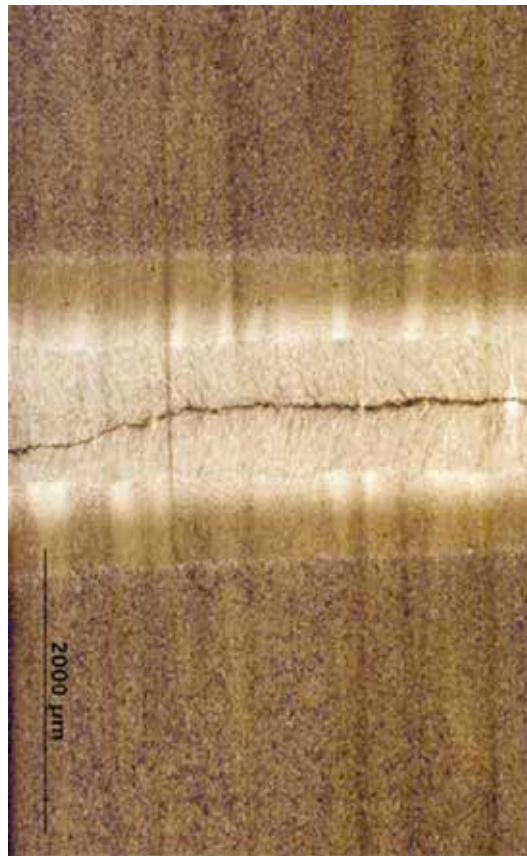
**Figure B-2**

As the melt solidifies, grain boundaries form along the edge of the HAZ and metallic columnar grains grow from this region forming chevrons that point in the direction of the weld with the centre line solidifying last. Within the region of the weld, cracks will tend to grow in either the fusion line or the weld centre line depending on their direction of propagation (Figure B-2).

Microstructure across the region of the weld
