Accident Investigation Board Norway

REPORT SL 2018/04

REPORT ON THE AIR ACCIDENT NEAR TURØY, ØYGARDEN MUNICIPALITY, HORDALAND COUNTY, NORWAY 29 APRIL 2016 WITH AIRBUS HELICOPTERS EC 225 LP, LN-OJF, OPERATED BY CHC HELIKOPTER SERVICE AS

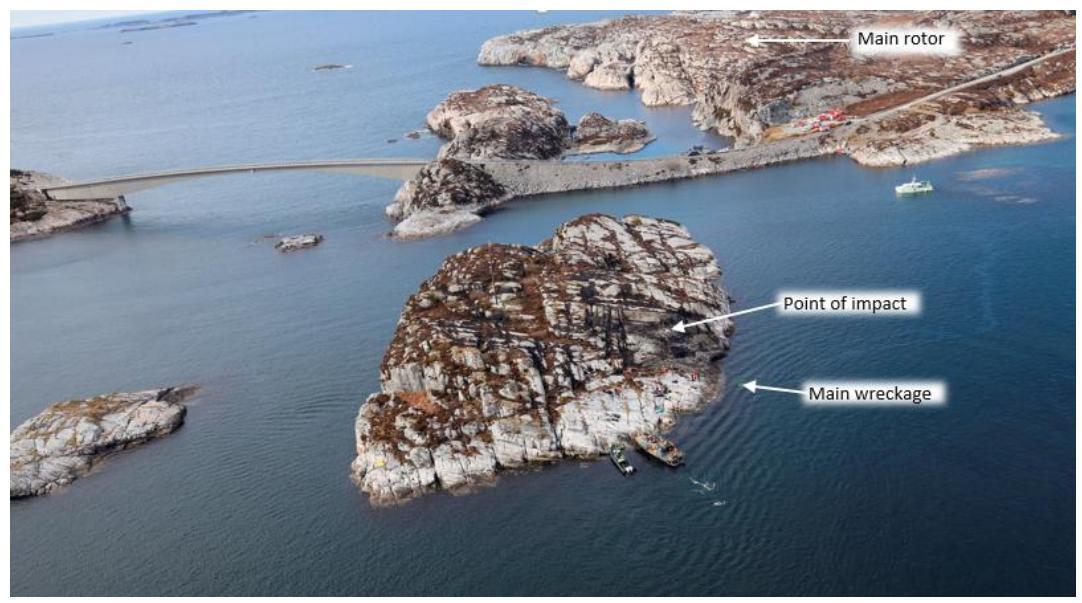
- 1.1.1.7 The main rotor detached above the western end of the Turøy Bridge and continued to fly on its own in a wide erratic descending left hand turn towards the north and fell down on the island Storskora (See Figure 2 and Figure 21).

Figure 2: Photo of the accident area taken at 1500 hours 29 April 2016. The helicopter flew over the Turøy Bridge seen to the left. View from south. Photo: Kripos

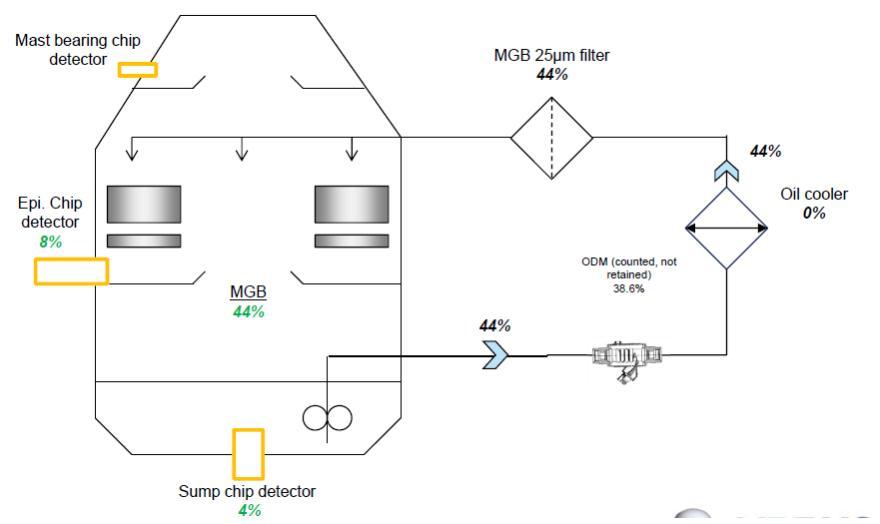
Following the LN-OJF accident, Airbus Helicopters provided an updated justification of the status of available MGB monitoring means. Based on the G-REDL test (see section 1.18.3.3) it was initially found that 12 % of the debris had been detected by the chip detectors while 44 % of the debris had been captured by the MGB oil filter (see Figure 12).

The configuration of the G-REDL test bench was different from the helicopter as it was not fitted with a standard oil cooler. Later, during the investigation of the LN-OJF accident, it was discovered that the standard oil cooler acted as a particle trap thus preventing the largest debris from reaching the filter. 44 % of the debris would not have reached the MGB oil filter as shown in Figure 12, but would have been partly retained in the oil cooler. This led to a thorough inspection of the LN-OJF oil cooler, in which several particles were recovered (see section 1.16.10.3).

Figure 12: The configuration of the G-REDL test and the detection rate of chip detectors (%: Particle quantity). Source: Airbus Helicopters

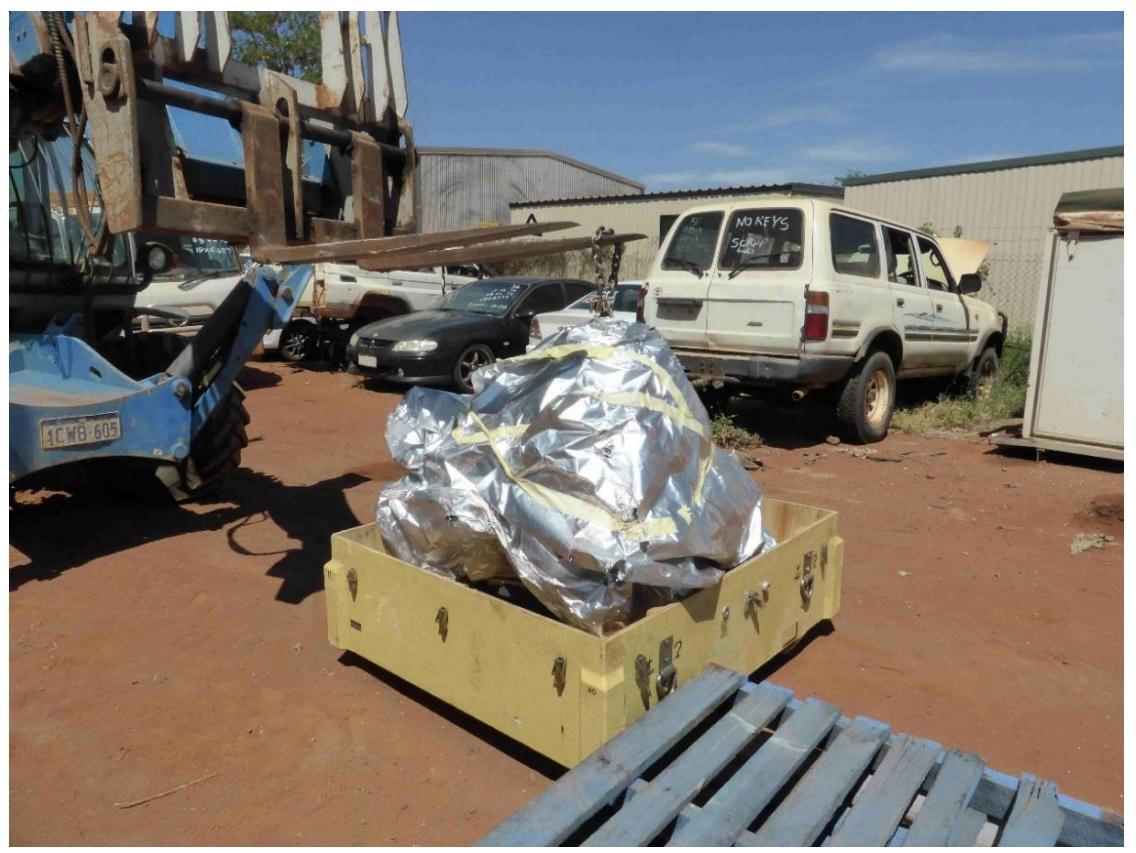
The gearbox was returned to Airbus Helicopters in Marignane, France for inspection and repair. Following inspection and repair, the MGB was supplied with an EASA Form 1 dated 5 January 2016 (see section 1.17.6.5). The document stated that the part was repaired with reference to overhaul instruction MRV EC 225 LP chapter 63 and log cards. According to Airbus Helicopters no anomalies on internal components were detected during this work, and all bearings and gears were re-installed.

Figure 14: The MGB in the transport container without the damaged top after the ground transport accident 13 March 2015. Photo: Airbus Helicopters

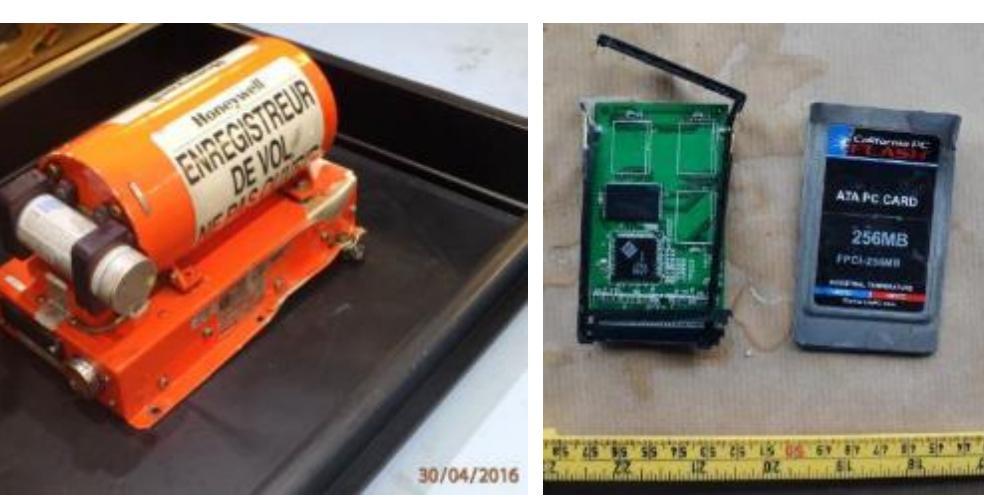
LN-OJF was equipped with a Honeywell 6021 Combined Voice and Flight Data Recorder (CVFDR), part number 980-6021-066, serial number AR-COMBI-12025 (see Figure 15). The model was developed for installation in general aviation fixed wing aircraft and helicopters to accommodate mandatory cockpit voice and flight data recording requirements. The audio and flight data are stored on solid state memory that is protected within a Crash Survivable Memory Unit (CSMU).

Figure 15: CVFDR from LN-OJF as received at Figure 16: HUMS PCMCIA card. the AAIB. Photo: AIBN

Both the voice and data recordings stopped at the same time, suggesting that power to the CVFDR was cut. The Miscellaneous Flight Data Acquisition Unit (MFDAU), which supplied the CVFDR with data, continued to operate after the CVFDR stopped and data were transferred to the HUMS PCMCIA memory card (see Figure 16).

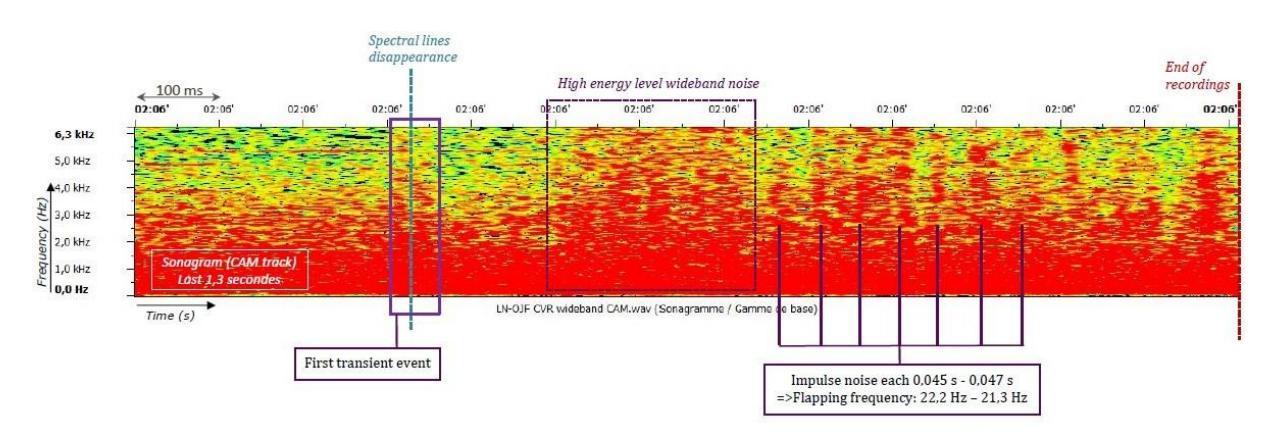
Following the readout at the AAIB, all four audio files were transferred to the BEA in France for further analysis. Spectrum analysis from the CAM recording is shown in Figure 17. The CAM spectrogram shows that the CVR recording ended 1 second after the first transient event.

Figure 17: Spectrum analysis from the CAM audio file showing 1.3 seconds believed to be the beginning of the MGB break-up. Source: BEA

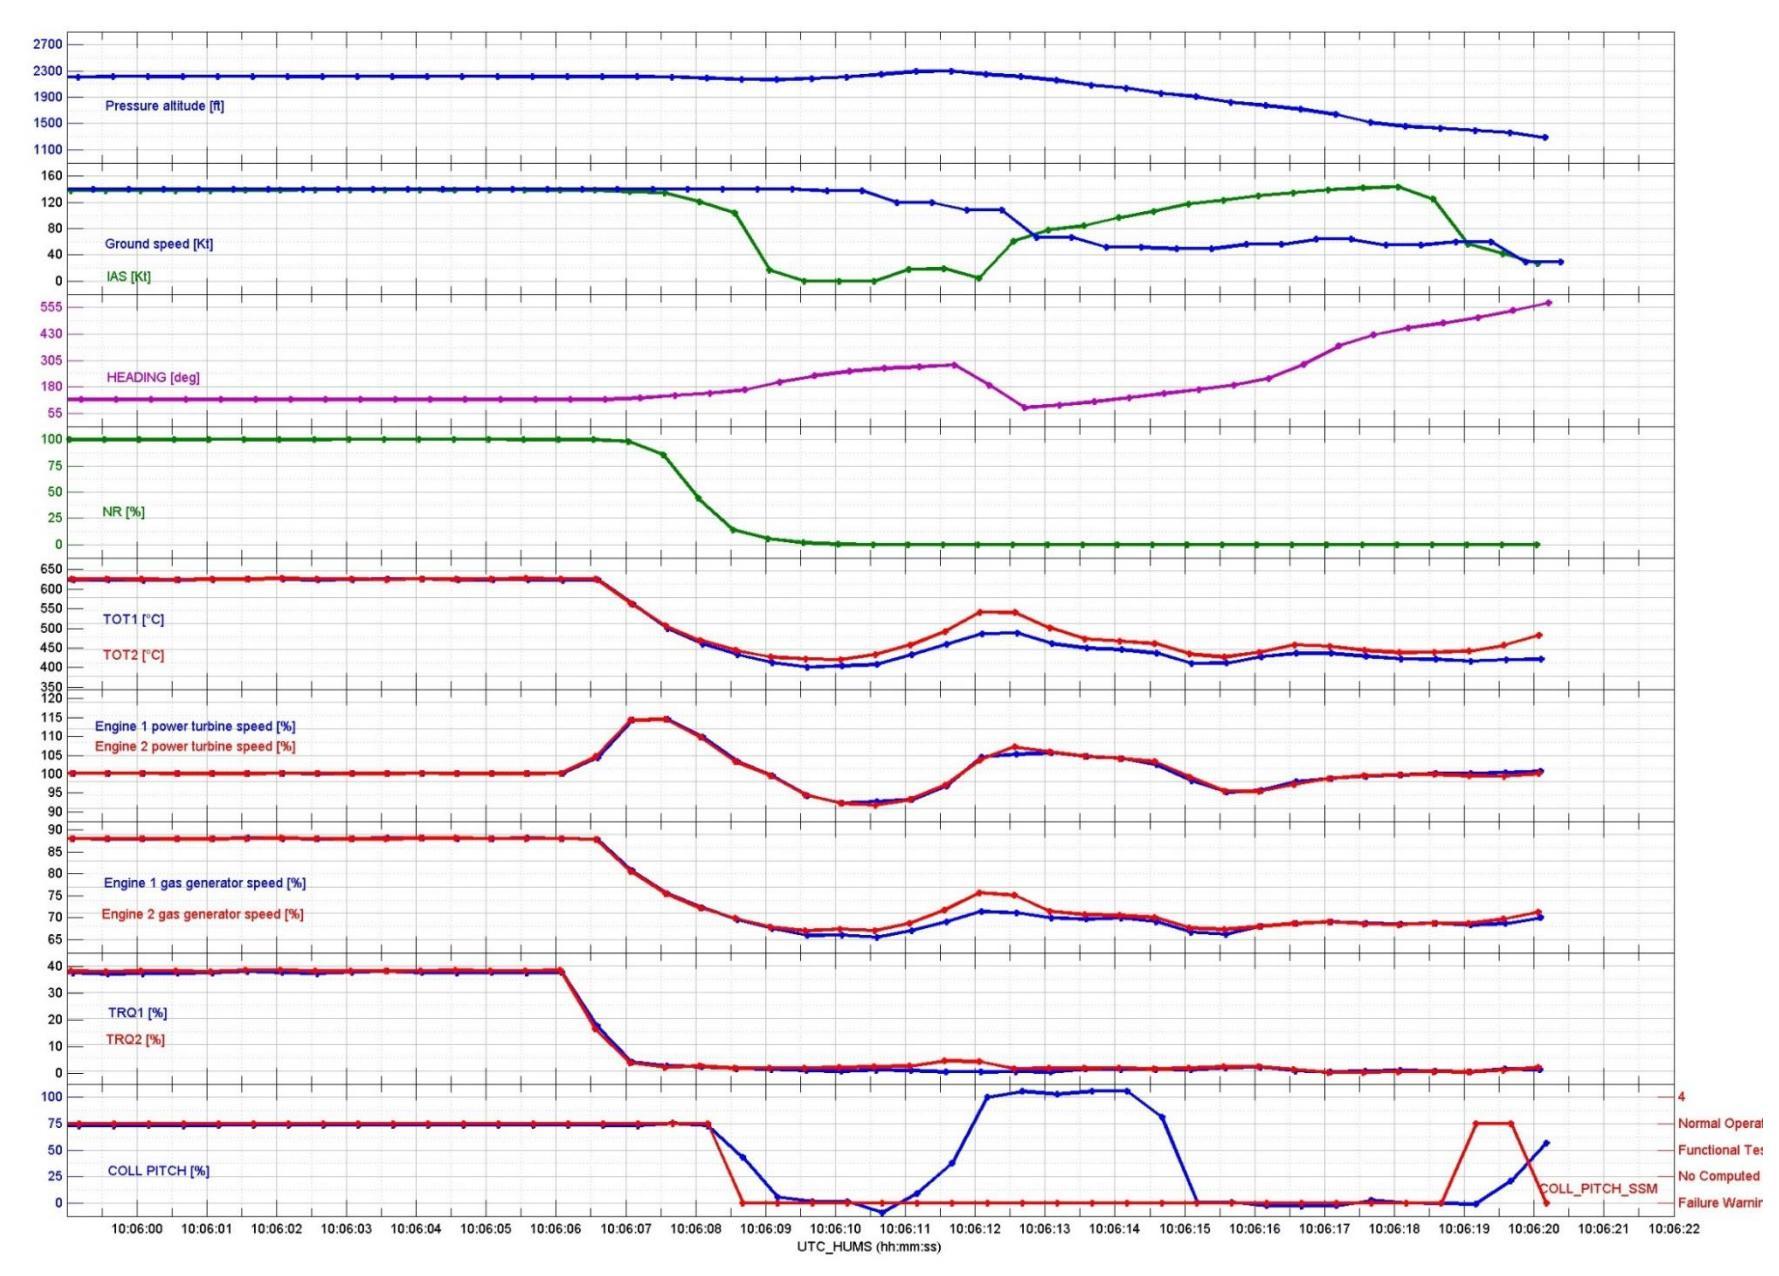
Figure 19: Recorded parameters from the PCMCIA card. T0 is defined as 10:06:06. Note: Time is UTC minus approximately 11 min. Source: BEA

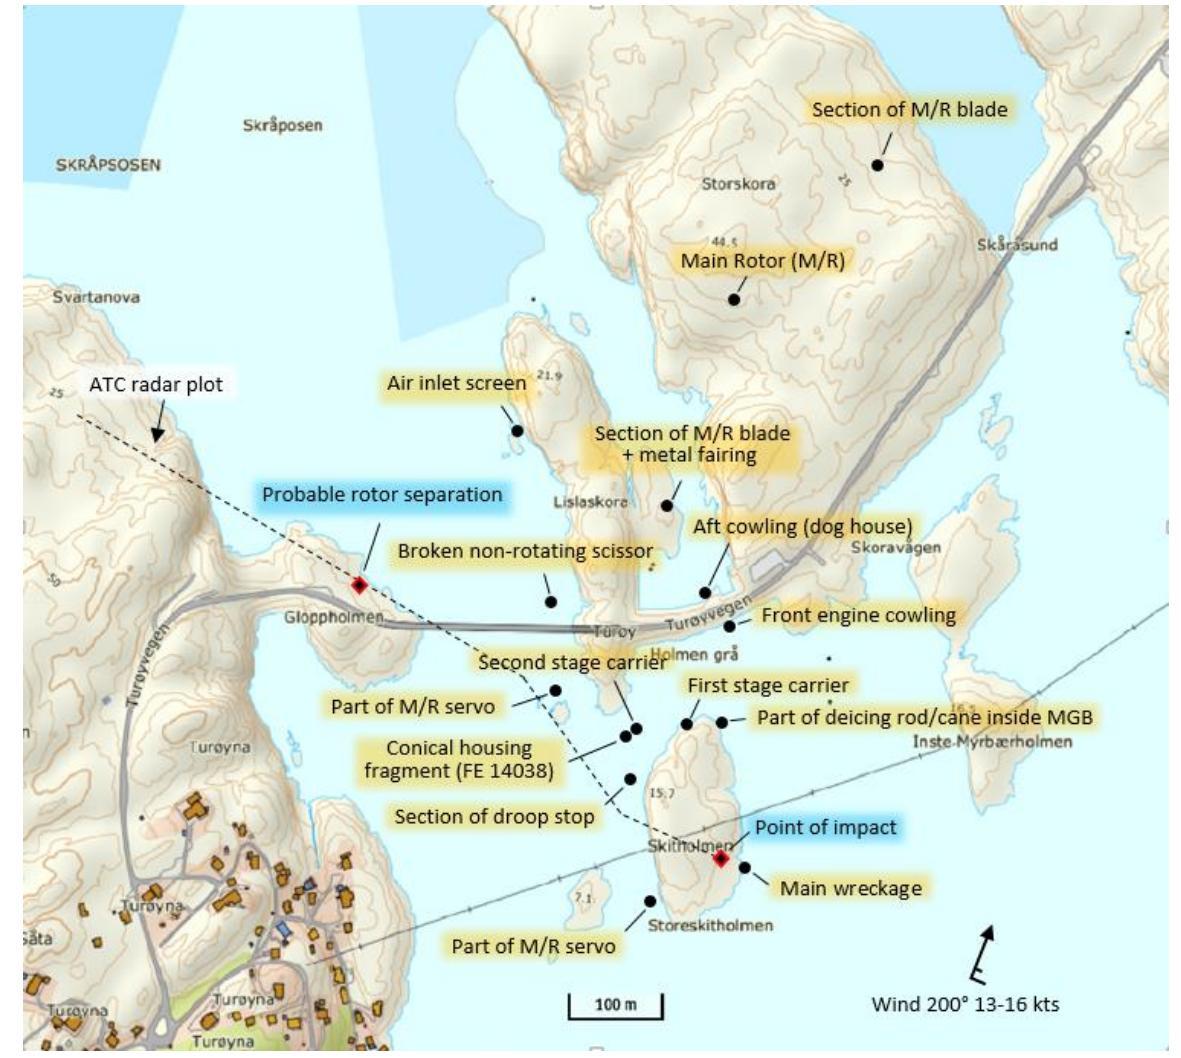
As mentioned in section 1.12.1.1, a number of parts from the helicopter were found dispersed over an area of about 180,000 m². However, most of the helicopter wreckage came to rest on the seabed just outside Storeskitholmen island. The largest part found separate from the accident site itself, was the main rotor, which was at the Storskora island. The map in Figure 21 shows where a number of parts were discovered.

Figure 21: Accident site overview with wreckage parts of interest. Source: The Norwegian Mapping Authority adapted by the AIBN

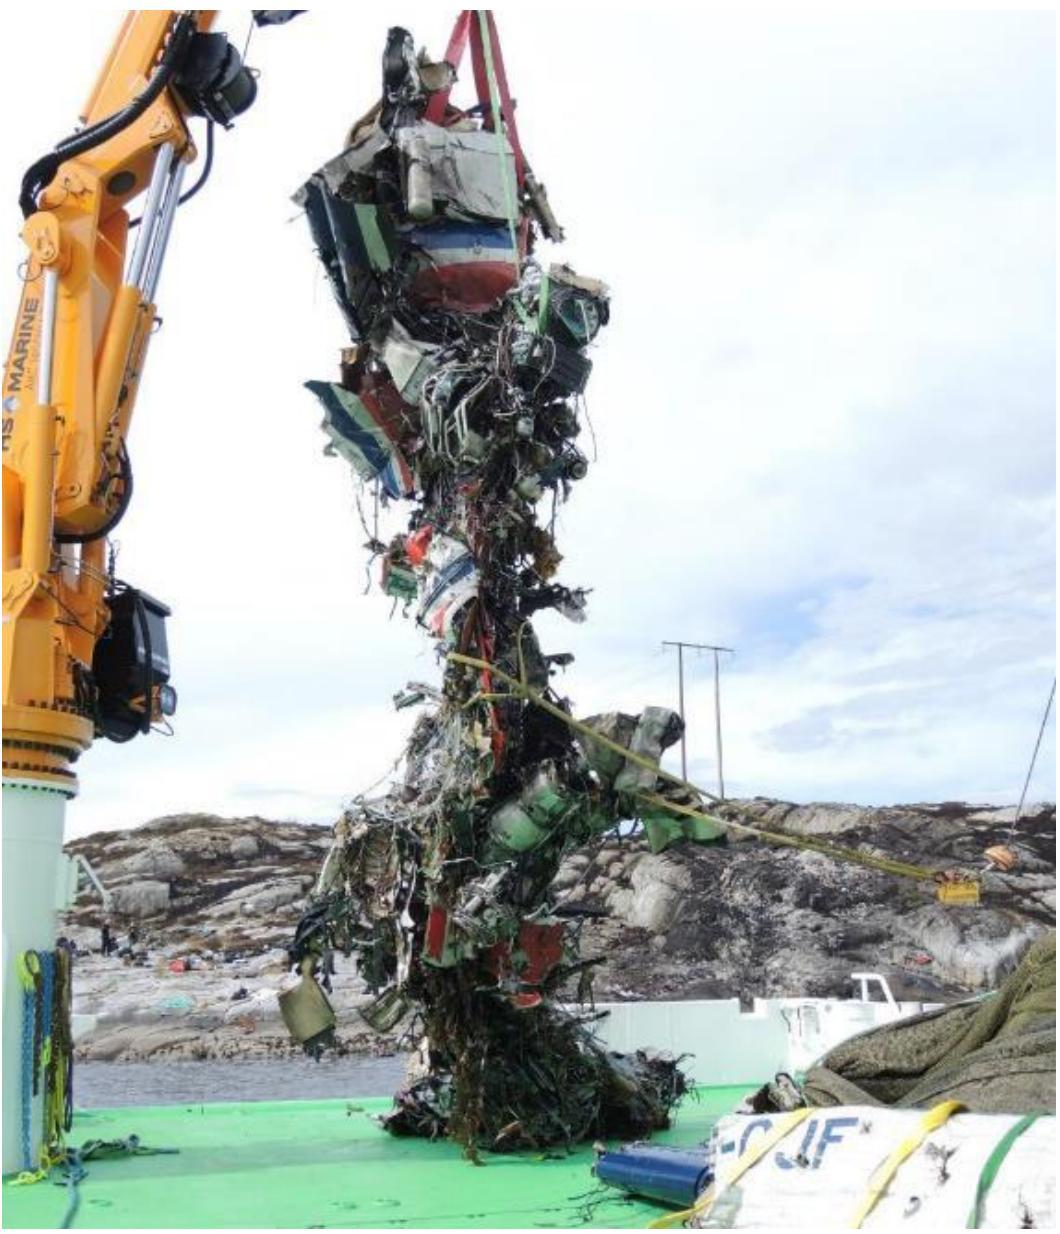
The main parts of the helicopter cabin, including the cockpit, were recovered as one piece, held together by bars, wires, tubes and pipes, but otherwise structurally destroyed. They were damaged to such extent that it was almost impossible to conduct any meaningful investigations of the wreckage components (see Figure 22).

Figure 22: The main wreckage during recovery. The tail boom seen at the lower right had already been recovered. Photo: AIBN

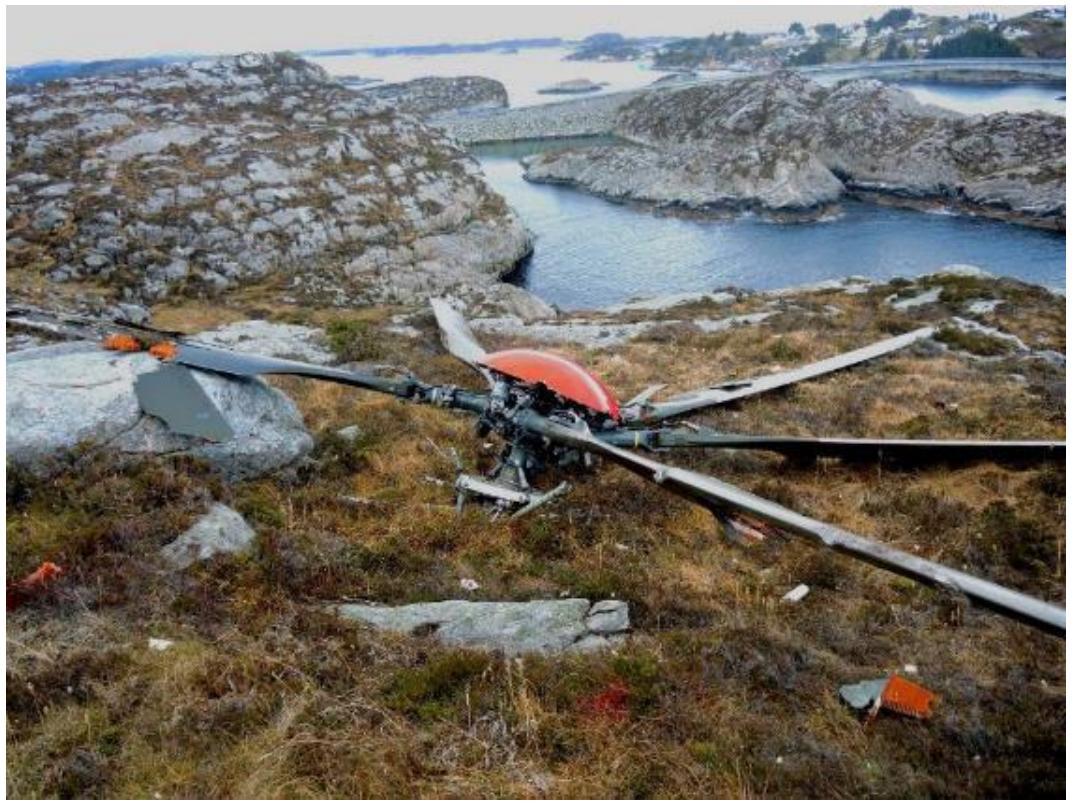
The main rotor blades were dismantled from the rotor head and examined by the AIBN. In general, the innermost sections of the main rotor blades were structurally intact, but the outer parts of the black, white, red and blue blades were significantly damaged. Several blades had lost large sections of the honeycomb structure behind the main spar. There was a clear imprint on the yellow blade, after contact with one of the engine's air inlet screens, 1.9 metres from the blade bolts.

The rotor head and the mast were sent to Airbus Helicopters and further examined under the supervision of the AIBN and the BEA. Detailed examinations of the Main Rotor Mast coupling splines and the Main Rotor Mast bearing did not reveal any pre-impact anomalies and they were found to be in normal and standard operational conditions.

Figure 24: The main rotor and rear suspension bars as found on the island Storskora. Photo: AIBN

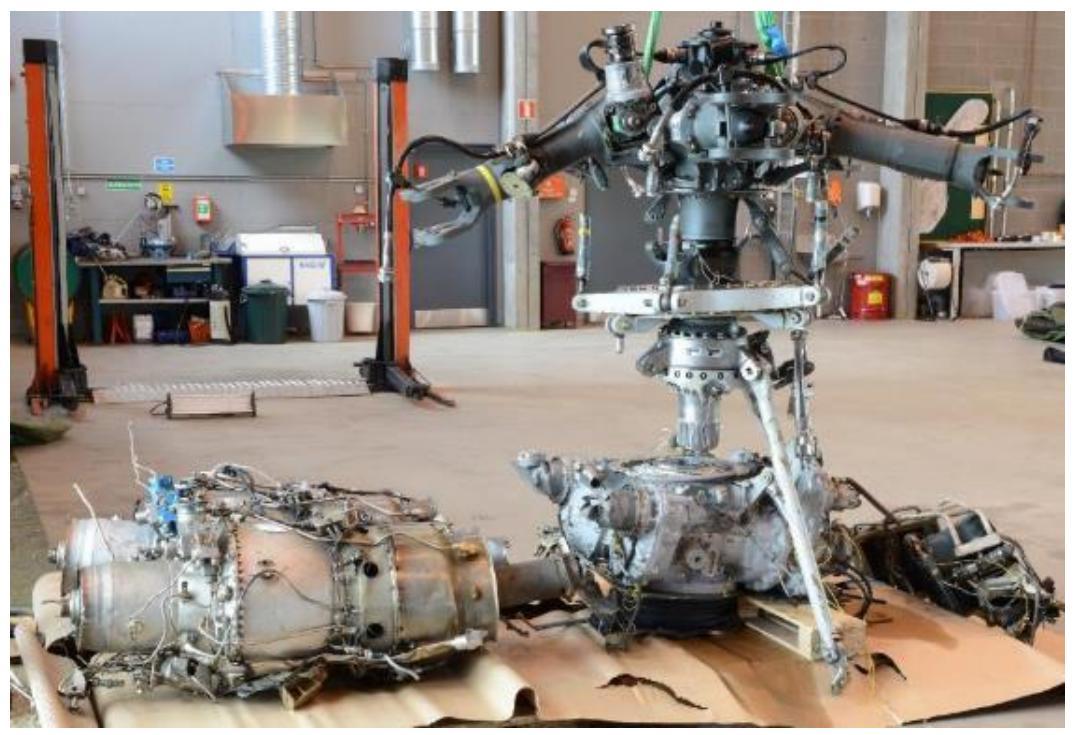
The main module was relatively complete and with limited damage. Both engine high speed input shafts had been twisted off near the main gearbox in a manner which indicates high torque, possibly combined with bending. The linking tubes (liaison tubes) were bent upwards (see Figure 25). The oil sump in the main module contained large quantities of metal fragments and shavings. All findings during examinations of the main module are consistent with the helicopter hitting the ground with great force and then ending up in the sea. Seawater had caused heavy corrosion, particularly to magnesium alloy parts.

Figure 25: Engines, substantial parts of the MGB, two suspension bars and main rotor head assembled at the AIBN premises. Photo: AIBN

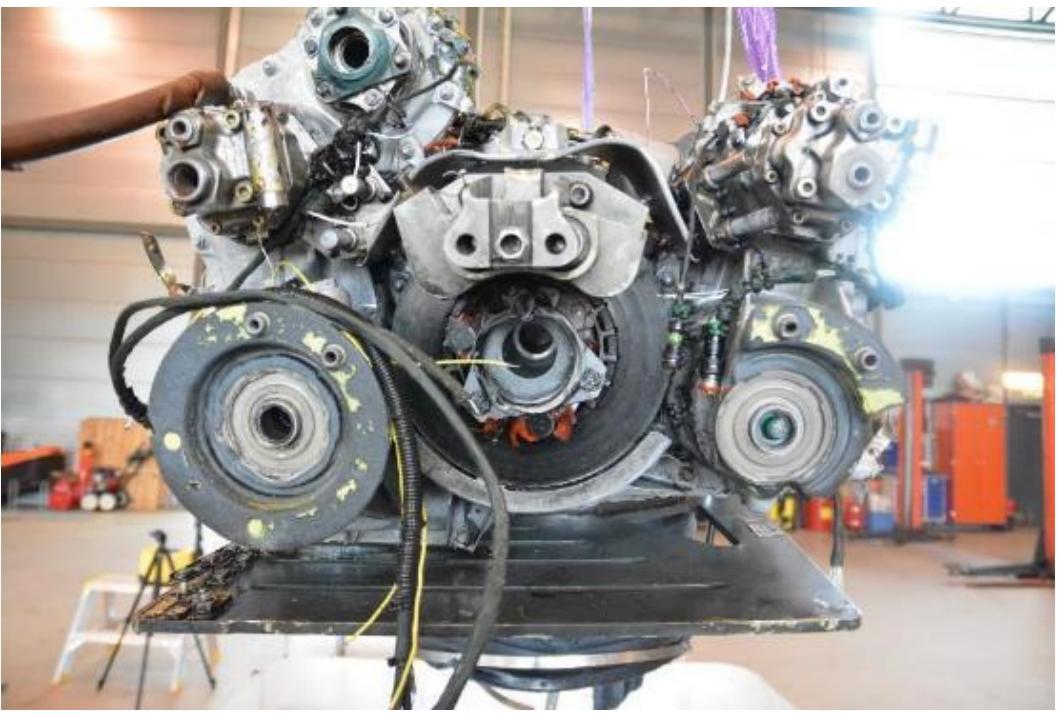
The right and left accessory modules were relatively complete and with only minor damage (see Figure 26). Both generators had come loose from the gear box. Both hydraulic pumps were still attached. The axles for the cooling fan and tail rotor had broken off very close to the connections.

Figure 26: L/H and R/H accessory modules seen from behind. The flexible mounting plate is seen attached to the MGB oil sump. Photo: AIBN

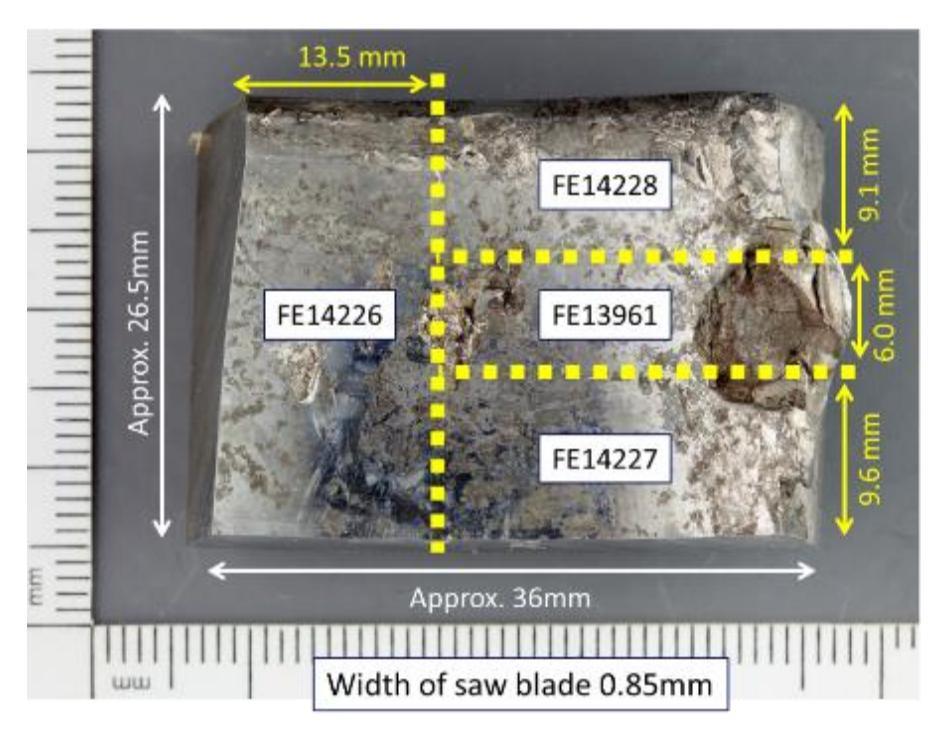
Based on the CT-scan, examples shown in Figure 38 and Figure 39, further cuts were agreed, see Figure 40. The cutting described in Figure 40 together with the cuts shown in Figure 46, made it possible to examine the crack path between spalls 1, 2, 3 and 4 and also to open up the crack to examine the crack fracture surface in attempt to understand the propagation direction and speed.

Following detailed examination, the outer race of section FE 13961 (see Figure 40) was separated from the gear bulk material at QinetiQ. The outer race (cap/calotte) was later sent to Airbus Helicopters for additional examinations.

Figure 40: Cutting lay out based on CT-scan results (see Figure 38). FE13961 contains spall three and four, FE14226 contains spall one and two. Photo: AIBN/QinetiQ

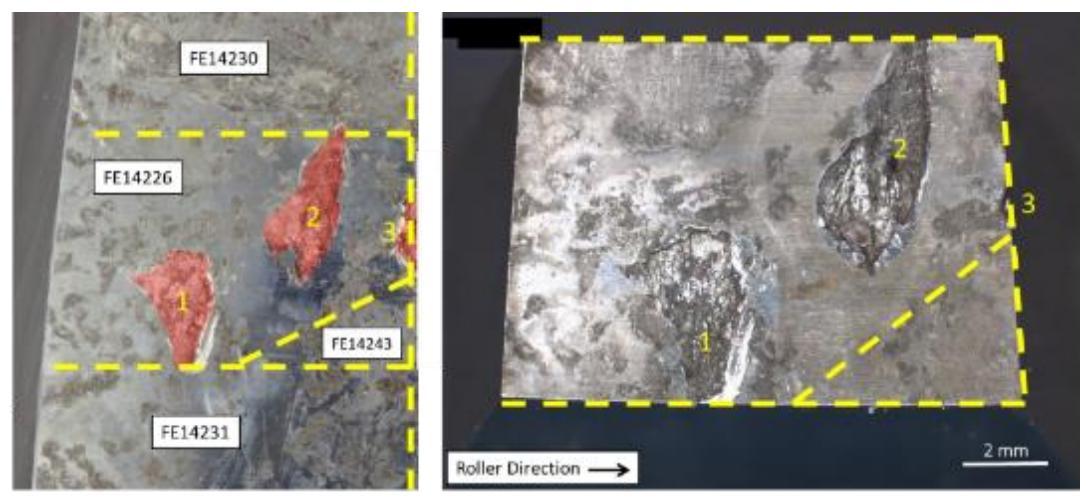
The sample (section FE 14226) was cut again in order to examine spalls 1 and 2 and the cracks between spalls 1, 2 and 3 (see Figure 40 and Figure 46).

Figure 46: Figure showing cutting for examining spalls 1 and 2 and the cracks between spalls 1, 2 and 3. Photo: AIBN/QinetiQ

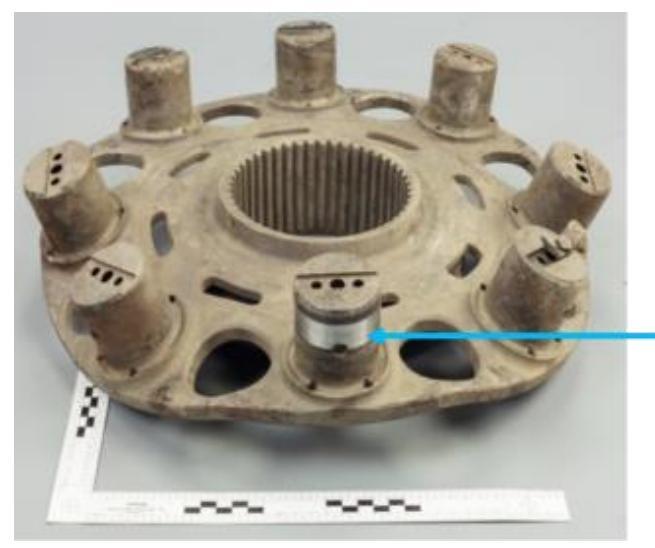
- 1.16.4 <u>Second stage planet carrier</u>
- 1.16.4.1 During a diving exercise in February 2017, about 10 months after the accident, the second stage planet carrier was found (see Figure 52). On the planet carrier the inner race of the fractured planet gear was still on the carrier, but rotated 35° and pulled off 20.4 mm. The lower rotor mast bearing was still attached to the carrier.

Figure 52: The second stage planet carrier found in February 2017 shown after cleaning. The inner race of the fractured second stage planet gear has been removed from stub shaft number 3 in front. Photo: AIBN/QinetiQ

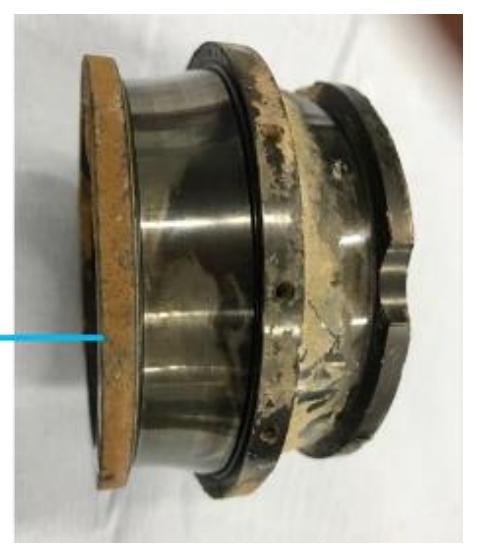
- 1.16.4.2 After cleaning, the inner race surface (see Figure 53) was in good condition for further examination at QinetiQ together with the carrier and the mast bearing. The rotor mast splines have been visually inspected and no geometrical deviations or mechanical damage, other than corrosion, were observed. Examination of the lower rotor mast bearing showed no mechanical damage, see Figure 54, as might arise from misalignment or jamming. The carrier had symmetrical deformations around the stub shaft where the fractured planet gear had been mounted (see Figure 55).

Figure 53: The inner race of the fractured planet gear after cleaning of the upper race (left in photo). Position on the carrier is given by the arrow. Photo: AIBN/QinetiQ

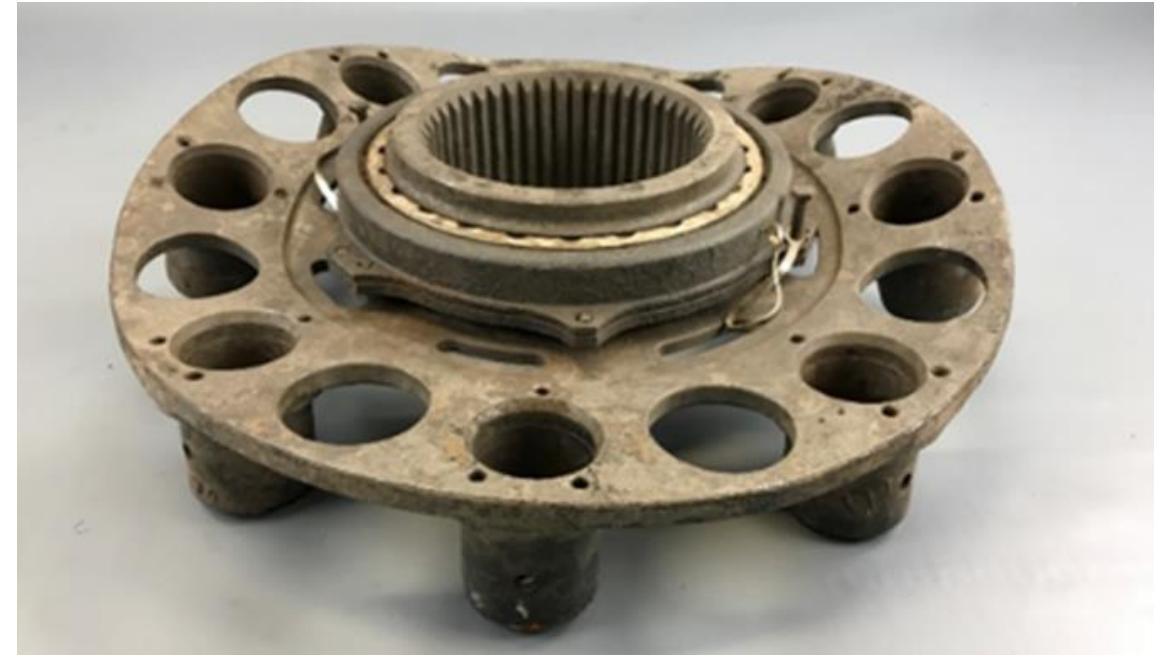
Figure 54: The second stage planet carrier found in February 2017 shown after cleaning. The lower mast bearing is shown on top of the carrier. Photo: AIBN/QinetiQ

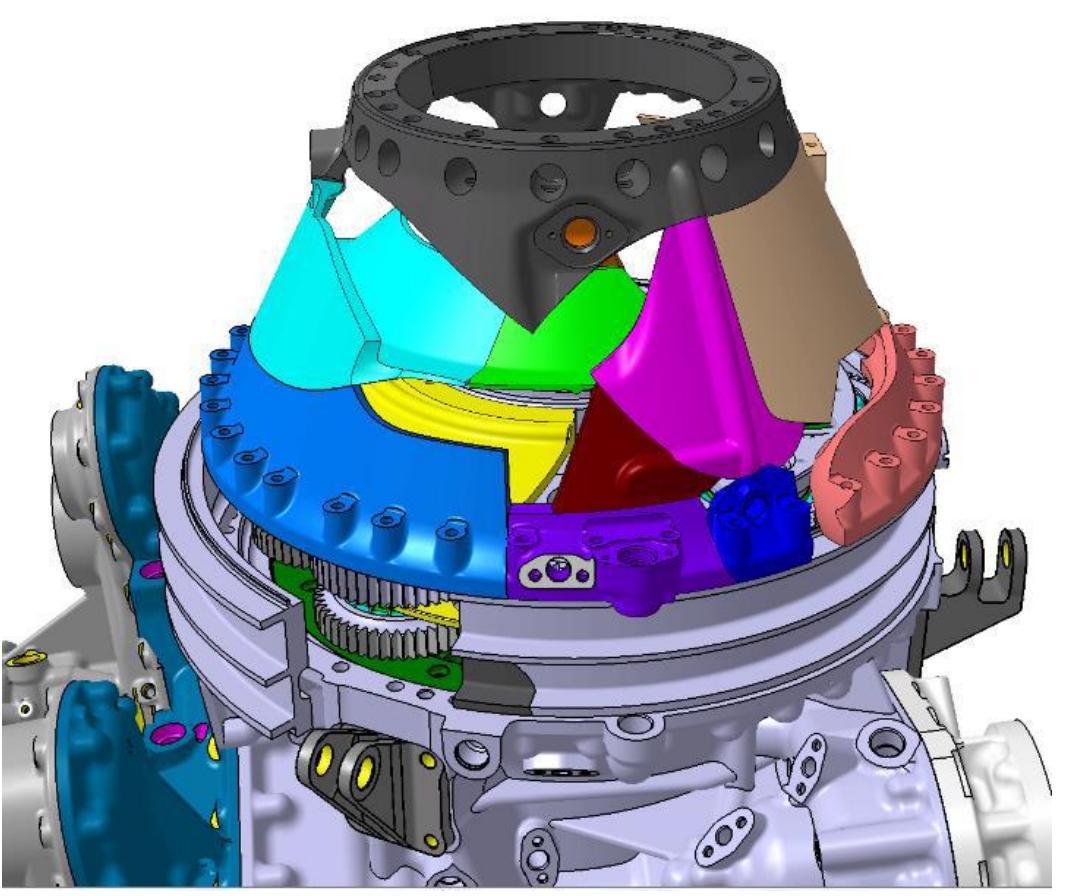
Figure 58: Illustration of how the retrieved fragments of the conical housing are pieced together in order to look for break-up sequence/mechanism. Illustration: Airbus Helicopters

- 1.16.7.1 The conical housing is made from an aluminium alloy. The conical housing was shattered and found in many smaller segments. As these segments were gradually salvaged piece by piece, they were examined, scanned and documented. A complete conical housing was used as template at QinetiQ. Airbus Helicopters used their design and manufacturing data model in order to fit the different parts in the correct position (see Figure 58).

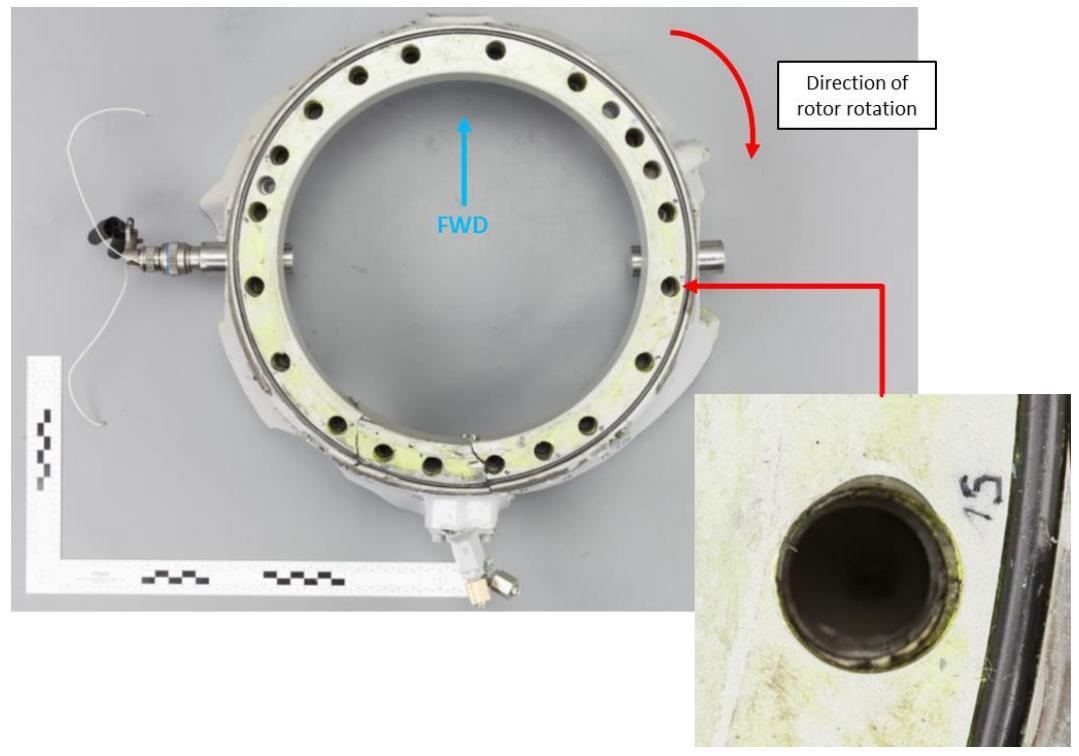
Figure 60: Top of conical housing. This segment of the conical housing was still attached to the rotor mast following the accident. Photo: AIBN/QinetiQ

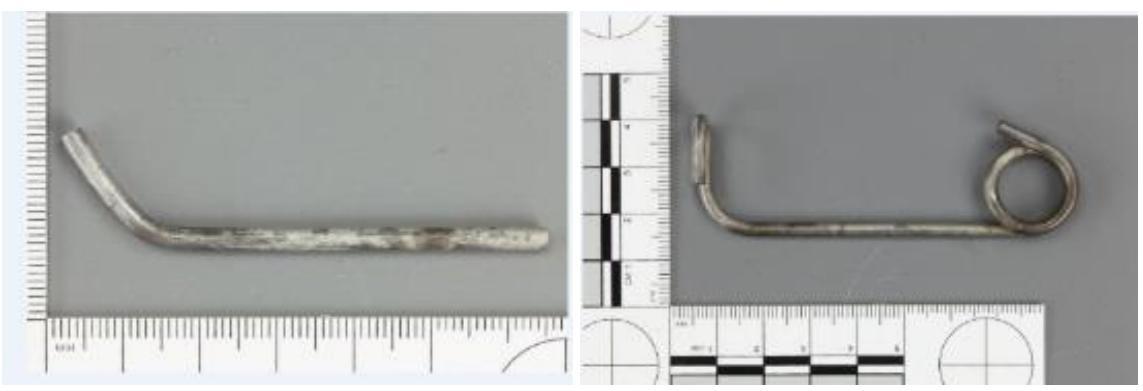
Figure 62: Two segments of safety pins found near the rotor mast. Metallurgical examination proved these to be from two different pins. Photo: AIBN/QinetiQ

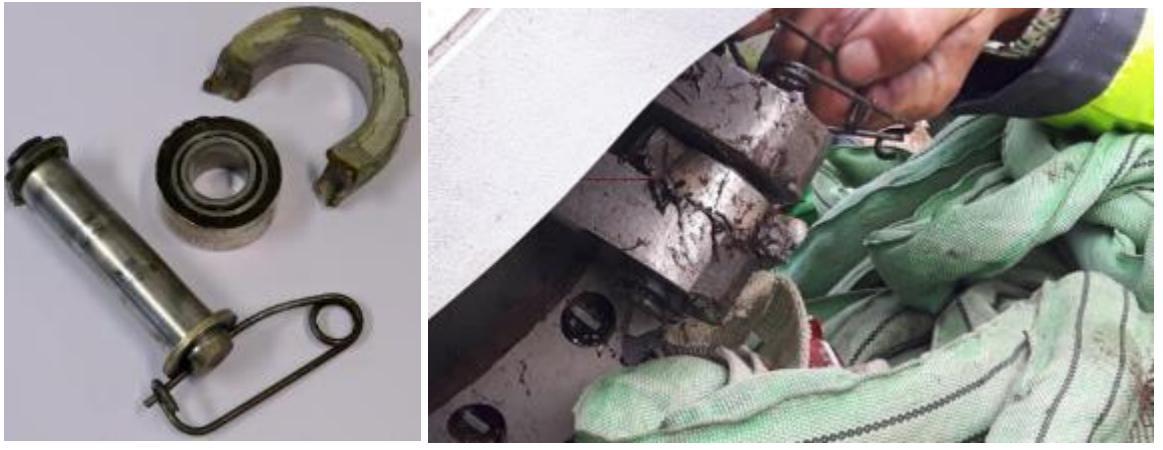
The only parts from the forward suspension bar that were recovered were the upper fractured mounting lug with its clevis, and two safety pins that were attached to the lift housing. These parts were brought to the QinetiQ laboratories for metallurgical examination, see Figure 63 (two safety pins shown on right photo).

Both top and bottom fractures were examined in a scanning electron microscope (SEM) and found to be overload. There was no evidence of progressive crack growth such as fatigue. Both top and bottom fractures exhibited necking and deformation consistent with tensile overload failure. The deformation was consistent with the lift strut bending in a port direction. More deformation (twisting) was observed on the bottom fracture, which suggests that the top of the lug failed first, allowing the strut to twist about the remaining bottom part of the lug before final failure. Bottom fracture face appeared to be twisted approximately 10° anticlockwise, see Figure 64.

Figure 63: Upper forward suspension bar, part of the mounting lug, the bearing, the clevis pin (with only one of the two safety pins) and the safety pins. Here shown both as found at the rotor mast (right photo) and dismantled (left photo). Photo: AIBN

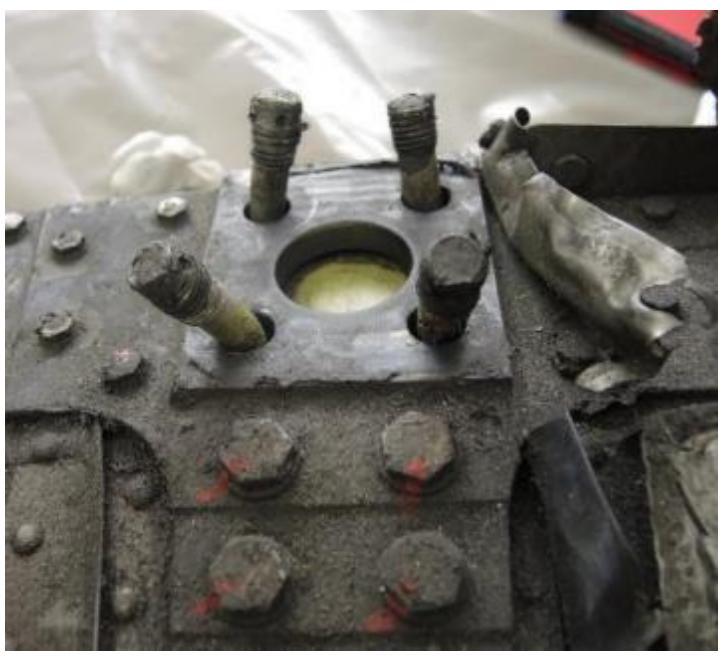
Inspection of available suspension bar airframe fittings, the mating airframe shim and plate, showed no major fretting, see Figure 65.

No evidence of fatigue failure was observed on the parts.

Figure 65: The four bolts from the lower forward fuselage fitting protruding from the support plate. Photo: AIBN

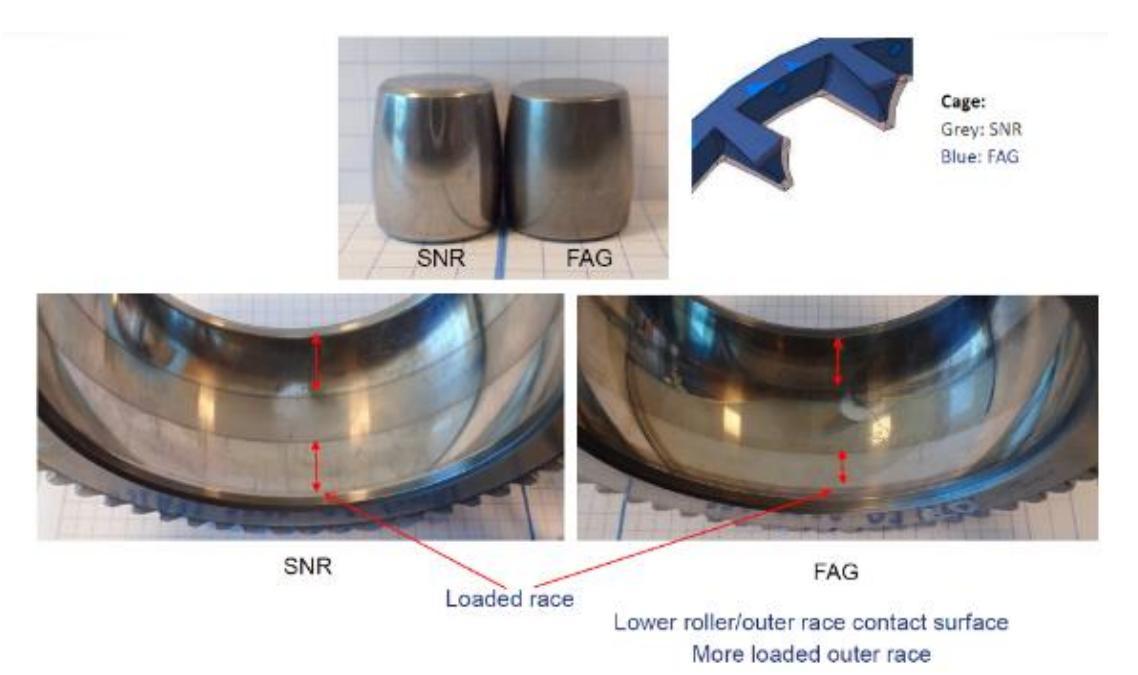
Figure 68 shows the geometry differences between a FAG and a NTN-SNR bearing and their contact pattern on outer race. The roller geometry and the cage dimensions differ.

Figure 68: Geometry differences between NTN-SNR and FAG bearings and contact pattern on outer race. The two cages, one grey and one blue, superimposed to show the difference in design. Source: Airbus Helicopters

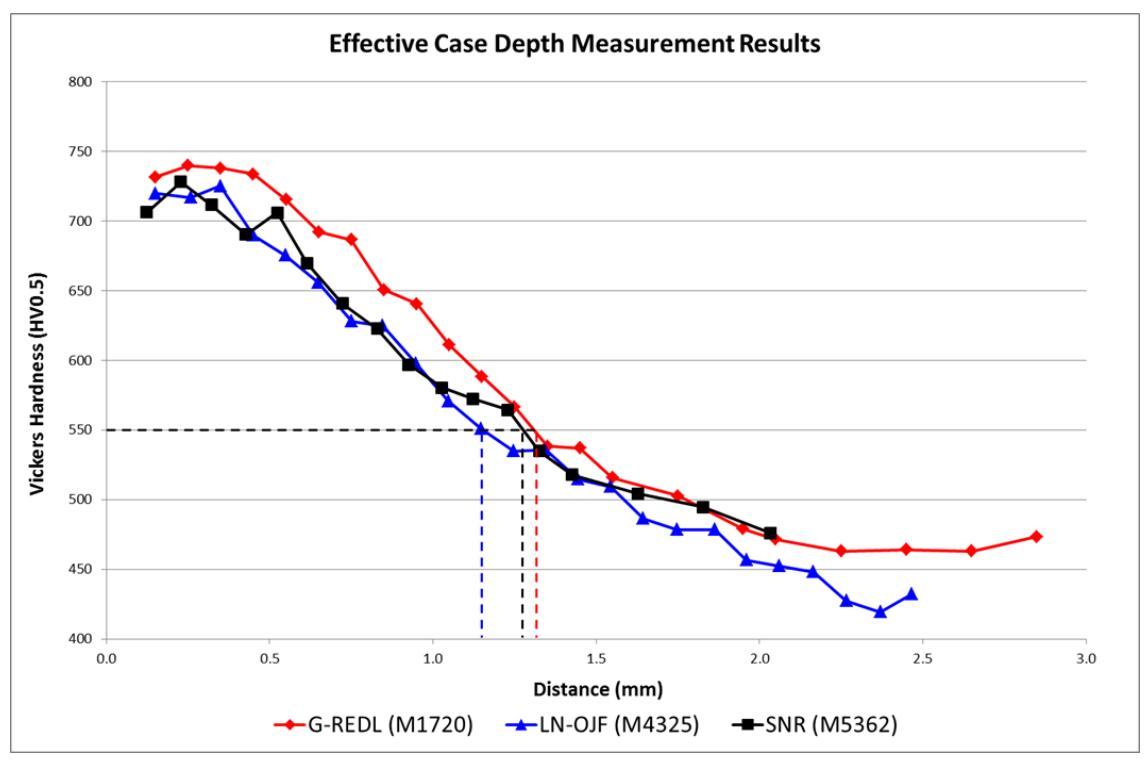
All of the planet gears are case hardened (carburised) by Airbus Helicopters before final grinding of the bearing surfaces. No significant differences in effective case depth have been noted between any of the gears examined, see Figure 69. Surface hardness measurements by both AIBN/QinetiQ and Airbus Helicopters at a range of different loads showed that the FAG gears tend to have a higher surface hardness, see Figure 70. This is consistent with the typically higher surface compressive residual stress in FAG gears, and is believed to be related to the final stage of the manufacturing process.

Figure 69: Outer race hardness values, comparison between a NTN-SNR gear, LN-OJF and G-REDL Figure: AIBN/QinetiQ

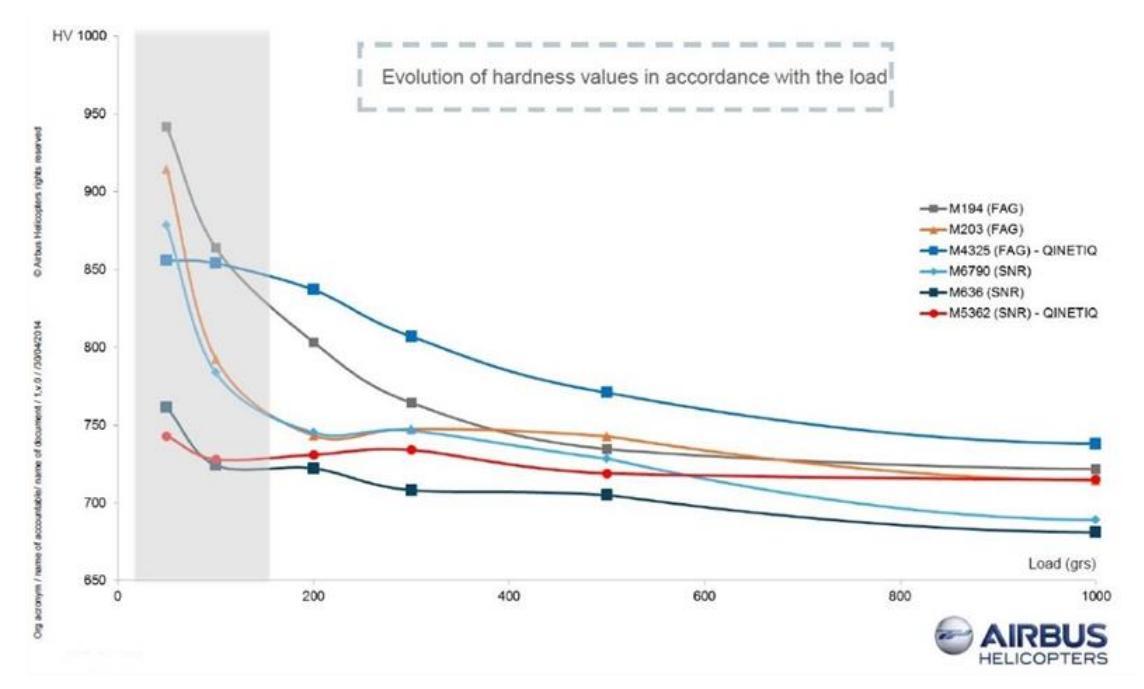
Figure 70: Hardness values vs. indentation load. From upper at the left hand side in the figure: FAG, FAG, FAG (QinetiQ), NTN-SNR, NTN-SNR, NTN-SNR (QinetiQ). Figure: Airbus Helicopters
