Accident Investigation Board Norway

REPORT SL 2018/04

REPORT ON THE AIR ACCIDENT NEAR TURØY, ØYGARDEN MUNICIPALITY, HORDALAND COUNTY, NORWAY 29 APRIL 2016 WITH AIRBUS HELICOPTERS EC 225 LP, LN-OJF, OPERATED BY CHC HELIKOPTER SERVICE AS

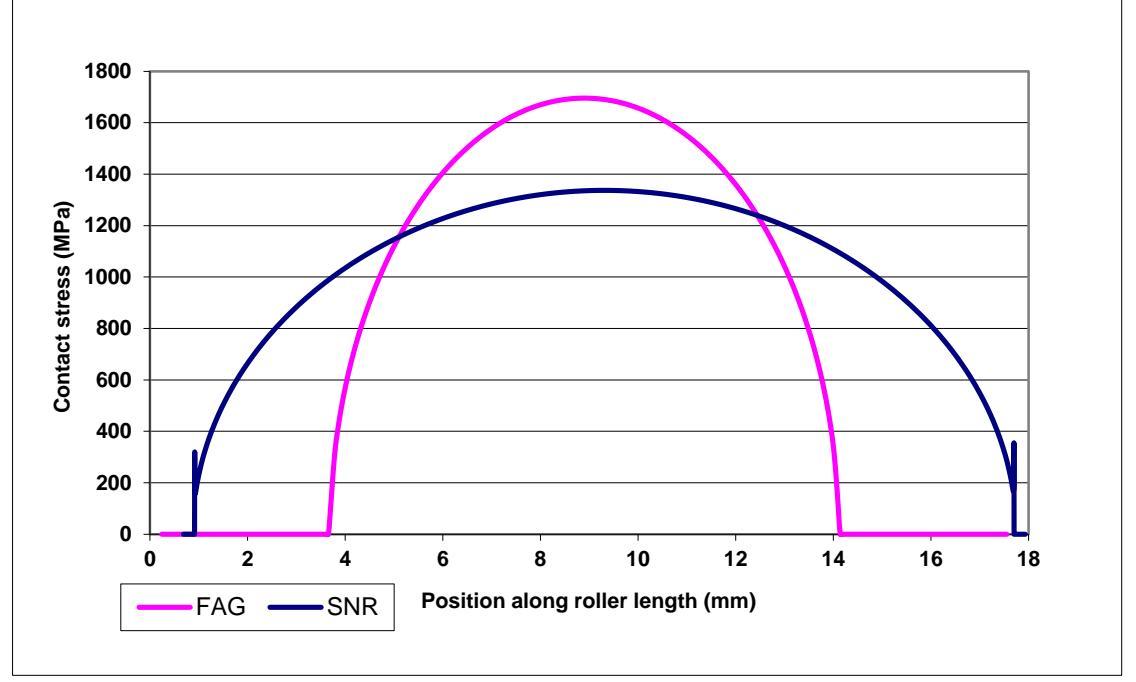
Both inner and outer raceways of the FAG bearing experience higher central contact stress than the SNR bearing. The stresses for the outer raceway are the most relevant to the failure mode in this investigation, and the graph below compares the two types (see Figure 71). As can be seen, the contact pattern for the FAG bearing is more concentrated towards the centre of the roller length. These results are consistent with Airbus Helicopters calculations performed after the accident.

ISO 281 (2007 and earlier) calculation methods for bearing L10 life do not take into account the curvature of the raceway and roller profiles, and therefore show almost identical L10 lives (within 10 %) for both bearing types. This method would have been used for design and assessment purposes, and so there was nothing at the time to alert the helicopter manufacturer to possible differences between the bearings.

Figure 71: Comparison of outer race contact stresses for peak roller load. EC 225 LP mean cubic power condition. Source: Romax/AIBN

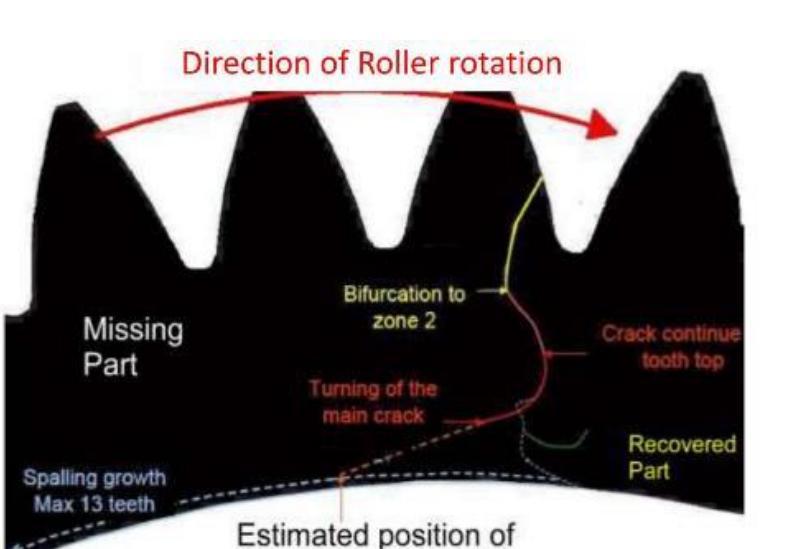
initiation of the main crack

Figure 74: Stress model estimation of crack growth. Source: Airbus Helicopters

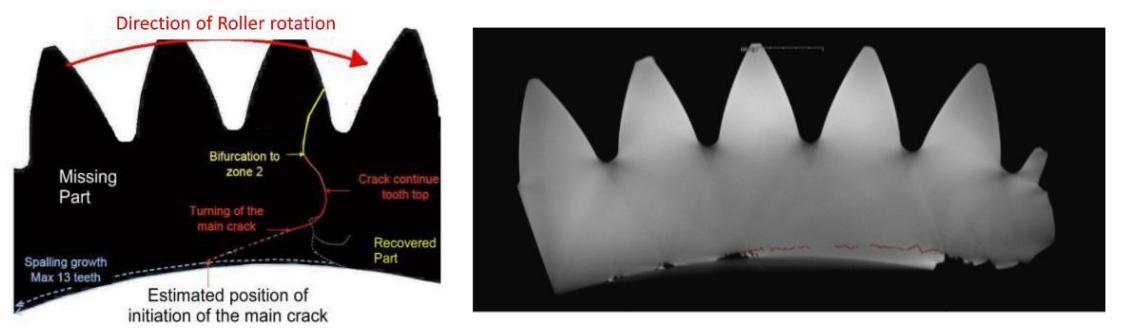
- 2.8.2.6 The G-REDL report displayed a stress model prediction of crack growth in the section of the planet gear which was not recovered (see section 1.18.2). The crack propagation underneath the depth of the carburized layer in the retrieved second stage planet gear from the LN-OJF accident appears to be very similar to the G-REDL stress model prediction of crack growth (see Figure 77). The LN-OJF gear segment closely resembles the estimated missing gear part from G-REDL.

Figure 77: Stress model estimation of crack growth from the G-REDL accident to the left (Source: Airbus Helicopters) compared with the CT scan from the LN-OJF gear with the crack in red (Photo: CT-scan from AIBN/Southampton University).
