Loss of Control at Takeoff
Air Methods Corporation
Airbus Helicopters AS350 B3e, N390LG
Frisco, Colorado
July 3, 2015

NTSB/AAR-17/01
PB2017-101425

Aircraft Accident Report

Loss of Control at Takeoff

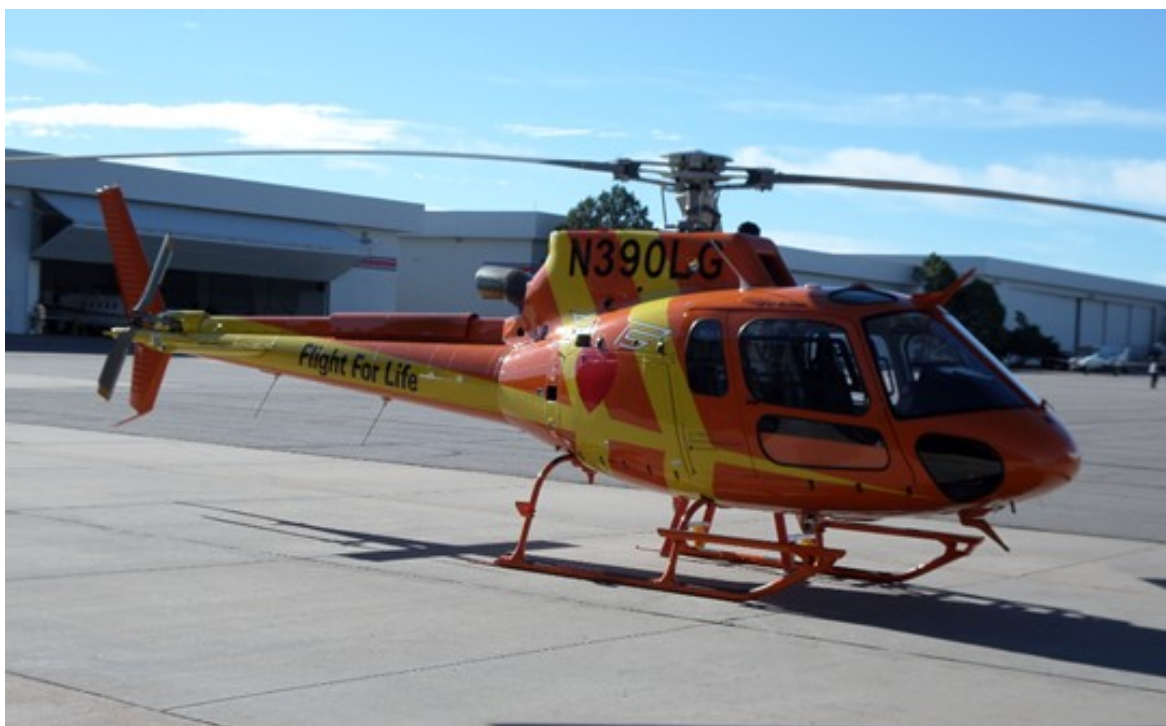
Figure 2. N390LG upon delivery to Air Methods.

The accident helicopter, serial number 7595, was manufactured in March 2013. Figure 2 shows the helicopter at the time of delivery to Air Methods.¹⁵ At the time of the accident, the helicopter had a total time of about 487 flight hours. The helicopter was equipped with a Turbomeca Arriel 2D turboshaft engine, which had a total time of about 481 hours. (See section 1.3.2 for more information about the engine.) The helicopter’s weight at the time of the accident was about 4,717 pounds, which was based on the operating conditions that day and included the weights of the occupants, fuel, and medical equipment.

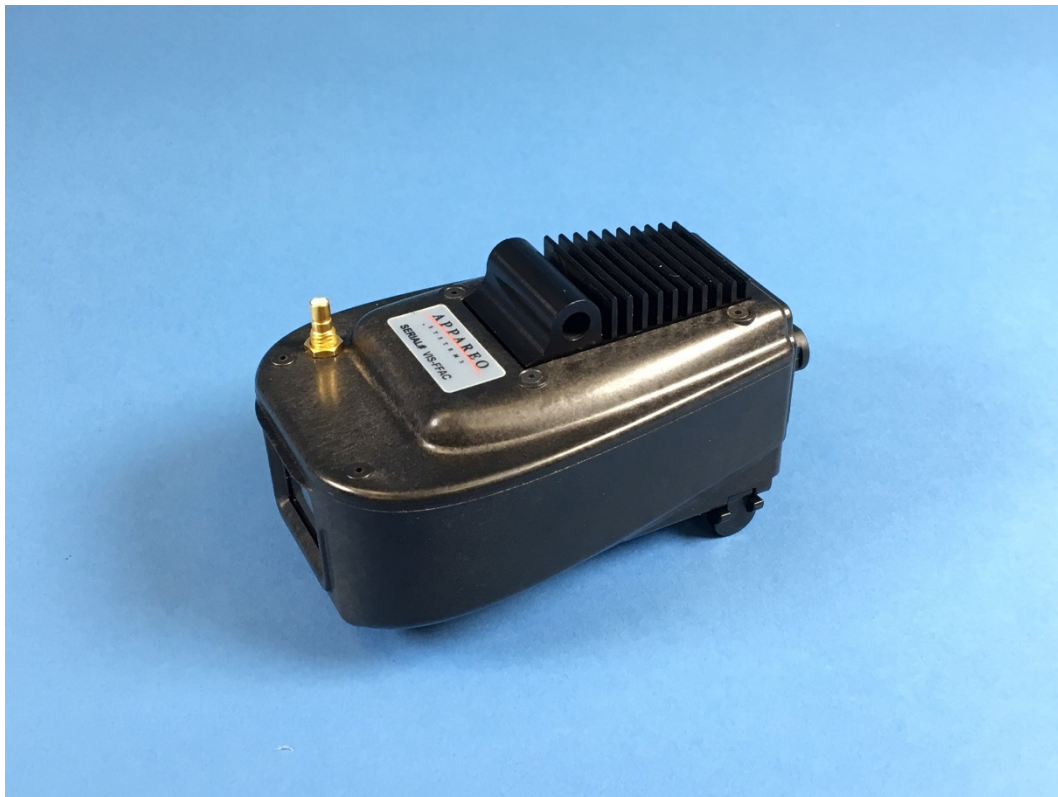
Figure 6b. Exemplar Appareo Vision 1000 onboard image recorder.

Postaccident examination of the helicopter's Appareo device showed that the device sustained extensive heat damage. Figure 6a shows the condition of the Appareo device upon arrival at the NTSB's vehicle recorders laboratory, and figure 6b shows an exemplar Appareo Vision 1000 onboard image recorder for comparison purposes. The SD memory card was removed from the Appareo device. The silicon memory device (internal to the SD card) was cracked and fractured throughout, so data recovery from the SD card was not possible. The Appareo device's internal NVM module was then removed, and the two NVM chips were removed from the internal memory device chassis. One chip (referred to as NVM chip 1) exhibited bubbling on, and cracking along, its plastic packaging surface. The other chip (referred to as NVM chip 2) exhibited heavy bubbling on its plastic packaging surface. The bubbling and cracking were indicative of high-temperature heat damage.
