Aviation Investigation Preliminary Report

Location:	Freeland, WA	Accident Number:	DCA22MA193
Date & Time:	September 4, 2022, 15:09 Local	Registration:	N725TH
Aircraft:	DEHAVILLAND DHC-3	Injuries:	10 Fatal
Flight Conducted Under:	Part 135: Air taxi & commuter - Scheduled

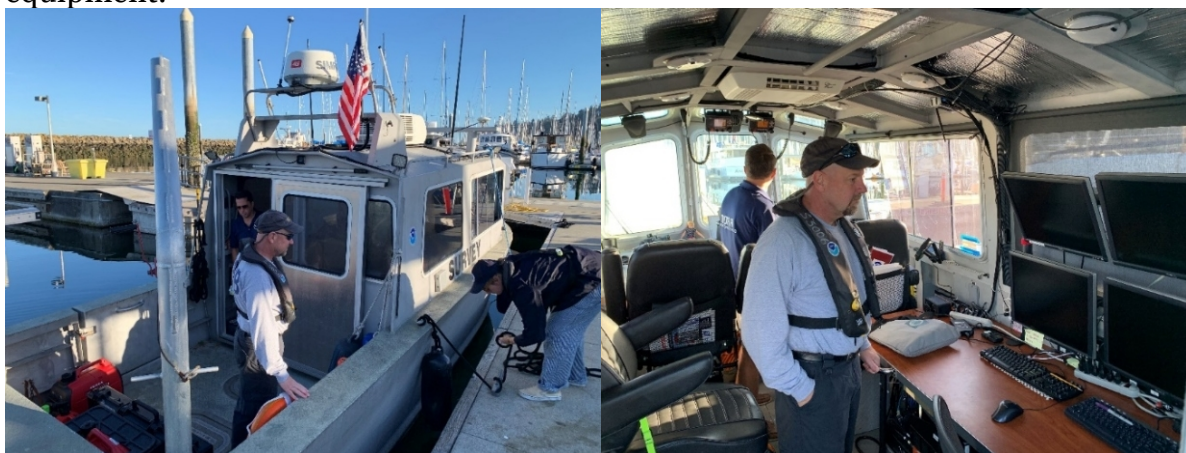
Figure 2: NTSB onboard NOAA S3006 survey boat

The NTSB structure's group chairman went on board vessels provided by the Washington Department of Fish and Wildlife, the National Oceanic and Atmospheric Administration (NOAA) and the University of Washington to collect data using varying types of sonar equipment.
