# National Transportation Safety Board (

## Aviation Accident Final Report (

<b>Location:</b>	Daytona Beach, Florida	<b>Accident Number:</b>	ERA18FA120
<b>Date &amp; Time:</b>	April 4, 2018, 09:53 Local	<b>Registration:</b>	N106ER
<b>Aircraft:</b>	Piper PA28R	<b>Aircraft Damage:</b>	Destroyed
<b>Defining Event:</b>	Aircraft structural failure	<b>Injuries:</b>	2 Fatal
<b>Flight Conducted Under:</b>	Part 91: General aviation - Instructional

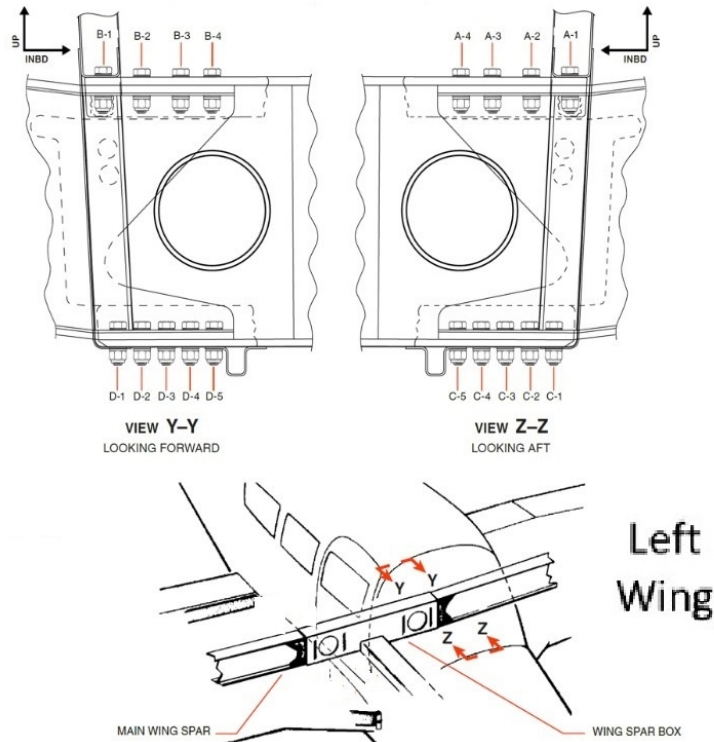
Each wing main spar on a Piper-28R-201 airplane is attached to the center wing box with 8 attachment bolts through the main spar upper cap and 10 through the main spar lower cap. As shown in figure 1, the locations on the lower spar cap forward of the spar web are identified as C-1 through C-5, and the locations on the main spar lower cap aft of the spar web are identified as D-1 through D-5 (later in this report, we use L [for the left wing] or R [for the right wing] in addition to the spar cap location identifiers where appropriate [for example, LC-1]). Doublers are riveted to the forward and aft sides of the spar at the attachment location and outboard beyond the bend in the spar that forms the wing dihedral. Flanges for the doublers extend over the main spar upper and lower caps at the forward side of the spar and over the lower cap at the aft side of the spar.

Figure 1. Diagram showing forward and aft side of wing main spars and associated attachment bolt designator map
