Aviation Investigation Report AIR-23-01

# Abrupt Loss of Pitch Control and Water Impact West Isle Air dba Friday Harbor Seaplanes de Havilland DHC-3, N725TH

Mutiny Bay, Washington  
September 4, 2022

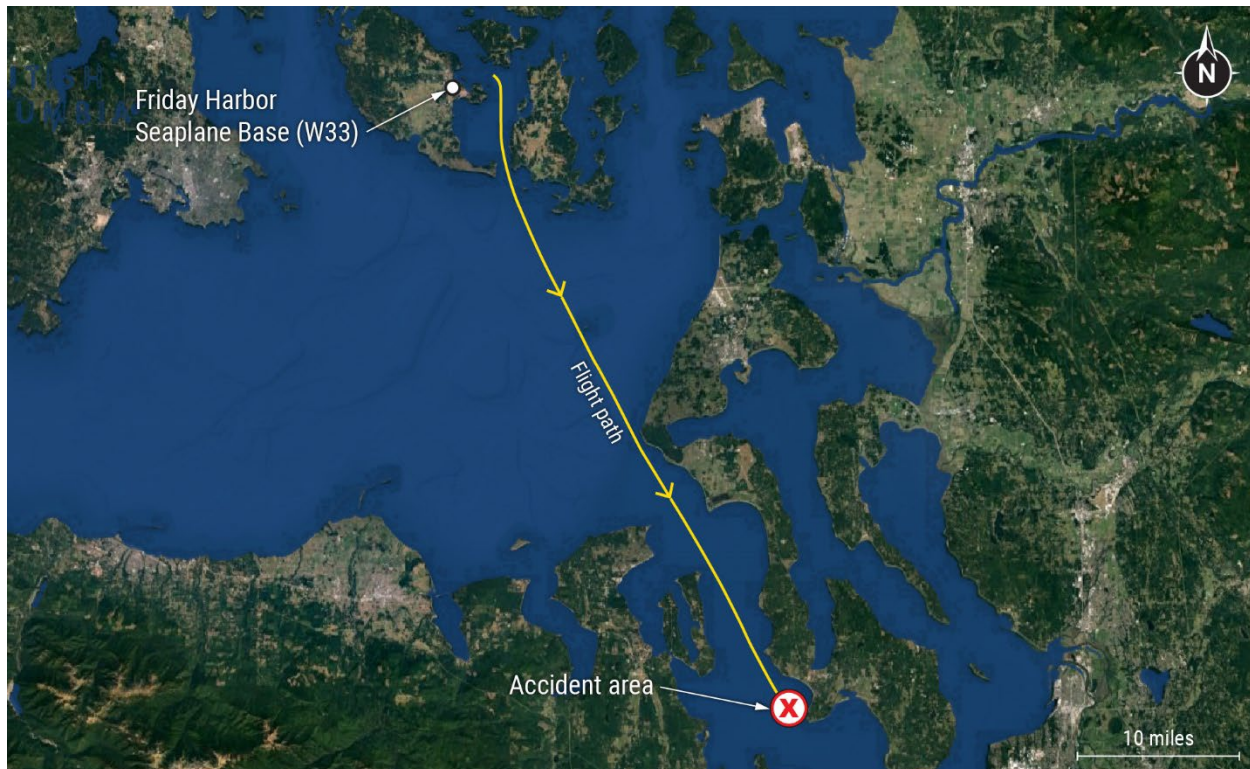
**Figure 1.** Flightpath of the accident airplane based on ADS-B data.

was more than 9,500 ft per minute (the flightpath of the airplane is depicted in figure 1).<sup>3</sup>

Witnesses near the accident site reported, and security camera video confirmed, the airplane was in level flight before it entered a slight climb and then pitched down. One witness described the descent as “near vertical” and estimated the airplane was in an 85° nose-down attitude before impact with the water. Several witnesses described the airplane as “spinning,” “rotating,” or “spiraling” during portions of the steep descent. One witness reported hearing the engine/propeller and noted that he did not hear any “pitch change” in the sounds. The airplane continued in a nose-low, near-vertical descent until it impacted water in Mutiny Bay.

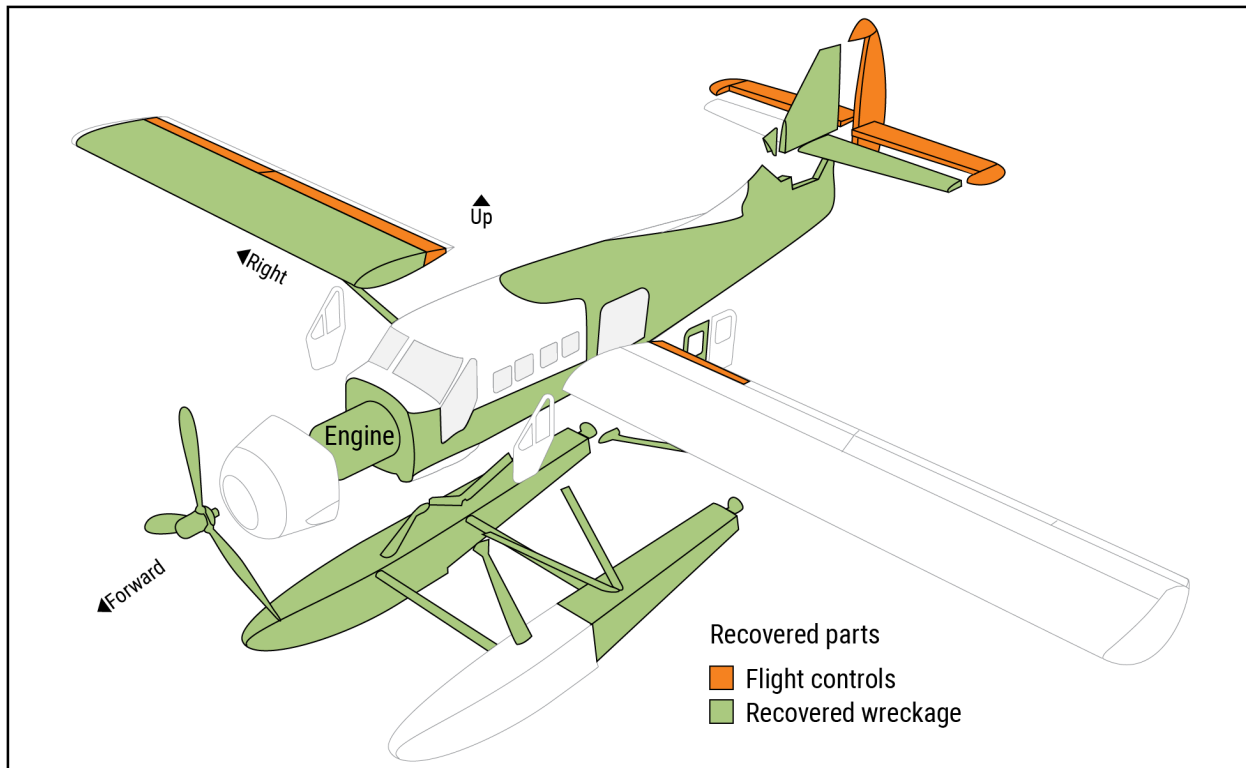
**Figure 6.** A diagram of the recovered wreckage and flight controls (Source: Viking Air, recreated by NTSB).

The airplane impacted Mutiny Bay and sank to a depth of about 200 ft. Wreckage was recovered between September 6 and September 30, 2022. After recovery from Mutiny Bay, the wreckage was transported to a secure facility for examination. The main items recovered included the nose fuel tank, engine mount and engine, propeller hub and blades, forward fuselage, center fuselage, tail section (empennage), right wing, most of the floats, some sections of flaps, and the left and right elevators (see figure 6).

The aft fuselage and empennage were separated from the rest of the airplane during recovery. The left side of the horizontal stabilizer, vertical stabilizer, and the lower portion of the rudder remained attached to the empennage. The left and right elevators were separated from the horizontal stabilizer.

An indentation in the shape of the horizontal stabilizer leading edge was observed on the left side fuselage skin just forward of the stabilizer cutout. The horizontal rib assembly installed in the aft fuselage below the horizontal stabilizer (shelf) and the fuselage side skins were crushed downward near the location of the stabilizer rear spar. Linear (fore-aft) scrapes were observed on the horizontal stabilizer lower skin rivet lines coincident with the edges of the shelf.

Most of the right side of the horizontal stabilizer was fractured off and not recovered. About 2 feet of the forward spar and leading edge of the right horizontal stabilizer remained attached. The forward end of this section was pulled outboard away from the fuselage and had a downward bend located about 6 inches from the root. The remaining part of the stabilizer fractured from this section on a 45° angle downward and aft. A downward indentation on the leading edge started at the stabilizer root and extended outboard about 2 feet.

The center and left side of the horizontal stabilizer remained attached to the forward hinge points in the aft fuselage and was twisted clockwise (as viewed looking down) about 15° around the center of the stabilizer. The entire left side of the stabilizer was mostly intact but was damaged and bent.

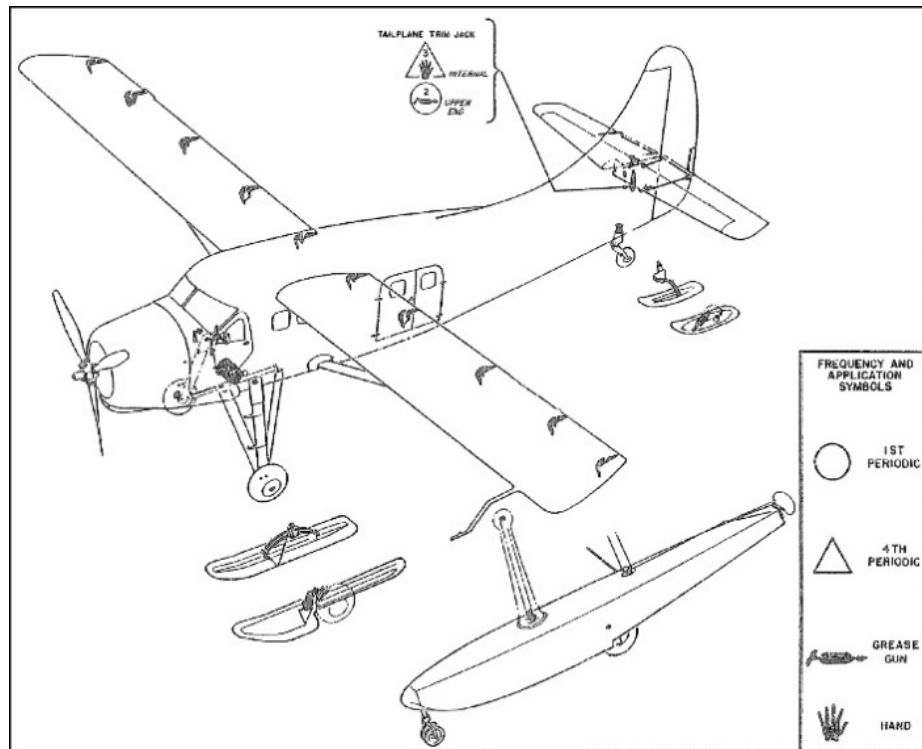
**Figure 13.** Lubrication diagram for the airplane (Source: Viking Air, edited by NTSB).

Regarding a lubrication schedule for the horizontal stabilizer trim actuator, a review of the DHC-3 AMM revealed a lubrication diagram that included symbols to specify the frequency and type of application; no written instructions were included regarding the lubrication requirements (see figure 13).<sup>45</sup> Based on the diagram, maintenance personnel should apply one type of grease to the upper end of the horizontal actuator using a grease gun at each 100-hour inspection and internally apply another type of grease, by hand, every 400 hours.<sup>46</sup>
