Inadvertent Activation of the Fuel Shutoff Lever  
and Subsequent Ditching  
Liberty Helicopters Inc., Operating a FlyNYON Doors-Off Flight  
Airbus Helicopters AS350 B2, N350LH  
New York, New York  
March 11, 2018

NTSB/AAR-19/04  
PB2020-100100

# Aircraft Accident Report

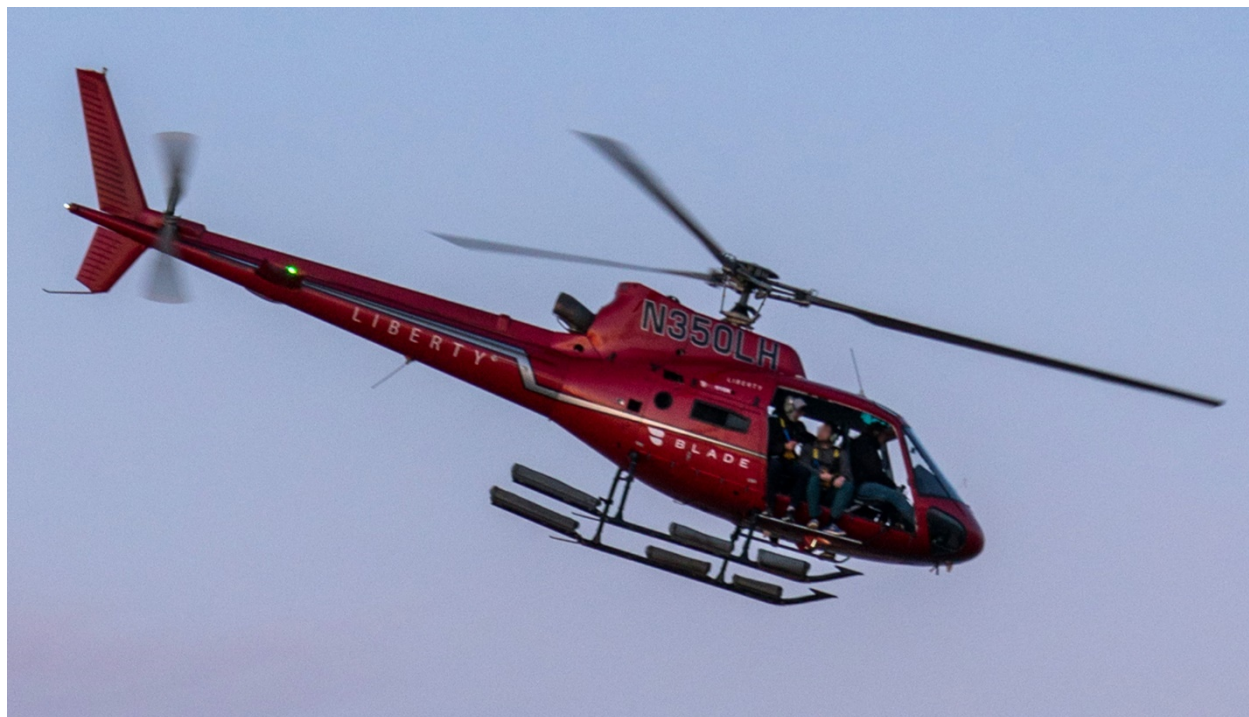
The accident flight (like other FlyNYON doors-off flights) was marketed by NYONair as an aerial photography flight in which passengers were allowed to take photographs while extending their feet outside of the helicopter's open doorways during portions of the flight. For the accident flight (and other FlyNYON flights Liberty operated per contract with NYONair), Liberty removed the helicopter's two right doors and front left door and locked the left sliding door in the open position (see figure 1).

**Figure 1.** Accident helicopter configured for FlyNYON doors-off operations.

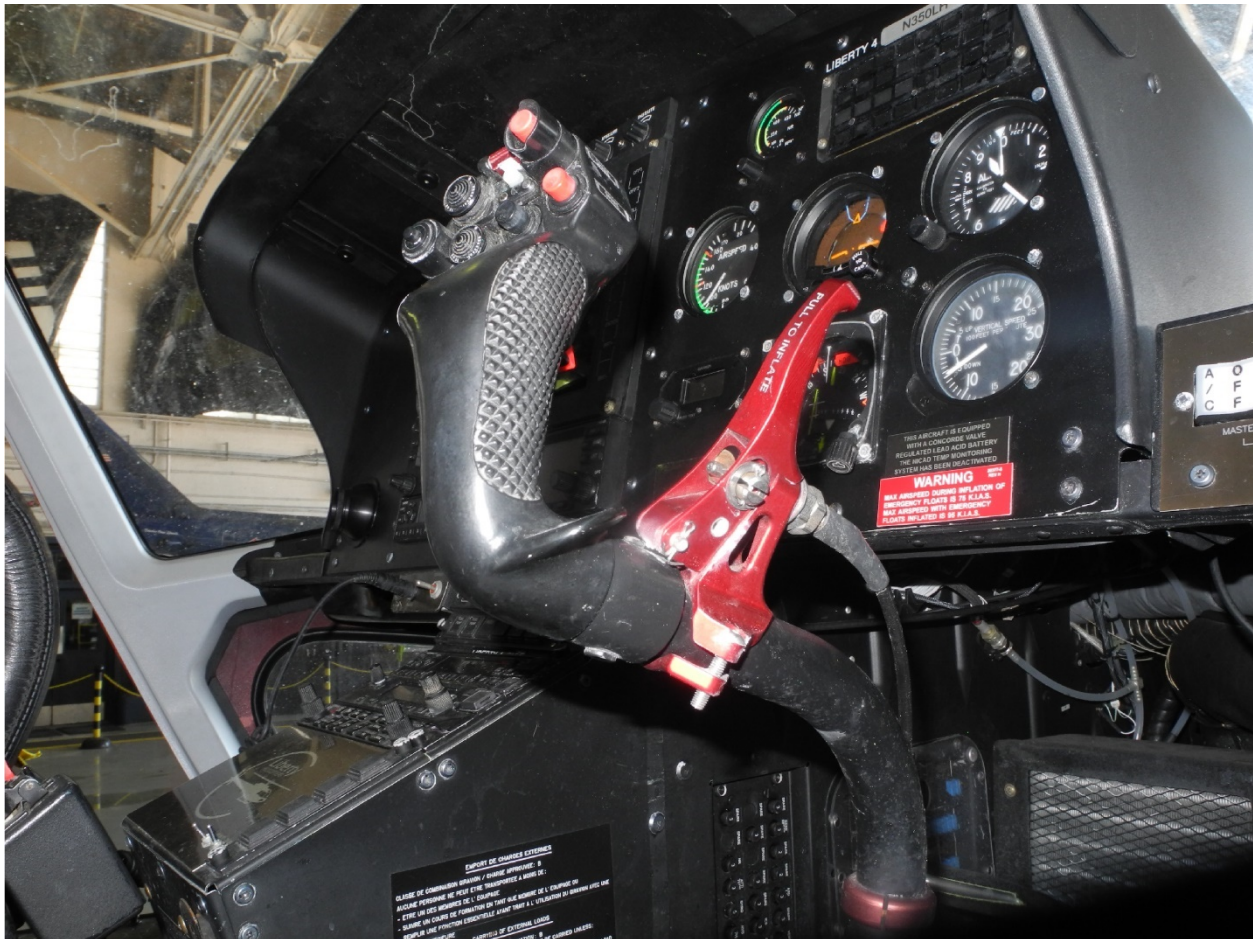
The activation handle was equipped with a shear pin (designed to break under about 12 lbs of force) to help prevent inadvertent activation. According to the FAA Los Angeles Aircraft Certification Office (ACO) project manager for the review and approval of STC SR00470LA, the applicant (Apical) had proposed (and the ACO had accepted) a 30-lb pull-force limit for the activation handle (that is, the maximum allowable force needed to pull the handle to successfully deploy the floats). A review of the STC and related documents found that none specified a pull-force limit for the activation handle.<sup>16</sup> On the accident helicopter, the activation handle alignment was offset from the cyclic grip about 32° to the right (as specified in the installation instructions) to prevent interference with the cyclic grip (see figure 6).

**Figure 6.** Float activation handle (red) installed on the accident helicopter's cyclic control.

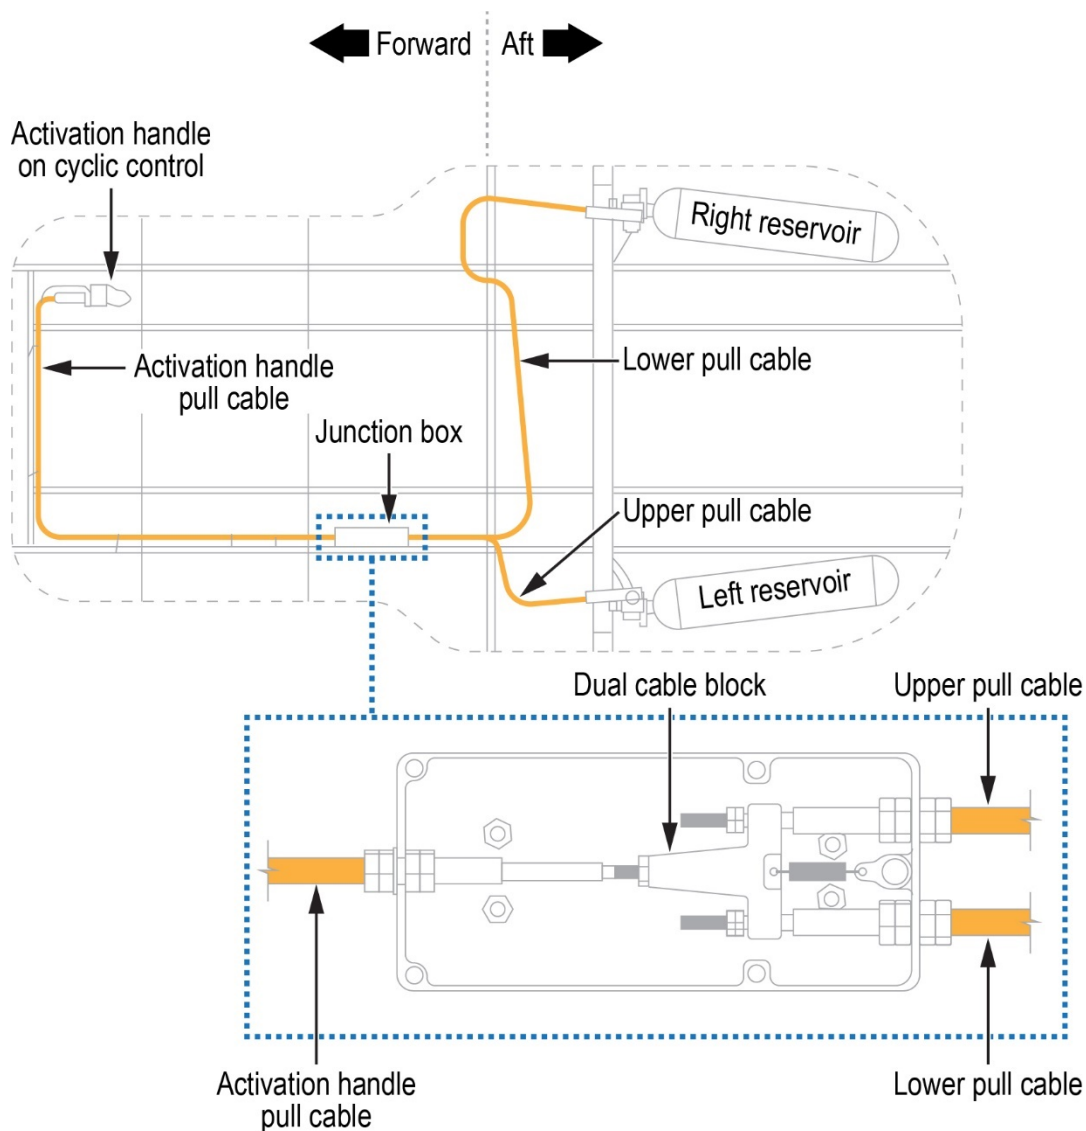
mounted on the helicopter's left frame rail. The junction box contained a dual cable block designed to transmit the motion of the activation handle's single pull cable (attached to the forward end of the block) to the pull cables for each reservoir assembly. The aft-upper and aft-lower pull cables, which extended forward from the left and right reservoir assemblies, respectively, passed through the dual cable block and terminated at jam nuts that abutted the dual cable block's forward surface. By design, pulling the activation handle would move the dual cable block forward (by means of the activation handle pull cable), which would pull the aft-upper and aft-lower pull cables forward by means of the cable block's contact with each cable's jam nut. Thus, when the activation handle is pulled to full travel, the resulting movement of the dual cable block and the aft-upper and aft-lower pull cables would result in activation of the valves to discharge each reservoir assembly (see figure 7).

**Figure 7.** Top-down view of helicopter showing basic routing of the pull cables for the emergency flotation system and inset showing side view of components inside the junction box.

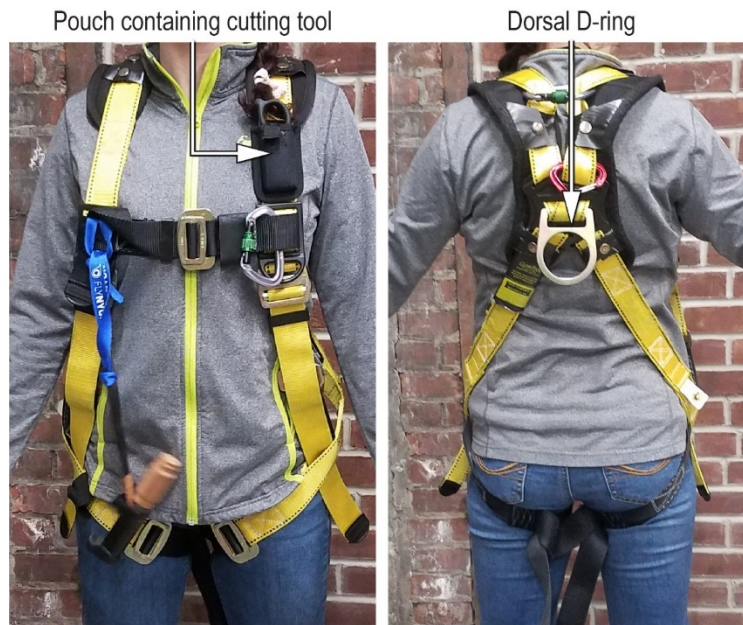
The harness that NYONair provided for each passenger on the accident flight (referred to as the "yellow" harness by Liberty and NYONair personnel due to their color) was designed to protect users from workplace fall hazards.<sup>27</sup> The harness included interconnected shoulder straps and leg straps, a chest strap that spanned the two front shoulder straps, and a dorsal D-ring (used on the accident flight for attaching a tether) between the wearer's upper shoulder blades. NYONair attached a pouch containing an emergency cutting tool on either the right or left upper shoulder strap of each harness (see figure 10).<sup>28</sup>

**Figure 10.** Front and rear views of a person wearing an exemplar yellow fall-protection harness with a pouch containing a cutting tool attached to the upper left shoulder strap.

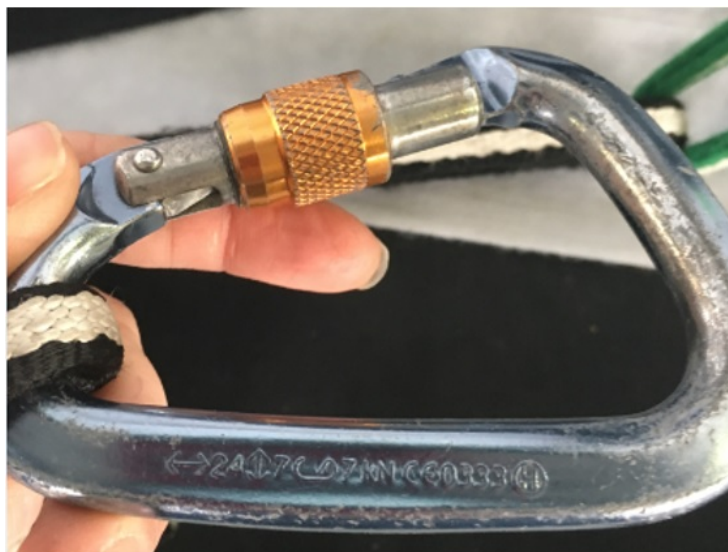
Three different models of locking carabiners were used on the accident helicopter, each of which featured a similar type of gate and locking mechanism. The gate could be opened by pushing it inward when not locked. The locking mechanism featured a screw-type, threaded locking sleeve that was operated by manually rotating multiple turns to lock or unlock the gate (depending on the direction of rotation) (see figure 12).

**Figure 12.** An exemplar locking carabiner used on a tether on the accident helicopter.

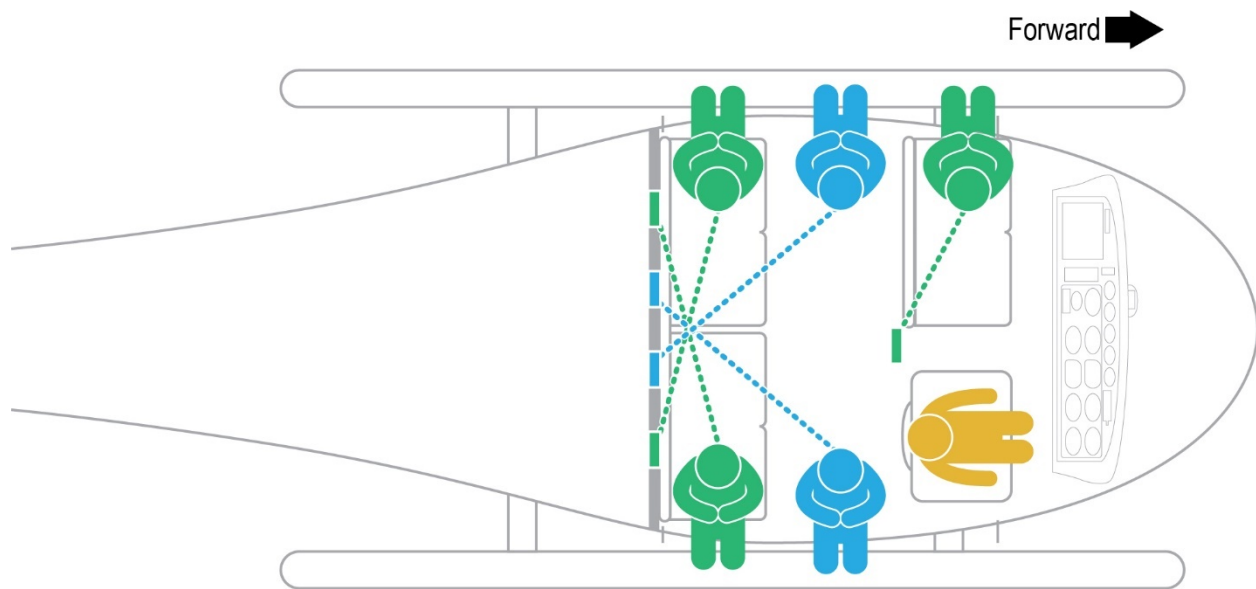
The onboard video showed that the front passenger's tether was routed under the armrest of his seat and to a floor anchor located aft of the helicopter's floor-mounted controls. According to Liberty personnel, each rear seat passenger's tether was routed such that it was secured to an anchor point located behind a different passenger. That is, the right outboard passenger's tether was secured to an anchor point (on the aft bench bar) behind the left outboard passenger (and vice versa), and the right inboard passenger's tether was secured to an anchor point behind the left inboard passenger (and vice versa). (See figure 13.)

**Figure 13.** Diagram showing the tether routing for each passenger to the respective anchor point in the cabin.

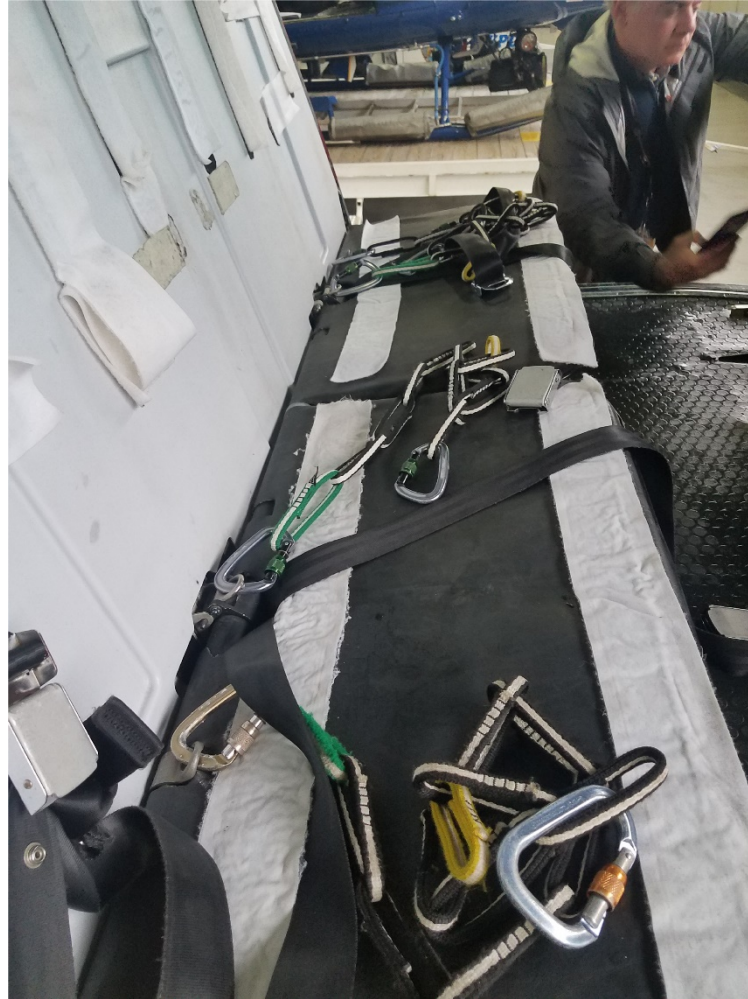
The tethers for the four rear passengers each consisted of multiple loops of webbing secured to an anchor point with a locking carabiner.<sup>31</sup> The anchor end of each tether was secured through a terminating loop. When examined by investigators (after passenger recovery), the top (occupant end) of each rear tether had a locking carabiner inserted through a loop such that excess tether loops hung from the carabiner as a tail. Each tether (from the anchor point to the D-ring attachment) was between 39 and 41 inches long (see figure 15).

**Figure 15.** Rear passengers' tethers from the accident flight secured to anchor points on the aft bench bar with locking carabiners.

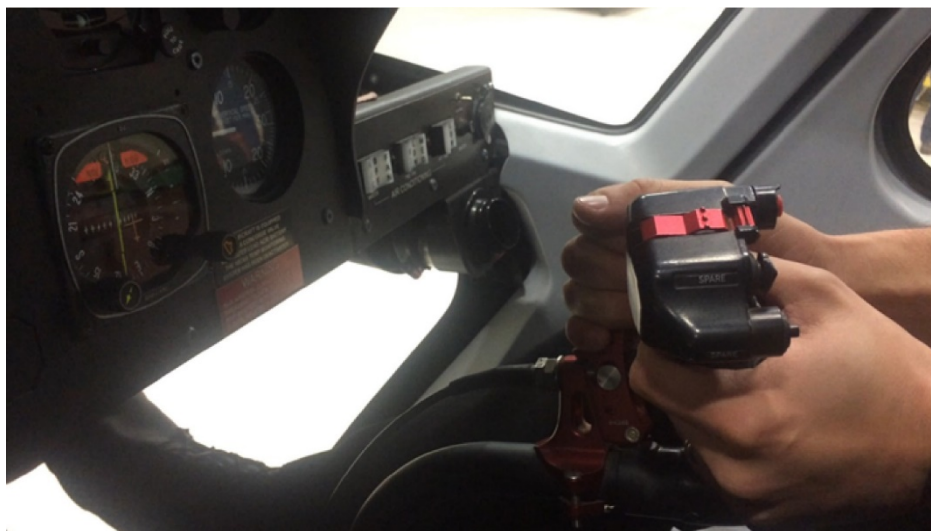
During the investigation of this accident, Liberty provided several videos of inflation tests performed as part of the 36-month float inspections of its helicopters equipped with the Dart emergency flotation system.<sup>38</sup> In every video, a participant seated in the right seat braced the cyclic control with the left hand and pulled the activation handle with the right hand (see an example in figure 18).

**Figure 18.** Screen capture from a Liberty-provided video of a test activation of the Dart emergency flotation system.

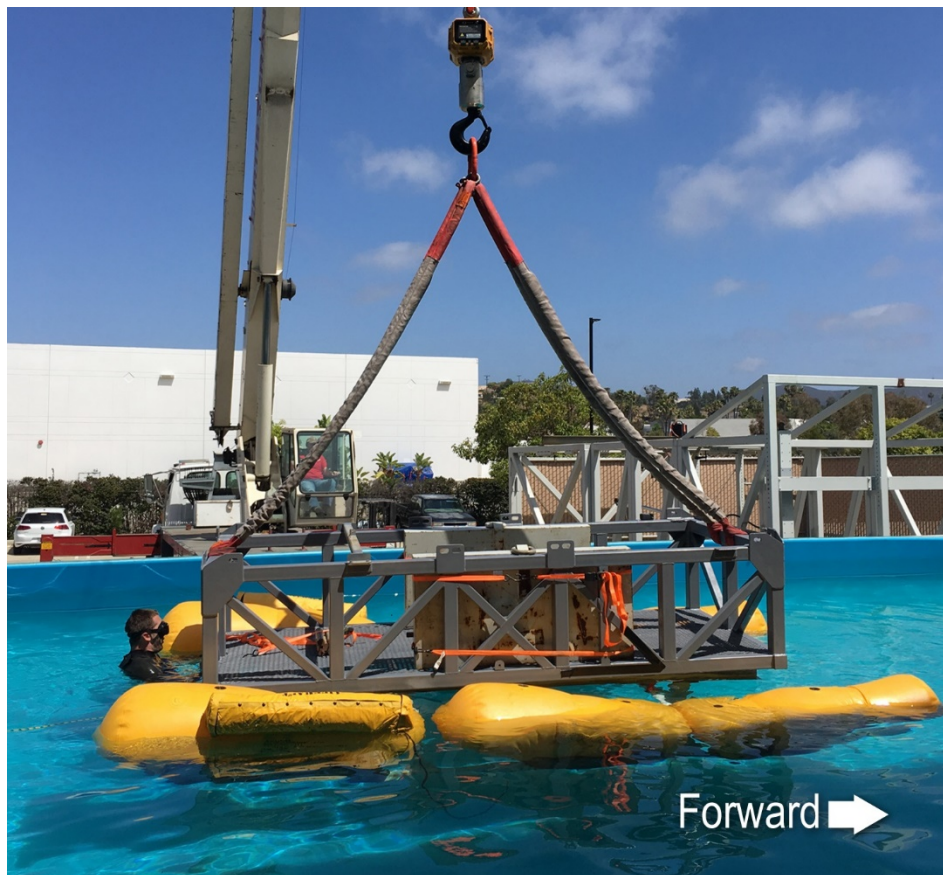
For the tests described below, the test rig weighed about 5,220 lbs (the maximum gross weight for the AS350 B2) and was suspended from a crane above a pool. Investigators used one gas reservoir to partially and symmetrically inflate the floats, then slowly lowered the rig into the pool to observe its buoyancy stability (see figure 19).

For another test, air from a shop compressor was added to increase the partial inflation pressure in each float chamber to about 1 psi (the designed minimum operating pressure of the floats). Once the test rig was lowered into the pool, it floated with no evidence of listing after several minutes. None of the six floats became completely submerged.

**Figure 19.** A test rig with partially, symmetrically inflated floats is shown suspended by a crane and lowered into a pool.

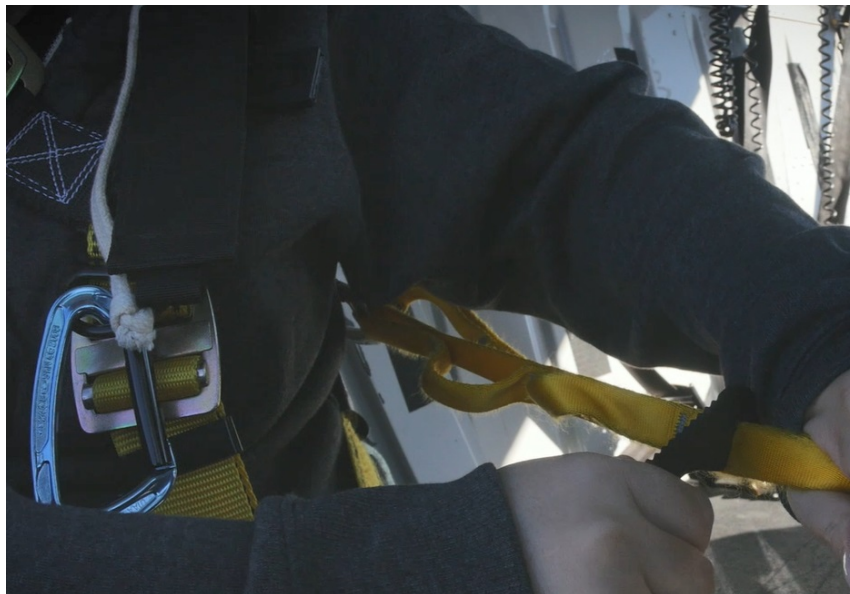
The video also instructed passengers that "a cutter [cutting tool] is also secured to one of your chest straps and will allow you to quickly cut through the harness if you are unable to reach the quick release clip." The visual that accompanied this narrative showed a tether made of a different webbing than the tethers provided to the accident passengers. It showed a person (seated alone in the back of a helicopter) grasping the tether with one hand and applying the cutting tool with the other, successfully cutting through the tether with one pull of the tool (see figure 20).<sup>58</sup>

**Figure 20.** Screen capture from the safety video shown to the passengers before the accident flight showing a person using a cutting tool on a type of tether.
