# Loss of Thrust in Both Engines After Encountering a Flock of Birds and Subsequent Ditching on the Hudson River

US Airways Flight 1549  
Airbus A320-214, N106US  
Weehawken, New Jersey  
January 15, 2009

NTSB/AAR-10/03  
PB2010-910403

# Aircraft Accident Report

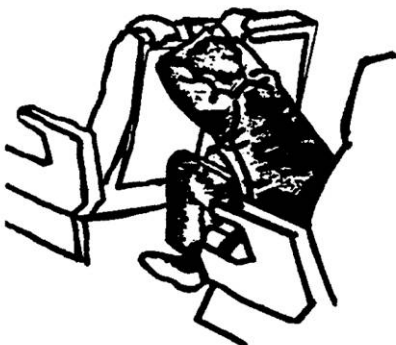
**Figure 7.** Passenger brace position shown in AC 121-24C.

The brace positions shown on the US Airways safety information card were in accordance with current FAA guidance on brace positions contained in Appendix 4 of AC 121-24C, which states, "in aircraft with high-density seating or in cases where passengers are physically limited and are unable to place their heads in their laps, they should position their heads and arms against the seat (or bulkhead) in front of them." (See figure 7.)

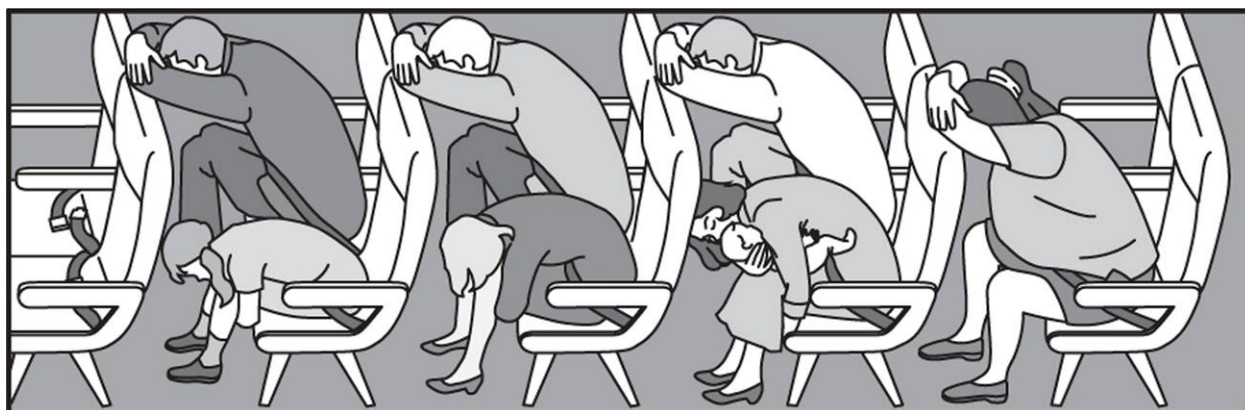
**Figure 8.** Passenger brace positions shown in the US Airways safety information card.

Of the four passengers who sustained serious injuries, three received their injuries during impact. The two female passengers who sustained very similar shoulder fractures both described assuming similar brace positions, putting their arms on the seat in front of them and leaning over. They also stated that they felt that their injuries were caused during the impact when their arms were driven back into their shoulders as they were thrown forward into the seats in front of them. The brace positions they described were similar to the one depicted on the US Airways safety information card, which is shown in figure 8.
