**In-Flight Separation of Vertical Stabilizer
American Airlines Flight 587
Airbus Industrie A300-605R, N14053
Belle Harbor, New York
November 12, 2001**

NTSB/AAR-04/04

**NTSB/AAR-04/04
PB2004-910404
Notation 7439B
Adopted October 26, 2004**

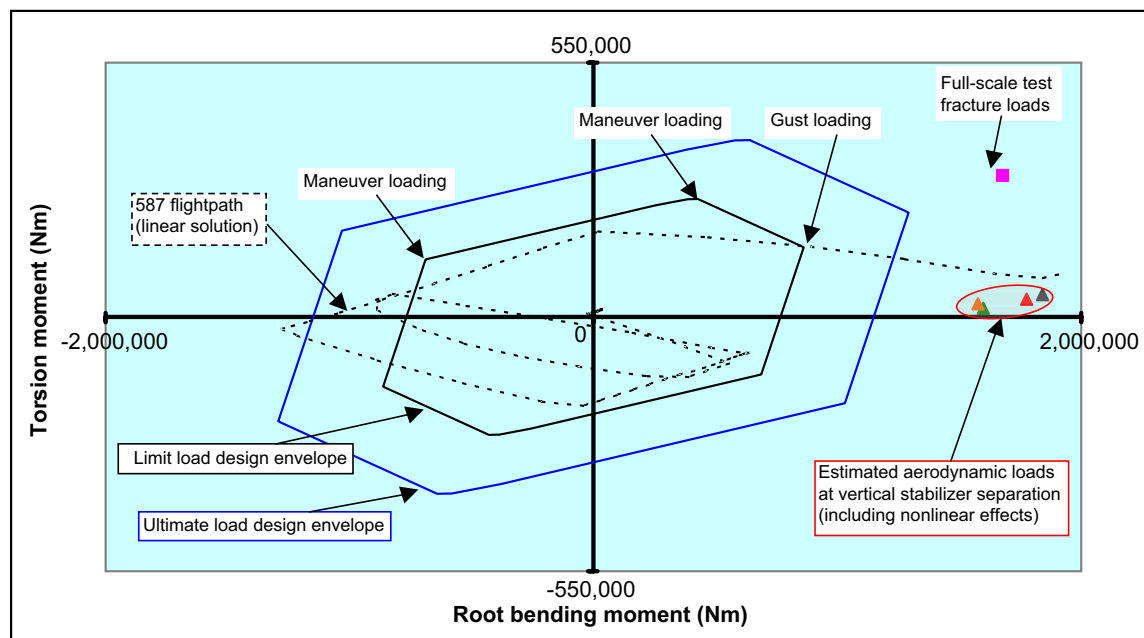
Figure 15. Estimated Aerodynamic Loads in Relation to the Torsion Versus Bending Correlated Shear Force Diagram

The bending moment load ranges shown in figure 14 are presented along with the “effective sideslip angle” range¹⁰¹ and the rudder range at the time that the vertical stabilizer separated from the airplane. Figure 15 compares the estimated aerodynamic loads with the A300-600 design envelopes (as defined by the torsion versus bending correlated shear force diagram).

Note: The four triangles correspond to the four points in figure 14. Specifically, the red triangle is point A, the gray triangle is point B, the green triangle is point C, and the orange triangle is point D.

Safety Board investigators conducted an airplane performance study to describe the motion of the accident airplane, identify the causes of the motion, and calculate the resulting aerodynamic loading on the vertical stabilizer.¹⁷⁷ The airplane performance study revealed that the first officer's cyclic rudder pedal inputs, which began about 7 seconds before the vertical stabilizer separation, led to increasing sideslip angles that, along with the continued rudder deflections, produced extremely high aerodynamic loads on the vertical stabilizer. The airplane performance study indicated that, at 0915:58.4, when the vertical stabilizer separation began, the aerodynamic loads on the vertical stabilizer were about two times the loads defined by the limit load design envelope (see figure 15).¹⁷⁸

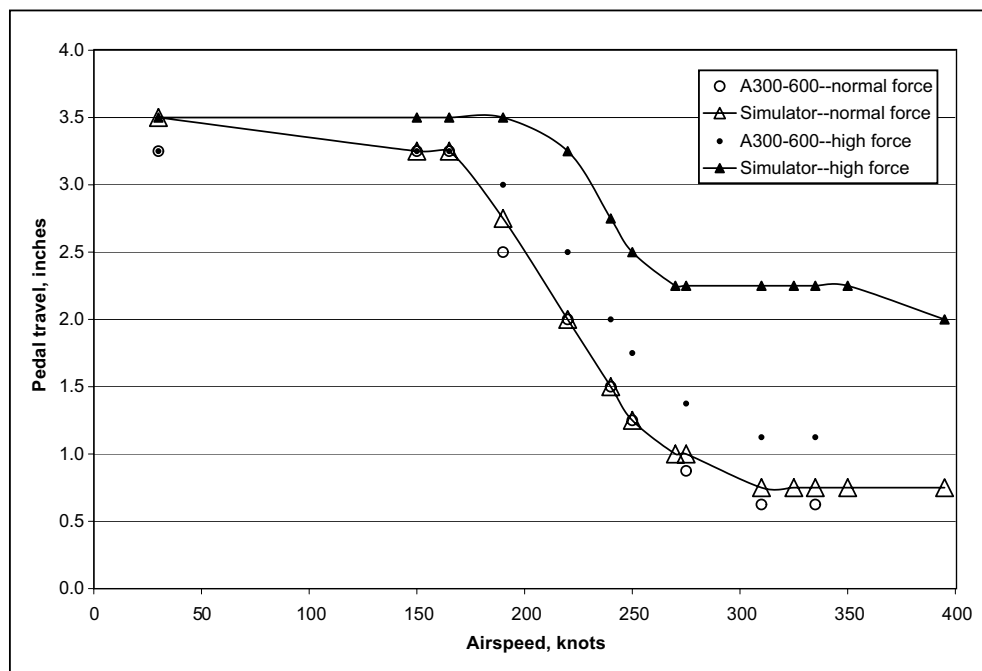
Figure 18. Rudder Pedal Motion With Normal and High Pilot Pedal Force in the A300-600 Airplane and the American Airlines A310/300 Training Simulator

Safety Board investigators repeated these tests on April 23, 2003, in the American Airlines A310/300 training simulator. With the assistance of two American Airlines representatives, the investigators assessed how the portrayal of rudder pedal characteristics in the simulator compared with those of the actual A300-600 airplane. The investigators found that the rudder pedal motion in the simulator and the airplane produced by normal and high pilot input forces resulted in different pedal displacements despite the pedal travel limits, as shown in figure 18. The differences were attributed to the software representation of the elastic cable stretch in the simulator, which was less stiff than the cable stretch on the A300-600 airplane.
