# NATIONAL TRANSPORTATION SAFETY BOARD

## AIRCRAFT ACCIDENT REPORT

EXPLOSIVE DECOMPRESSION--  
LOSS OF CARGO DOOR IN FLIGHT  
UNITED AIRLINES FLIGHT 811  
BOEING 747-122, N4713U  
HONOLULU, HAWAII  
FEBRUARY 24, 1989

**Adopted: March 18, 1992  
Notation 5059C**

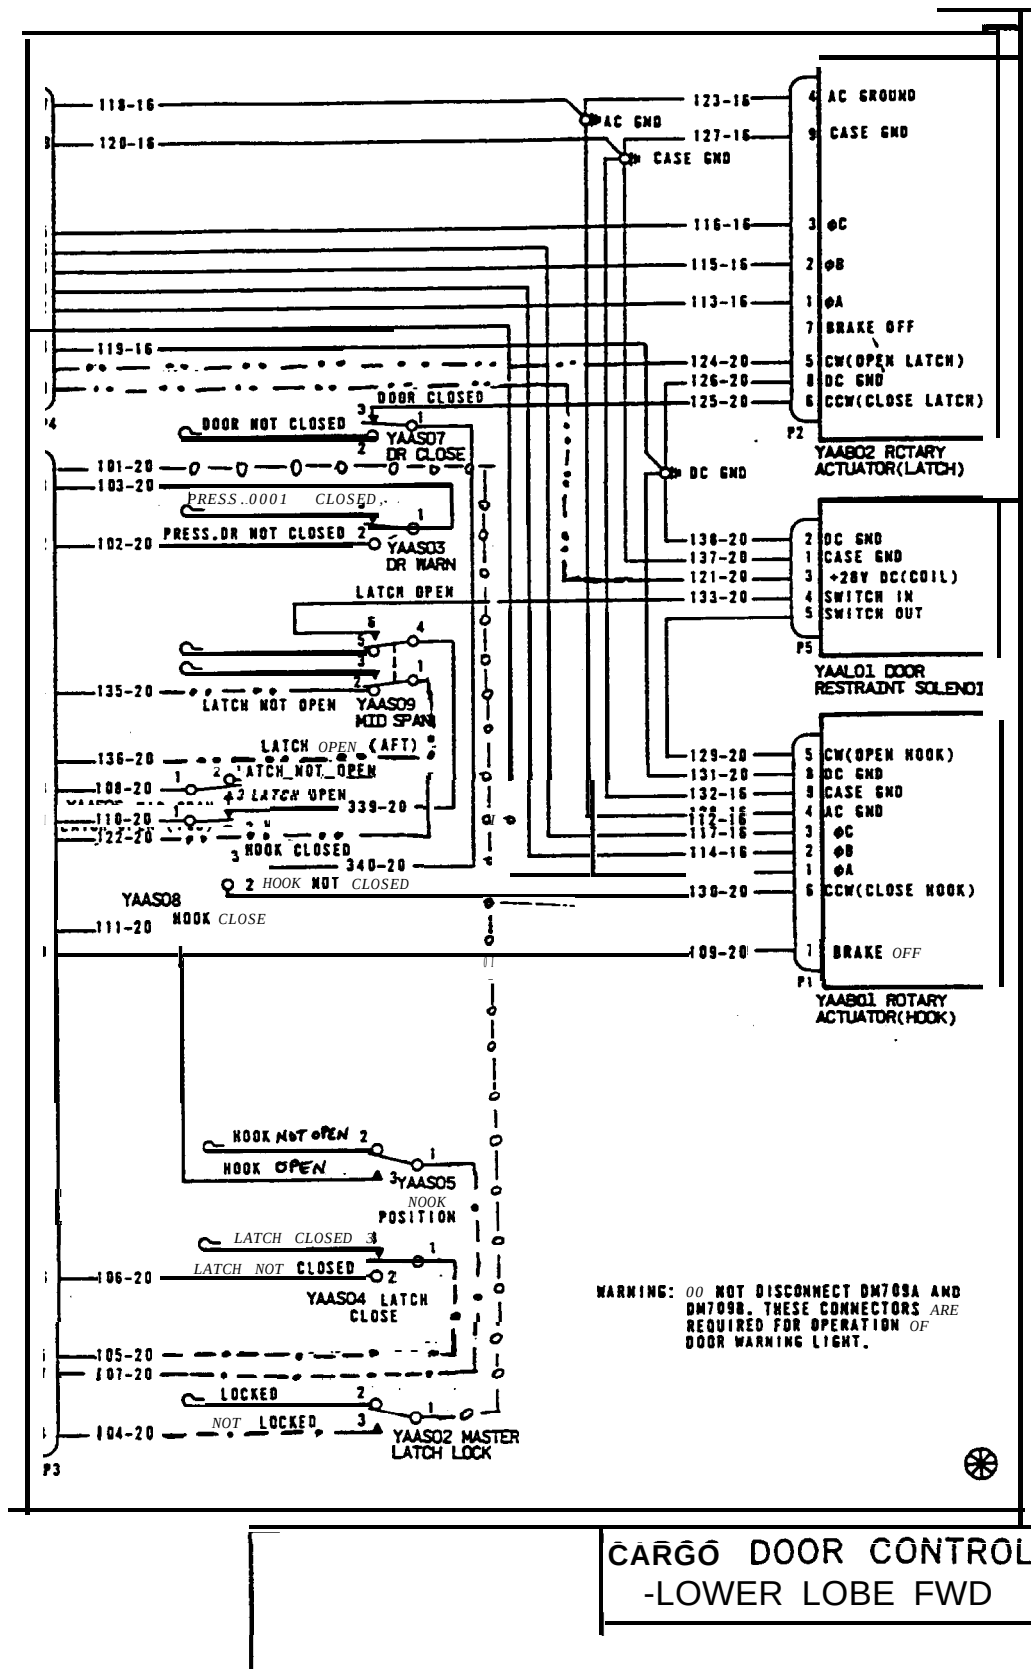
Figure 17.--Diagram of cargo door electrical circuitry.

Conductive contact of (-0-o-o-o) or (--...--.) coded wire with (-...-) coded wire could potentially result in providing a 28VDC circuit path to the latch actuator open circuit. Direct wire-to-wire paths are coded in Figure 17 as defined above. The two-wire short circuit paths are identified as wire pairs consisting of wire 101-20 shorting with any of the following wires; 108-20, 121-20, 122-20, 124-20, **135-20**, or 136-20.

If the S2 master latch lock switch fails in the “Not Locked” position, there are additional wire pairs that provide short circuit paths. These are coded in Figure 17 as (--...--.) to (-...-) wire pairs.
