Aerodynamic Stall and Loss of Control During Approach Embraer EMB-500, N100EQ Gaithersburg, Maryland December 8, 2014

NTSB/AAR-16/01 PB2016-103251

Aircraft Accident Report

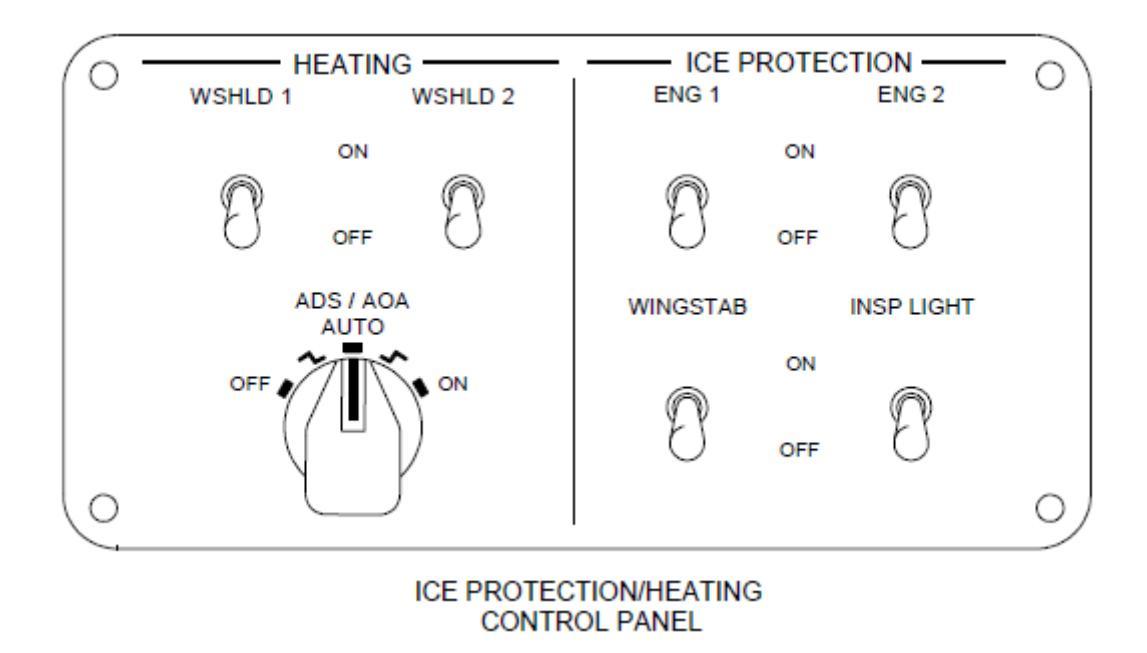
The airplane was equipped with engine anti-ice and wing and horizontal stabilizer deice systems that are controlled by ON/OFF switches (labeled ENG 1, ENG 2, and WINGSTAB) on the ice protection/heating control panel located at the bottom of the main panel on the left side of the cockpit (figure 1 shows a diagram of the ice protection/heating control panel).¹⁶ As an indicator pilots use to determine when the ice protection systems should be activated, the TAT display is located below and to the left of the PFD (see figure 2).

Figure 1. Diagram showing the EMB-500 ice protection/heating control panel.

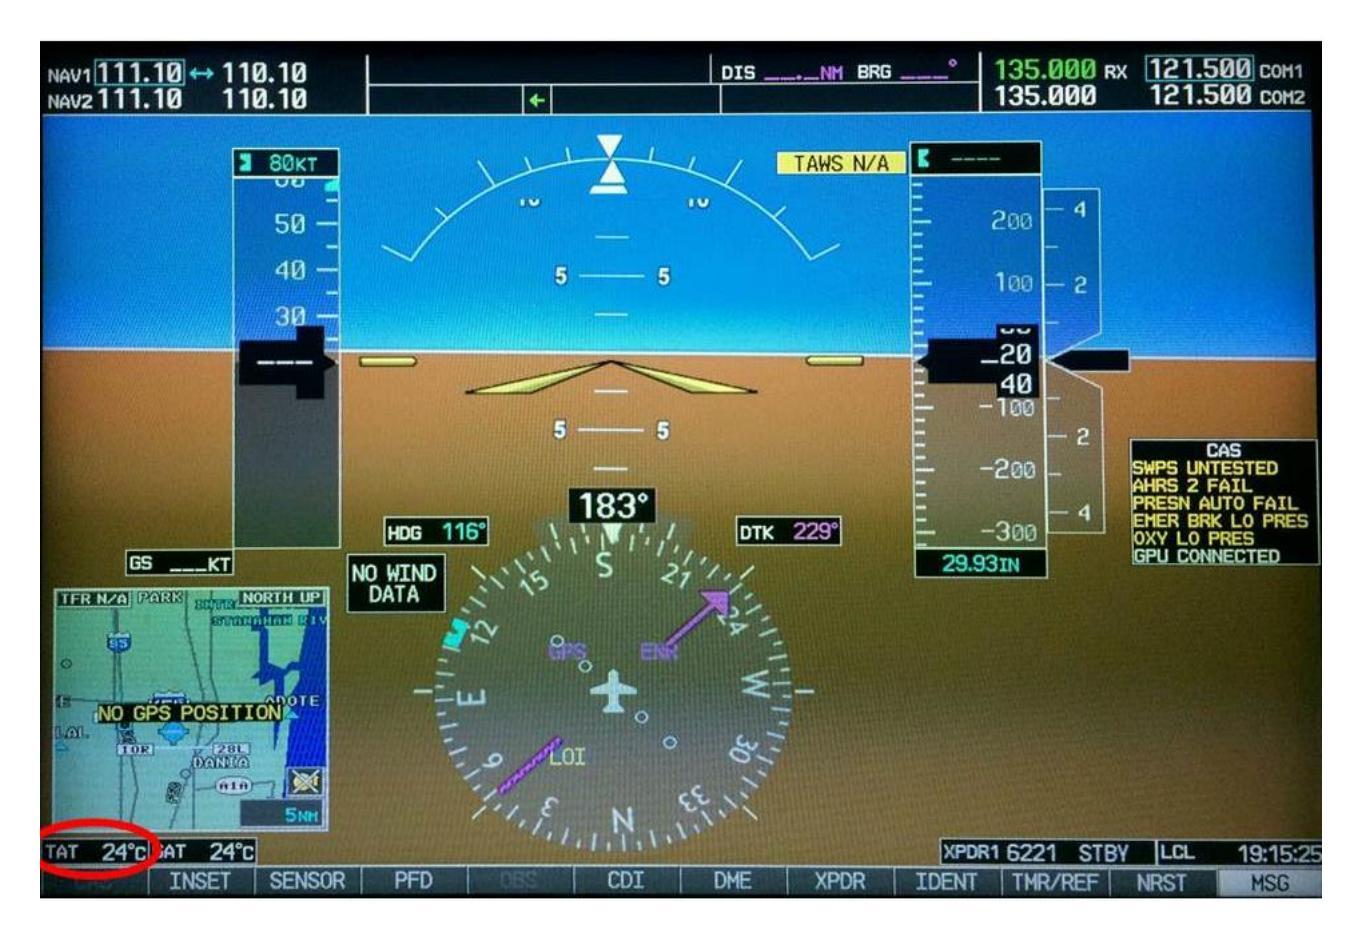
Figure 2. The TAT display (circled in red) as shown to EMB-500 pilots in normal operation.

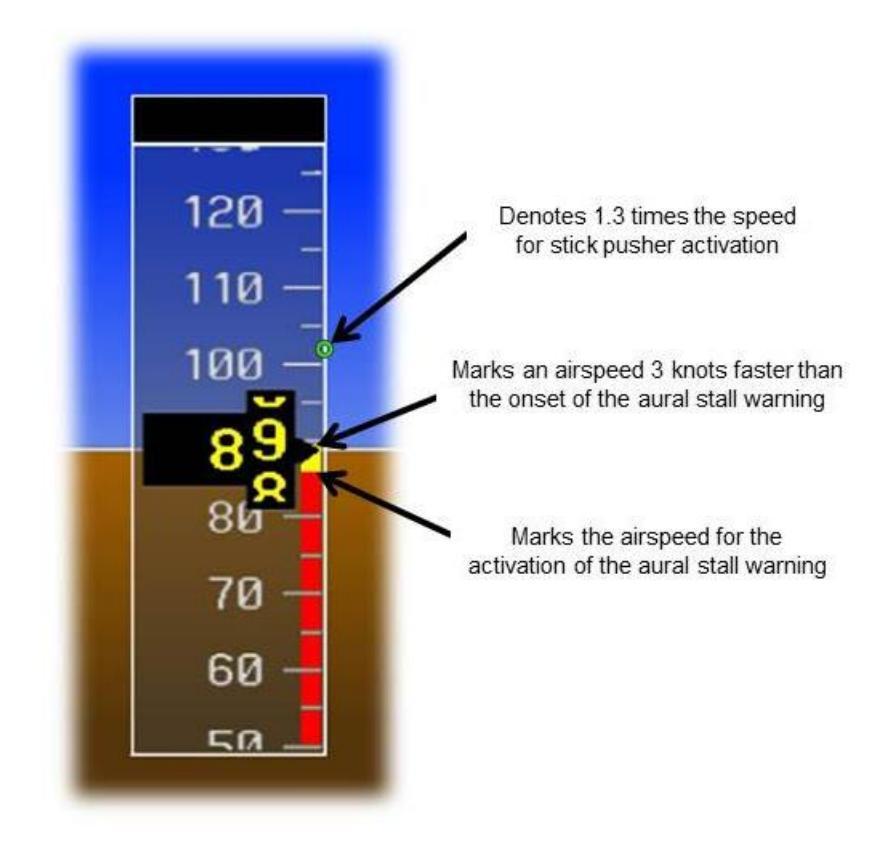
The airspeed tape on the PFD provides pilots with low-airspeed awareness indicators consisting of a short yellow band positioned above a longer red band and a green circle on the right edge of the tape (see figure 3). The top of the red band denotes the airspeed for the activation of the aural stall warning, the top of the yellow band marks an airspeed that is 3 knots faster than the onset of the aural stall warning, and the green circle denotes 1.3 times the speed at which the stick pusher would activate. Activating the airplane's wing and horizontal stabilizer

Figure 3. Simulated EMB-500 airspeed tape display (with ice protection deactivated).

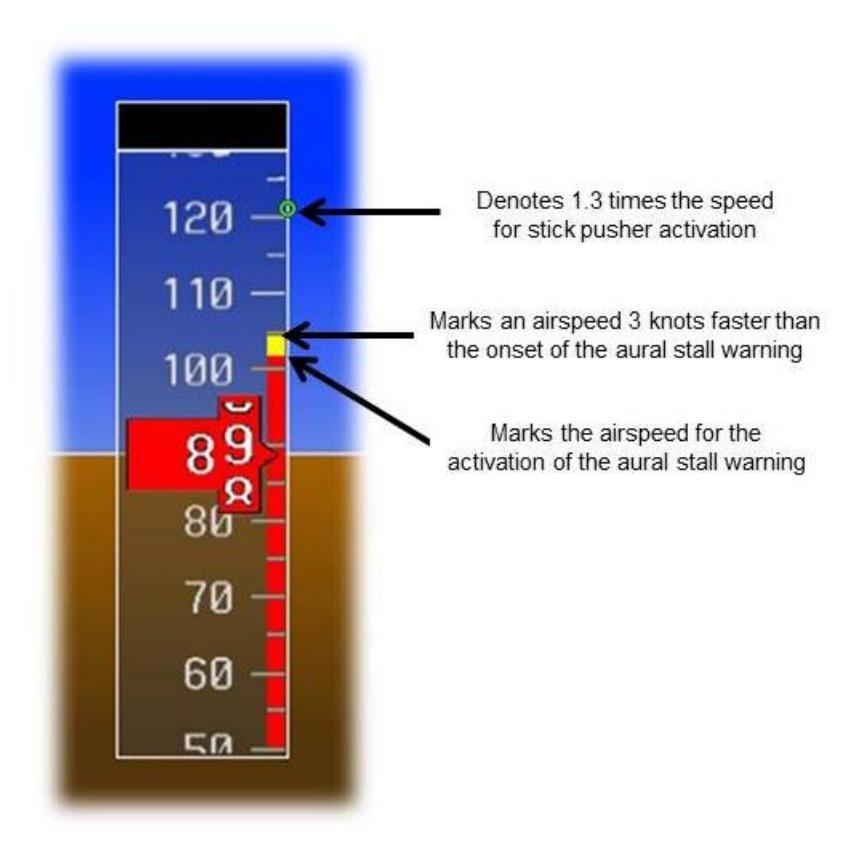
deice system results in a lower AOA threshold to trigger the SWPS and, therefore, higher indicated airspeeds for the warning bands on the airspeed tape display (see figure 4).

The aircraft performance study also included simulations of the low-airspeed awareness cues on the airspeed tape. According to the simulations, because the pilot had not activated the wing and horizontal stabilizer deice system during the approach to GAI, the airspeed tape would have shown, just before the stall warning sounded, the top of the red band at 87 knots, the top of the yellow band at 90 knots, and the green circle at 102 knots (see figure 3). The simulations showed that, if the deice system had been activated, the airspeed tape would have displayed the top of the red band at 102 knots, the top of the yellow band at 105 knots, and the green circle at 121 knots (see figure 4).
