NATIONAL  
TRANSPORTATION  
SAFETY  
BOARD

# AIRCRAFT ACCIDENT REPORT

EASTERN AIR LINES, INC.

L-1011, N310EA

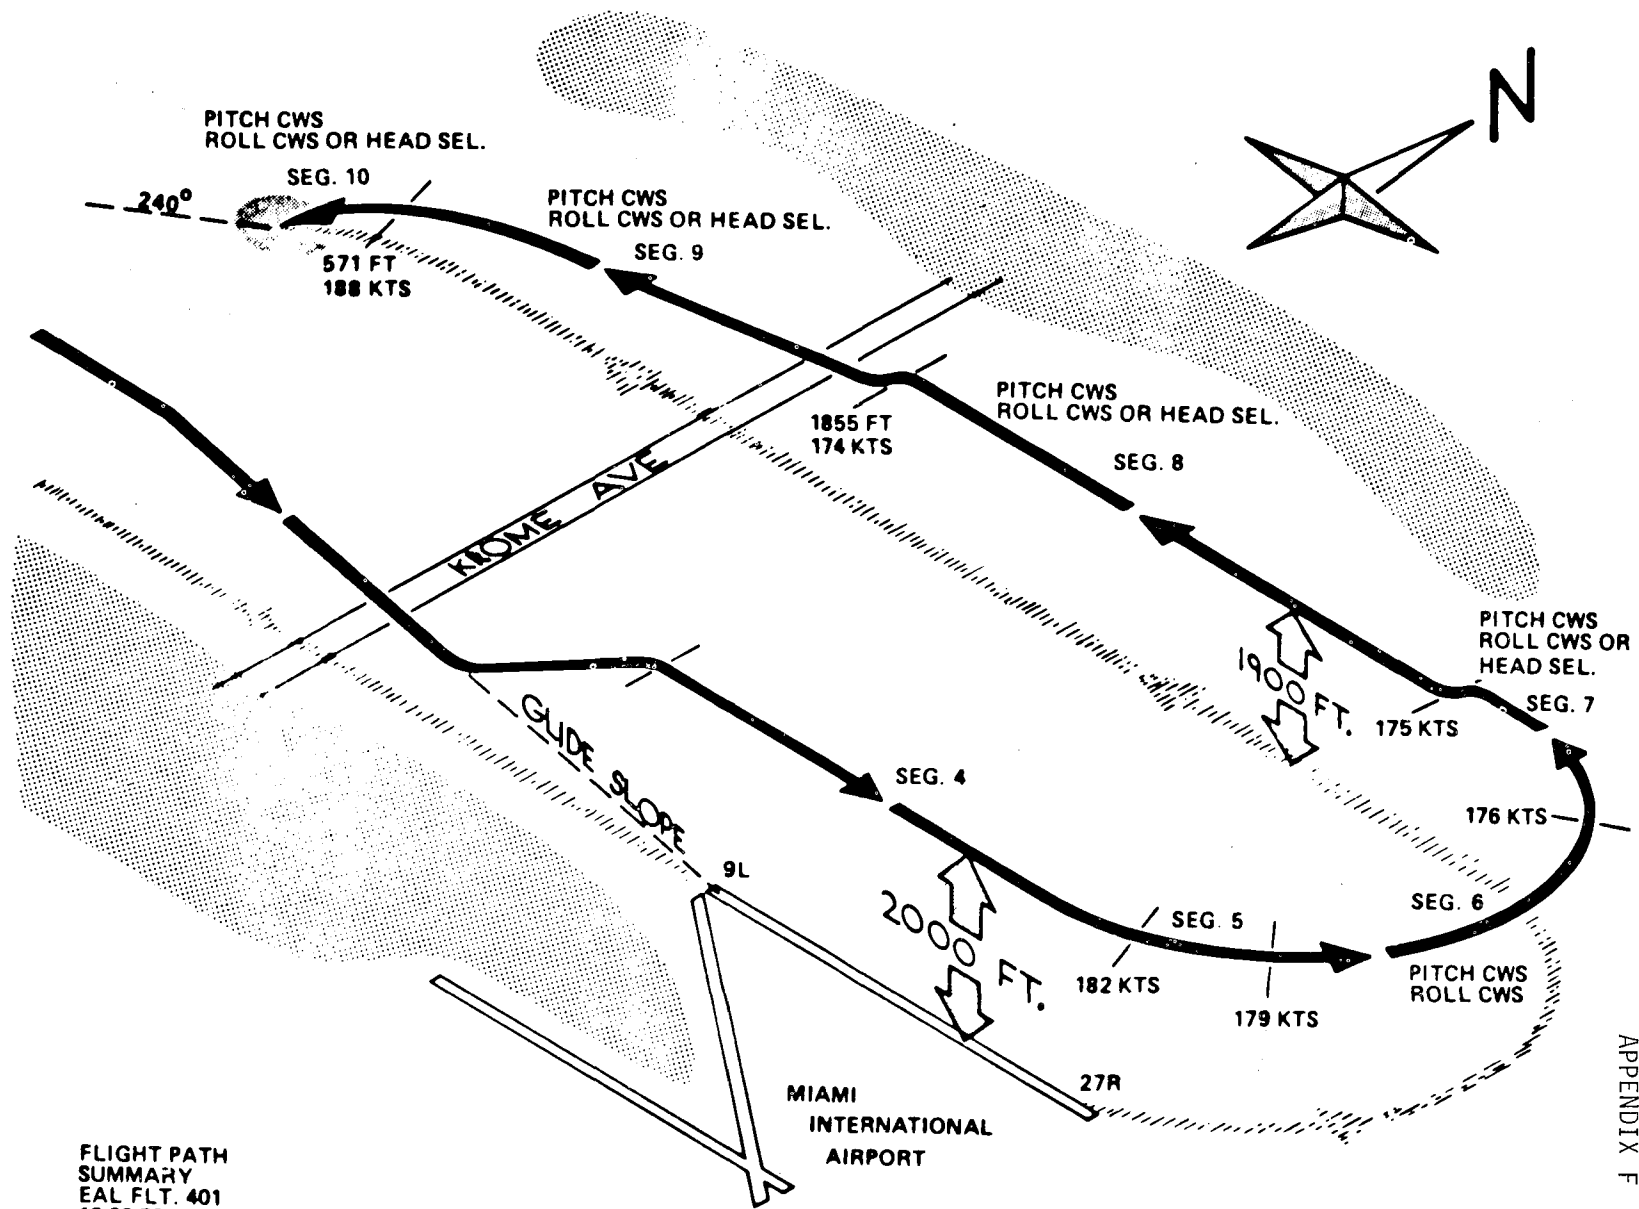
FLIGHT PATH  
SUMMARY  
EAL FLT. 401  
12-29-72

The National Transportation Safety Board determines that the probable cause of this accident was the failure of the flight crew to monitor the flight instruments during the final 4 minutes of flight, and to detect an unexpected descent soon enough to prevent impact with the ground. Preoccupation with a malfunction of the nose landing gear position indicating system distracted the crew's attention from the instruments and allowed the descent to go unnoticed.

At 2337:24, a downward vertical acceleration transient of 0.04 g caused the aircraft to descend 100 feet; the loss in altitude was arrested by a pitchup input.
