**AIRCRAFT ACCIDENT REPORT
92-11**

EL AL FLIGHT 1862

**BOEING 747-258F 4X-AXG
BIJLMERMEER, AMSTERDAM
OCTOBER 4, 1992**

on the accident with EI AI 1862
on October 4, 1992
at Amsterdam – Bijlmermeer

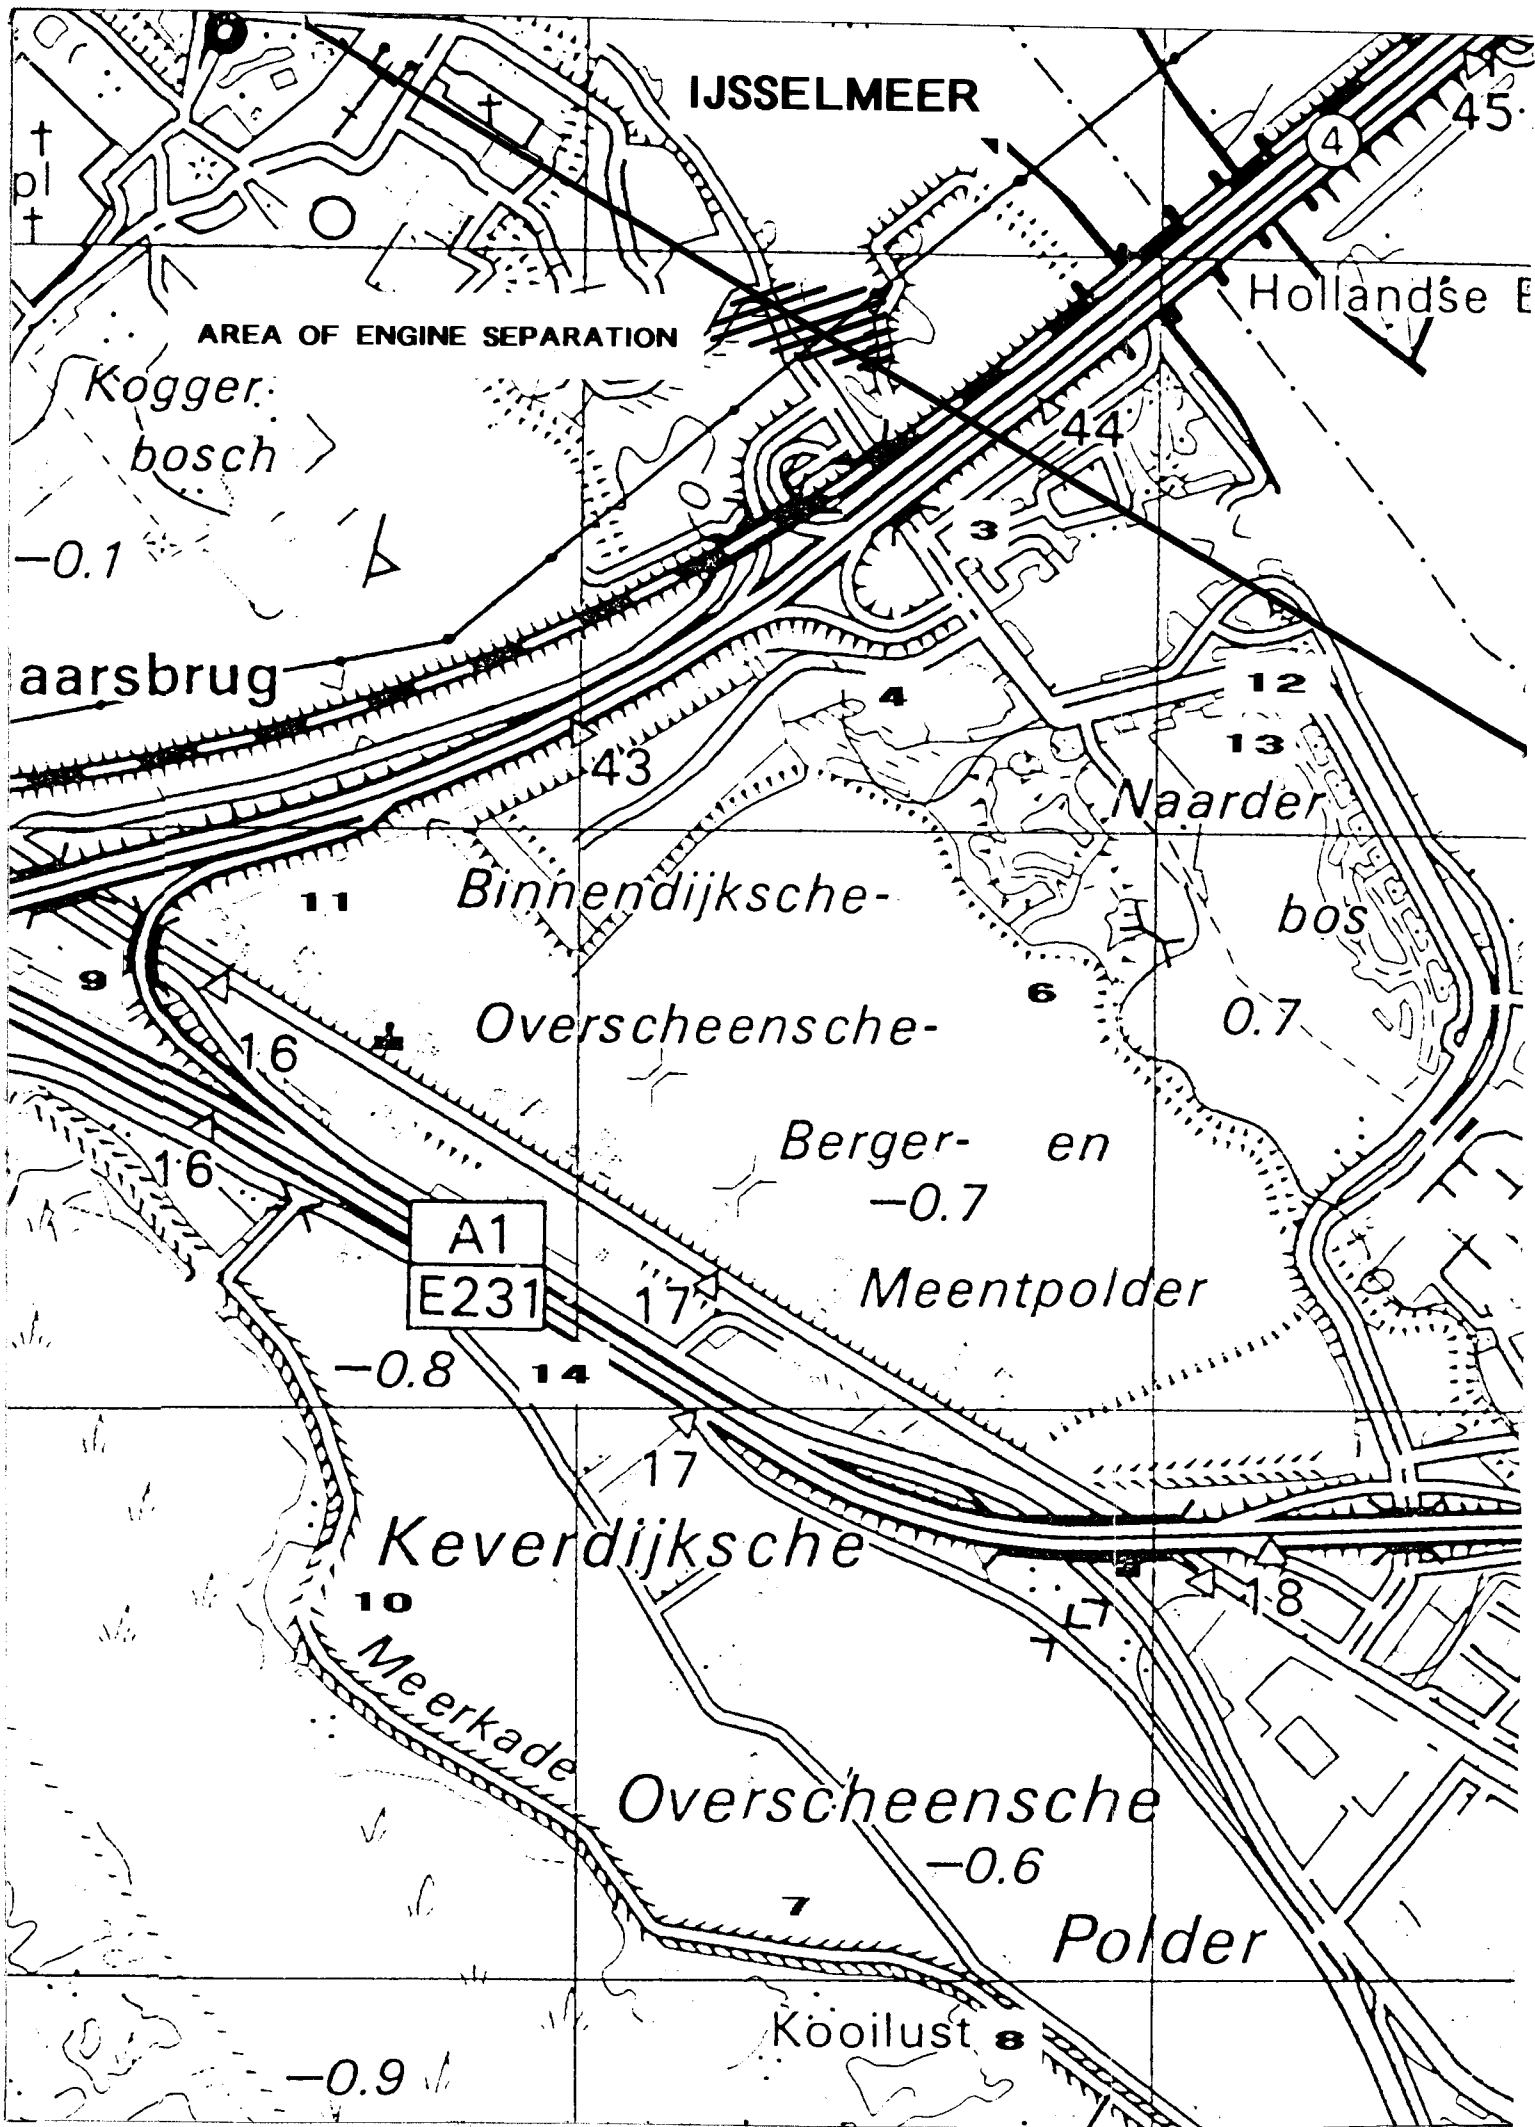
APPENDIX 2.1

DESCRIPTION OF THE WRECKAGE AREA AFTER ENGINE SEPARATION

1. Engine no. 4, with pylon and cowling parts of no. 4
2. Engine no. 3, with pylon and cowling parts of no. 3 and 4, parts of fanblades of no. 4
3. Diagonal brace no. 3
4. Diagonal brace no. 4
5. Spinner no. 4
6. Part of tailcone no. 3
7. Tip of tailcone no. 3
8. Reverser screen parts
9. Cowling parts no. 3
10. Cowling parts
11. Part wing leading edge
12. Leading edge flap no. 18 (RH wing) and flapdrive
13. Air driven pump no. 3 and 4
14. Rear part of pylon no. 4
15. Pneumatic system bleed air pipe (near Muiden, not on the map)

Scattered over the area: small parts of honeycomb material of cowling no. 4 and parts of leading edge panels and structure of the RH wing

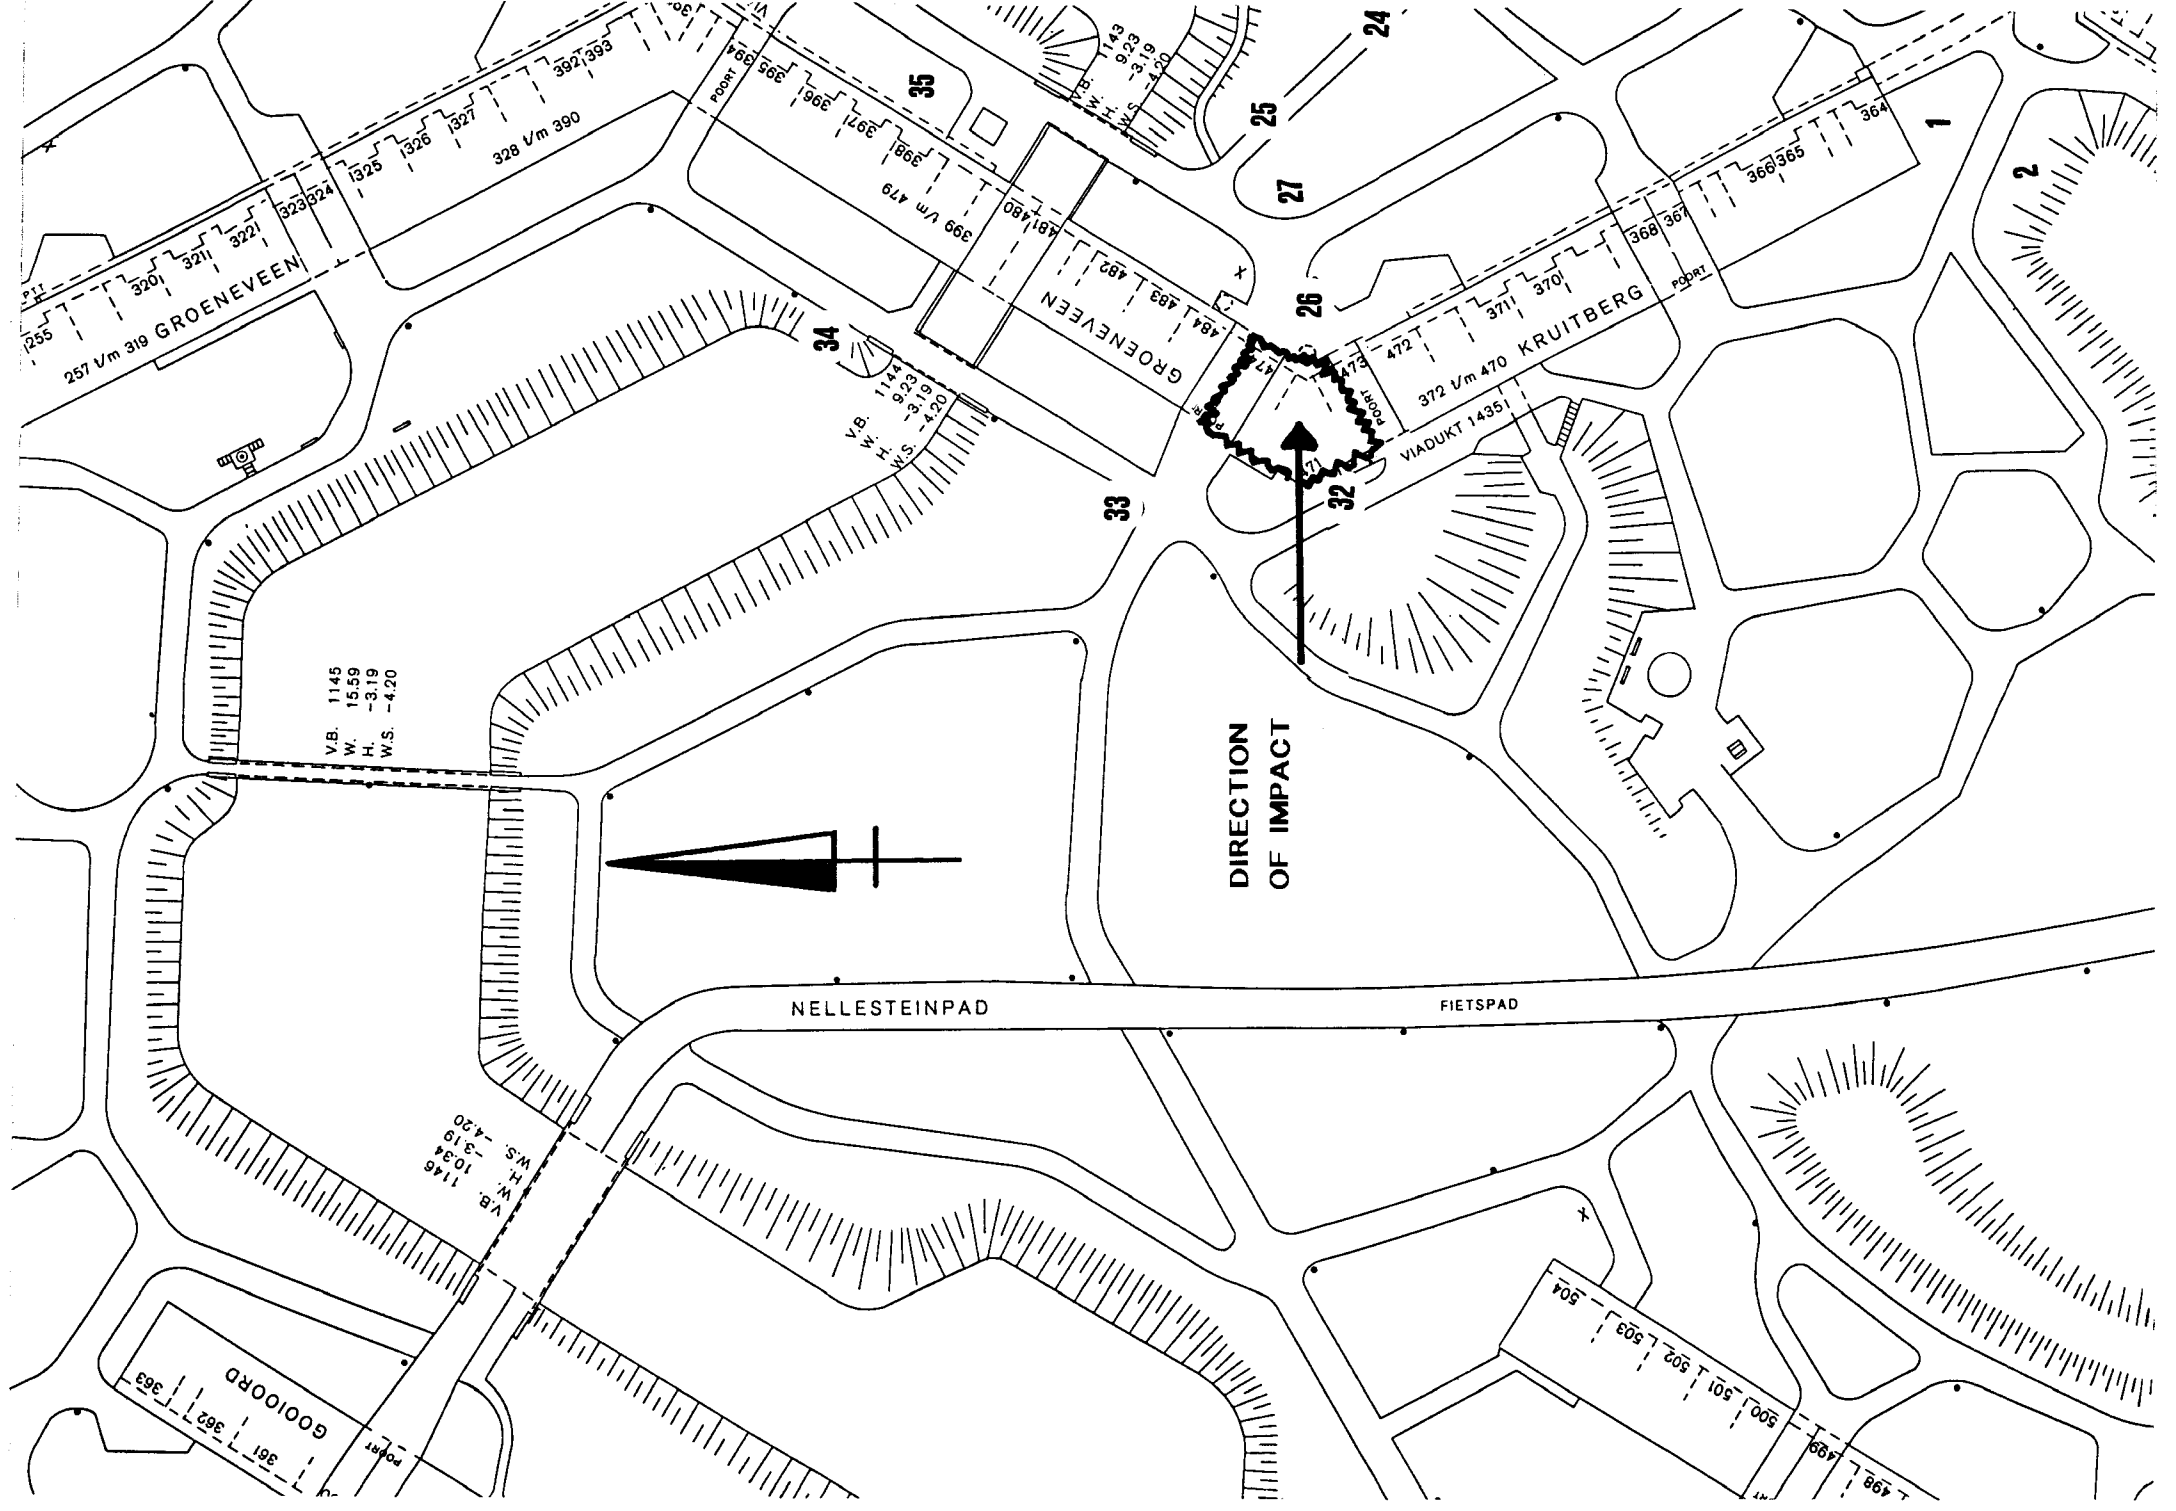
APPENDIX 2.2

DESCRIPTION OF THE MAIN IMPACT AREA

27. Parts maingear (wing and body)
Wing centersection
28. Engine cowling
29. Main gear door
30. Part rudder

31. Pylon with engine casing
32. Parts tailsection
33. Main gear door and fuselage parts
34. Parts R.H. wing
35. Parts L.H. wing, parts fin and stabilizer
