**AIRCRAFT ACCIDENT REPORT
92-11**

EL AL FLIGHT 1862

**BOEING 747-258F 4X-AXG
BIJLMERMEER, AMSTERDAM
OCTOBER 4, 1992**

FINAL RAPPORT

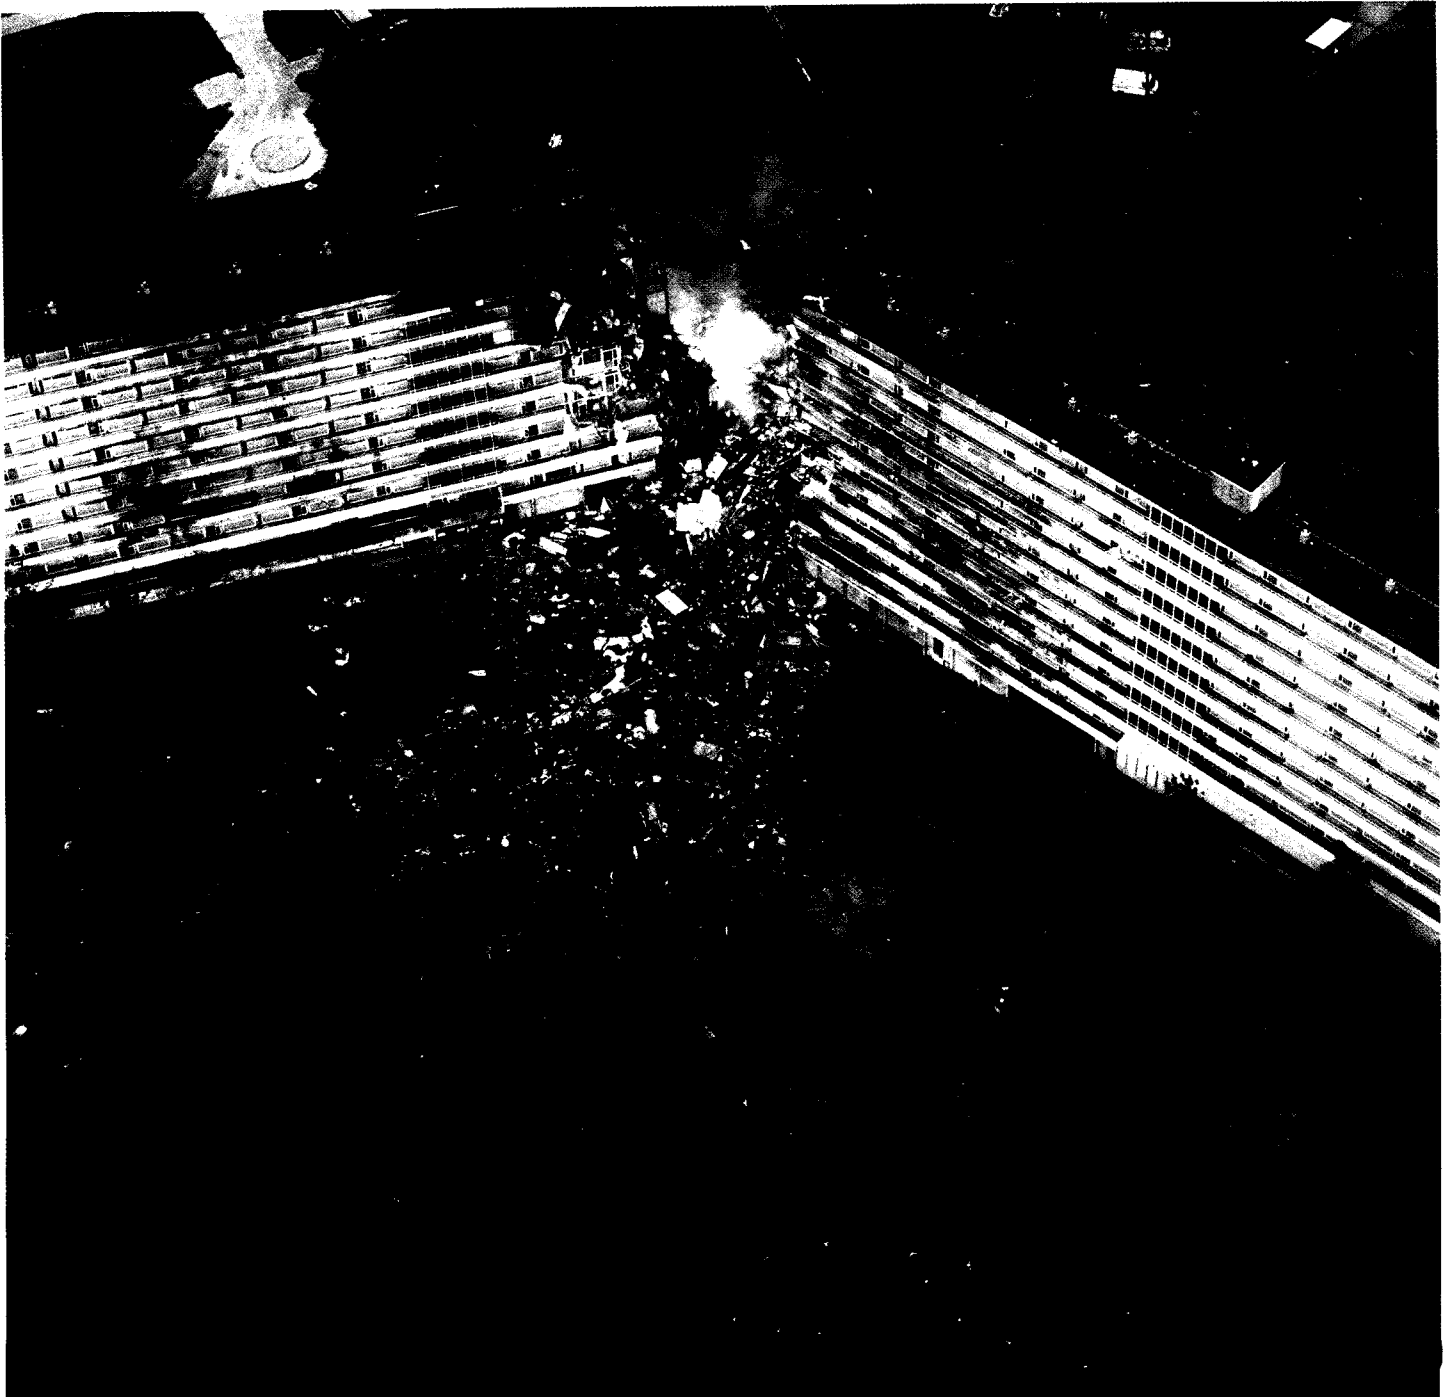
MAIN IMPACT AREA

SEEN AGAINST IMPACT DIRECTION

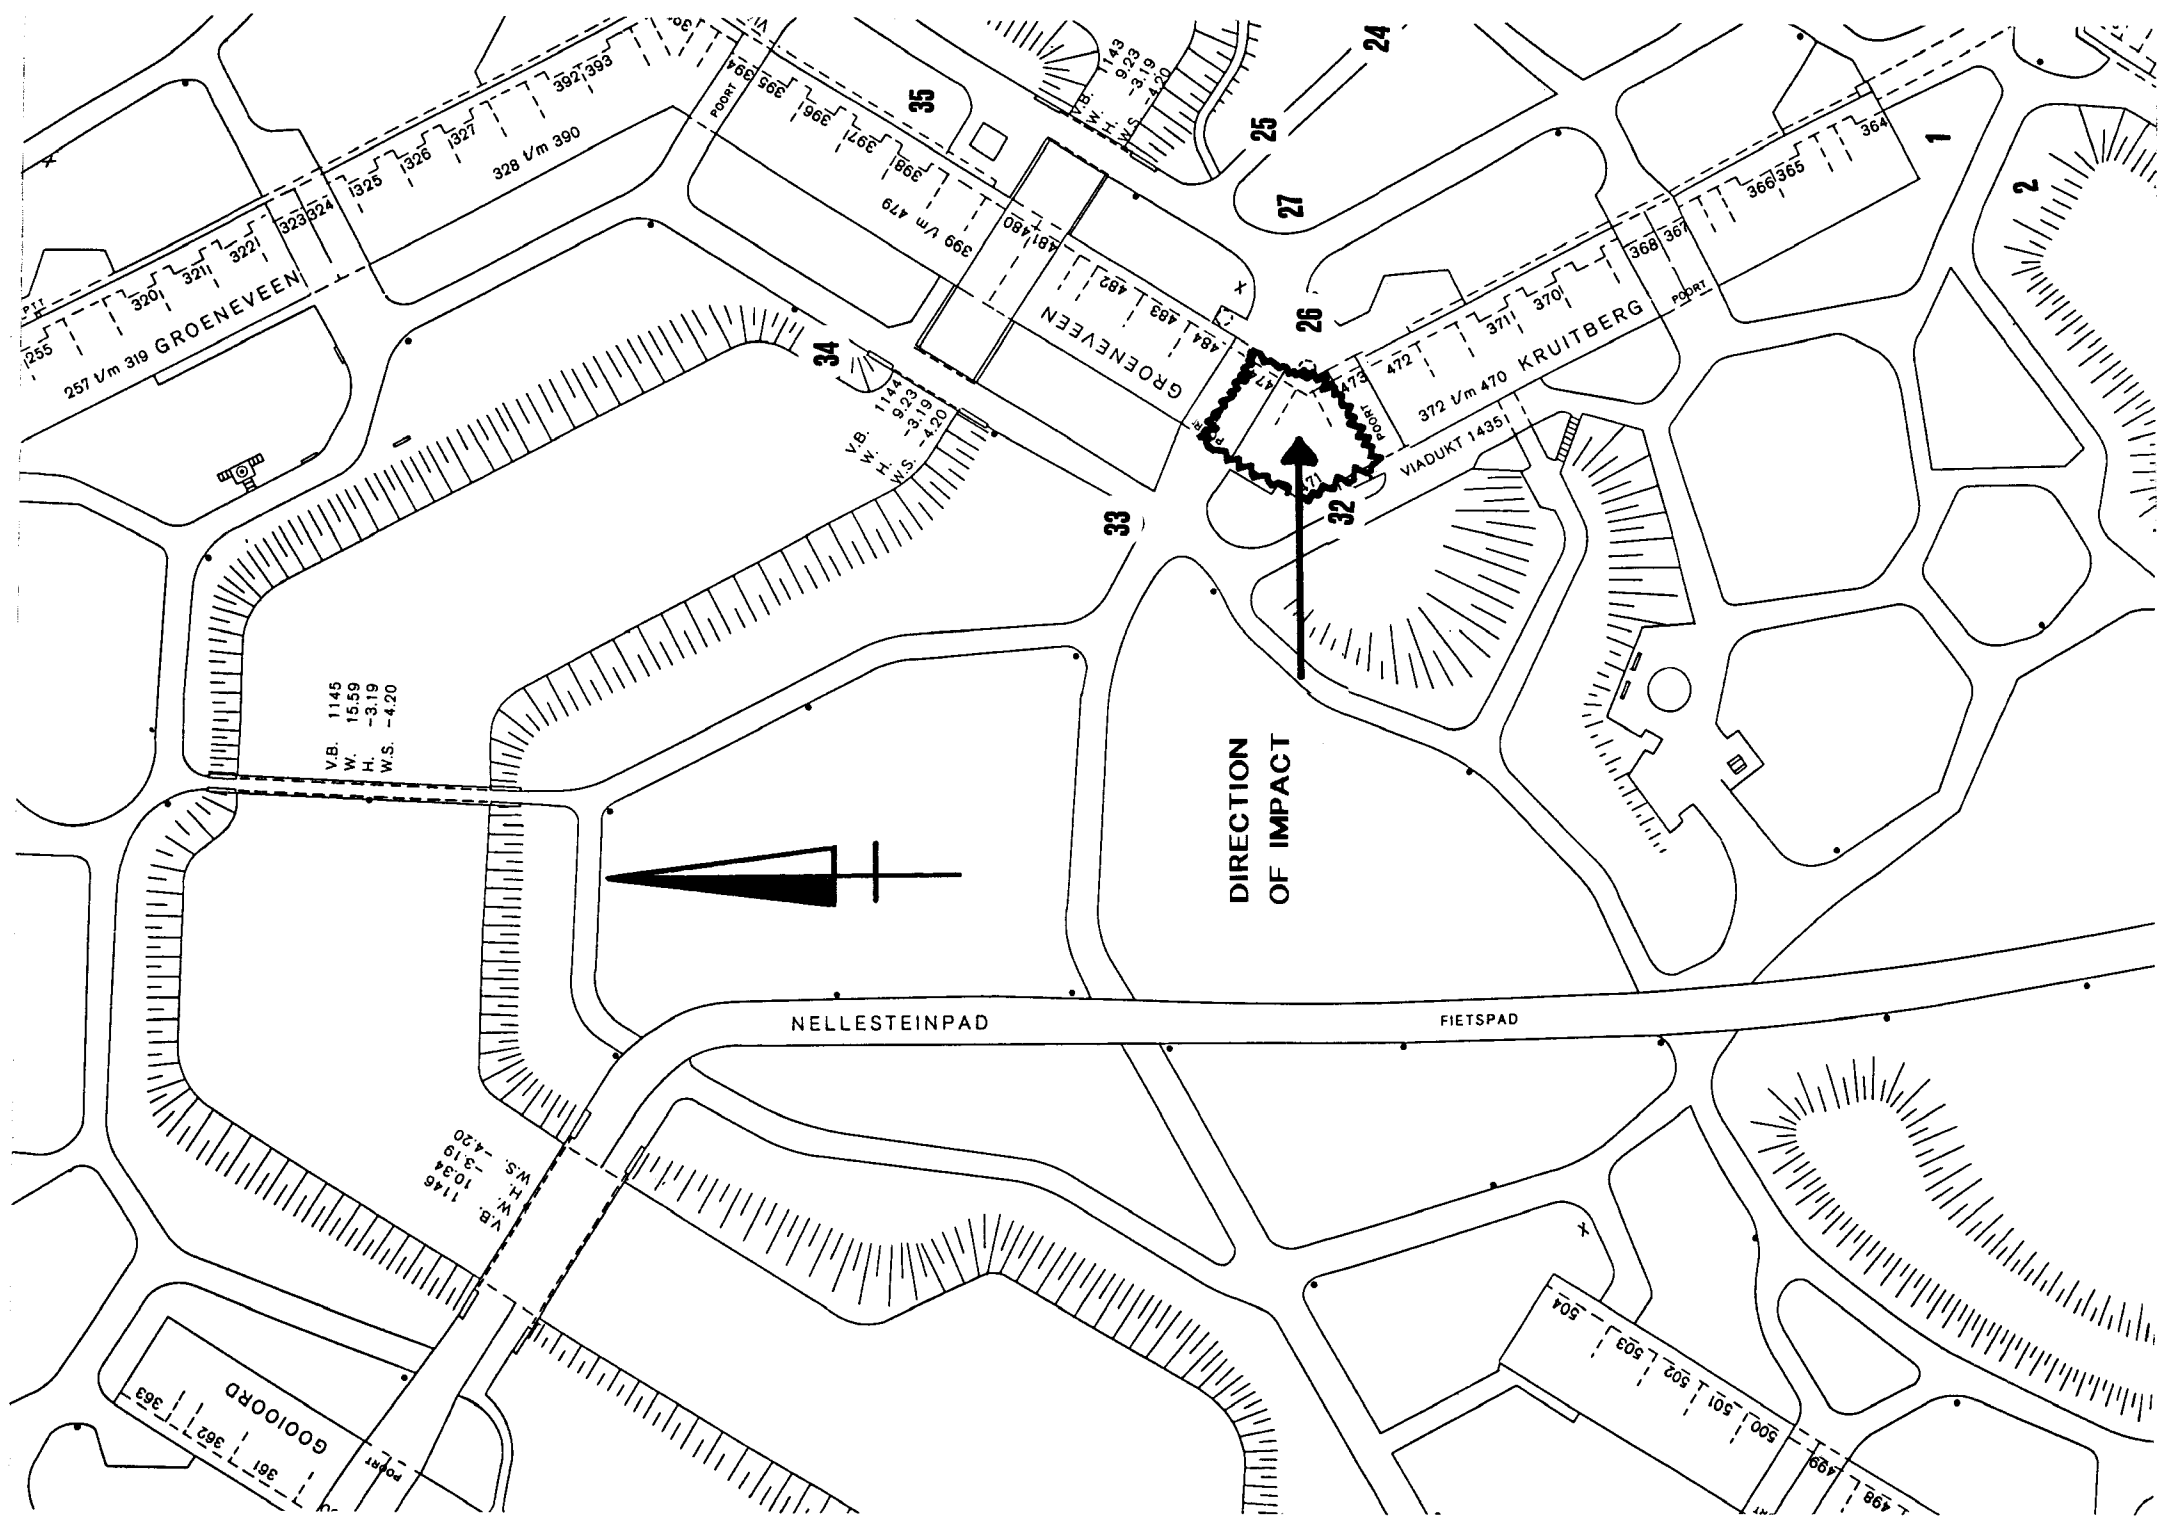
WRECKAGE DISTRIBUTION CHART

27. Parts maingear (wing and body)
Wing centersection
28. Engine cowling
29. Main gear door
30. Part rudder

- 31. Pylon with engine casing
- 32. Parts tailsection
- 33. Main gear door and fuselage parts
- 34. Parts R.H. wing
- 35. Parts L.H. wing, parts fin and stabilizer
