CRA Activities in Fukuoka FIR

IPACG FIT/35
September 2023

Outline of FANS Problem Reports

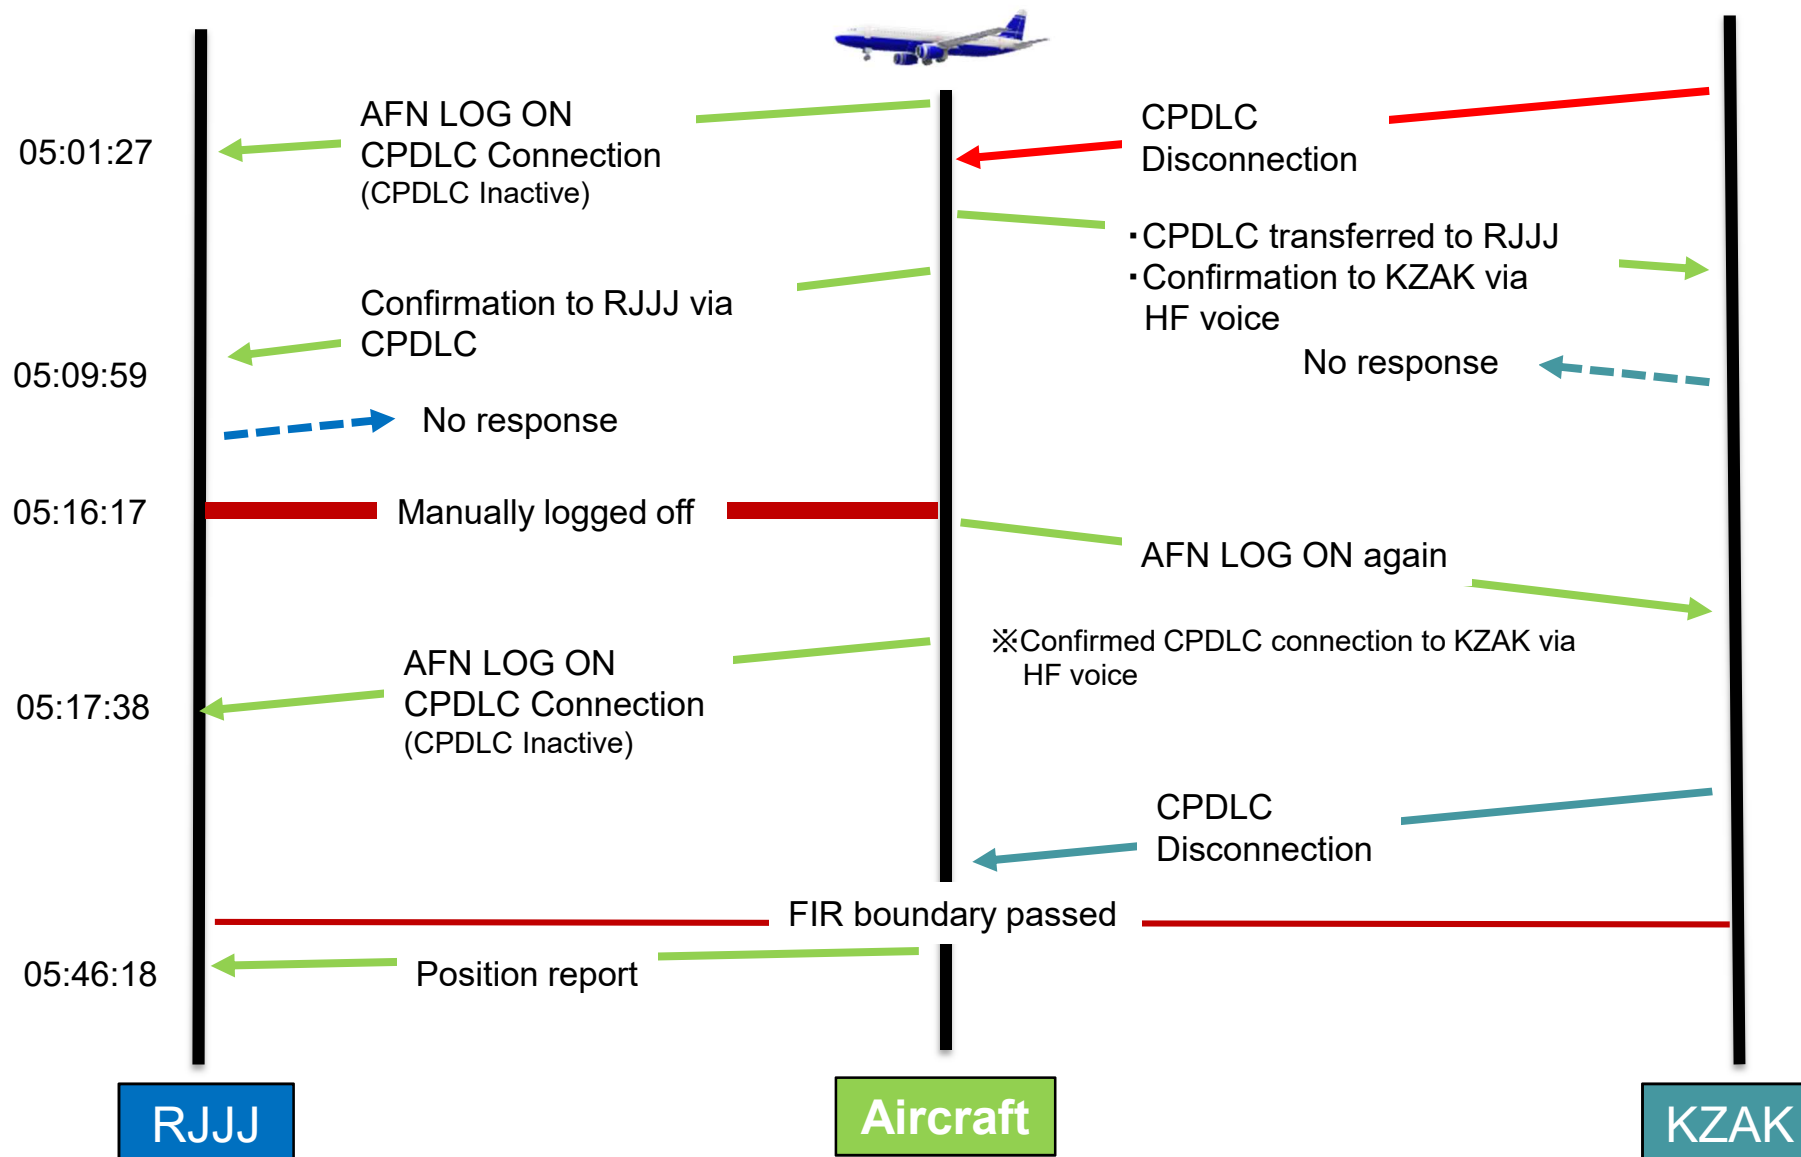
Operator communication transitions

Cause of early transfer of CPDLC authority

The cause was incorrect aircraft selection by ATCs.

: The controller intended to terminate the CPDLC connection with a different aircraft but instead the controller inadvertently terminated the CPDLC connection with this aircraft.

X : Position of transfer of CPDLC authority
4700N17000E

● : FIR boundary
4508N16321E

<Countermeasures for early transfer of CPDLC authority>

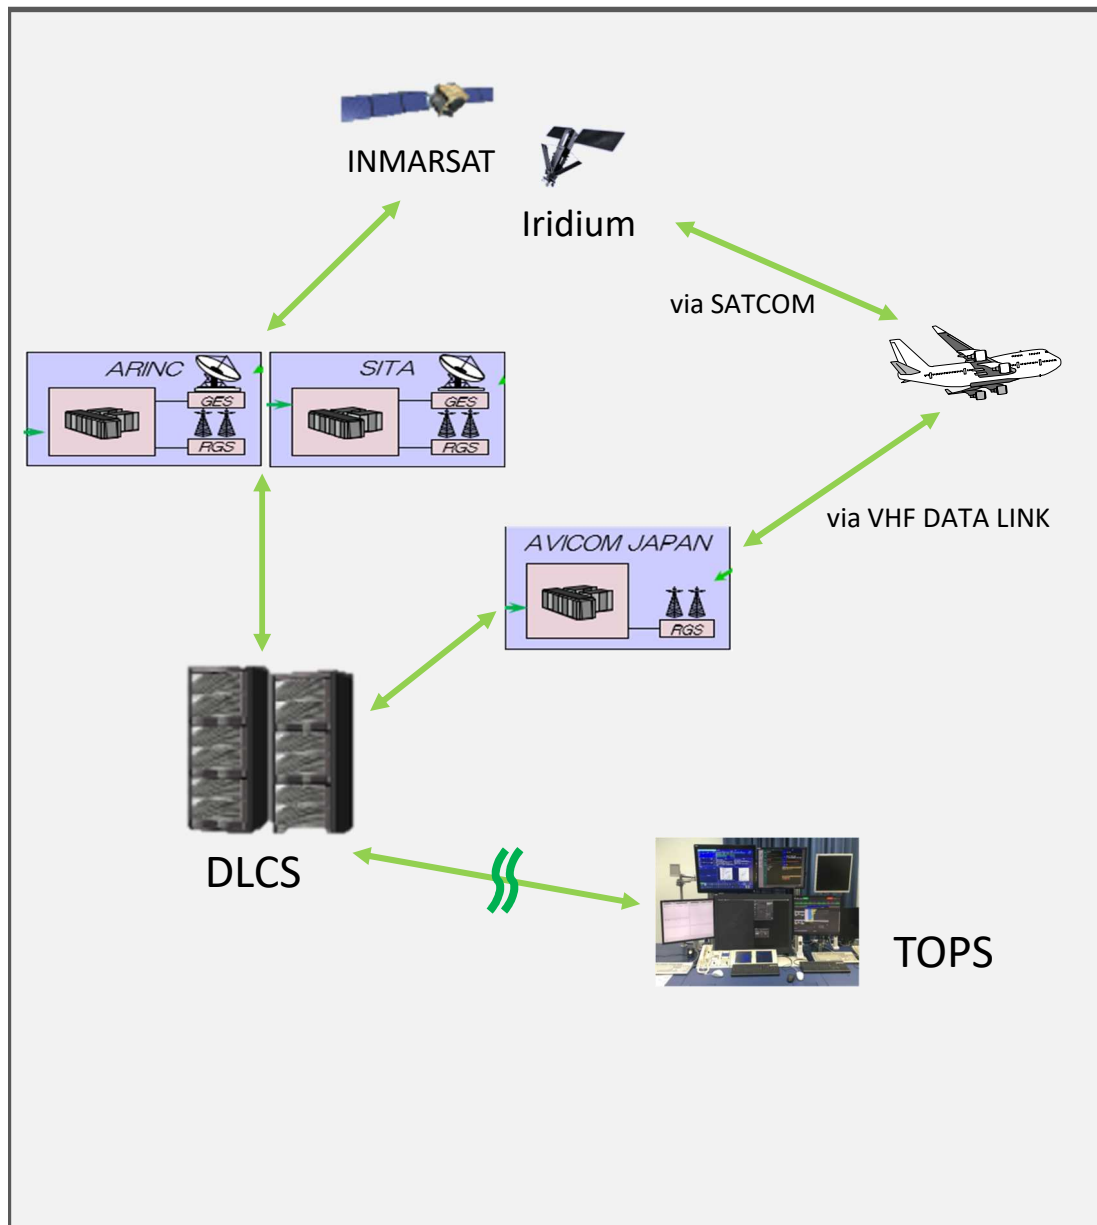
Role and Impact of DLCS

◆ Roles and Features

- Data link reception device at JCAB (Japan Civil Aviation Bureau)
- All data link information passes through
- Directly connected to provider (ARINC, SITA, and AVICOM JAPAN)

The cause of AFN LOG ON Failure

The timing of AFN logon was during DLCS failure

- DLCS failure time : 0053 ~ 0342z.
- The time the aircraft successfully logged on was also 0342z.
