Ref: 20150/4342/2005

Date: 03 September 2005

## ***AIRCRAFT ACCIDENT 01/04***

# ***FINAL REPORT ON THE ACCIDENT INVOLVING KISH AIRLINES FOKKER F27 MK.050, IRANIAN REGISTERED AS EP-LCA ON APPROACH TO SHARJAH INTERNATIONAL AIRPORT UNITED ARAB EMIRATES ON 10 FEBRUARY, 2004***

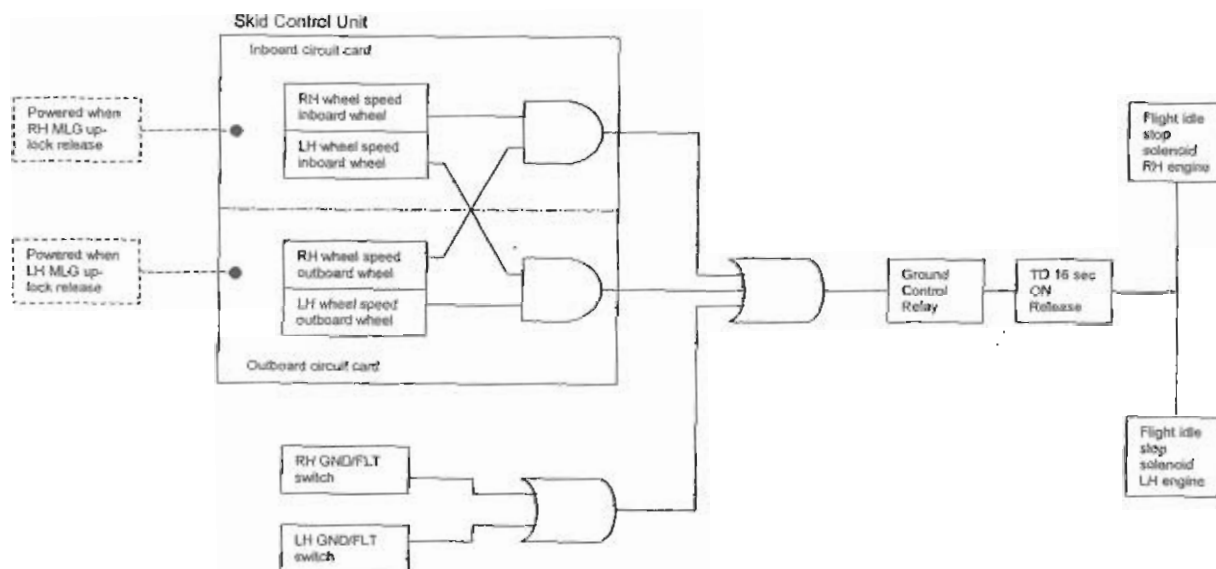
**ILLUSTRATION 5**

- 1.16.5.3 Undesired System Behaviour. The Skid Control Unit contains two channels which are electrically powered separately. The inboard card is powered when the RH MLG comes out of the up lock position and the outboard card when the LH MLG comes out of the up lock position.

Subsequent to loss of braking reports it also appeared that EMI on the wheel speed wiring or on the Skid Control Unit test switch wiring could cause wheel speed signals as well. Subsequently Fokker Services issued SBF50-32-035 which improves the Skid Control Unit grounding and thus the EMI susceptibility. Furthermore, activating the anti skid test button in the cockpit, recommended by the Aircraft Operating Manual to check the anti-skid system in flight after a lightning strike with landing gear down, would also cause temporary activation of the >20MPH wheel speed discretes. To rectify all known abnormalities, ABSC issued SB 6004125-32-01 (includes ABSC SB Fo50-32-04 modification) which was covered by Fokker Services SBF50-32-038 (which asks also for accomplishment of SBF50-32-035).

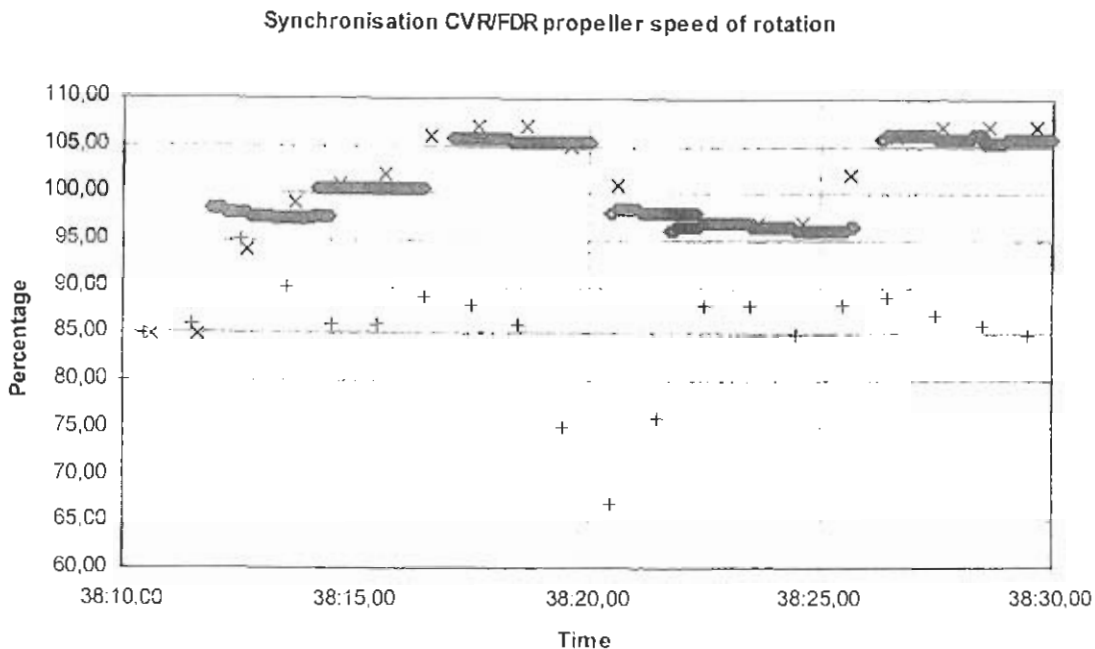
**Figure 12:** CVR/FDR synchronization of the propeller speed of rotation

From audio recording alone, it is not possible to differentiate between the left and right propellers. This can be achieved by comparison with the information coming from FDR data. Such comparisons allowed us to determine that only the sounds from the right propeller are visualized by the spectrum analyser in figure 12. This is consistent with a noisy engine in over-speed.

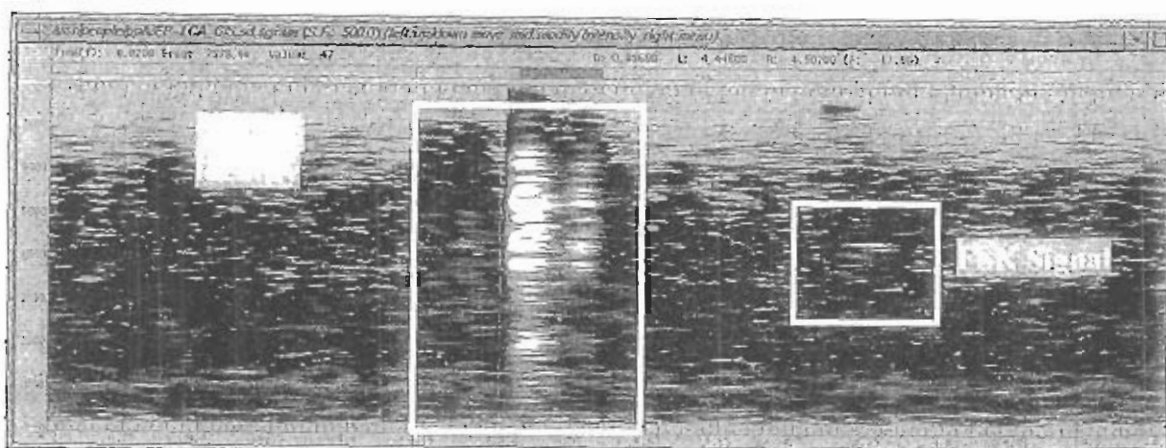
**Figure 13(a):** Time-Frequency representation of the target noise recorded at 07 h 38 min 01 s

As is seen in this figure, the noise to be identified is made up of 4 separate sounds. The last sound on the right of the figure is actually an FSK signal used to code UTC time recorded by diaphonic.

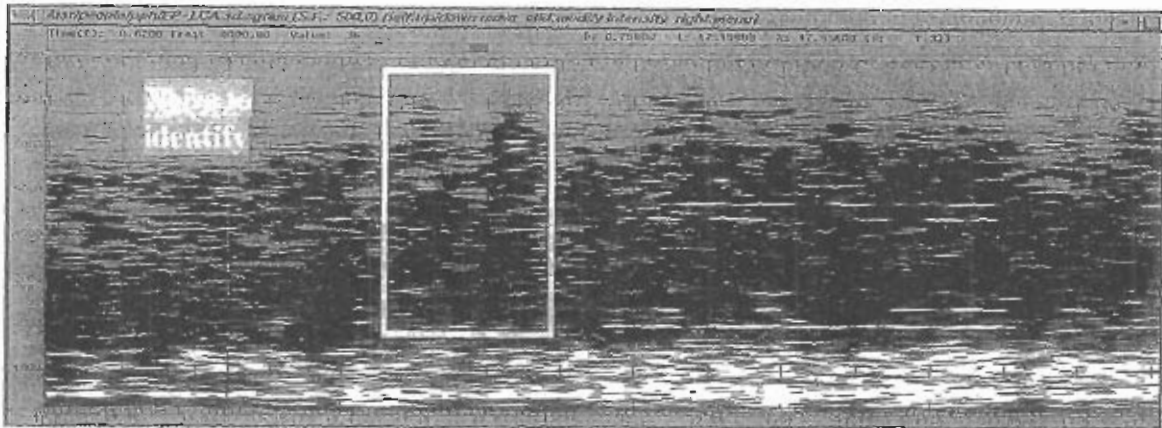
**Figure 15:** Time-Frequency representation of the target noise to be identified on EP-LCA aircraft

The analysis revealed a noise recorded at 07 h 38 min 11.3 s. This noise is very faint on the CVR recording and is barely visible on a spectral analysis that had to be manually programmed and computed with separate software in order to reveal it. Due to this very low acoustic signature, no detailed spectral analysis could be computed and compared with our database of previously analysed noises.

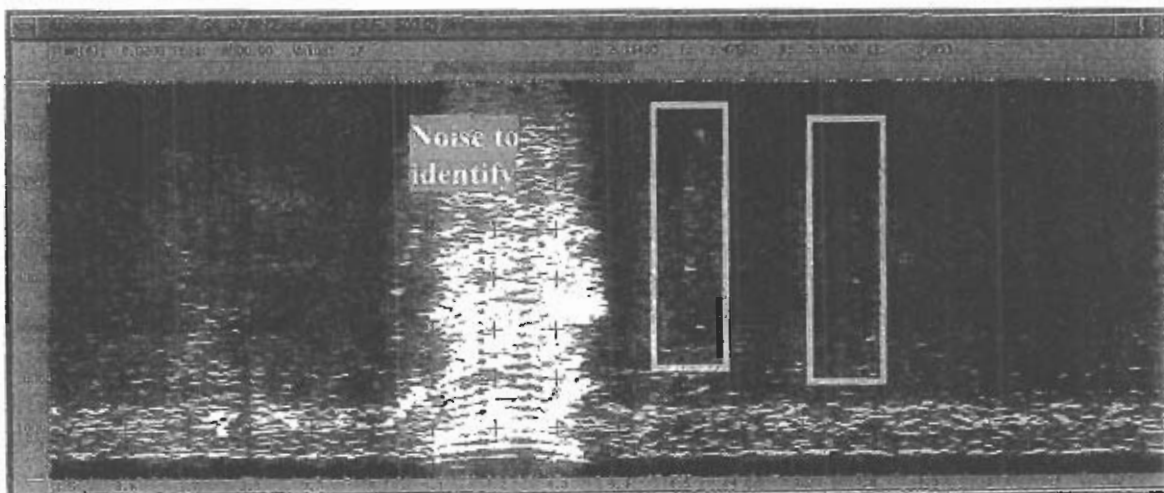
The analysis revealed a noise recorded at 07 h 38 min 12.6 s. This noise, made of two separate sounds, is very faint on the CVR recording and is barely visible on a spectral analysis that had to be manually programmed and computed with separate software in order to reveal it. Due to this very low acoustic signature, no detailed spectral analysis could be computed and compared with our database of previously analysed noises.

From the same test performed in October 2004 on a similar Fokker 50 with a hand microphone recording, the faint noise at 07 h 38 min 12.6 s also appears to be a movement of the ground range selectors, which are perhaps being released.

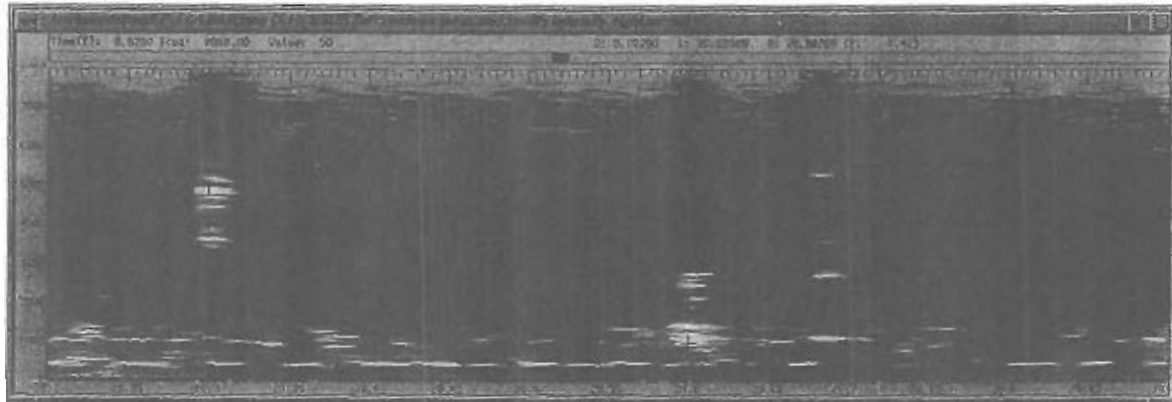
**Figure 16(a):** Time-Frequency representation of the target noise to be identified on EP-LCA aircraft

The noise recorded at 07 h 38 min 14.1 s is similar to a throttle lever movement to the stop. It was not possible to determine the final position of the throttle from spectral analysis alone. The "take-off", "flight idle" and "ground idle" positions are three possibilities. Synchronization with the evolution of the high pressure turbine parameters from the FDR seems to indicate that only the "take off" position being reached by the throttles.

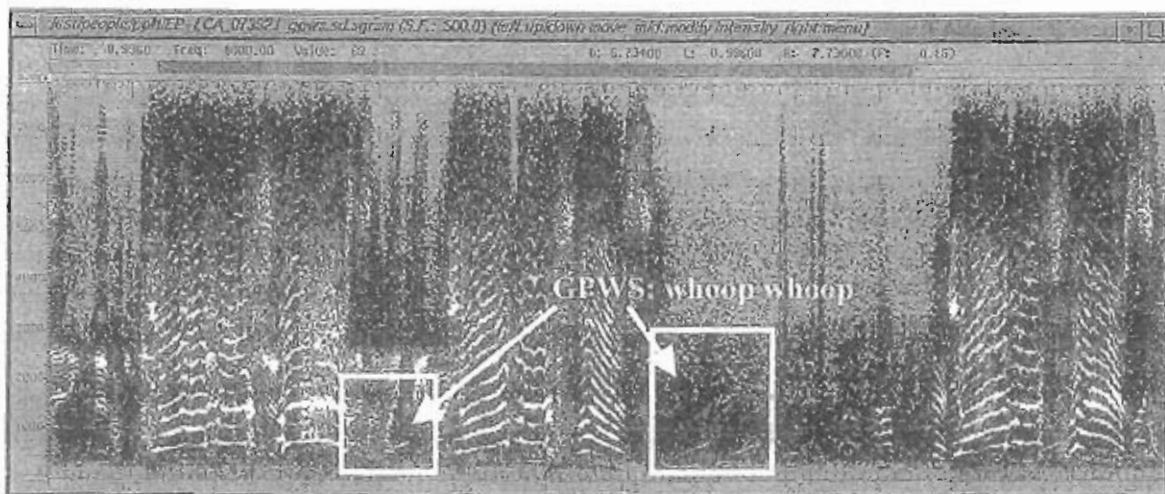
**Figure 21:** Time-Frequency analysis of the GPWS warning

It was possible to hear, when the pilots were not talking, a GPWS warning "whoop whoop pull up" from 07 h 38 min 21 s until the end of the recording. This message was played back by the synthetic voice of the aircraft. The issue was to determine when the GPWS warning started. The spectral analysis of this signal is typical and it was decided to check if it was possible to see the acoustic signature before listening.

The representation below shows the acoustic signature where the first signal seems to appear at the same time as the listening. Due to the automatic control of gain the synthetic voice may appear before but could be hidden by the pilot's voice.

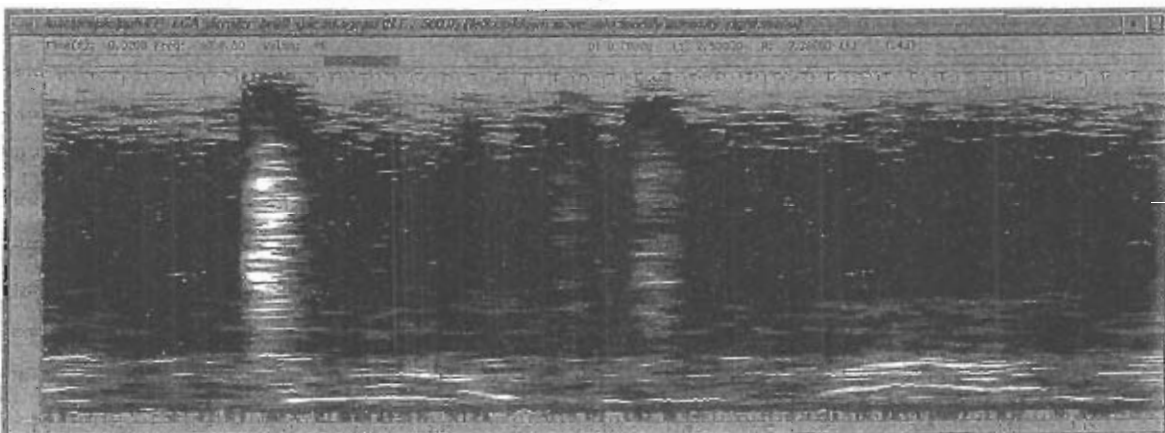
**Figure 22(a):** Time-Frequency analysis of the noise recorded at 07 h 38 min 23 s

The figure 22(a) represents a spectrum analysis of this noise.

As seen in the above two pictures, both noises at 07 h 38 min 23 s and 07 h 38 min 14 s present the same shape: they are made up of three separate sounds. In both cases, the first sound has more energy than the next two ones. Similarly to the noise recorded at 07 h 38 min 14 s, this noise is similar to the throttle levers movement.

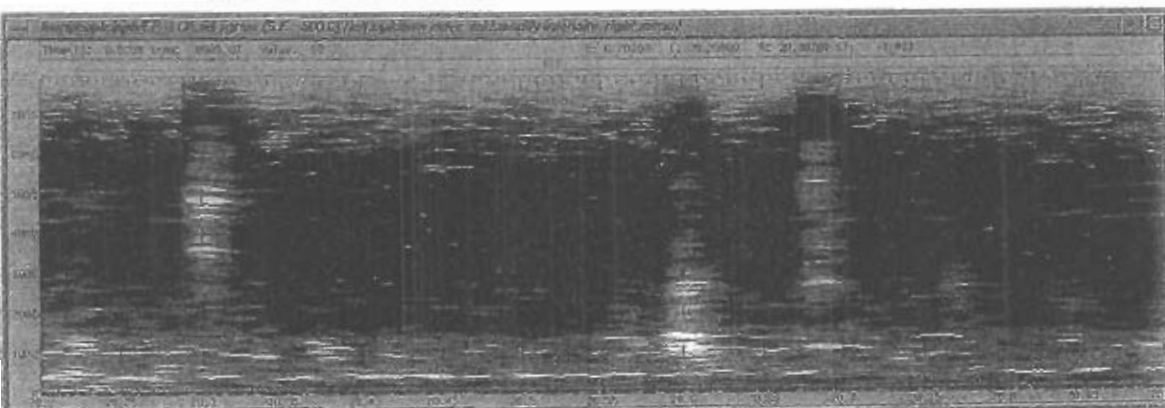
**Figure 22(b):** Time-Frequency analysis of the noise recorded at 07 h 38 min 14 s

As a comparison, the next figure represents a previous noise analysed at 07 h 38 min 14 s.

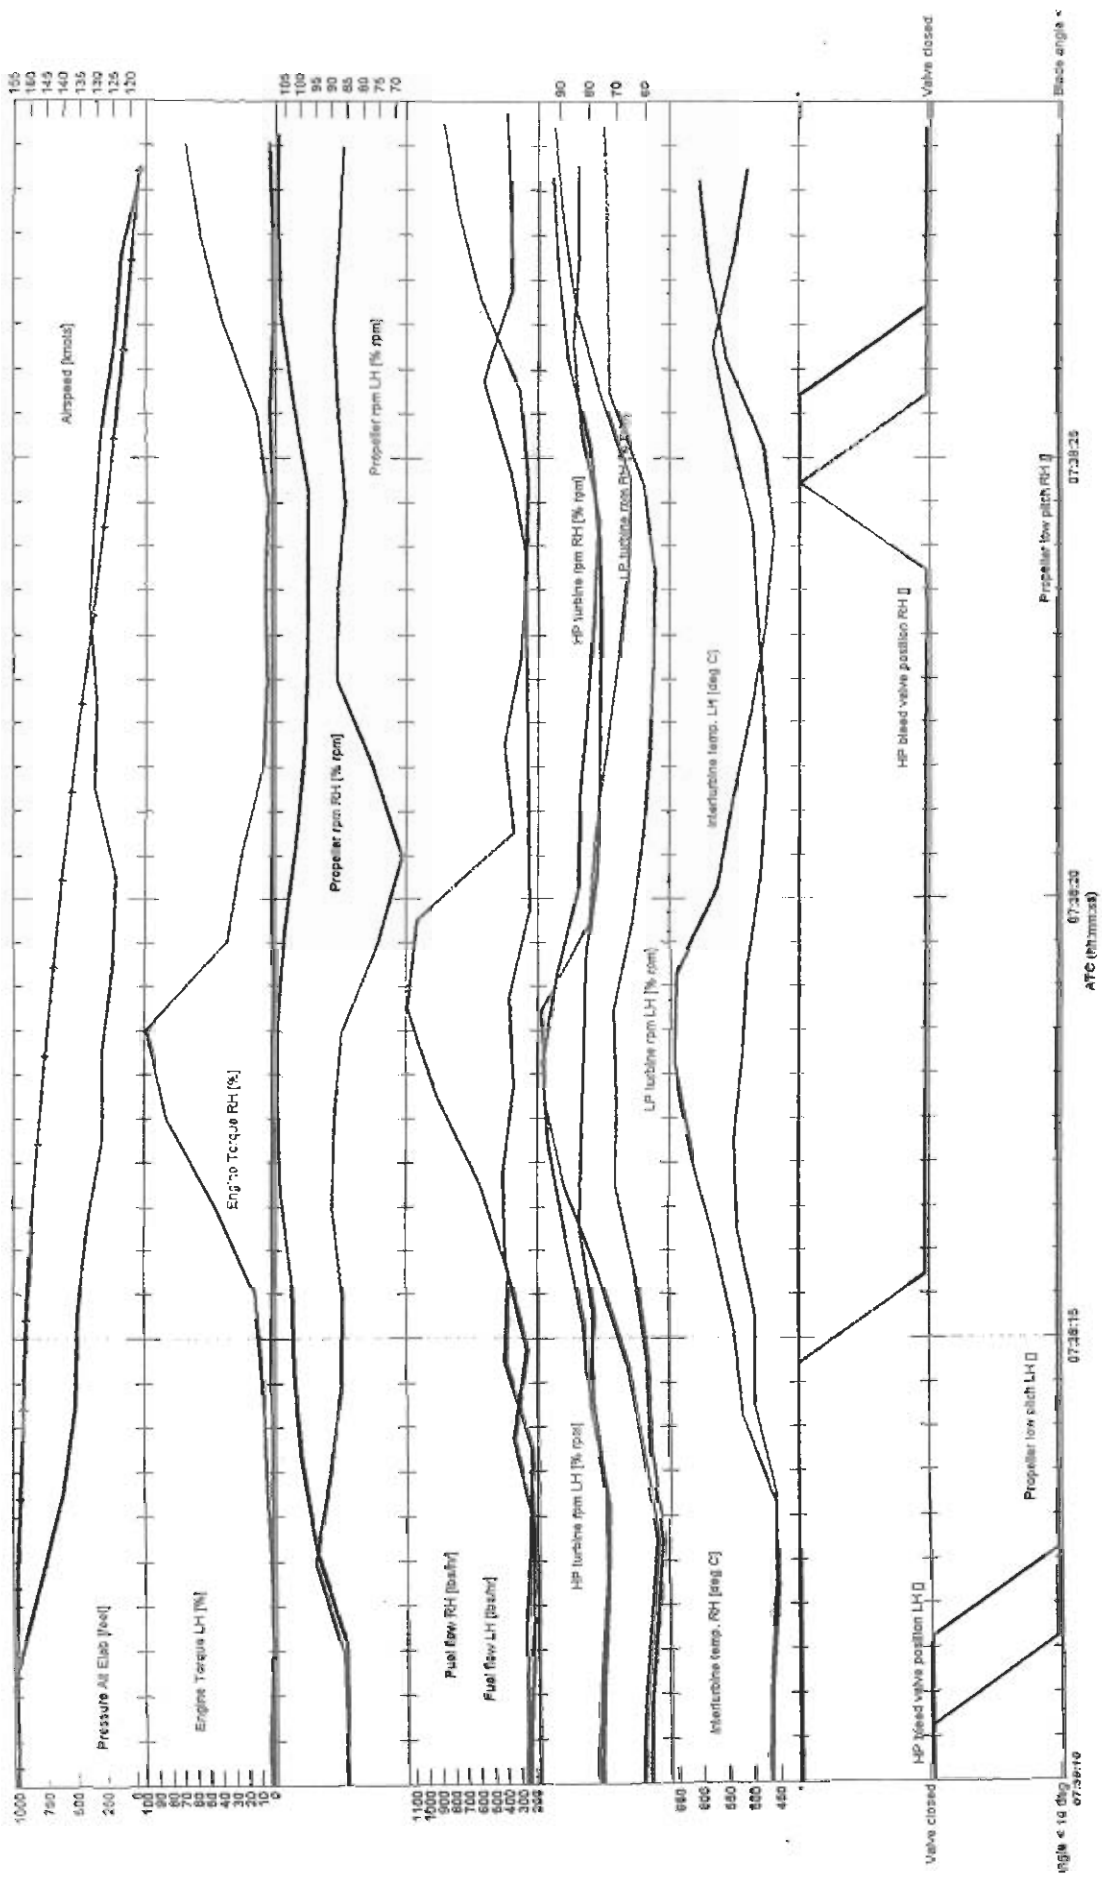
Plot 0 : Engines 20 seconds

- [4] The variations in high pressure rotor speed (Nh) on both engines show that the crew continued to operate both power levers synchronously after beta entry (see figure 1). The excursions on the right hand engine are however much smaller due to interference from the propeller overspeed governor. The power increase on the left hand engine between 7:38:13 and 7:38:18 indicates that the power levers were placed in the take-off position.

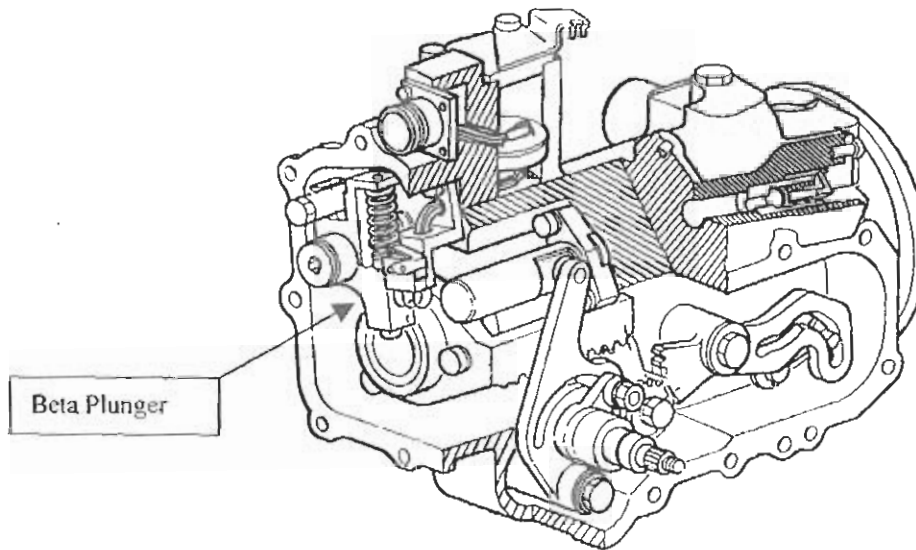
Rear View Illustration

The following figure depicts the configuration around the rear of the PCU where the beta plunger that activates the ground beta light locates on the beta tube.

It was not possible to install a dummy beta tube on the rig to check the operation of the beta light switch due to distortion of the main body resulting from the fire. The rear cover had burnt through during fire, see figure below. It was noted that the spring used to hold the beta cam had moved from its seat although it is considered that this most likely occurred during the cleaning process prior to handling at DPRO-G, see figure below.

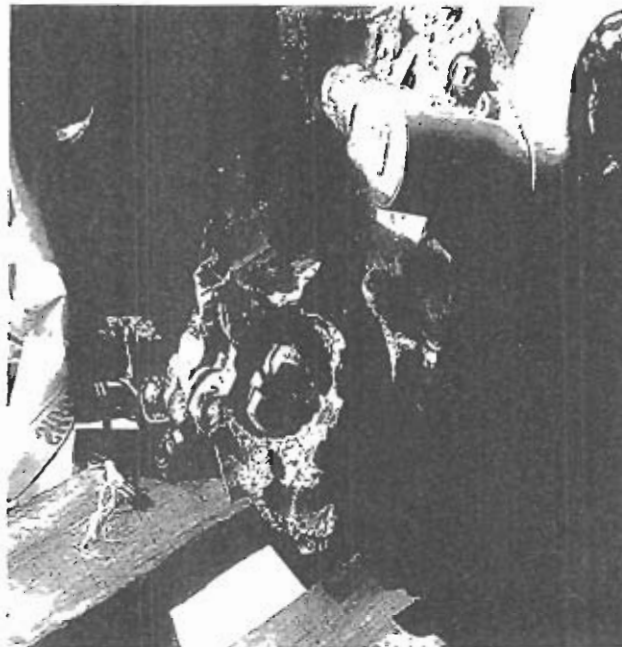
Remains of LH OSG on gearbox

The OSG had melted in the fire with the counterweights visible in the remainder of the unit. It was not possible to positively identify the unit but the remains were still attached to the reported LH powerplant.

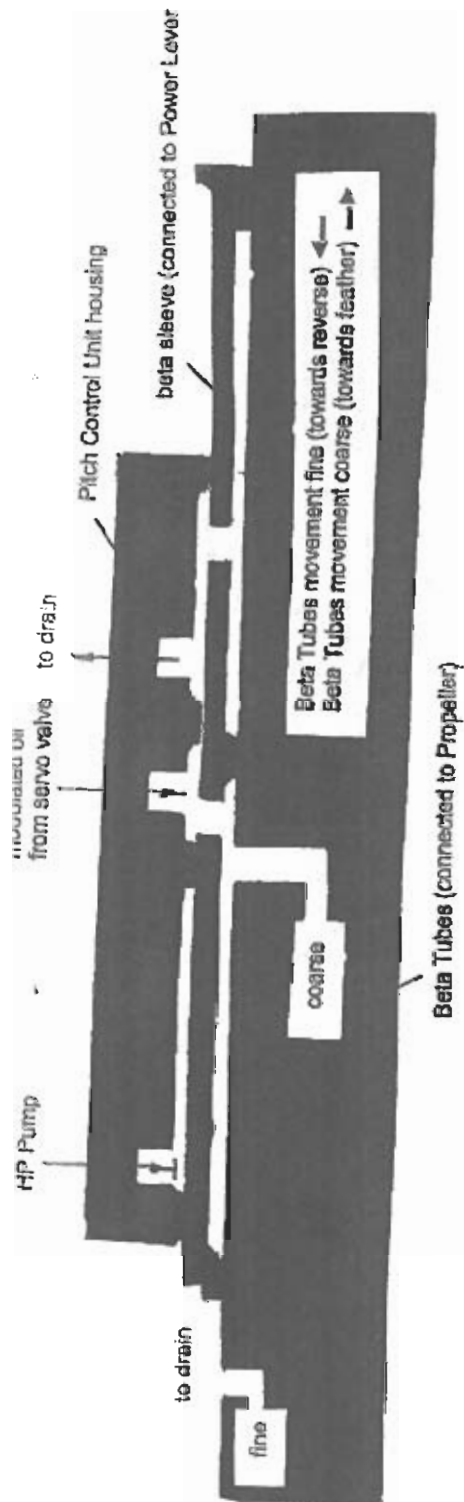
## 5.5 Ground beta transition or ground beta control with Power Lever suddenly moved above Flight Idle See Fig.6.

The beta sleeve was restored to the flight position at 07:38:13, as indicated by a sudden increase in fuel flow, presumed brought about by forward movement of the Power Lever. Modulated oil now had access to coarse pitch (explained in Fig.6), but modulated oil was only at high pressure and able to drive the propeller coarse back to the flight range while the propeller was underspeeding (below 85%). Underspeeding occurred for only four seconds from 07:38:18 to 07:38:22, since windmilling forces were generally keeping propeller speed high. Propeller pitch was dictated by the counterweight effort. It is believed that the LH propeller went sufficiently fine that it came under the influence of fine-seeking counterweight forces that took it eventually to maximum reverse pitch.

Fig.6 Power Lever has been moved suddenly above Flight Idle, high power, beta sleeve in flight position isolating hp oil, but propeller is still in ground range, pitch about 5 deg. Counterweight effort may be insignificant or even fine-seeking. Modulated oil able to enter coarse pitch, but pressure will decay if propeller speed exceeds selected value (85%). Coarse-seeking forces may be insufficient to bring propeller into flight pitch range.

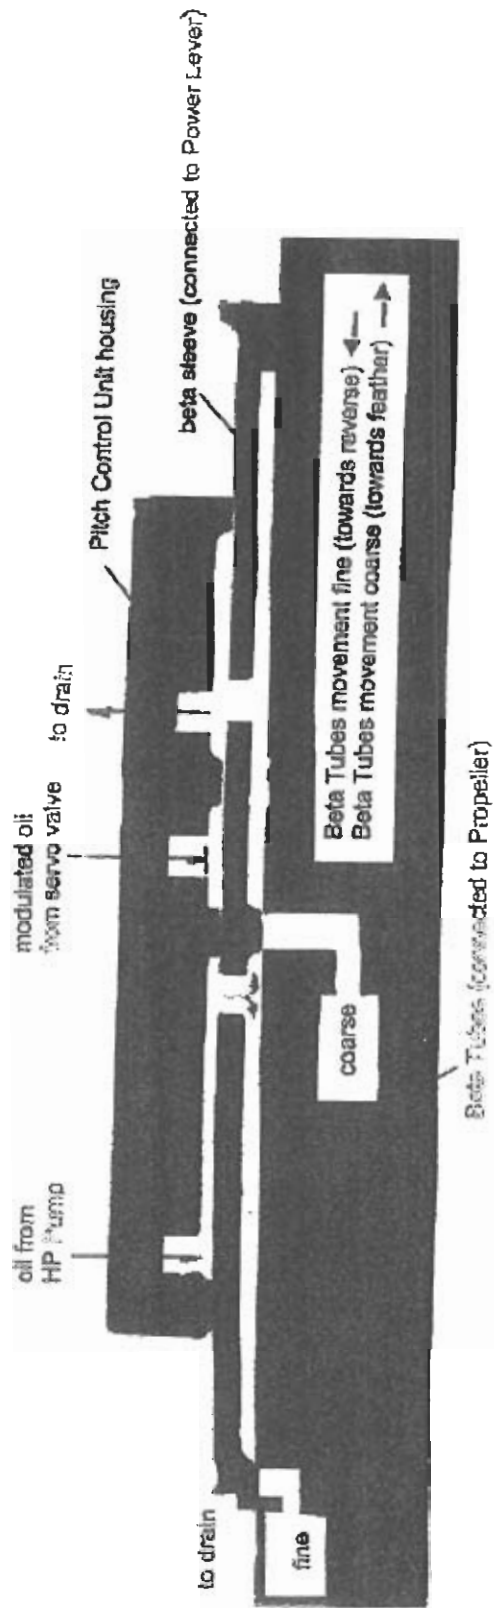
## 5.4 Ground beta control See Fig.5.

Fig.5 Power Lever below Flight Idle, low power, beta sleeve in ground position Isolating modulated oil, propeller beta controlling, pitch about 5 deg. Counterweight effort may be insignificant or even fine-setting.

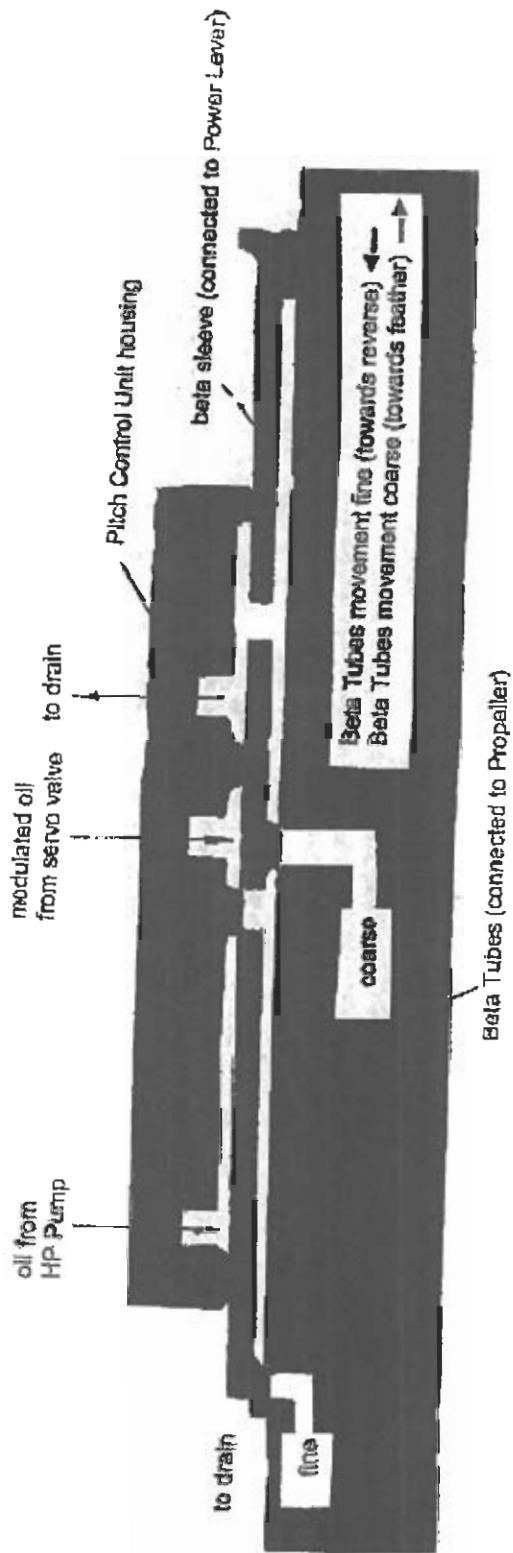
## 5.3 Ground beta transition See Fig.4.

Fig.4 Power Lever just below Flight Idle, beta sleeve between ground and flight positions (ground beta transition), pitch about 11 deg

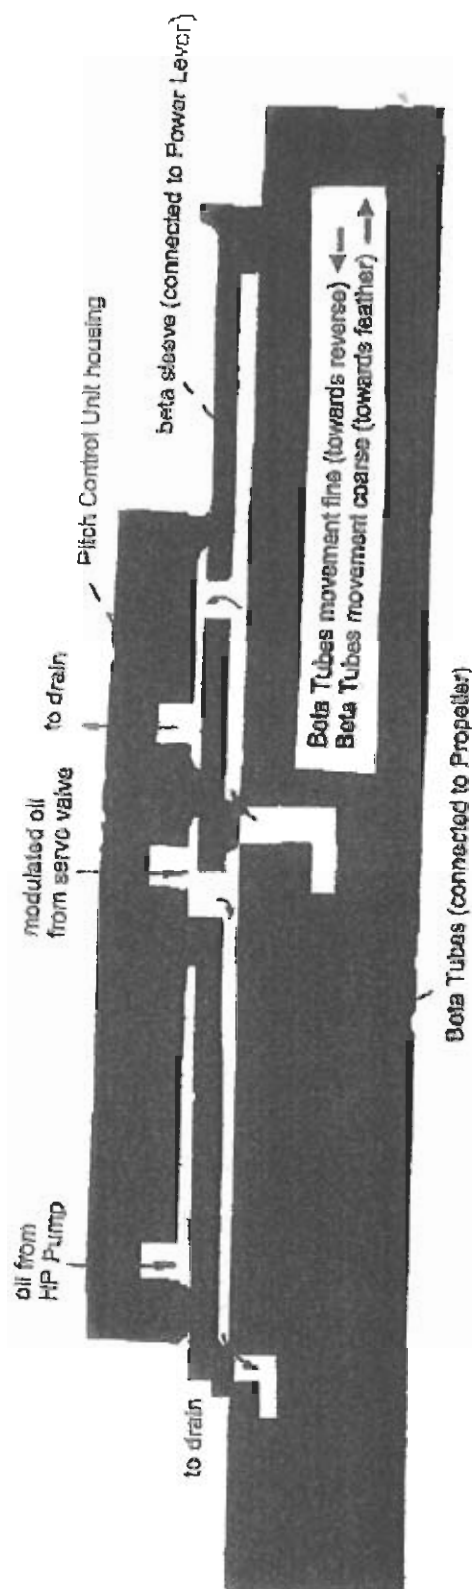
### 5.2 In-flight beta mode (NB, not ground beta) See Fig.3.

Fig.3 Power Lever at Flight idle, low power, beta sleeve in flight position isolating hp oil, propeller constant speeding with modulated oil pressure in fine pitch balancing coarse seeking counterweight effort, pitch at 15 deg

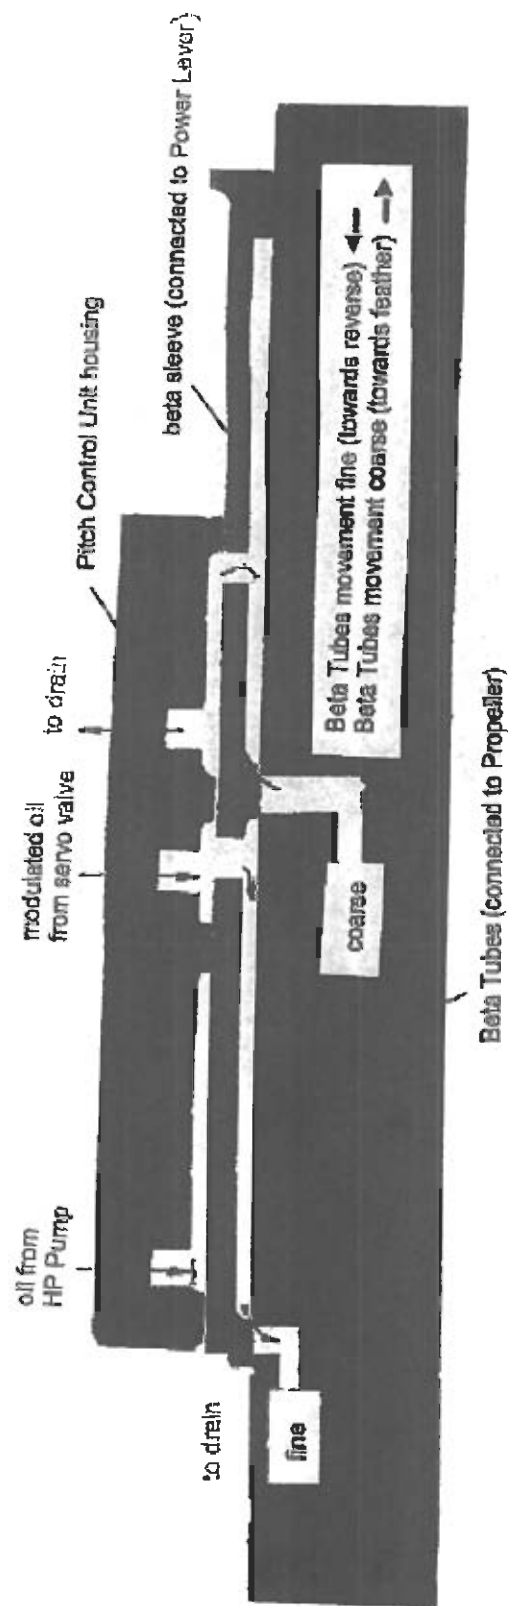
Fig-2 (failure case) Power Lever significantly above Flight Idle, high power, beta sleeve in flight position, but multiple failures in normal speed governor and Overspeed Governor have driven pitch down to beta schedule, pitch about 18 deg

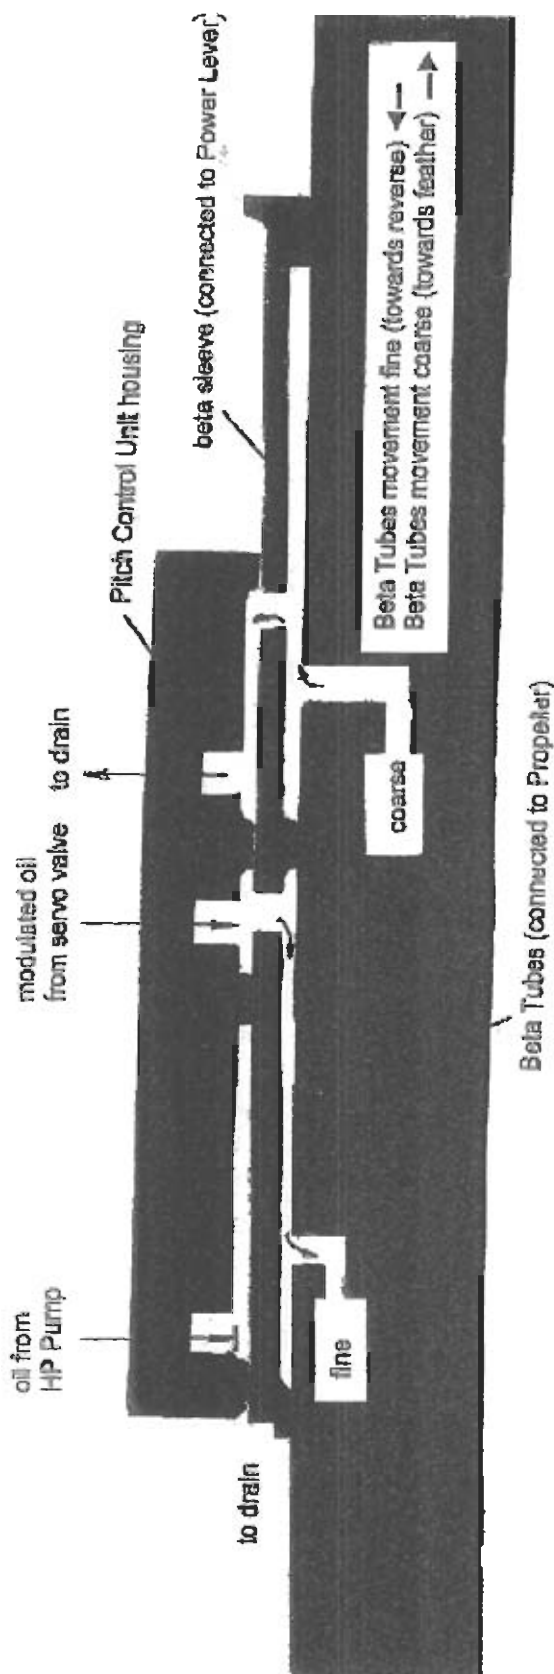
### 5.1 Constant speeding mode See Fig.1.

During cruise, 85% propeller speed is selected on the Engine Rating Panel and the Power Lever is between Flight Idle and Normal Take-off, giving a minimum pitch on the beta schedule of 17 deg. The beta sleeve is in the flight position. Actual pitch is much higher than 17 deg, since the propeller is constant speeding during flight when significant power is demanded from the engine. Fig.1 shows the propeller at 30 deg.

Fig. 1 Power Lever significantly above Flight Idle, high power, beta sleeve in flight position isolating hp oil, propeller constant speeding with modulated oil pressure in fine pitch balancing coarse-seeking counterweight effort, pitch about 30 deg
