Civilian Spatial Disorientation Mishap Experience

Stephen J.H. Véronneau, MD

Team Coordinator, Aircraft Accident Research

FAA Civil Aeromedical Institute

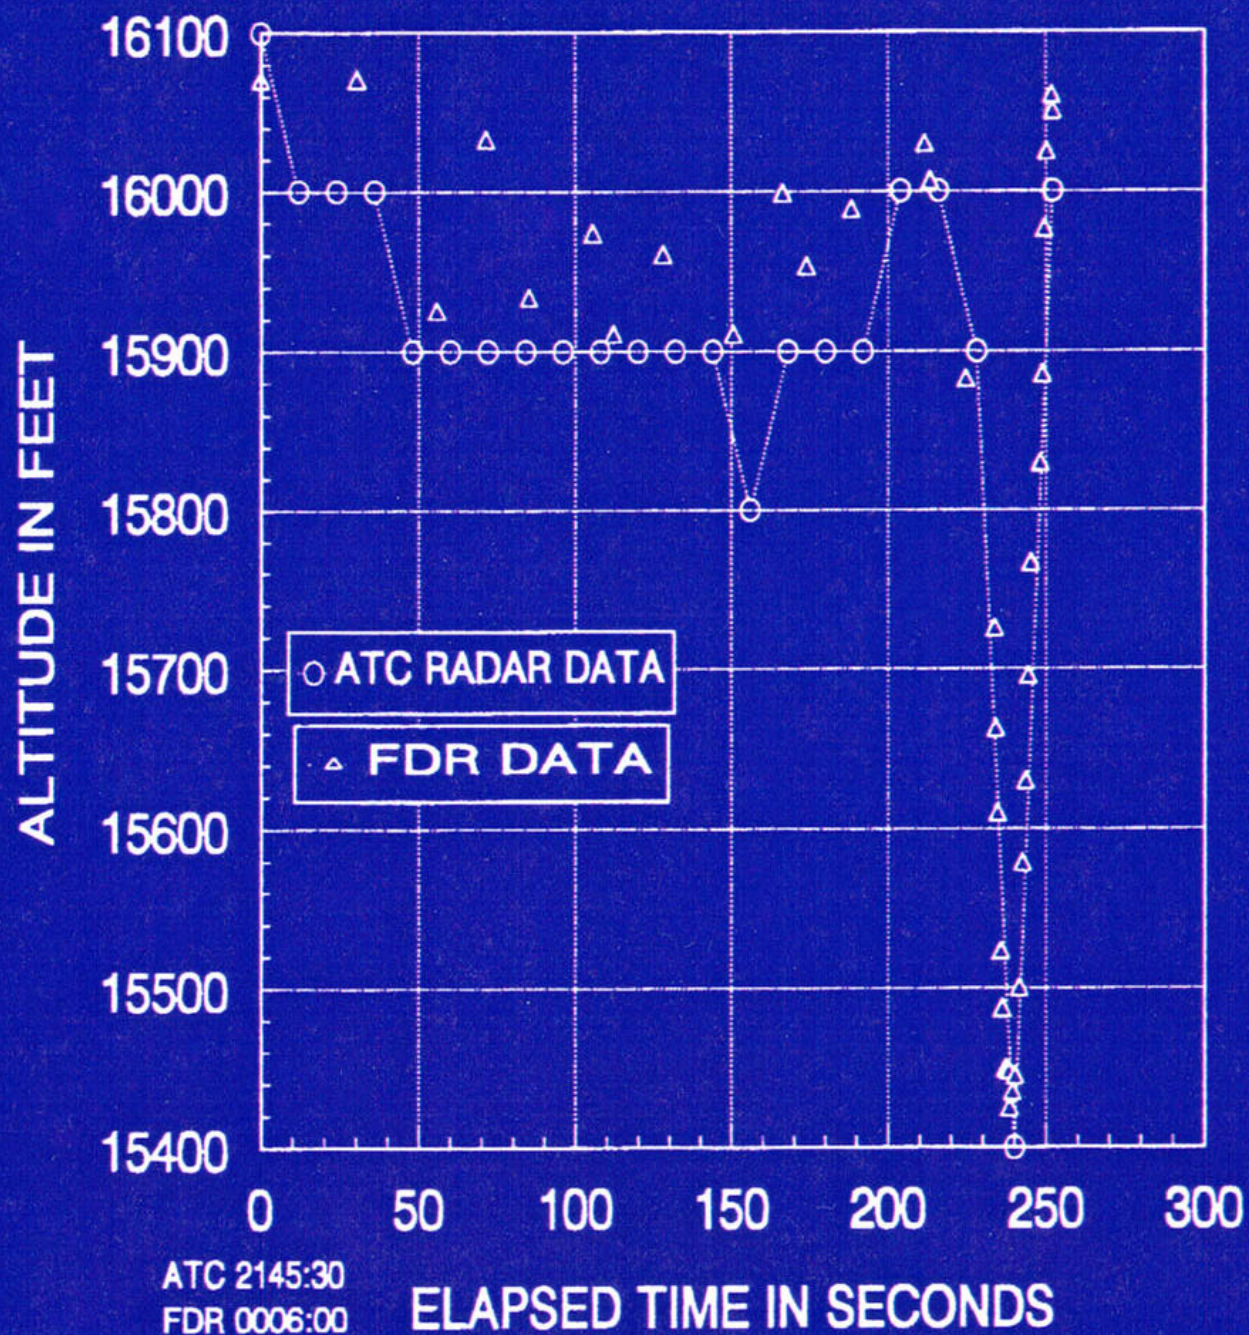
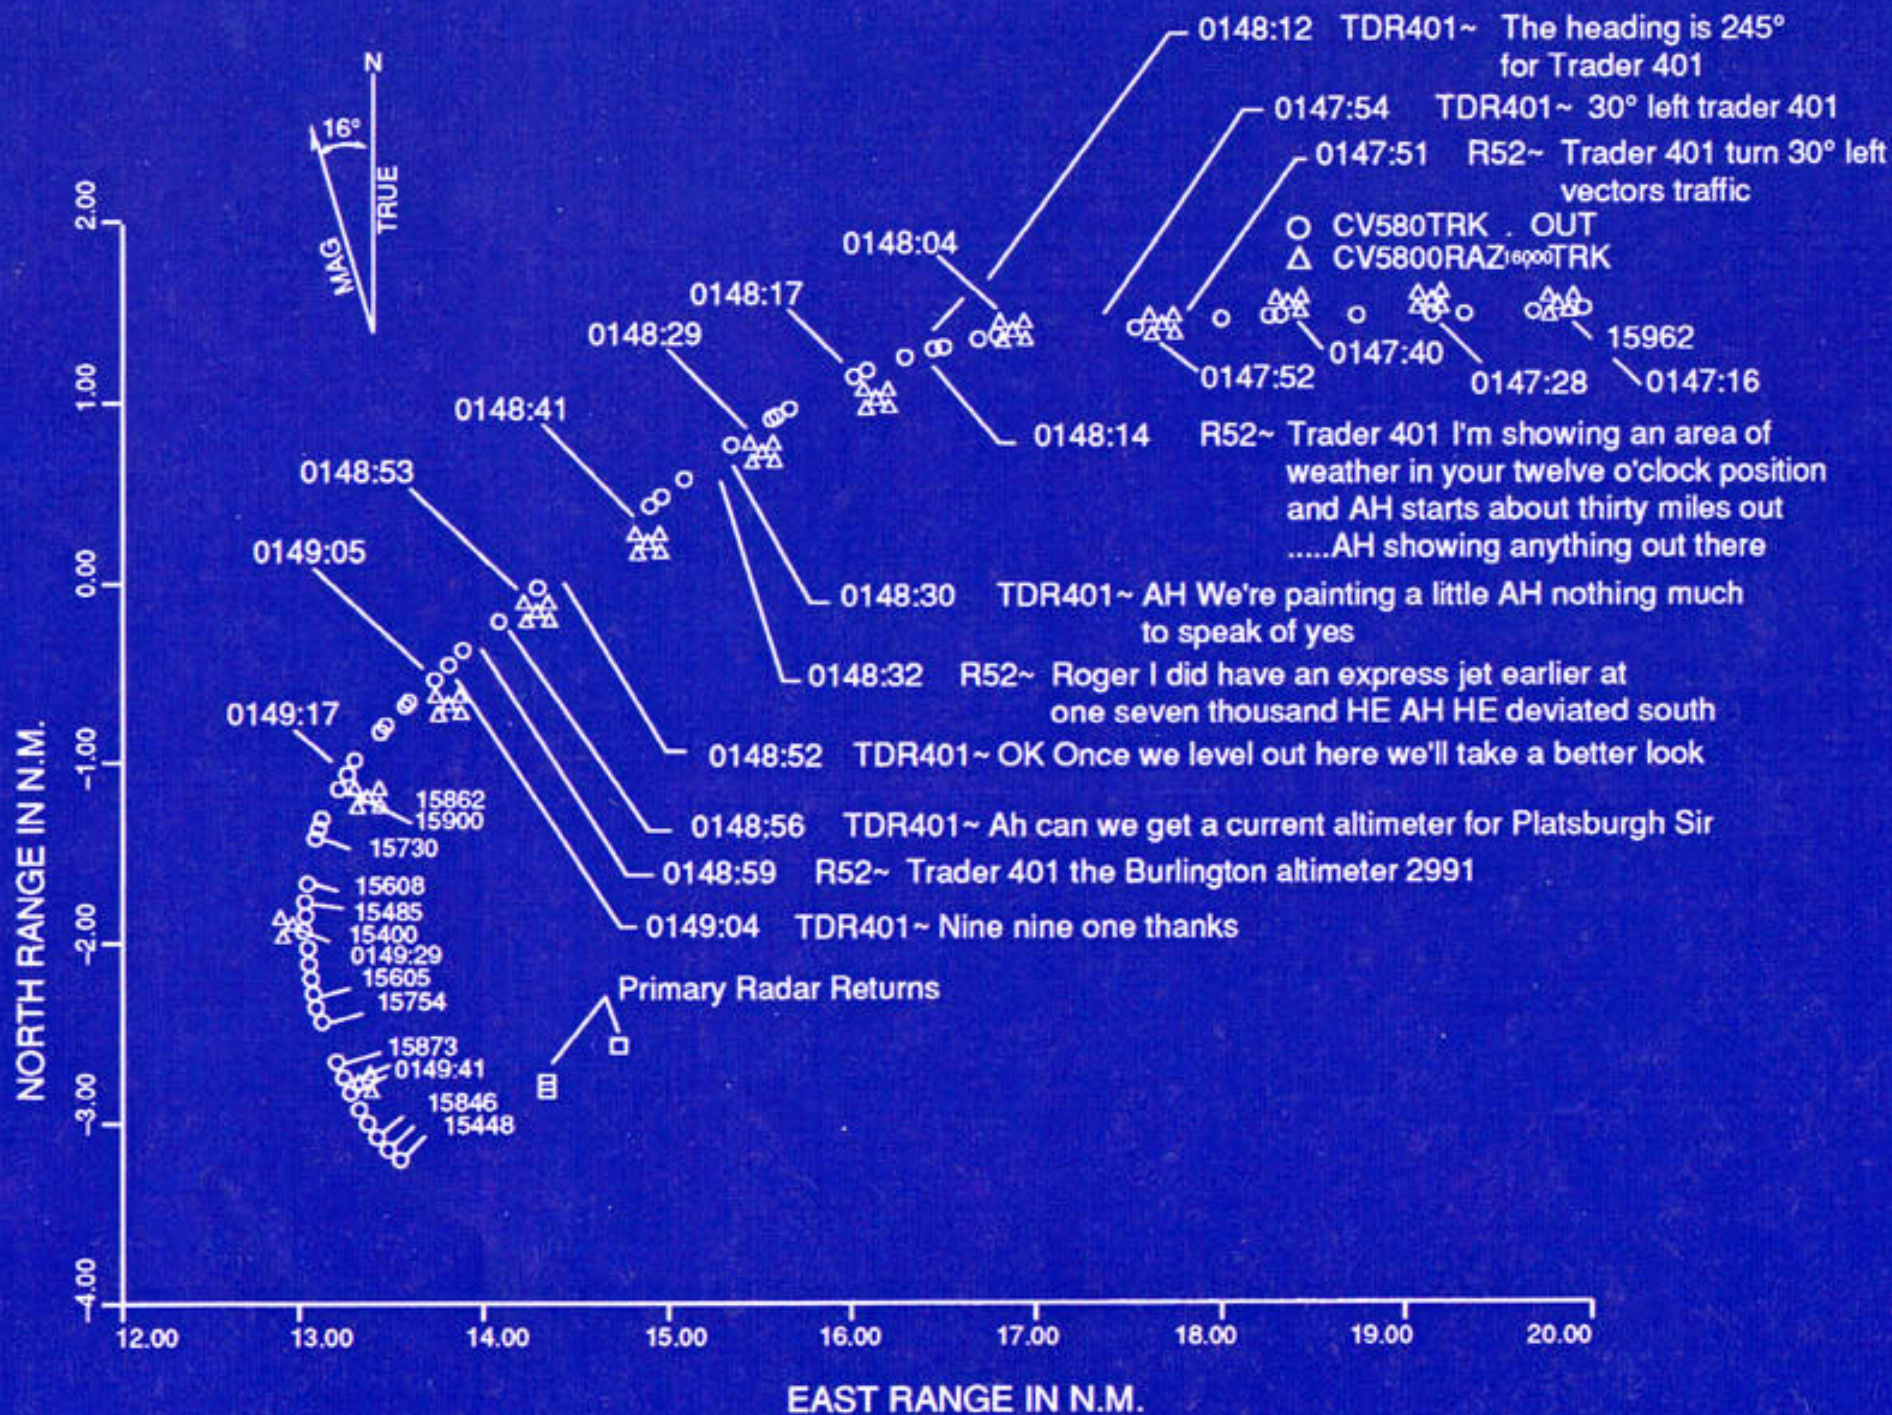
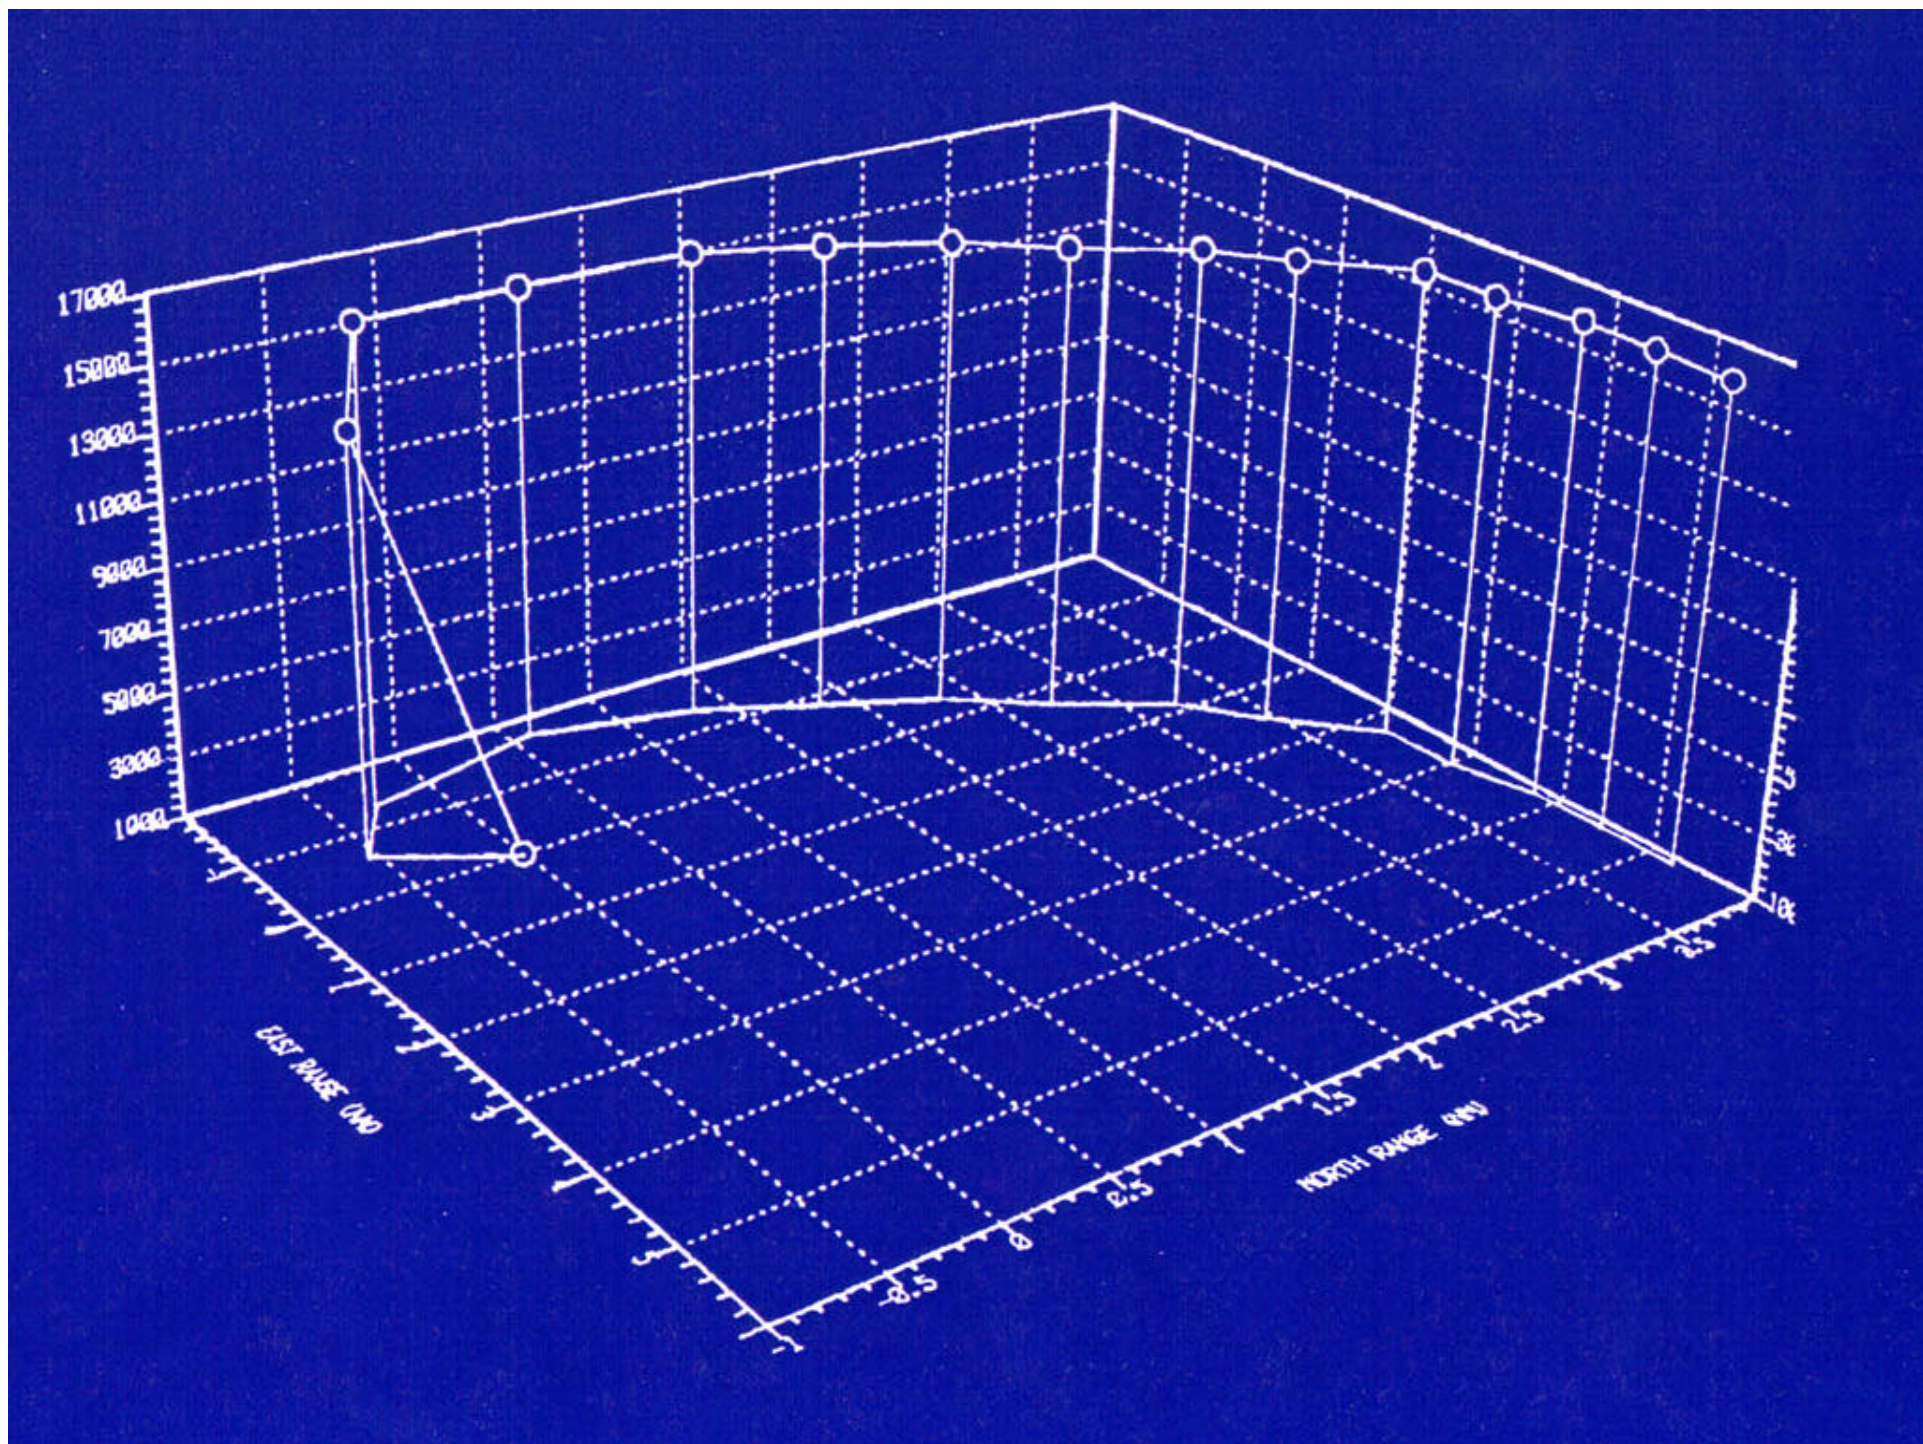
- 18-SEP-91 NYC91FA239
- THE AIRPLANE WAS CRUISING IN NIGHT INSTRUMENT METEOROLOGICAL CONDITIONS WHEN IT ENTERED A LEFT TURN AND EXCEEDED THE DESIGN AIRFRAME LIMITS. THE AIRPLANE BROKE UP IN THE DESCENT DUE TO AERODYNAMIC FORCES AND WAS DESTROYED. THE OUTBOARD WING PANELS HAD FAILED DOWNWARD AND CENTER WING SECTION SEPARATED FROM THE FUSELAGE. THE HORIZONTAL STABILIZER AND ELEVATORS HAD FAILED DOWN AND AFT. THE CAPTAIN WAS FOUND OUT OF THE COCKPIT WITH NO EVIDENCE OF HIM BEING IN THE SEAT AT IMPACT A HUMAN FACTORS STUDY FOUND THE AIRCRAFT'S LAST MINUTE OF FLIGHT MATCHED A PROFILE OF A PILOT EXPERIENCING SPATIAL DISORIENTATION.

- 18-SEP-91 NYC91FA239
- Probable Cause
FAILURE OF THE FIRST OFFICER (CO-PILOT) TO MAINTAIN CONTROL OF THE AIRCRAFT AFTER BECOMING SPATIALLY DISORIENTED, AND HIS EXCEEDING THE DESIGN STRESS LIMITS OF THE AIRCRAFT. FACTORS RELATED TO THE ACCIDENT WERE: THE LACK OF TWO PILOTS IN THE COCKPIT, DARKNESS, AND INSTRUMENT METEOROLOGICAL CONDITIONS (IMC) AT FLIGHT ALTITUDE.
