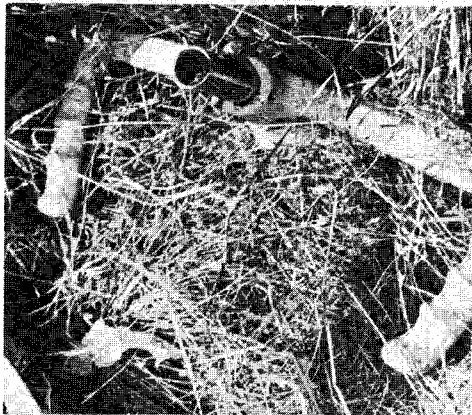
M. Tubular control column broken off.
