1. Report No. FAA AM- 72-7	2. Government Accession No.	3. Recipient's Catalog No.	
4. Title and Subtitle EVALUATION OF A FIBERGLASS INSTRUMENT GLARE SHIELD FOR PROTECTION AGAINST HEAD INJURY		5. Report Date February 1972

EVALUATION OF A FIBERGLASS INSTRUMENT GLARE SHIELD FOR PROTECTION AGAINST HEAD INJURY

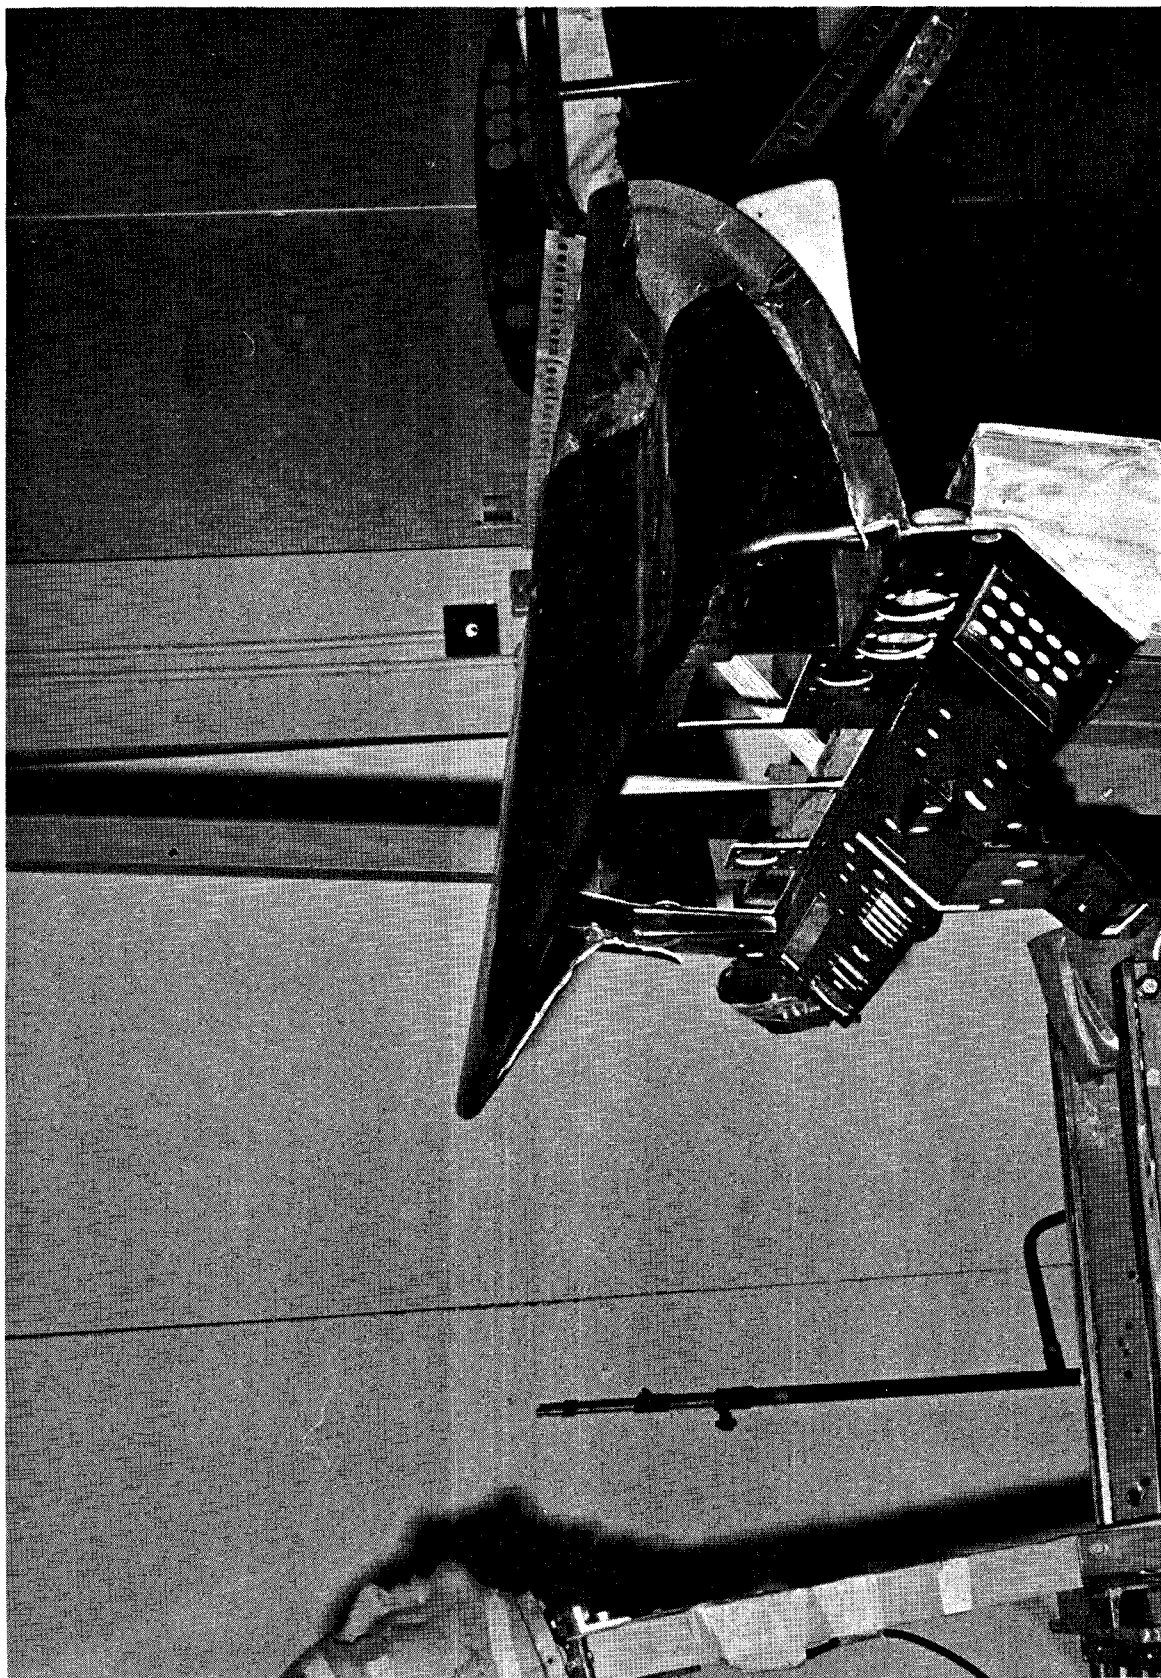
It should be noted at this point that the glare shield protruded only in front of the left pilot and that the right side dropped back such that the head impact area for the right seat occupant consisted of a layer of the thin padding over a rigid structure at the top of the instrument panel (Figure 1).

FIGURE 1. Fiberglass instrument panel and glare shield mounted at the end of the crash sled.

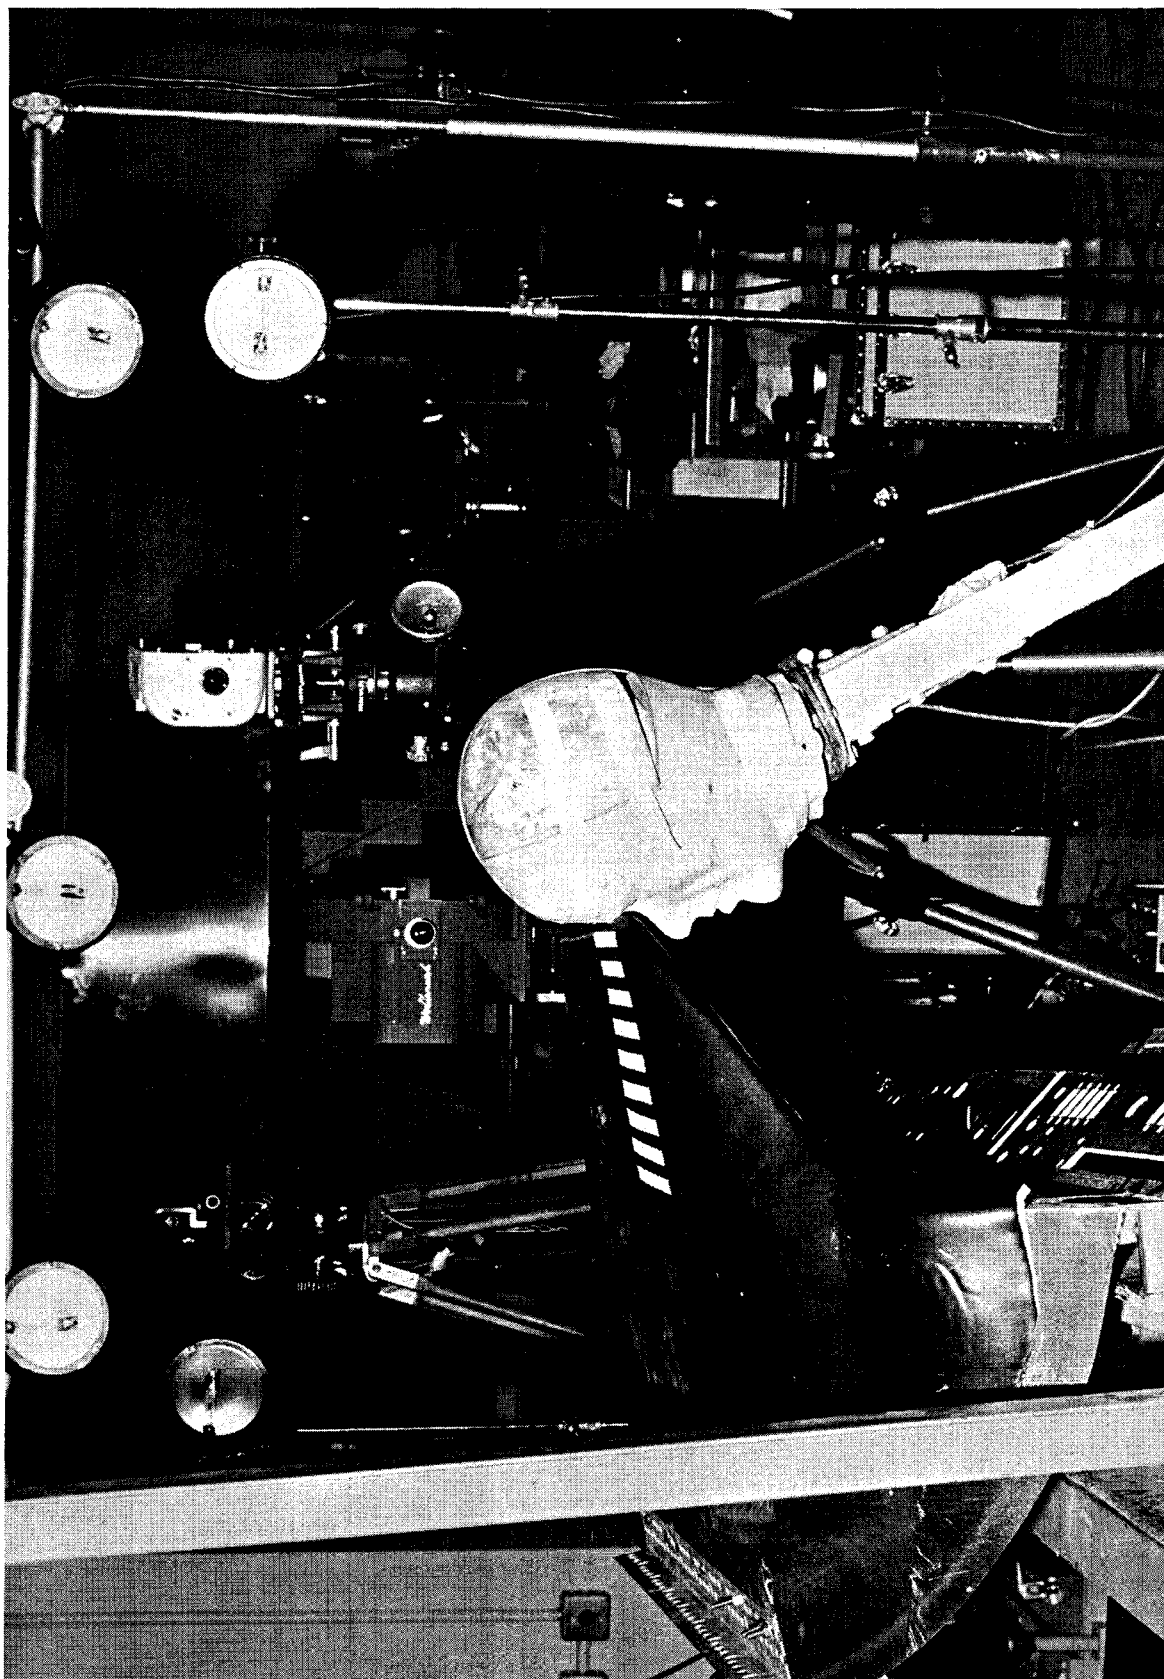
FIGURE 2. Strips of adhesive tape were added to show depth of head penetration.
