1. Report No. FAA-AM-73-1	2. Government Accession No.	3. Recipient's Catalog No.	
4. Title and Subtitle APPLICATION OF COMMERCIAL AIRCRAFT ACCIDENT INVESTIGATION TECHNIQUES TO A RAILROAD DERAILMENT.		5. Report Date January 1973	6. Performing Organization Code

# APPLICATION OF COMMERCIAL AIRCRAFT ACCIDENT INVESTIGATION TECHNIQUES TO A RAILROAD DERAILMENT

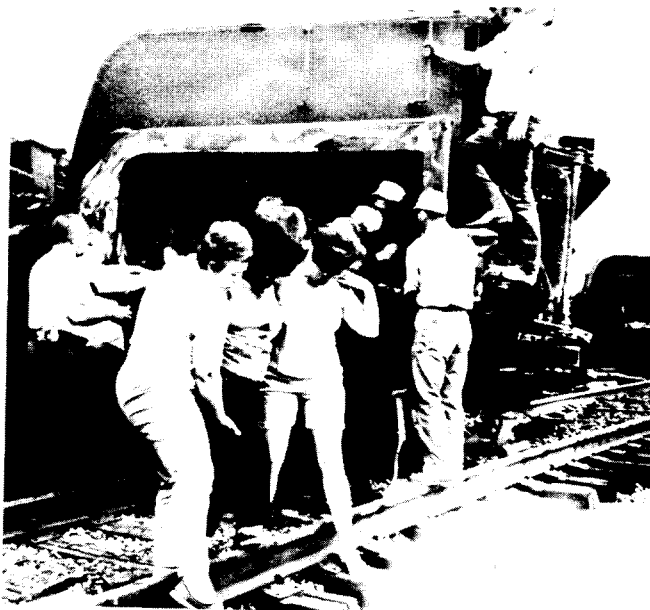
*E. Escape.* There are no emergency escape hatches or doors leading directly to the outside of a passenger car. As long as the car remains upright on its wheels, able-bodied passengers can wind their way through the narrow doors and passageway (slightly over 2 feet wide) around the restroom at either end of the car and go out the end of the car. It was impossible for rescue workers to move a seriously injured passenger on a 6-foot stretcher through the narrow, crooked passageway. Those that had broken arms or legs, or fractures of the vertebrae, could not escape on their own and had to wait to be lifted up through windows or carried up and down ladders. While five passengers were ejected through windows and fatally injured, at least three others were ejected through windows and survived with minor to serious injuries, and one was thrown from the end of the car (she was going from one car to another at the time of the derailment) into a field and survived with severe injuries. Figure 22 shows rescue workers helping passengers to escape from the overturned passenger cars.

a. Injured passengers being helped out the end of the car and down to the ground after having climbed over partitions and through the 2-foot high tunnels over or under the rest rooms as shown in Figure 25.

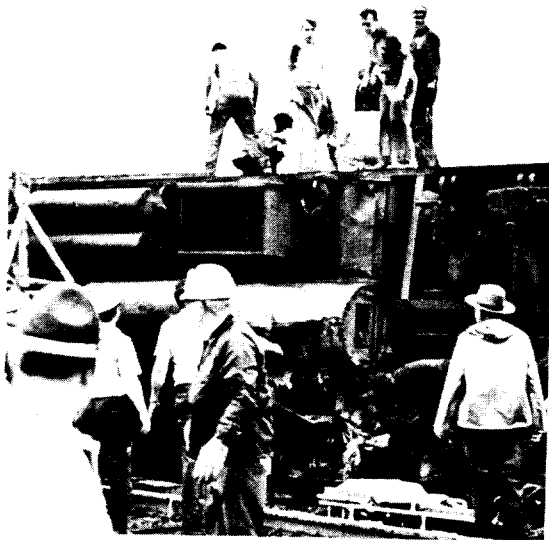
b. Some were rescued by being lifted up through windows by means of ropes.

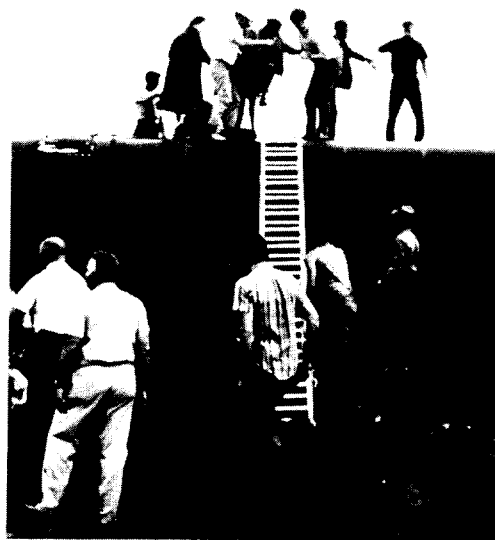
c. Other rescue workers brought ladders to assist passengers to the ground after they climbed up the seats and out the windows.

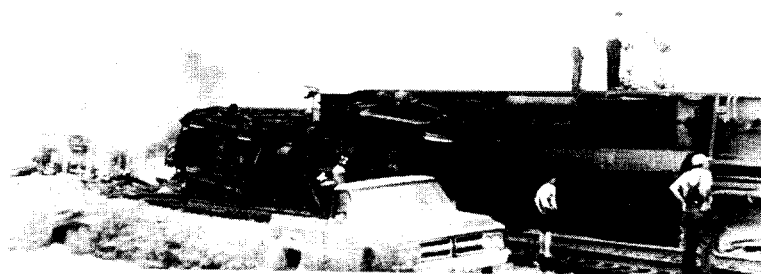
d. View of rescue workers lowering a ladder through a window they have knocked out to rescue passengers.

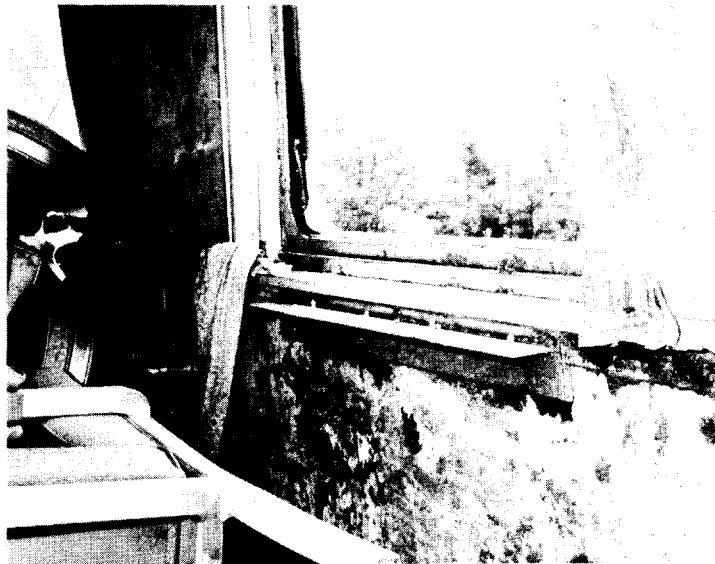
The only car on the train having a direct escape route to the outside was the Diner (see Figure 23). Figure 23 *a* shows the forward end of the diner as it appeared to the passengers after the derailment. All that was necessary to escape was to climb up on the booth seats, hold up the heavy metal door, climb through, and drop 3 feet to the ground. The rear end of the Diner (Figure 23*b*) presented a sheer wall and a narrow tunnel giving access to a small window on top of the car. Only one passenger was known to have climbed up on the counter into the tunnel and out the small window. All the rest used the door at the front of the Diner.

b. Rear end of diner on its side offered a more difficult escape route. One passenger climbed up into the 2-ft. high tunnel shown here and was rescued through the small broken window.

c. As the diner overturned two passengers were ejected through this window into a depression under the car but could not crawl out from under the car. They climbed back through the window and went out the end door shown in a.
