# NATIONAL TRANSPORTATION SAFETY BOARD

## SPECIAL INVESTIGATION REPORT

SAFETY ISSUES RELATED TO  
WAKE VORTEX ENCOUNTERS  
DURING VISUAL APPROACH  
TO LANDING

Special Investigation Report NTSB/SIR-94/01  
Notation 6264

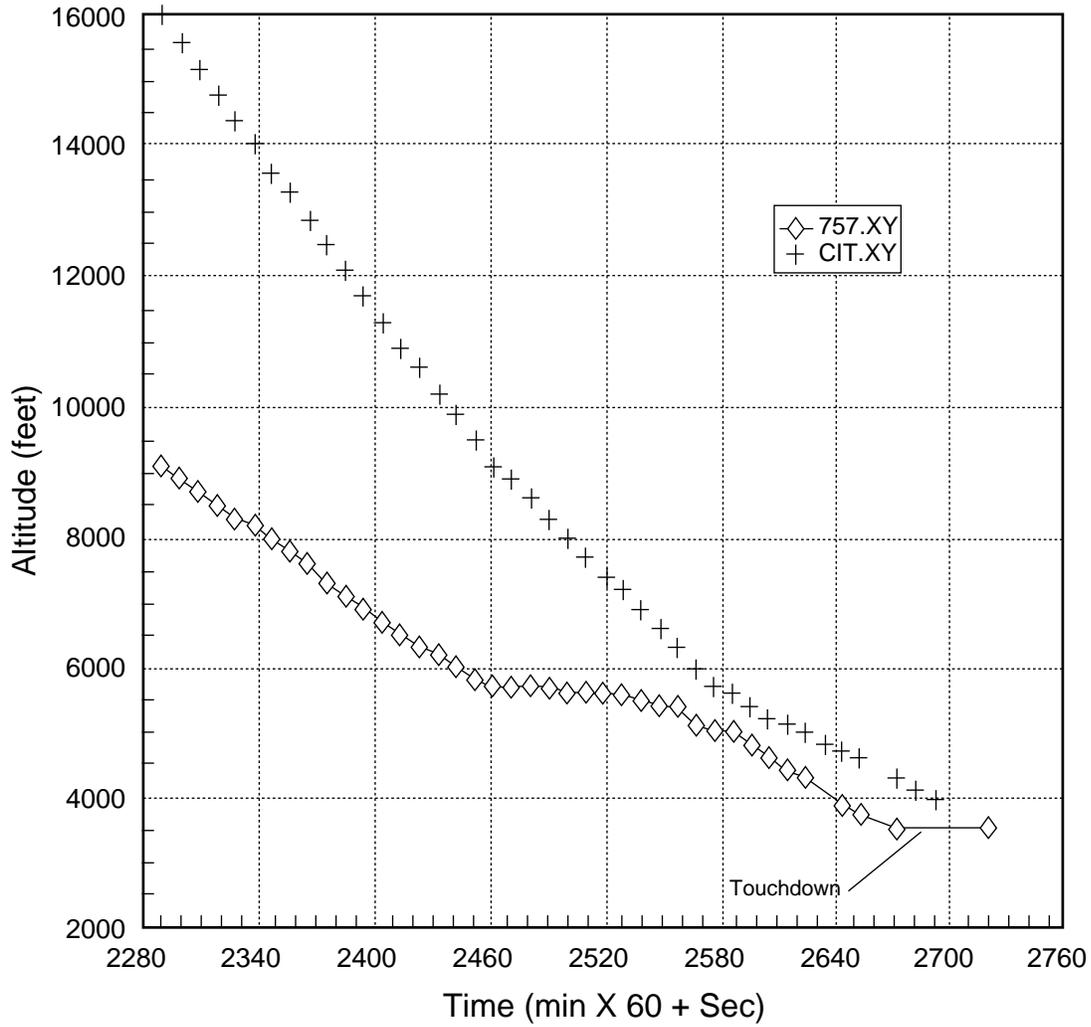
**Appendix C**  
**Altitude Profile of B-757 and Cessna Citation 550**  
**at Billings, Montana, on December 18, 1992**

Altitude Profile of 757 and Citation
