DOT/FAA/AM-95/18

A Human Factors Evaluation of the Operational Demonstration Flight Inspection Aircraft

Final Report

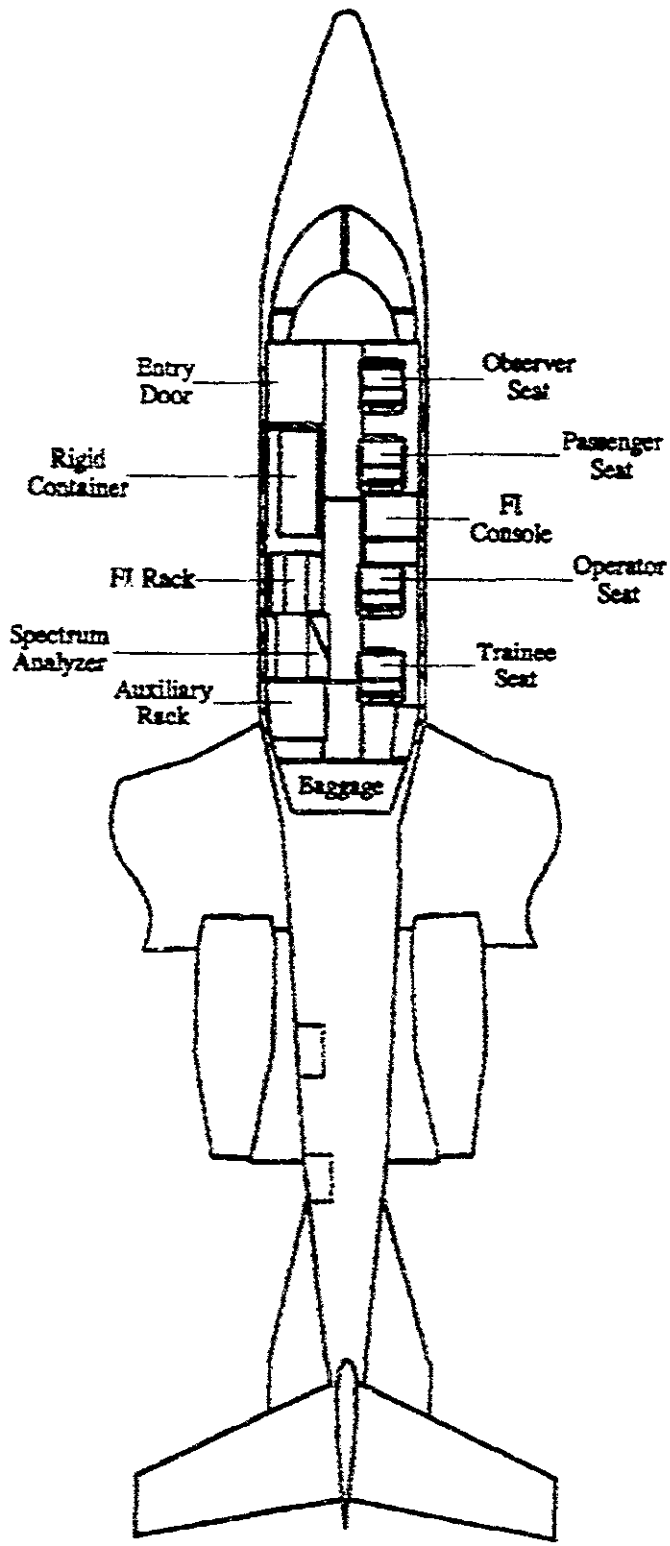
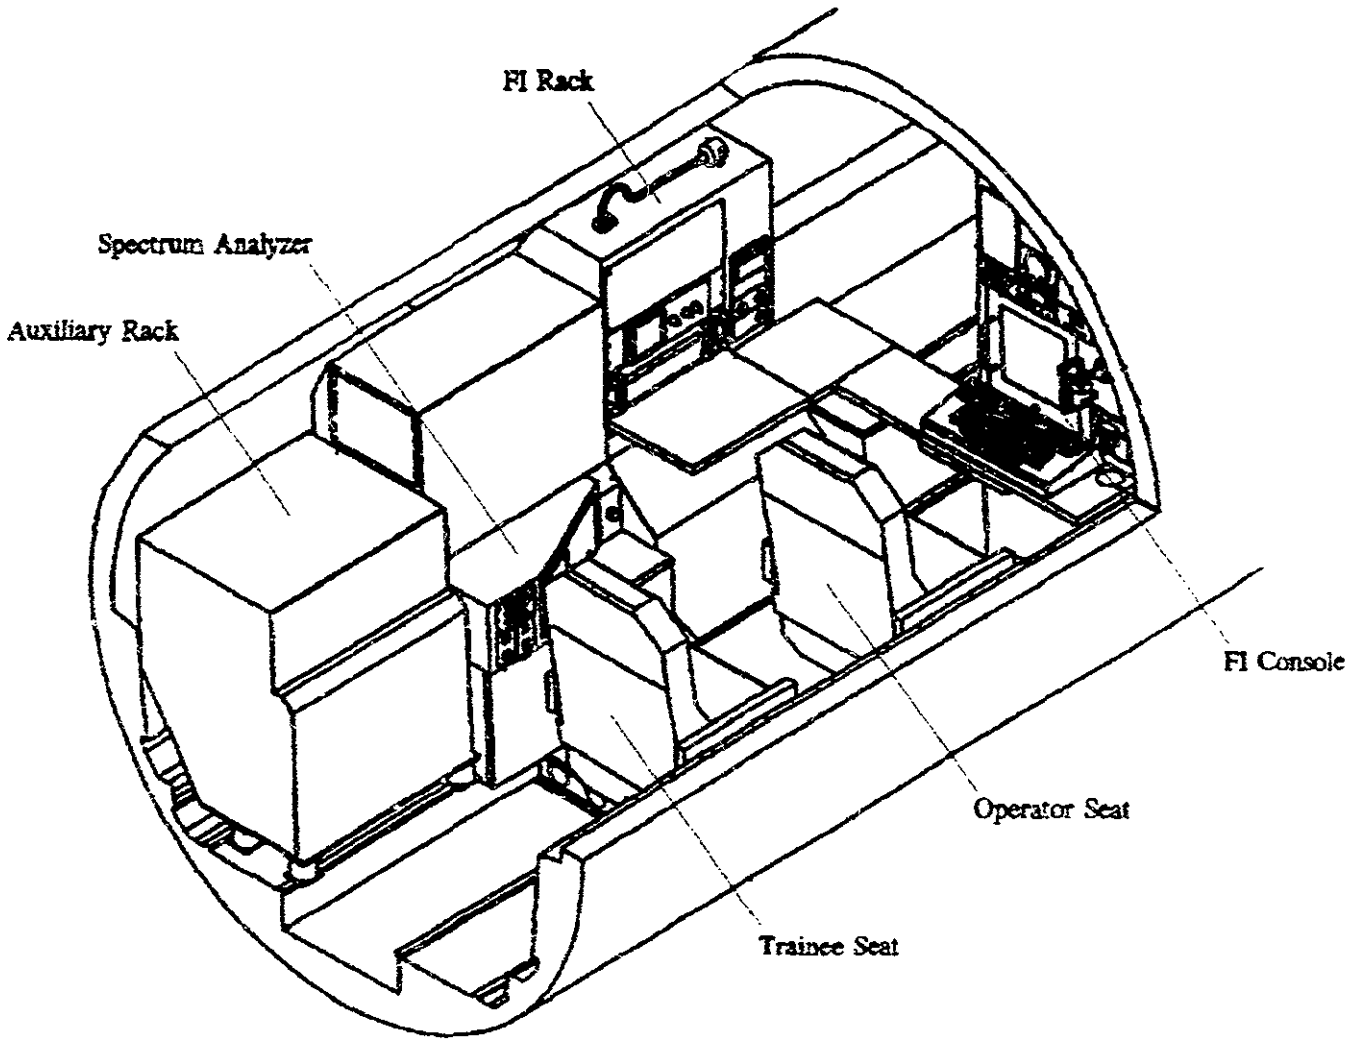
1. The recorder was positioned in a manner that would make it difficult to write on its associated printout. It was positioned on the left of the aircraft, requiring right-handed technicians to reach across their bodies to annotate the printout when facing the plasma display.

2. The spectrum analyzer is positioned to the lower left of the forward-facing technician's seat. It is possible to position the display for this unit at a higher level on one of the two instrument panels for easier viewing. The control unit can be located remotely.

3. No provision for storage space for equipment and documents was indicated in the mock-up. The spectrum analyzer position, if fitted with a door, would provide adequate storage. This option depends on the spectrum analyzer display and control unit being moved, as suggested above in point 2.

4. The event marker should be placed closer to the surface, instead of above the plasma display, so the arm/hand has a place to rest.
5. The cup holder location should be moved to allow for more writing space on the surface directly in front of the forward facing technician. If moved, it should not be placed where the recorder printout is annotated.

6. The corners of the workstation shelves and pullout writing surfaces should be rounded to reduce the likelihood of injury
7. There was no indication of the headphone jack position in the mock-up. It should be positioned so as not to interfere with technician movement

8. Windows are not proposed for installation on the right side of the aircraft cabin at the technician's workstation. It would be beneficial to provide the technician with these windows.

The main difference between the two layouts is the side of the aircraft on which the workstation is positioned. The original design proposal called for the workstation to be positioned on the left side of the aircraft, requiring right-handed technicians to reach across their body to annotate the recorder printout. The contractor initially did not suggest a right-handed workstation, since the size requirements for the rigid container restricted its placement in the aircraft cabin. It was suggested to AVN that the rigid container should not drive the design and layout of the technician's workstation. The rigid container specification was modified to allow for the repositioning of the workstation to the right side of the cabin. The suggestion to move the workstation to the right side of the air-

9. The workstation should be positioned on the opposite side of the aircraft to avoid the problem described in point 1. This would require the specification of the rigid container to be changed. The rigid container should not drive the design and layout of the technician's workstation.

11. The console containing the plasma display should be reduced in height to allow for forward viewing.
12. Although the revised design is considerably improved over the original design, it should not serve as a standard for other FIA systems installed in aircraft that allow for a truly forward facing work station. The current design has a forward seated console, a compromise to the specification to allow for the consideration of smaller aircraft. This design was a result of the decrease in floorspace associated with revisions in the specifications.

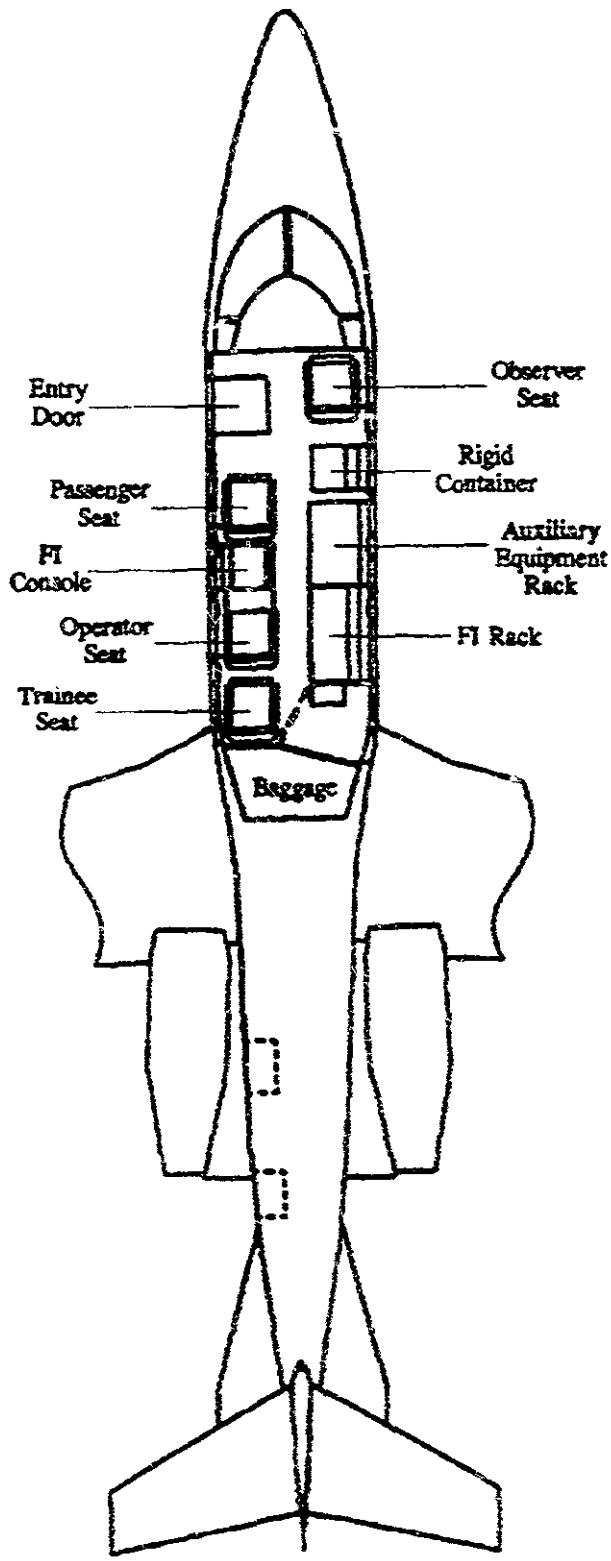
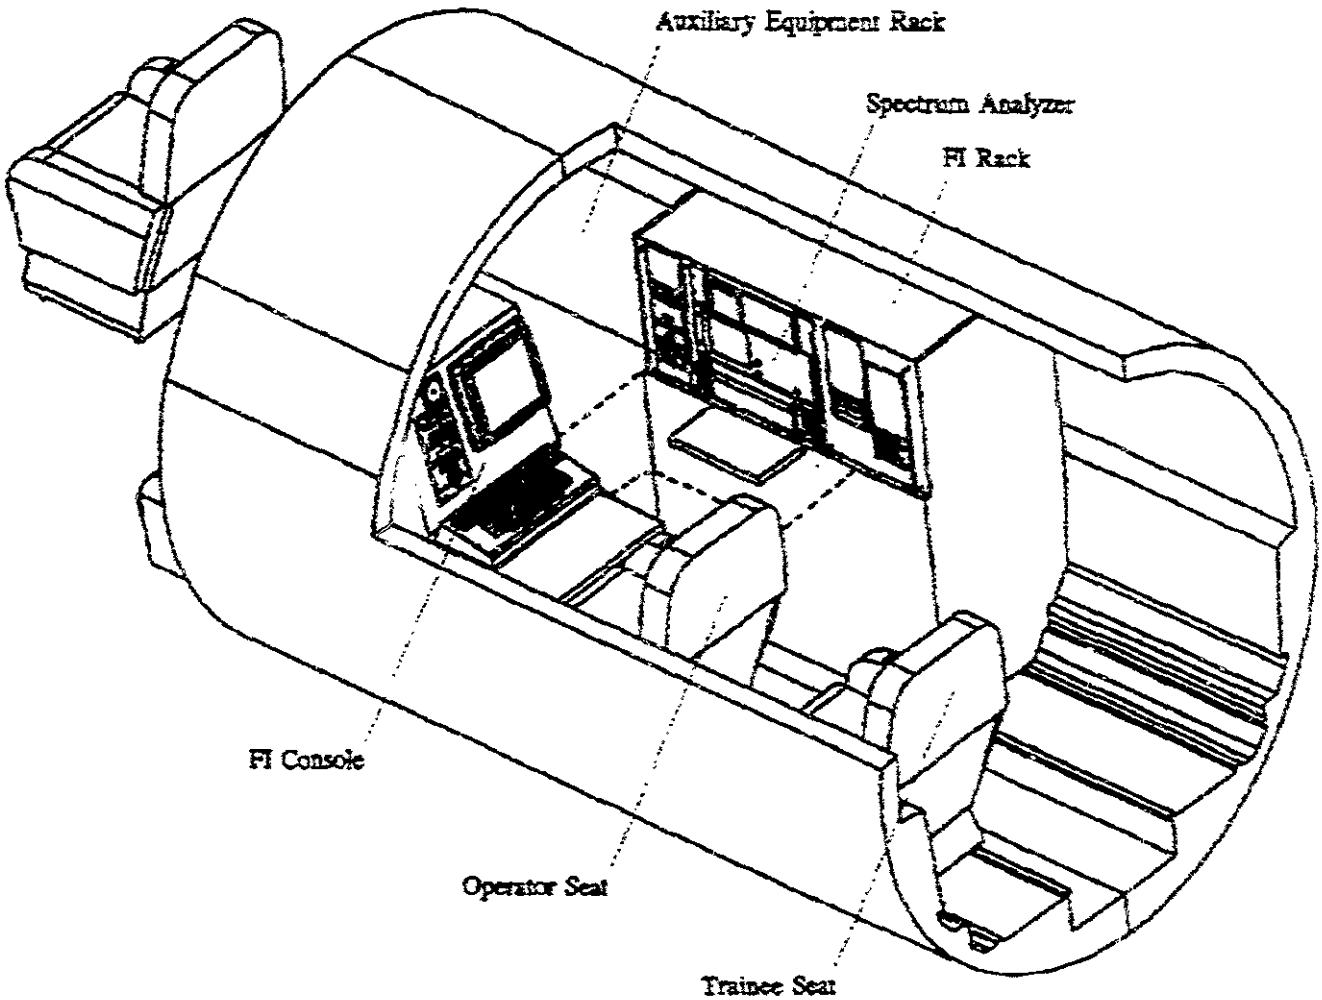
Based on the above considerations the contractor modified the design that had originally been proposed for integrating the flight inspection workstation into the aircraft. Each of the above points was addressed in the redesign of the revised workstation. Drawings of the original design and the design accepted by the agency are presented for comparison (Figures 8 through 11). Figures 8 and 9 detail the original aircraft cabin and technician's workstation layout. Figures 10 and 11 detail the design accepted by the agency for installation in the Lear 60 MSR FIA.

craft was incorporated into the design accepted by the agency. It was contended that since the workstation had to be either right- or left-handed, it should accommodate the majority of the user population.

The revised design places the spectrum analyzer in the flight inspection rack, where it can be easily viewed. The event marker was moved to a lower position near the keyboard so that the arm/hand has a place to rest. A provision was made in the display console for document storage. The cup holder was moved so that it does not reduce writing space. The edges of the workstation shelves and pullout writing surfaces were rounded to reduce the likelihood of injury. The headphone jacks were positioned to the right side of the technician's workstation. All usable windows (those not covered by flight inspection equipment) were added.

The only alternative to a right- or left-handed workstation was a design that incorporated the recorder/printer into the display console below the plasma display. Placing the recorder/printer below the plasma display was not acceptable for three reasons. First, the paper would spill into the technician's lap over the keyboard, making operation of the flight inspection equipment difficult. Second, the plasma display would need to be raised, potentially to an uncomfortable viewing angle. Third, it would not be possible to reduce the height of the console containing the plasma display to allow for forward viewing. The accepted design allows for forward viewing due to the reduced height of the display console.
