NTSB National Transportation Safety Board

General Aviation Weather Related Accidents

Donald Eick (“Ike”)

NTSB Senior Meteorologist

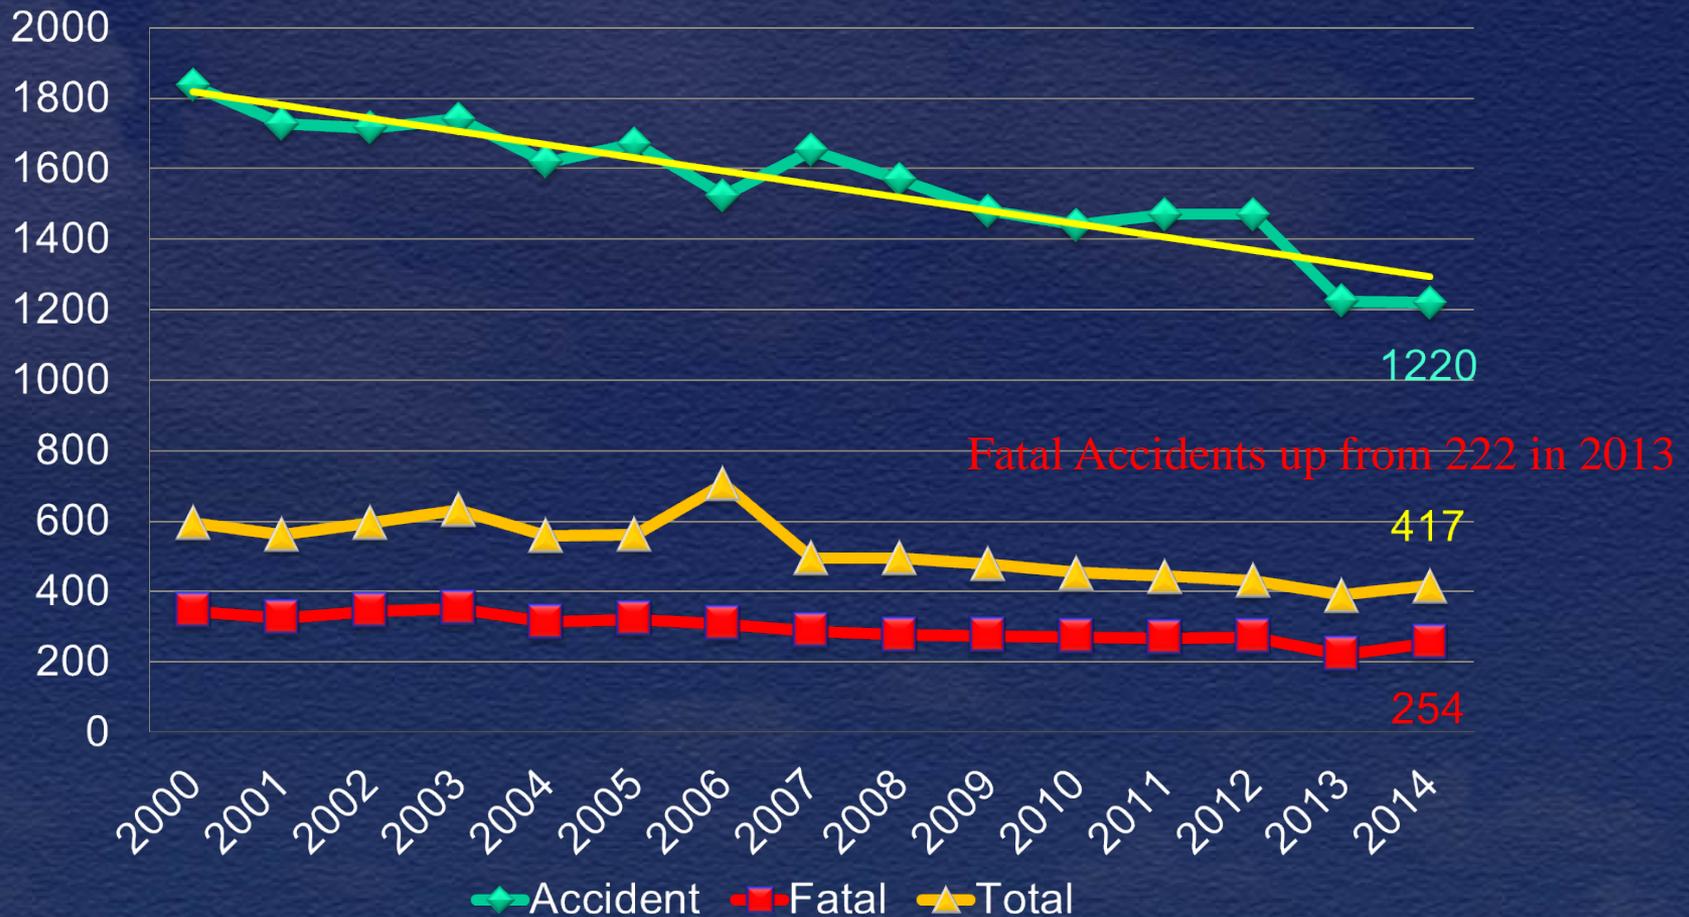
NTSB Part 91 Accident Trends

Continued decreasing trend in the number of accidents
2014 lowest rate in 20 years! But...
2000-2014

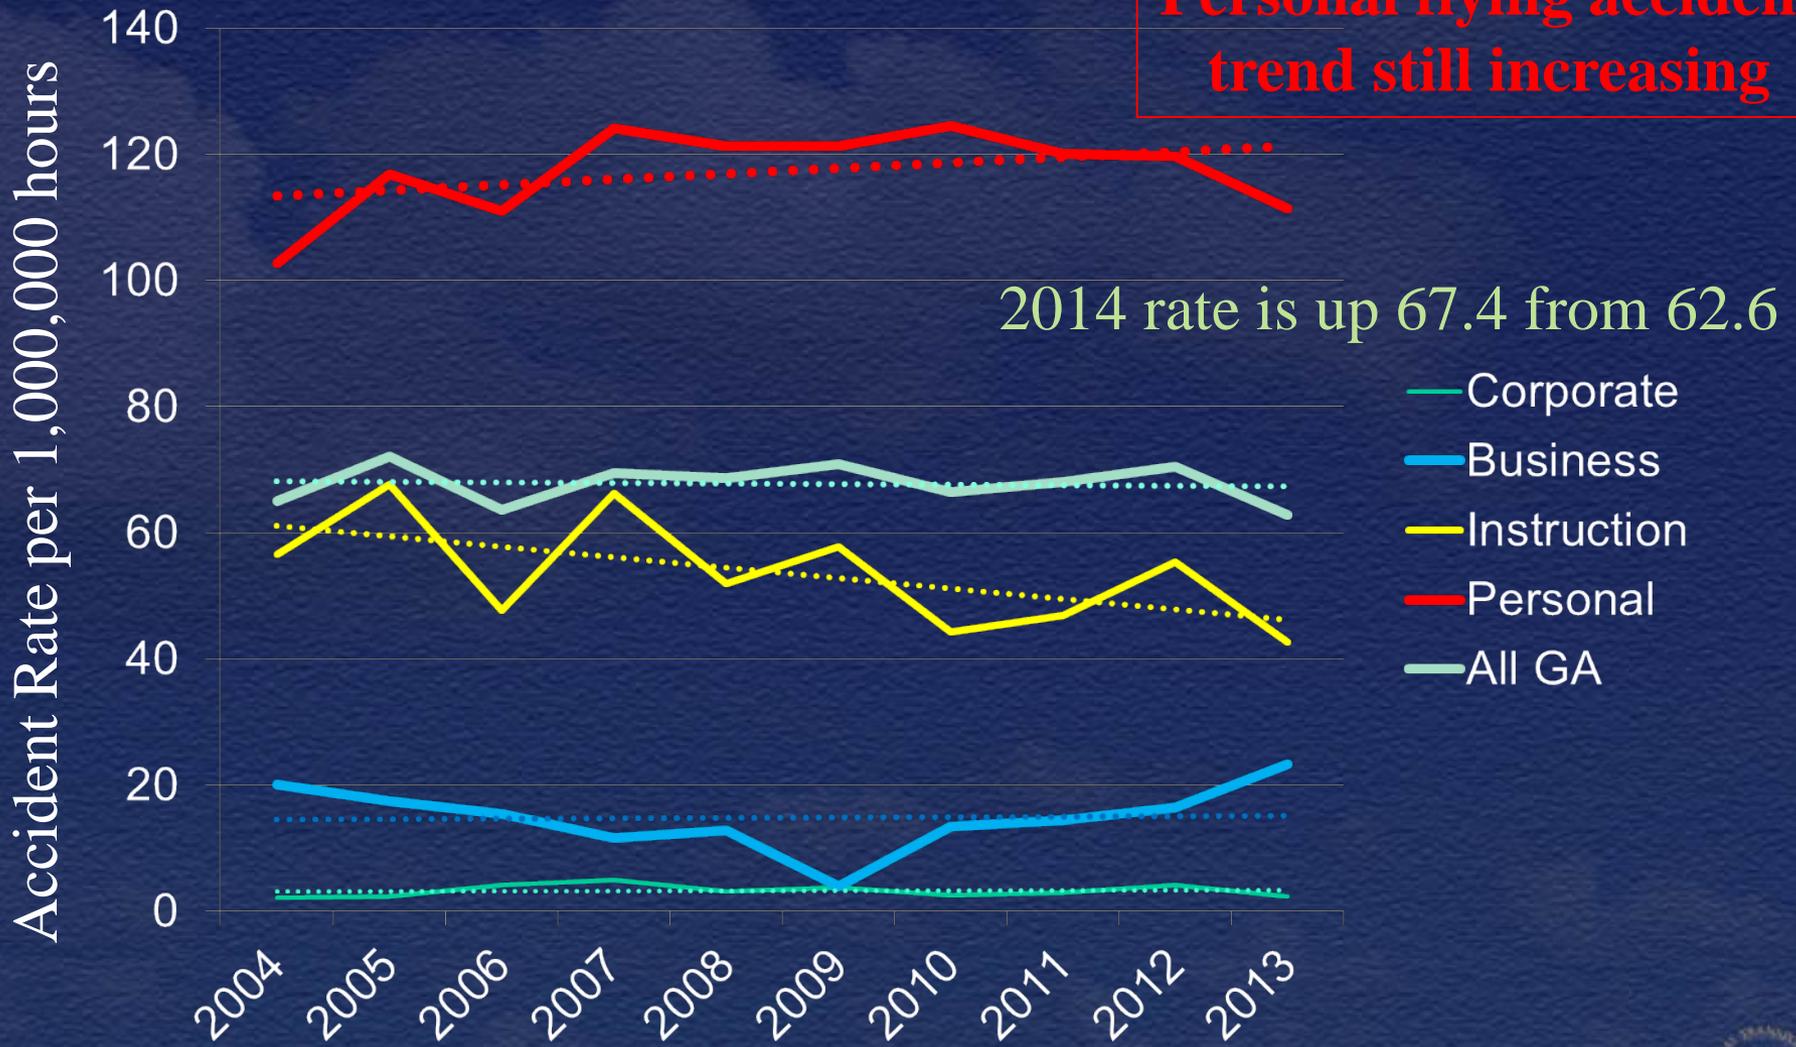
Part 91 Accident Rates

2004-2013

Personal flying accident trend still increasing

- NTSB investigates approximately 1,500 accidents per year (10 year average)
- **Part 91 – Overall GA accident rate is relatively flat**
 - Part 91 little improvement over the last decade
 - Part 121 air carrier accident rates have declined more than 80% during the period
- **Part 91 – Personal flying accidents**
 - Increased 20% over the last 10 years
 - Fatal rate increased 25% over the period

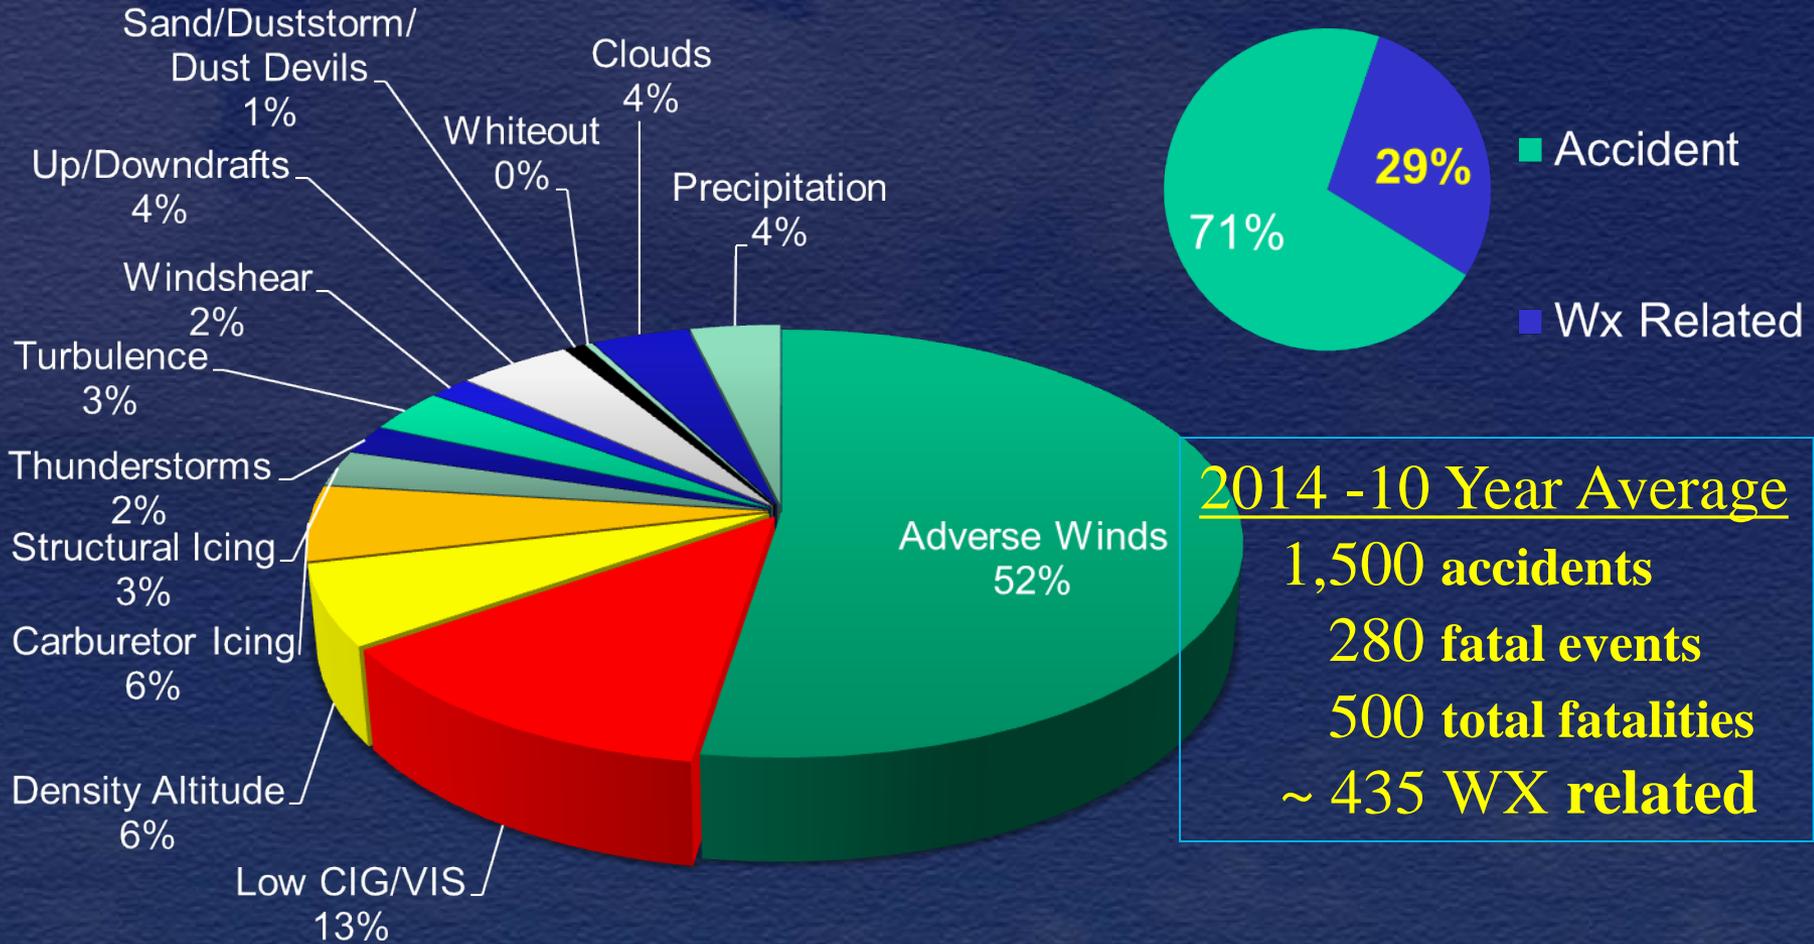
Part 91 – Weather As Cause/Factor period 2000-2011

19,441 Accidents

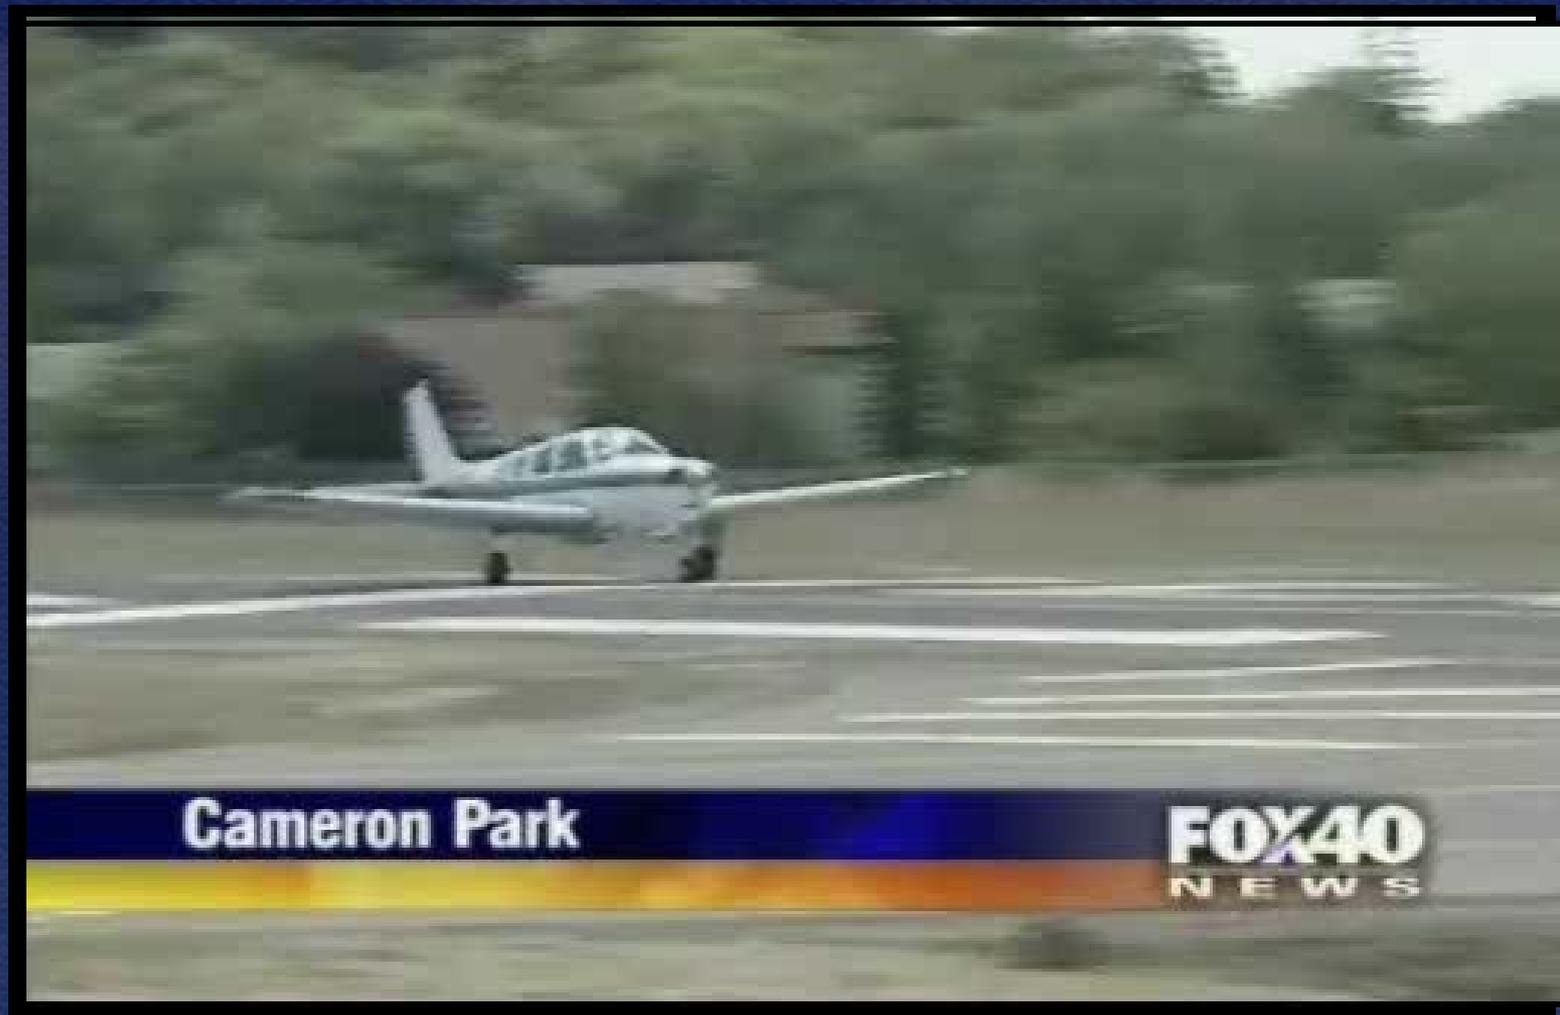
Unfavorable Winds & High Density Altitude LAX07FA258

Quartering crosswind & tailwind

- Part 91- personal flight
- Cameron Park (O61) , elevation 1,287 ft
- Runway 13/31 - 4,050 X 50 ft
- 1235 PDT - Weather 96° F & variable wind
- Density altitude 4,125 ft
- Full fuel, Pilot & 3 PAX, baggage
- No formal weight & balance performed
- Takeoff distance 50' required +30% = 4,030 ft

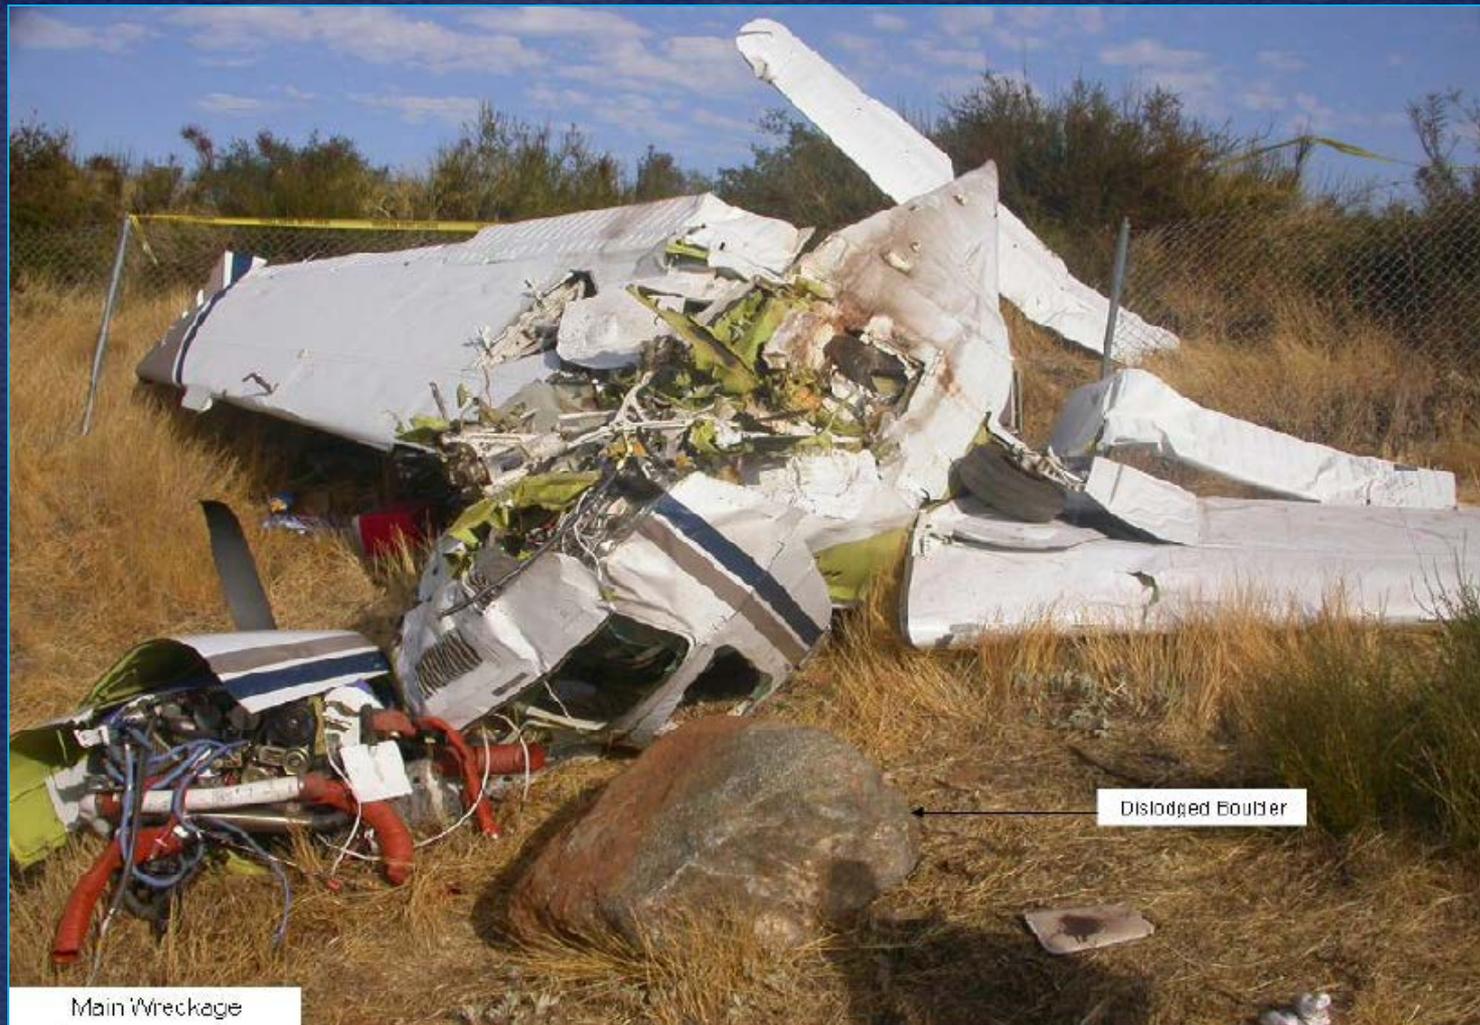
Main Wreckage
Photo 2- Main Wreckage 1

Dislodged Boulder

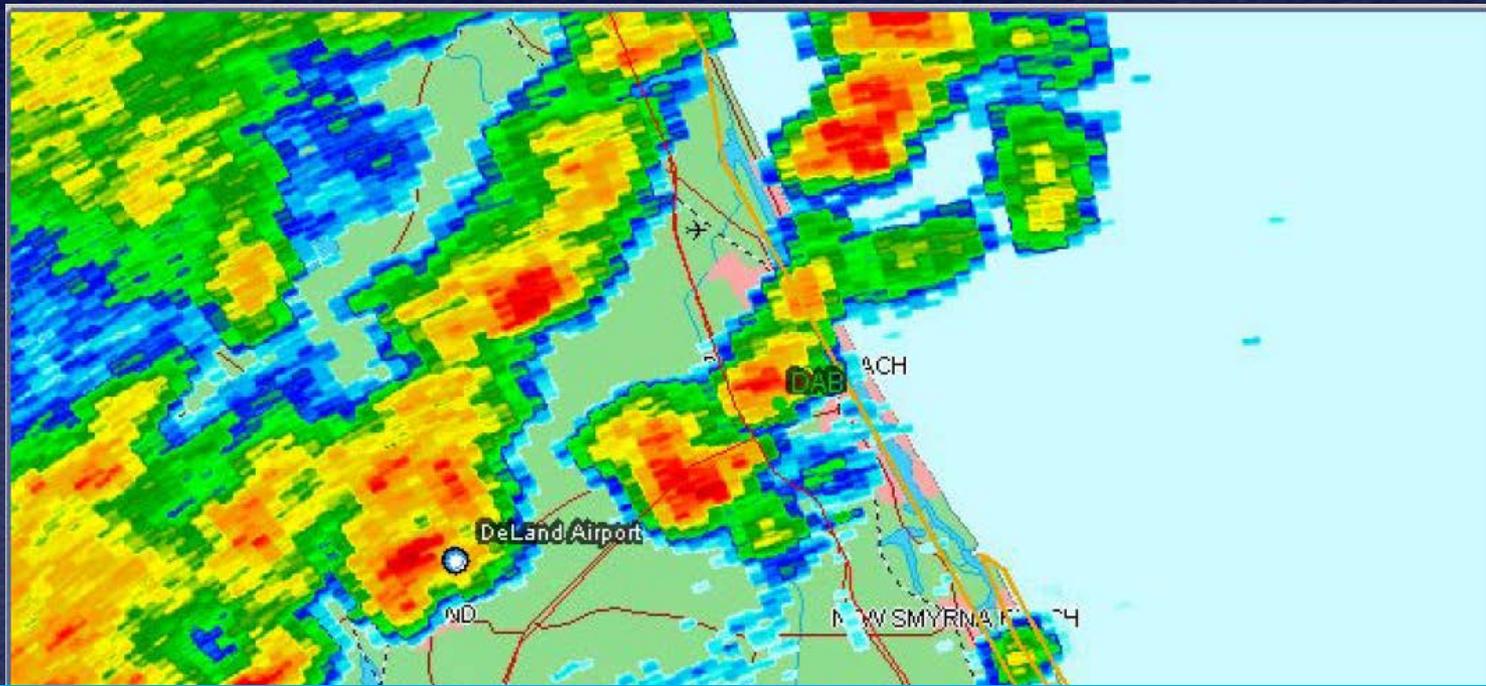
KMLB WSR-88D base reflectivity
images at 1508 and 1515 EDT

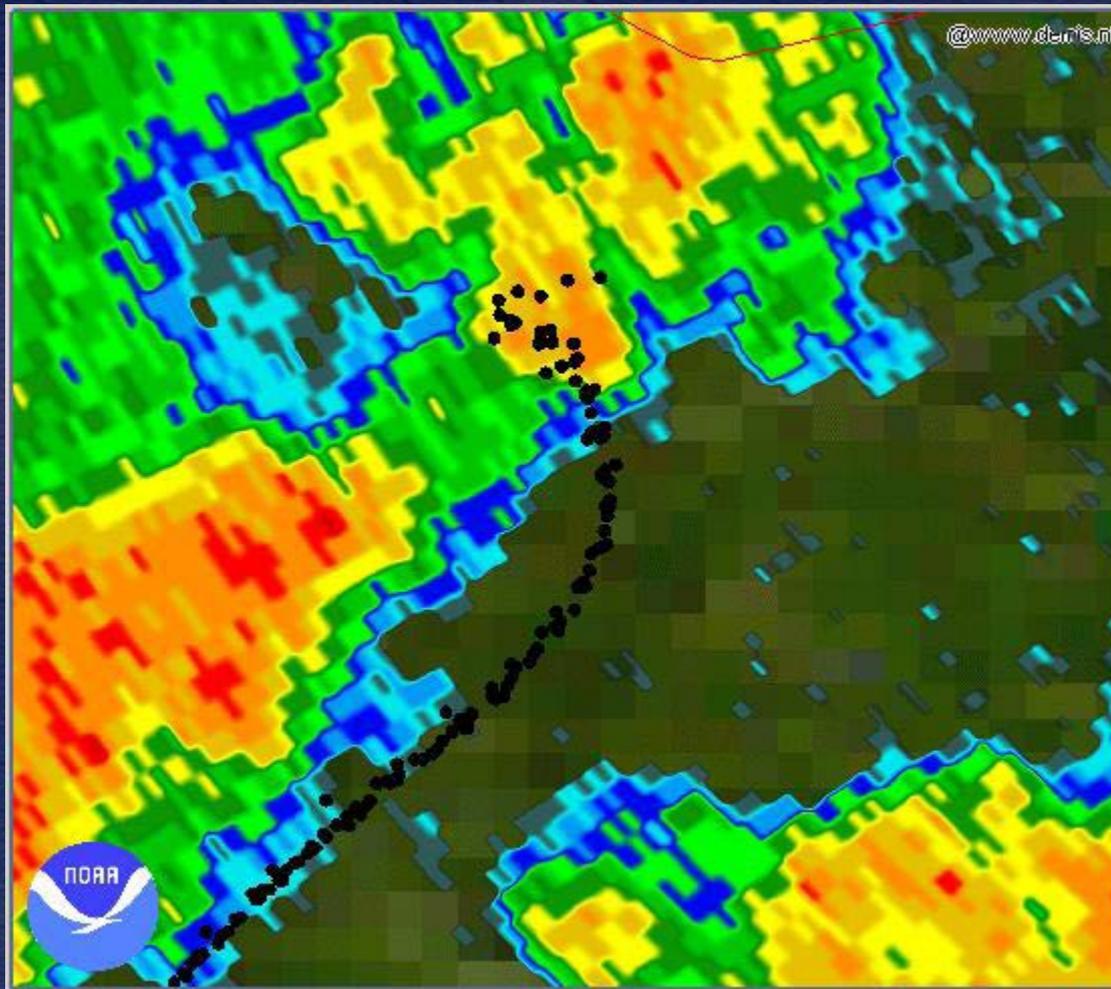
NEXRAD LEVEL-II
KJAX - JACKSONVILLE, FL
07/08/2009 13:03:57 GMT
LAT: 30/29/05 N
LON: 81/42/07 W
ELEV: 33 FT
VCP: 212

REFLECTIVITY
ELEV ANGLE: 0.45

Legend: dBZ (Category)

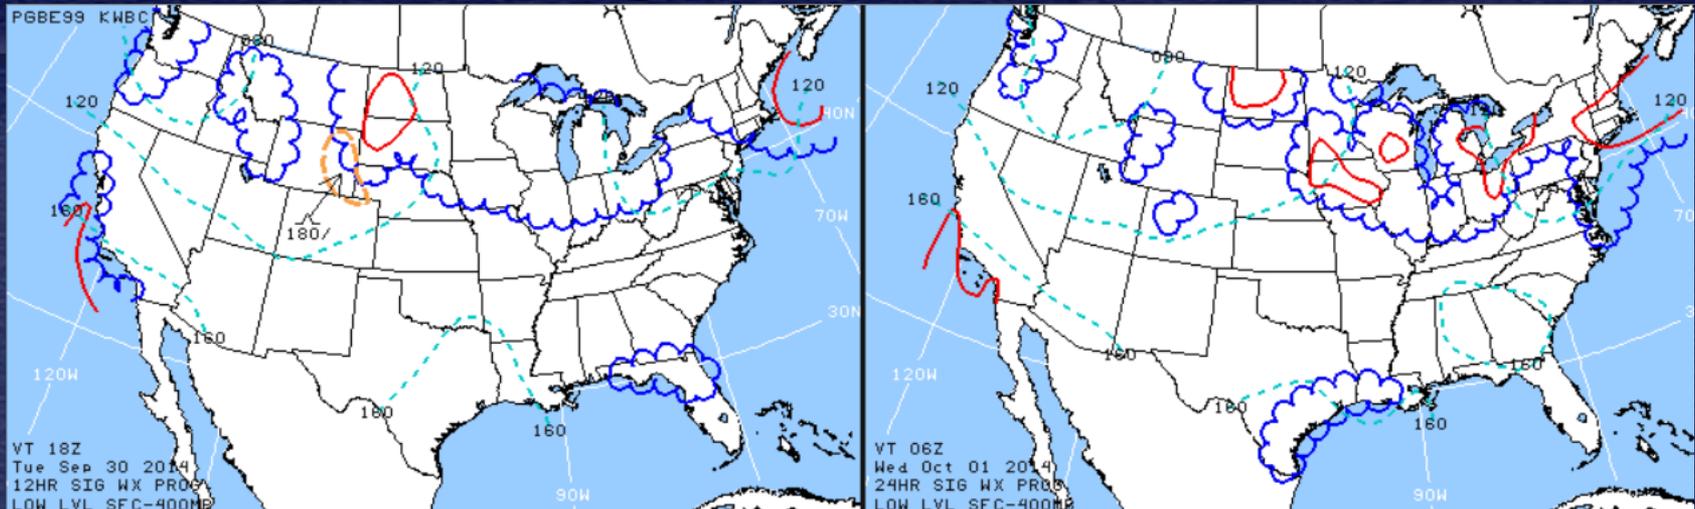
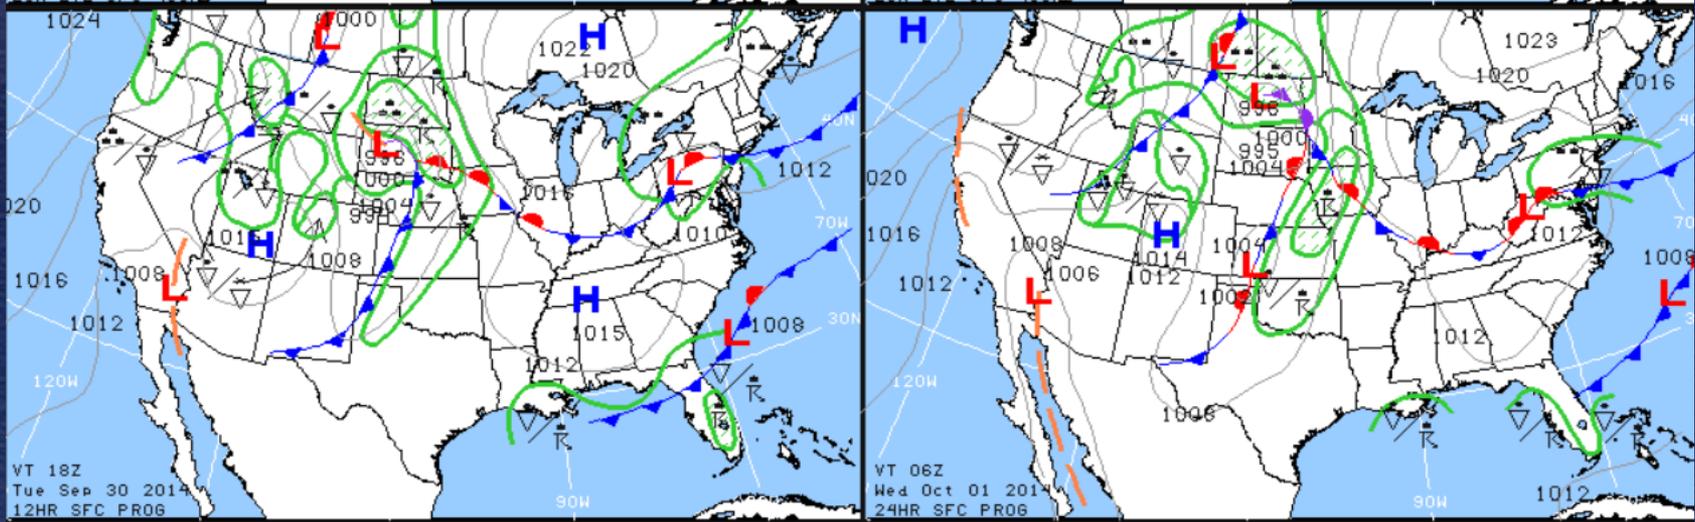
Low-Level Significant Weather Chart

Flight planning only. See TAFs for specific terminal forecast.

- ceiling less than 1000 ft and/or visibility less than 3 miles
 - ceiling 1000-3000 ft inclusive and/or visibility 3-5 miles incl
 - moderate or greater turbulence
 - freezing level above mean sea level
- freezing level at surface
Tstorms imply possible svr or greater turb, svr icing and LLWS.

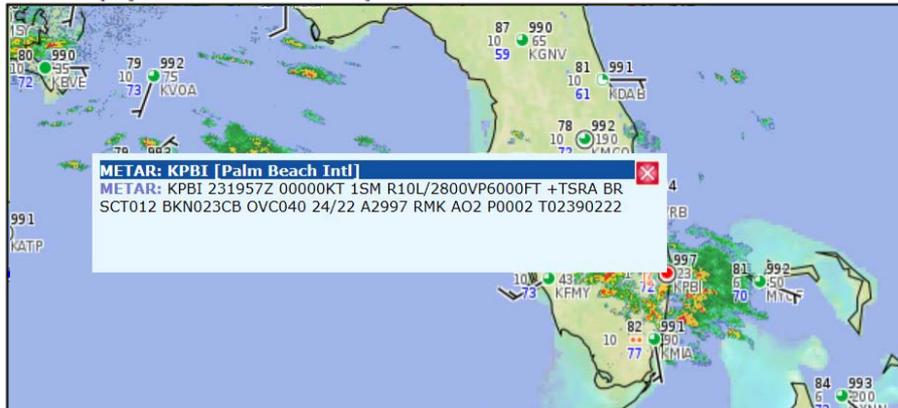
METAR Display at valid at 2009 UTC 23 Apr 2015

METAR: KPBI [Palm Beach Intl]
METAR: KPBI 231957Z 00000KT 1SM R10L/2800VP6000FT +TSRA BR
SCT012 BKN023CB OVC040 24/22 A2997 RMK AO2 P0002 T02390222

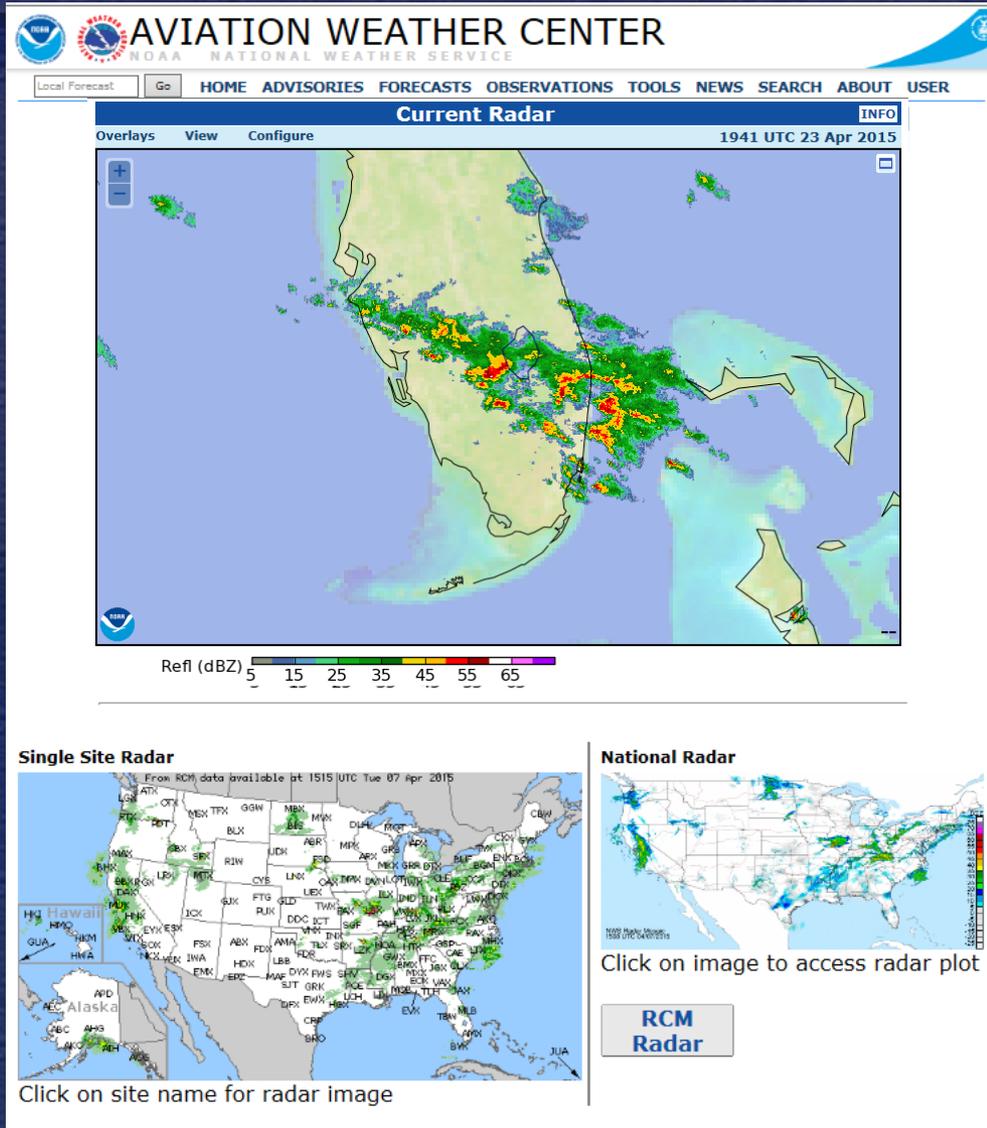
Observations - Radar

- National Composite Radar Mosaic
 - Updated 10 min
- Regional mosaic
- Individual WSR-88D sites
 - Base & composite reflectivity
- RCM Radar Summary
 - Movement & tops

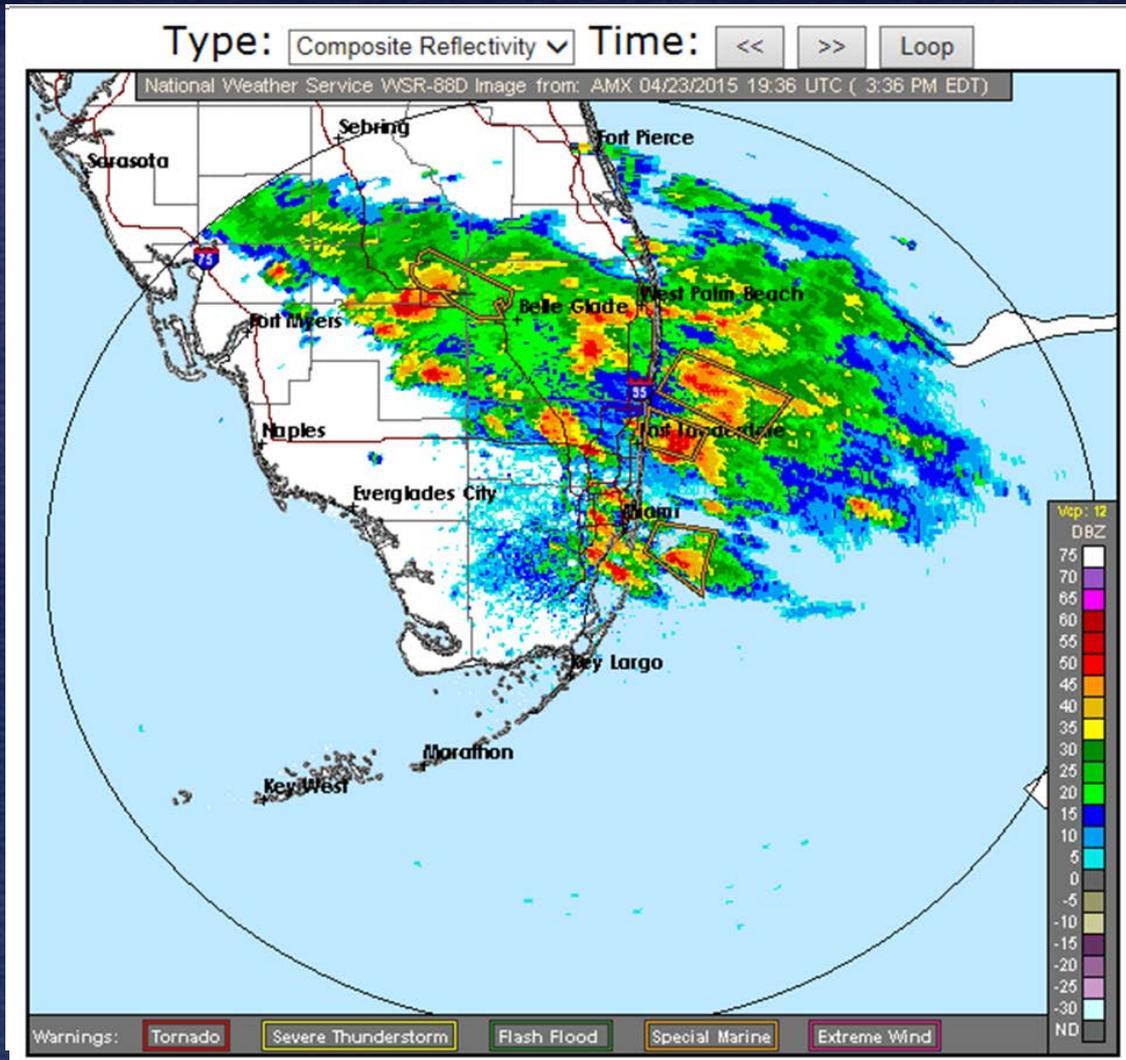
NWS Individual WSR-88D

- Individual WSR-88D sites
- Base reflectivity
 - Composite
 - local weather watches

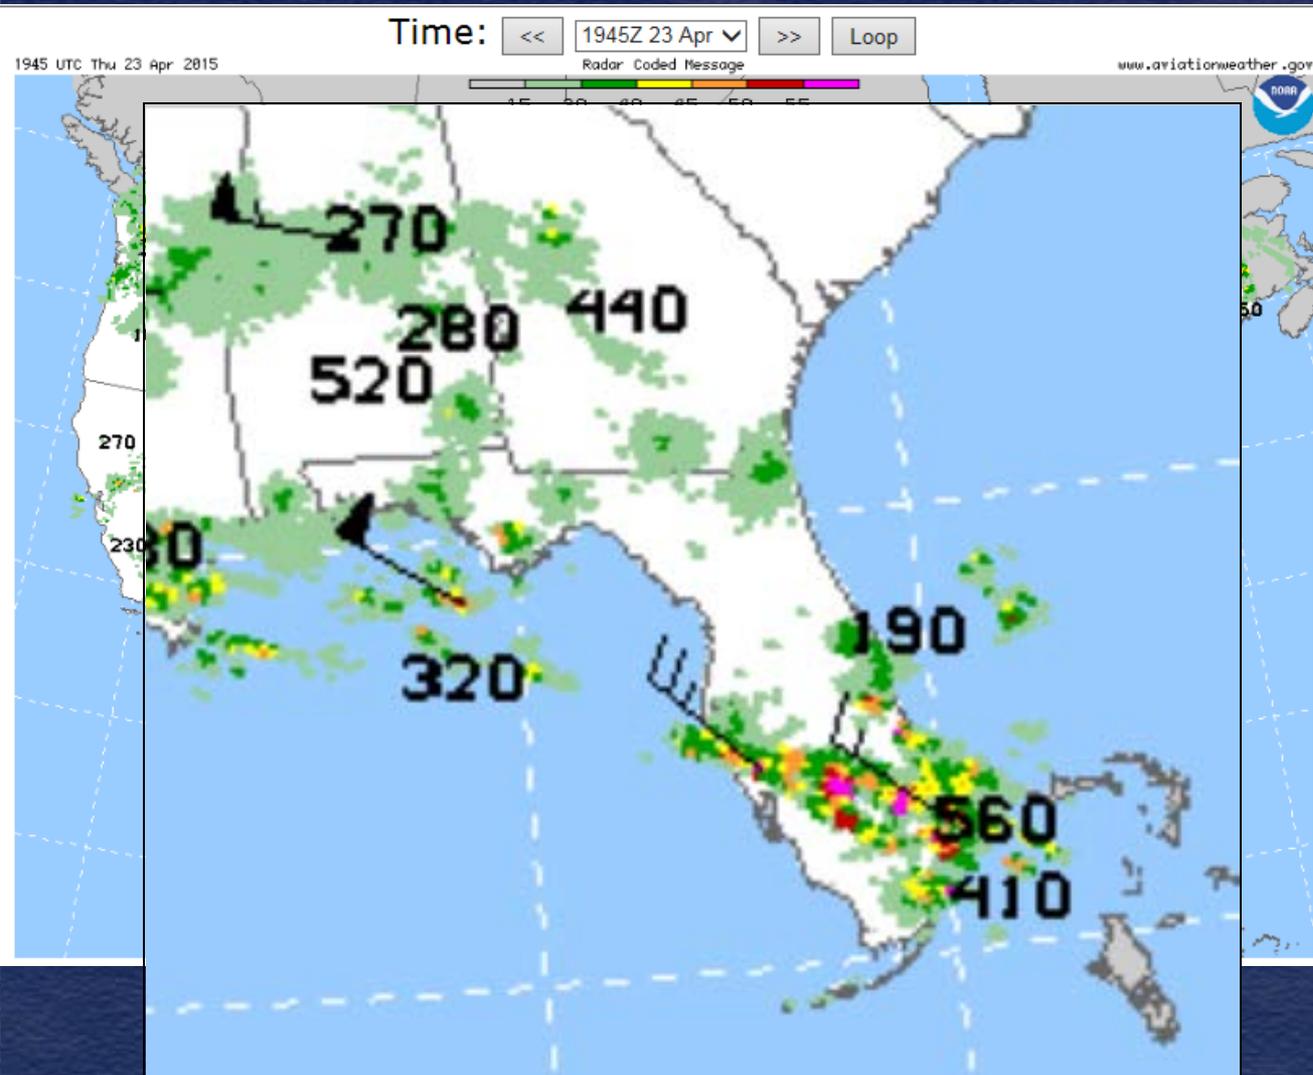
RCM Radar Summary

Radar Coded Message (RCM)

- Updated every 30 min
- Movement
- Tops
- Limitation – NWS does not use severe storm indicators (TVS, Hail, Meso, solid line, or add weather watches)

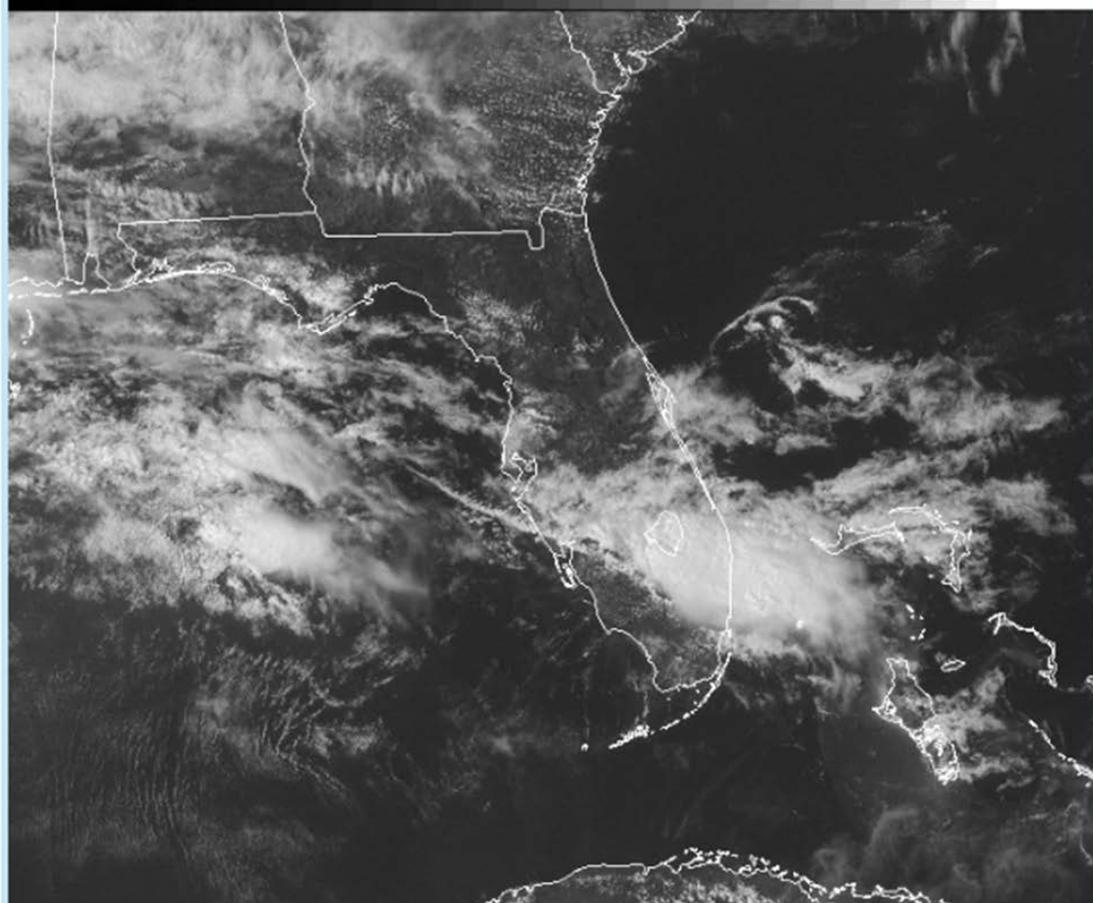
Visible Satellite

GOES Vis/Fog
VFR/IFR

satellite imagery
Infrared
Water Vapor
Visible

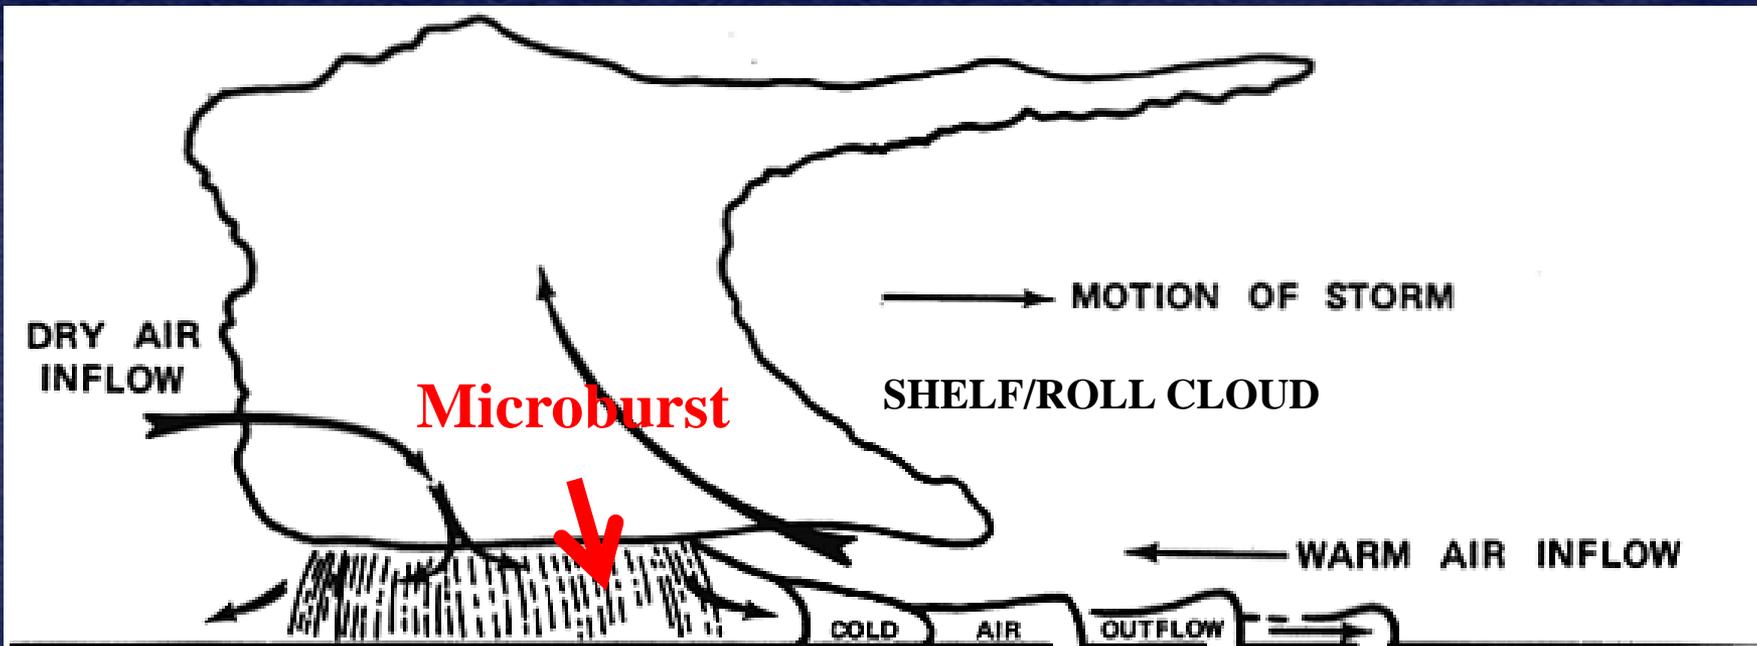
Squall Line - Gust front/Outflow boundary

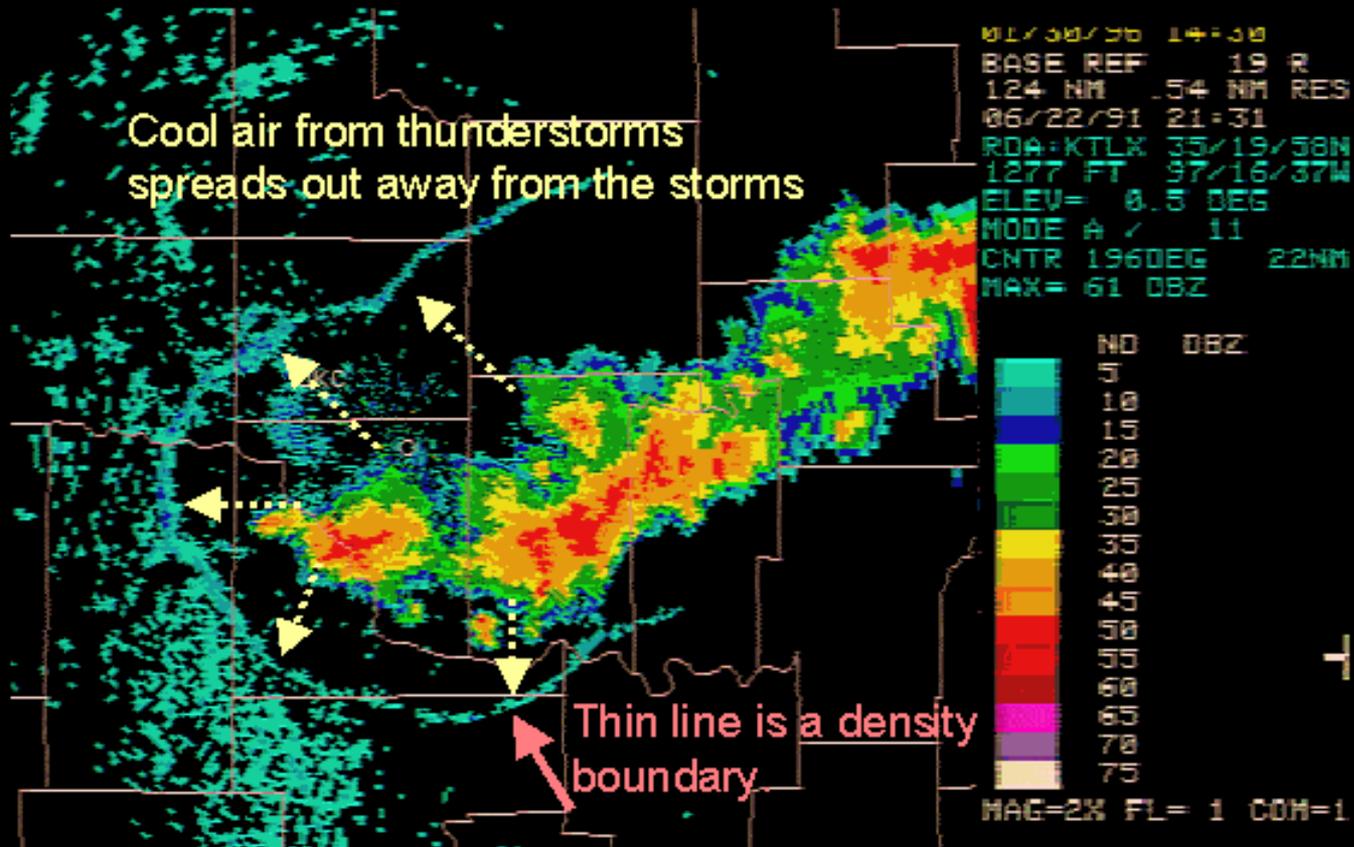
Outflow Boundary Example

Cool air from the thunderstorms spreads out in all directions away from the storms. These boundaries (separating the cool air from warmer ambient air) can act as focusing mechanisms for additional activity.

Warning – not identifiable in WARP and some radar displays

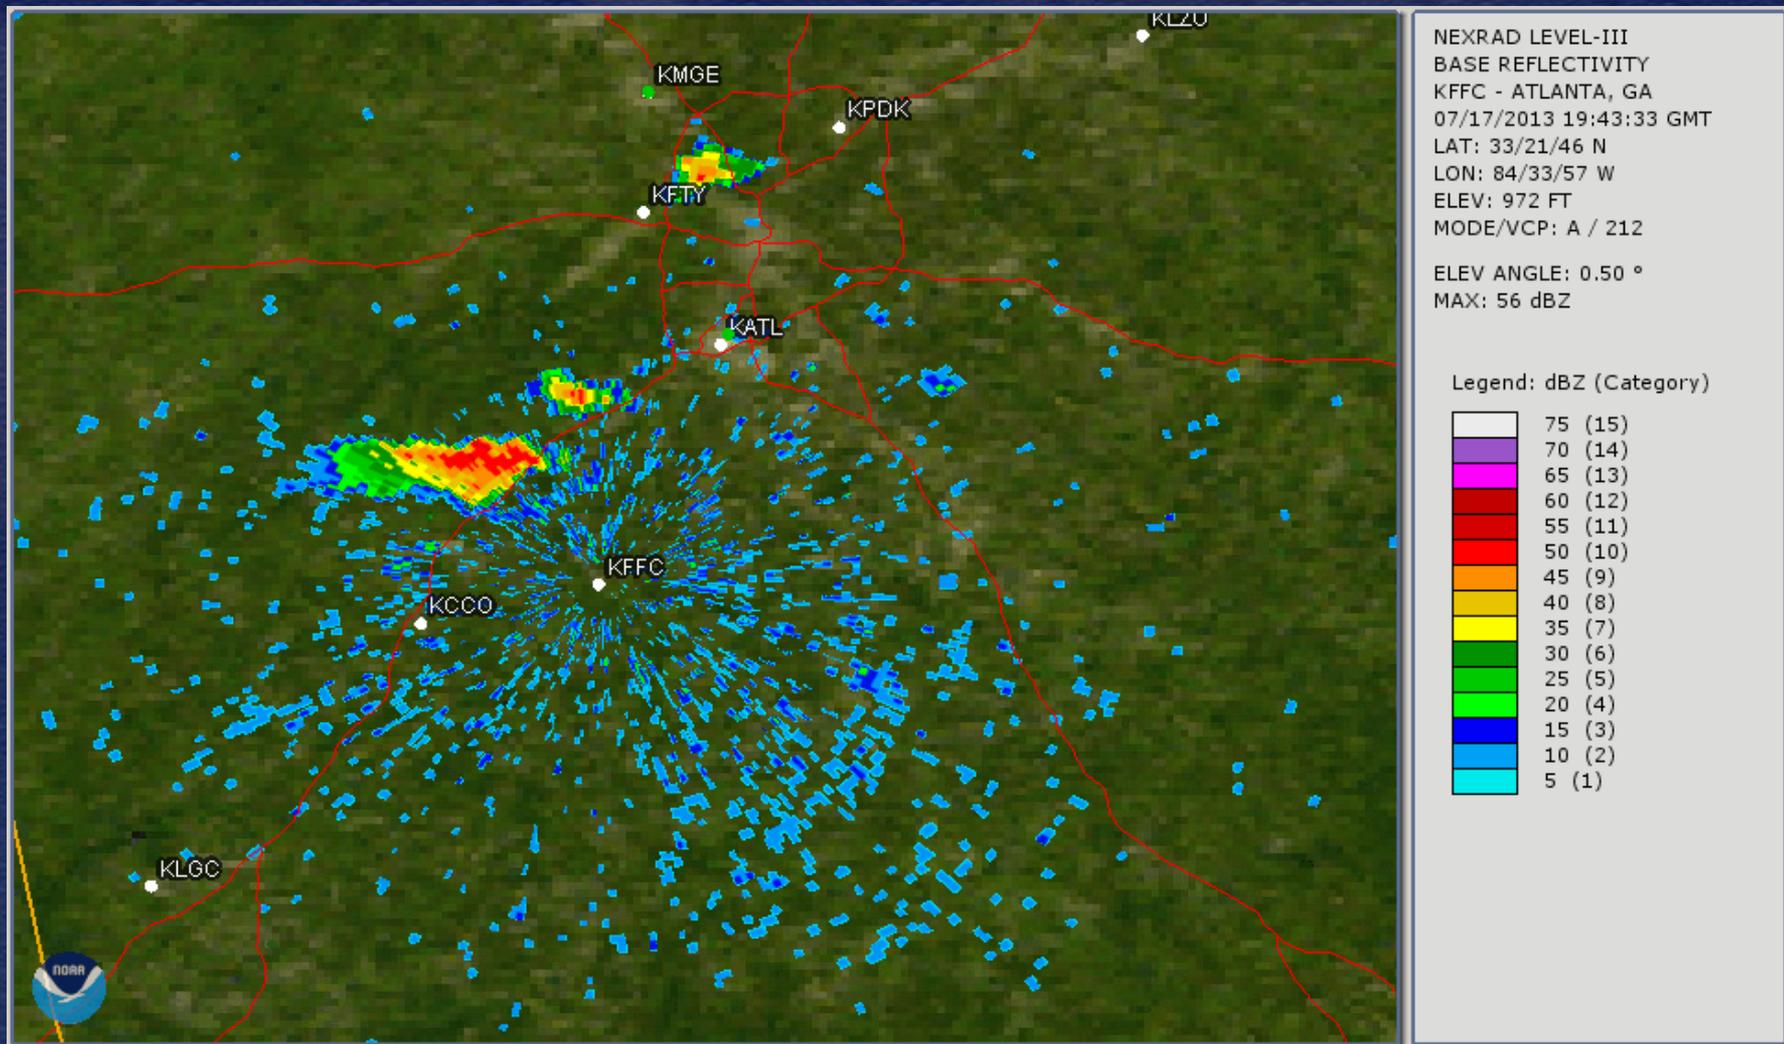
Atlanta, GA - Outflow boundary example

July 17, 2013

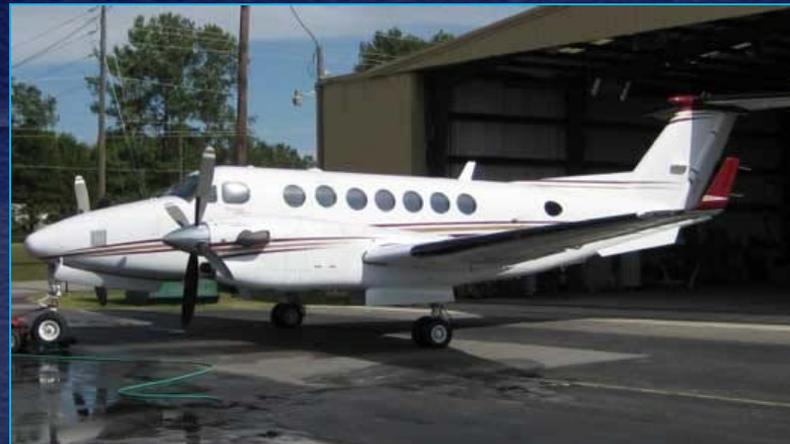
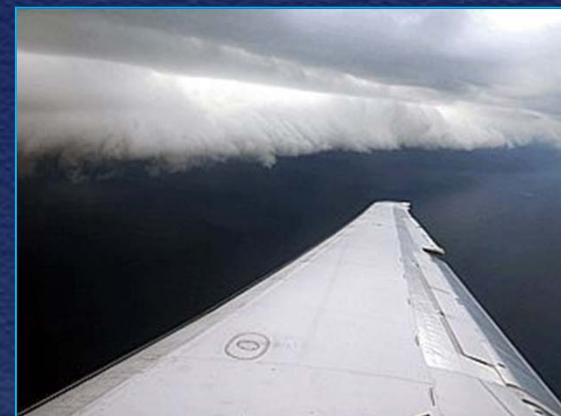
LAX08LA105

Tuscaloosa, AL

King Air, N900WP

April 4, 2008

- Approaching airport at 3,000 feet flew under shelf cloud and encountered severe turbulence and lost several hundred feet before regaining control.
- Structural damage to wing spar
- Squall line west of airport
- Fine line echoes 5-10 dBZ

**KTCL 04145 CDT 32025G33KT 2SM -TSRA
SCT029 BKN040 OVC075 20/14 A2986 RMK A02
PK WND 31033/1952 LTG DSNT SW AND W
TSB1950RAB52 PRESRR P0006**
