NTSB National Transportation Safety Board

General Aviation Weather Related Accidents

Donald Eick (“Ike”)

NTSB Senior Meteorologist

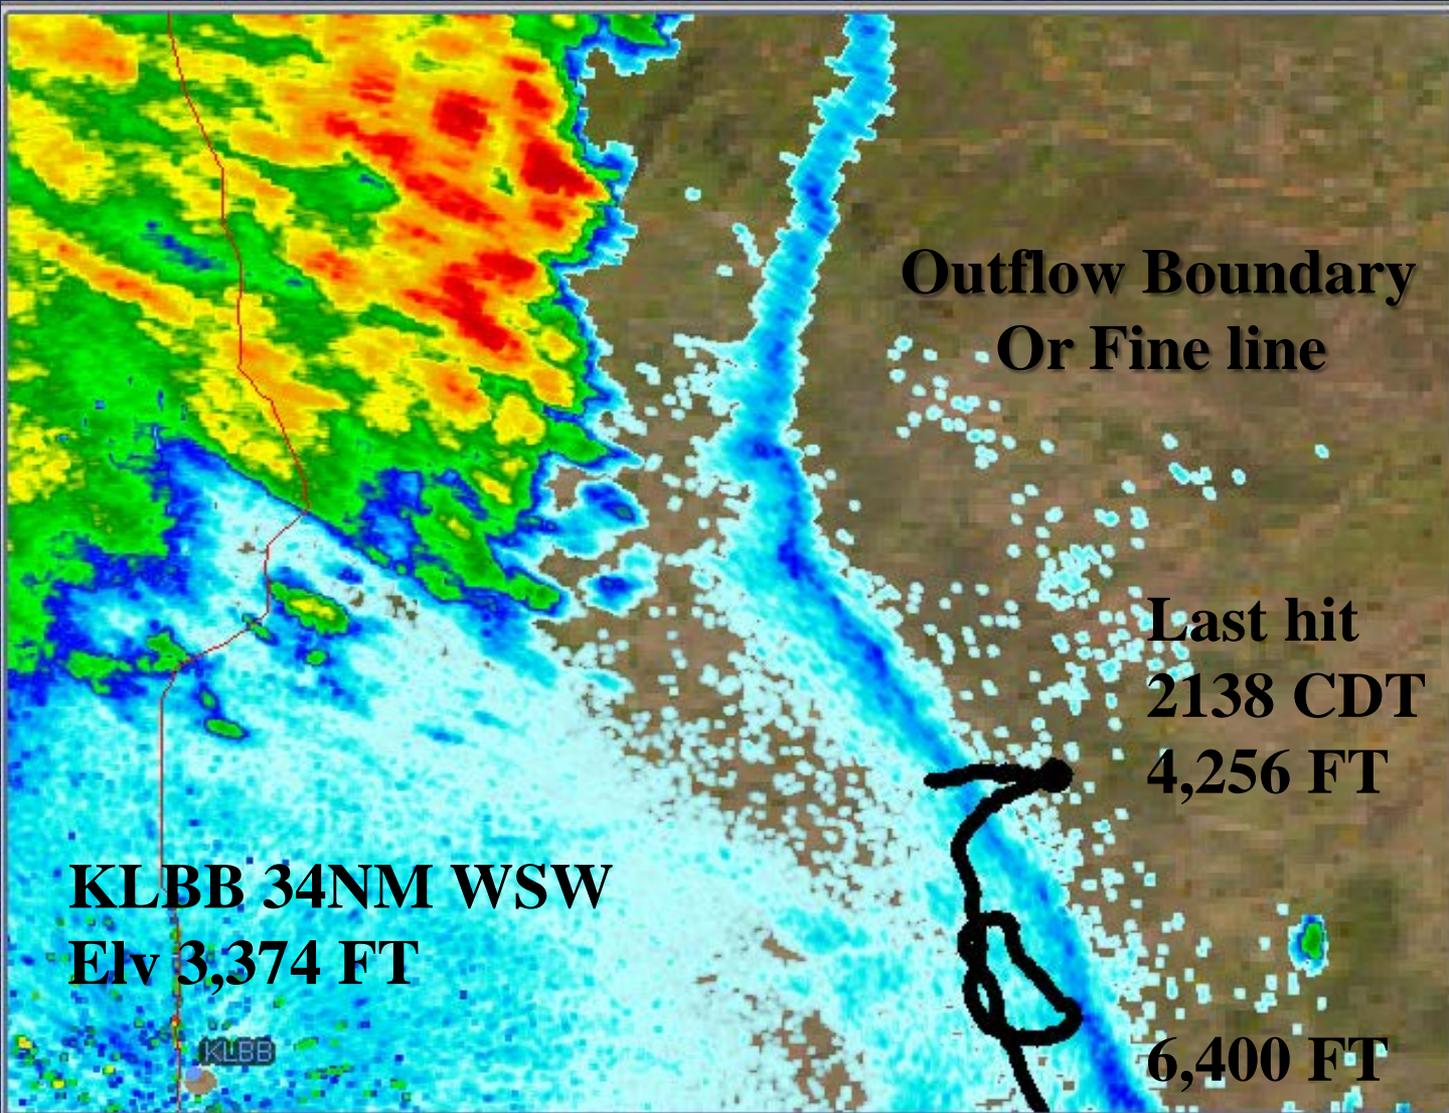
NEXRAD LEVEL-II
 KLBB - LUBBOCK, TX
 06/19/2009 02:40:33 GMT
 LAT: 33/39/14 N
 LON: 101/48/50 W
 ELEV: 3259 FT
 VCP: 12
 REFLECTIVITY
 ELEV ANGLE: 0.54

- Part 91 personal VFR flight
- Couple both private pilots
- Houston Southwest (KAXH) to Plainview (KPVX), TX
- No weather briefing/flight plan filed
- Female voice calls UNICOM 2140 CDT weather
 - KPVW 0225Z 27018G33KT 2 1/2SM +RA SCT008 BKN050 OVC065
19/17 A2997 RMK A02 SFC VIS 1 3/4V5
- Aircraft found 2 days later in field
- Fatal 2
- Witnesses reported winds gusting 60 KT, blowing dust & sand

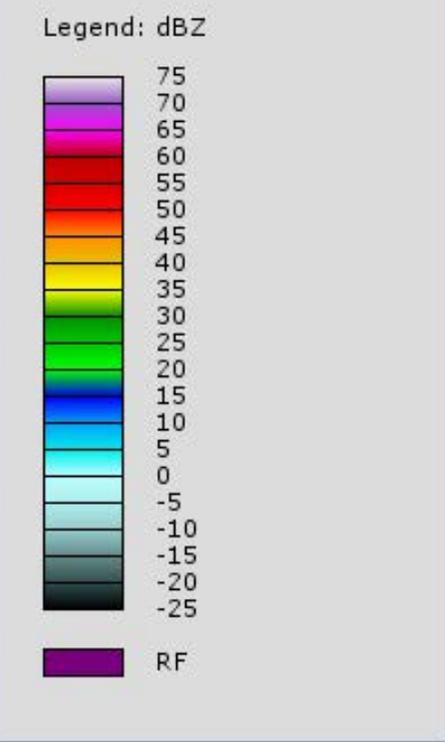
Flight path and “Outflow Boundary/Fine Line” location
 KLBB 26037G51KT 3/4SM BLDU SCT030 BKN070 24/14 A2990
 55 RMK CB DSNT W-NW

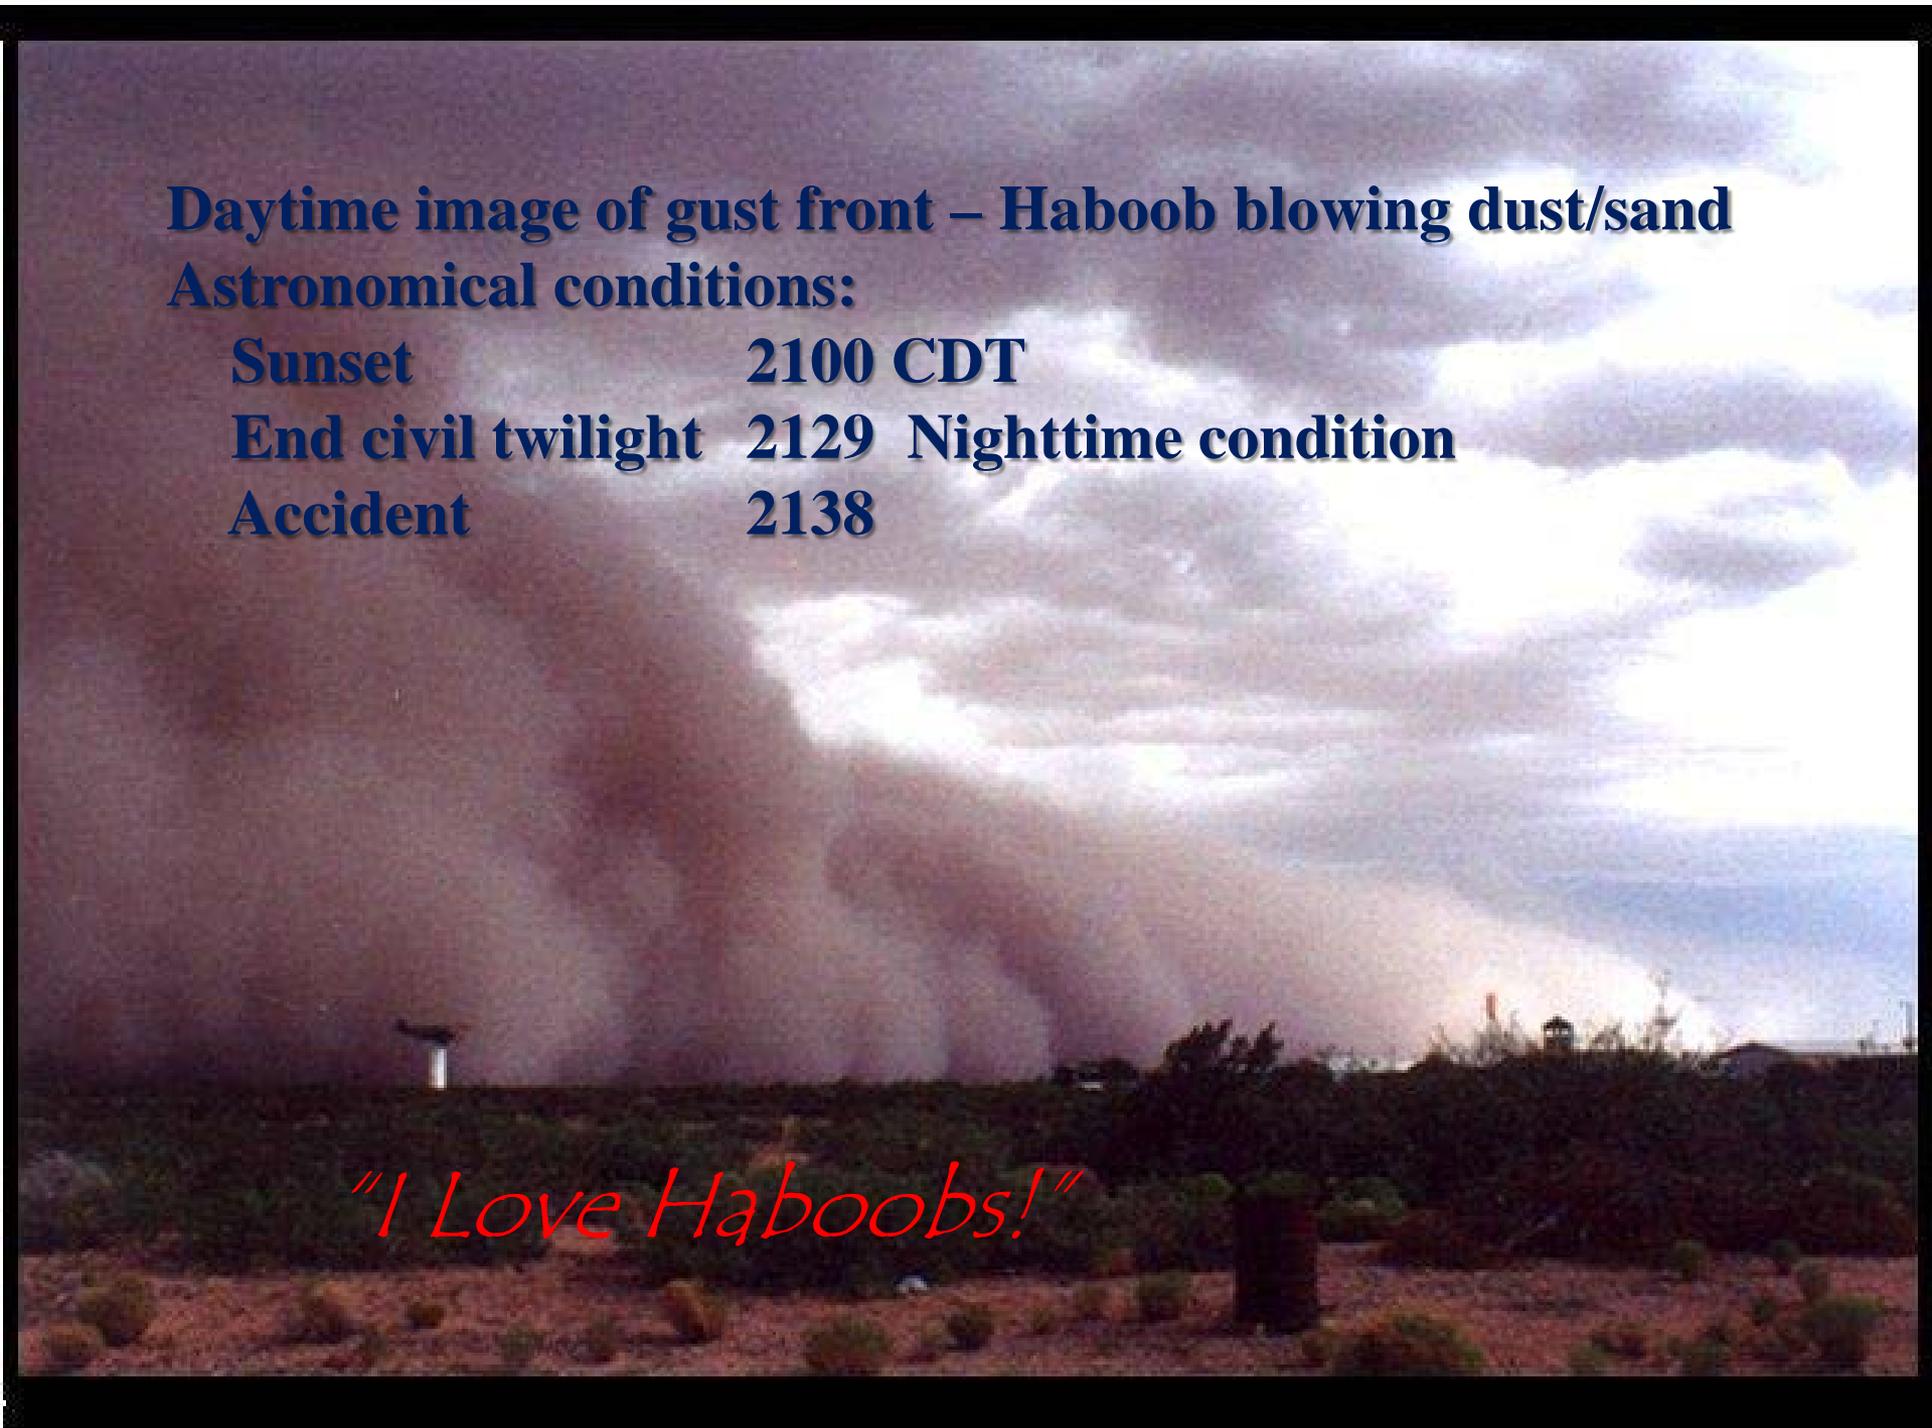
Daytime image of gust front – Haboob blowing dust/sand

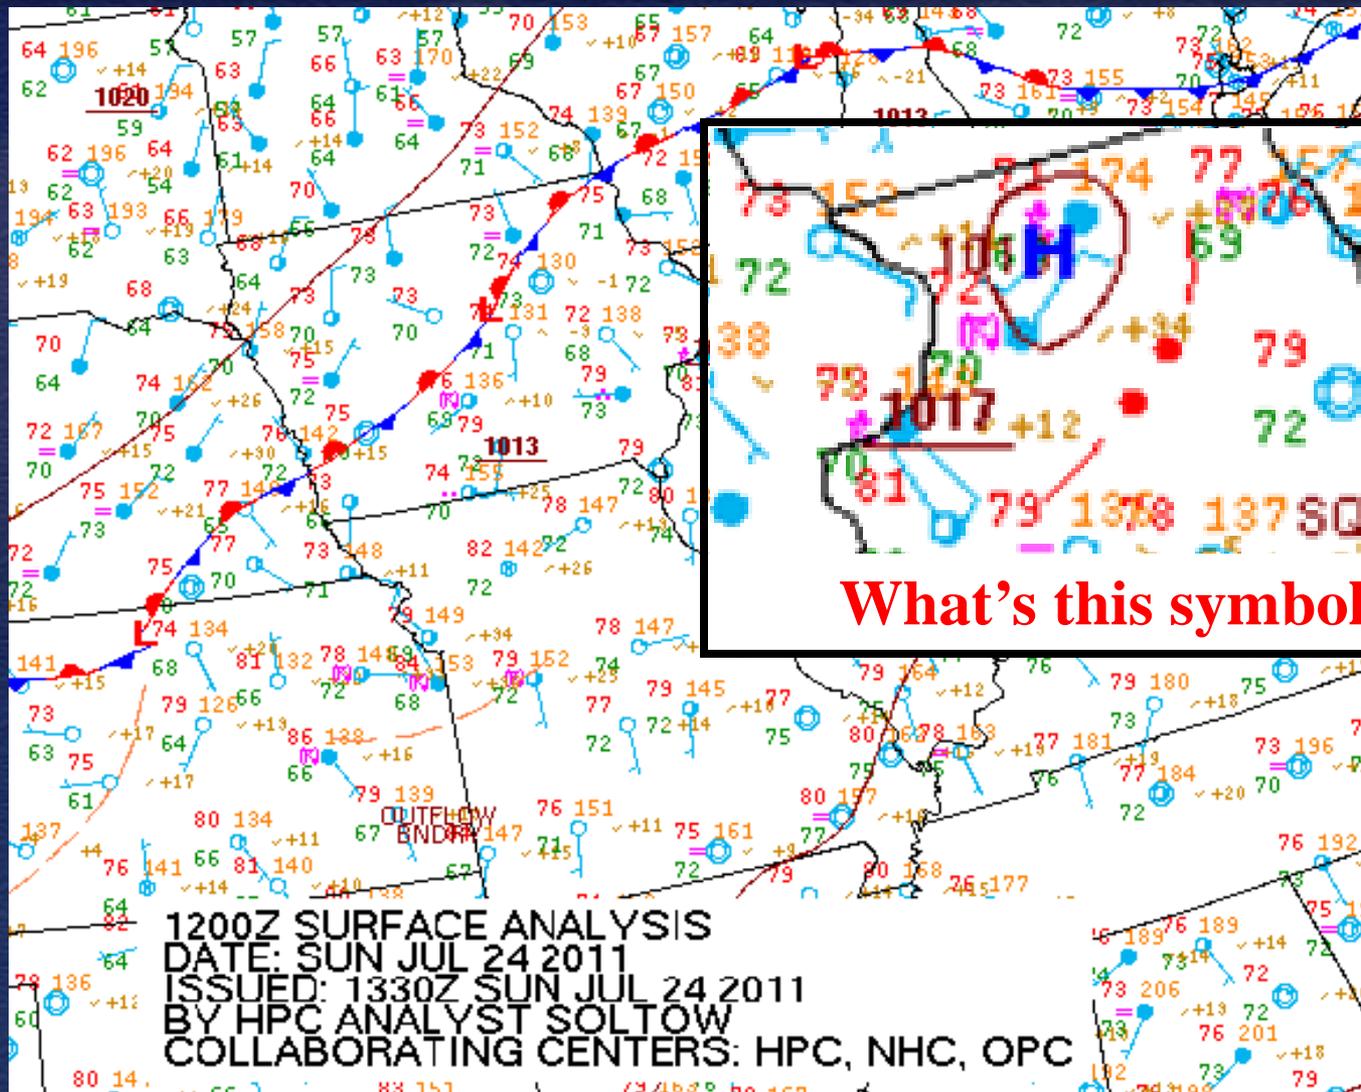
Surface Analysis

What's this symbol?

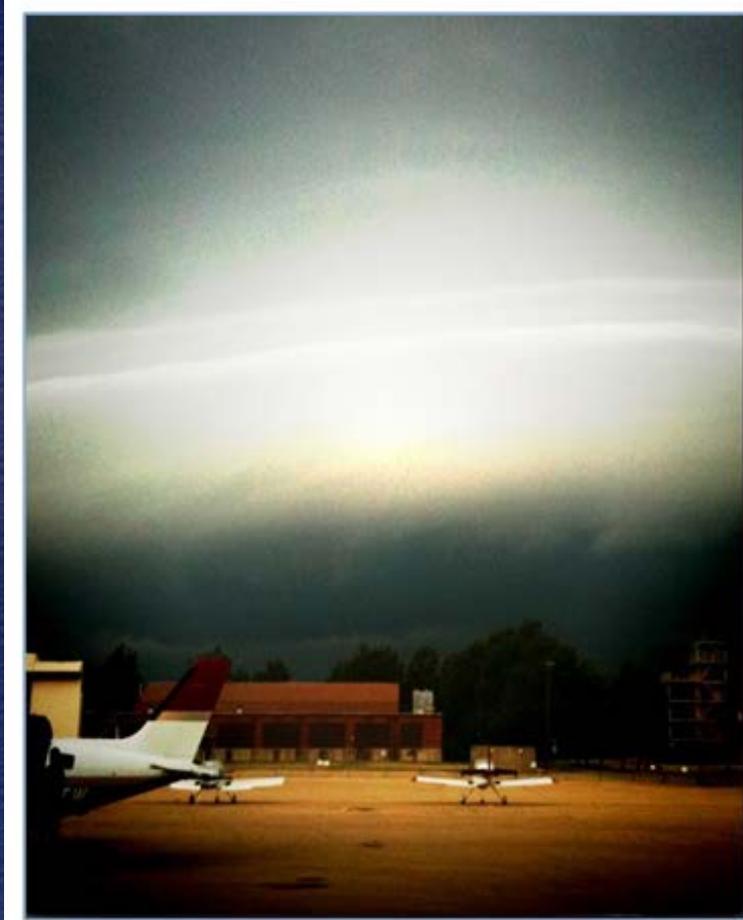
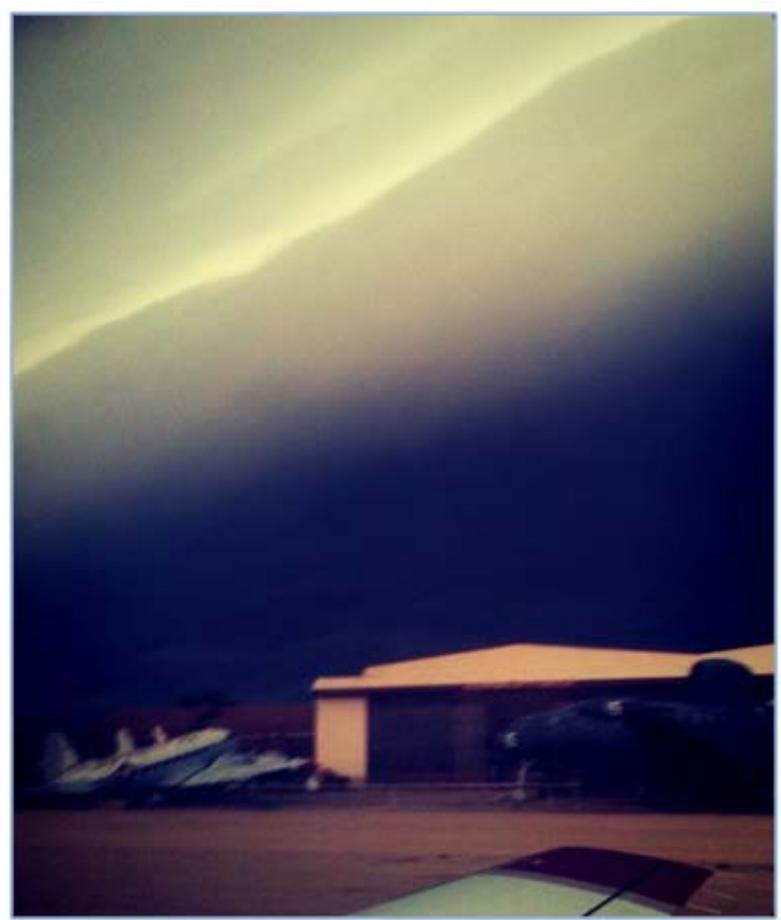
Photo's taken by passenger on board accident airplane

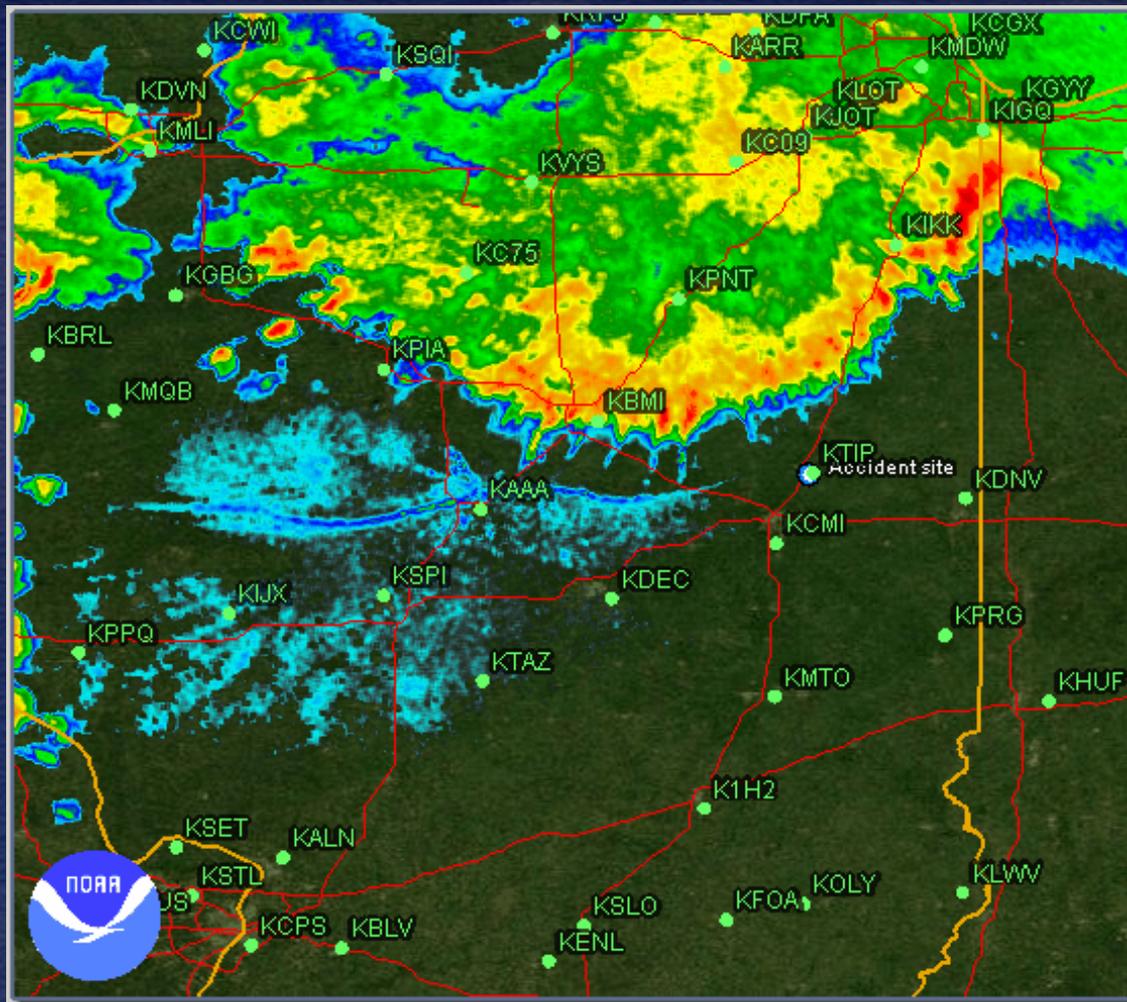
NEXRAD LEVEL-II
KILX - LINCOLN, IL
07/24/2011 14:02:51 GMT
LAT: 40/09/02 N
LON: 89/20/12 W
ELEV: 581 FT
VCP: 212

REFLECTIVITY
ELEV ANGLE: 0.47

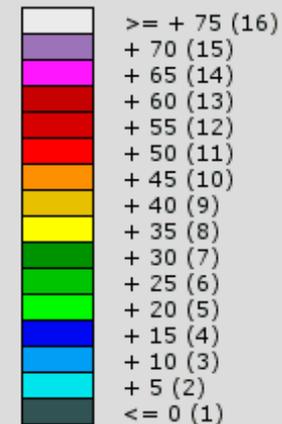
1,163 lightning strikes within 30NM and 15-min of accident

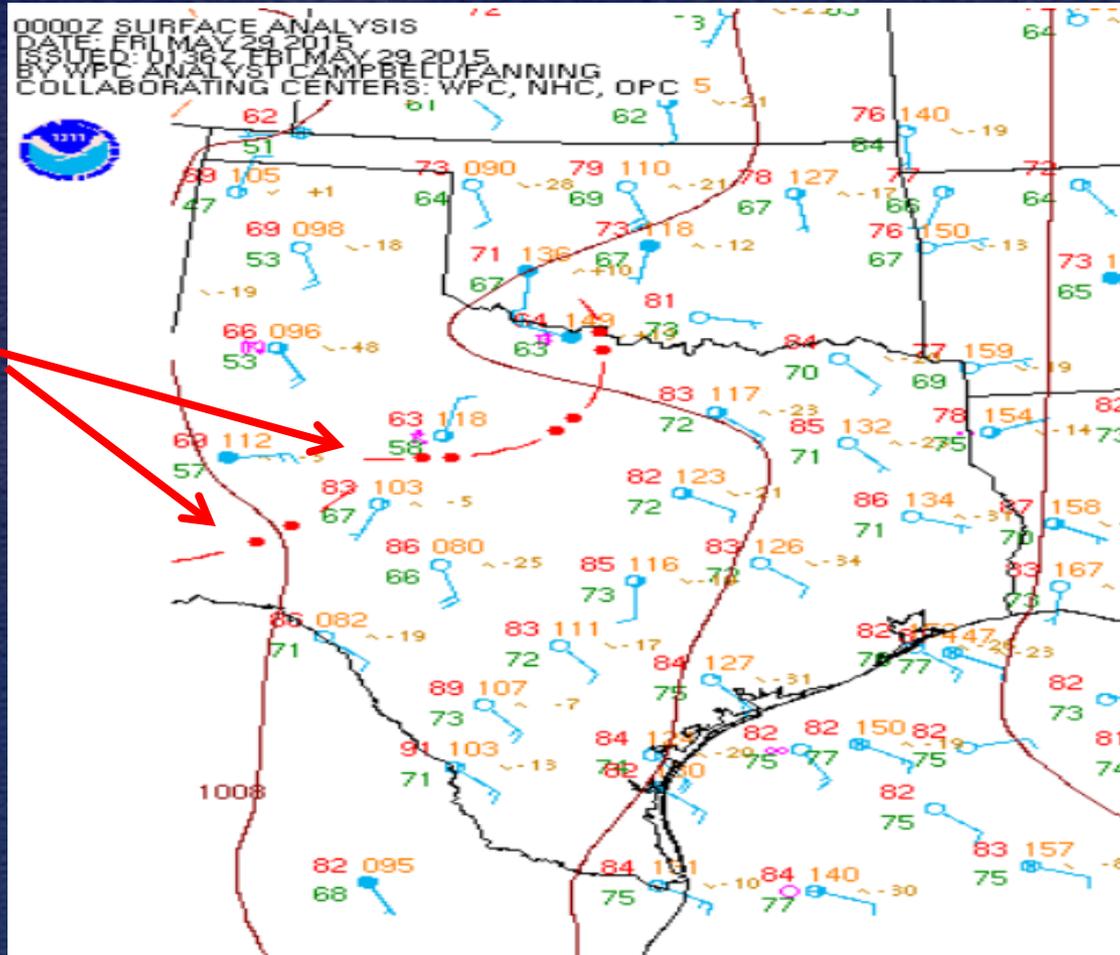
CEN15FA245 – Plainview, TX Synoptic Conditions

What's this
symbol?

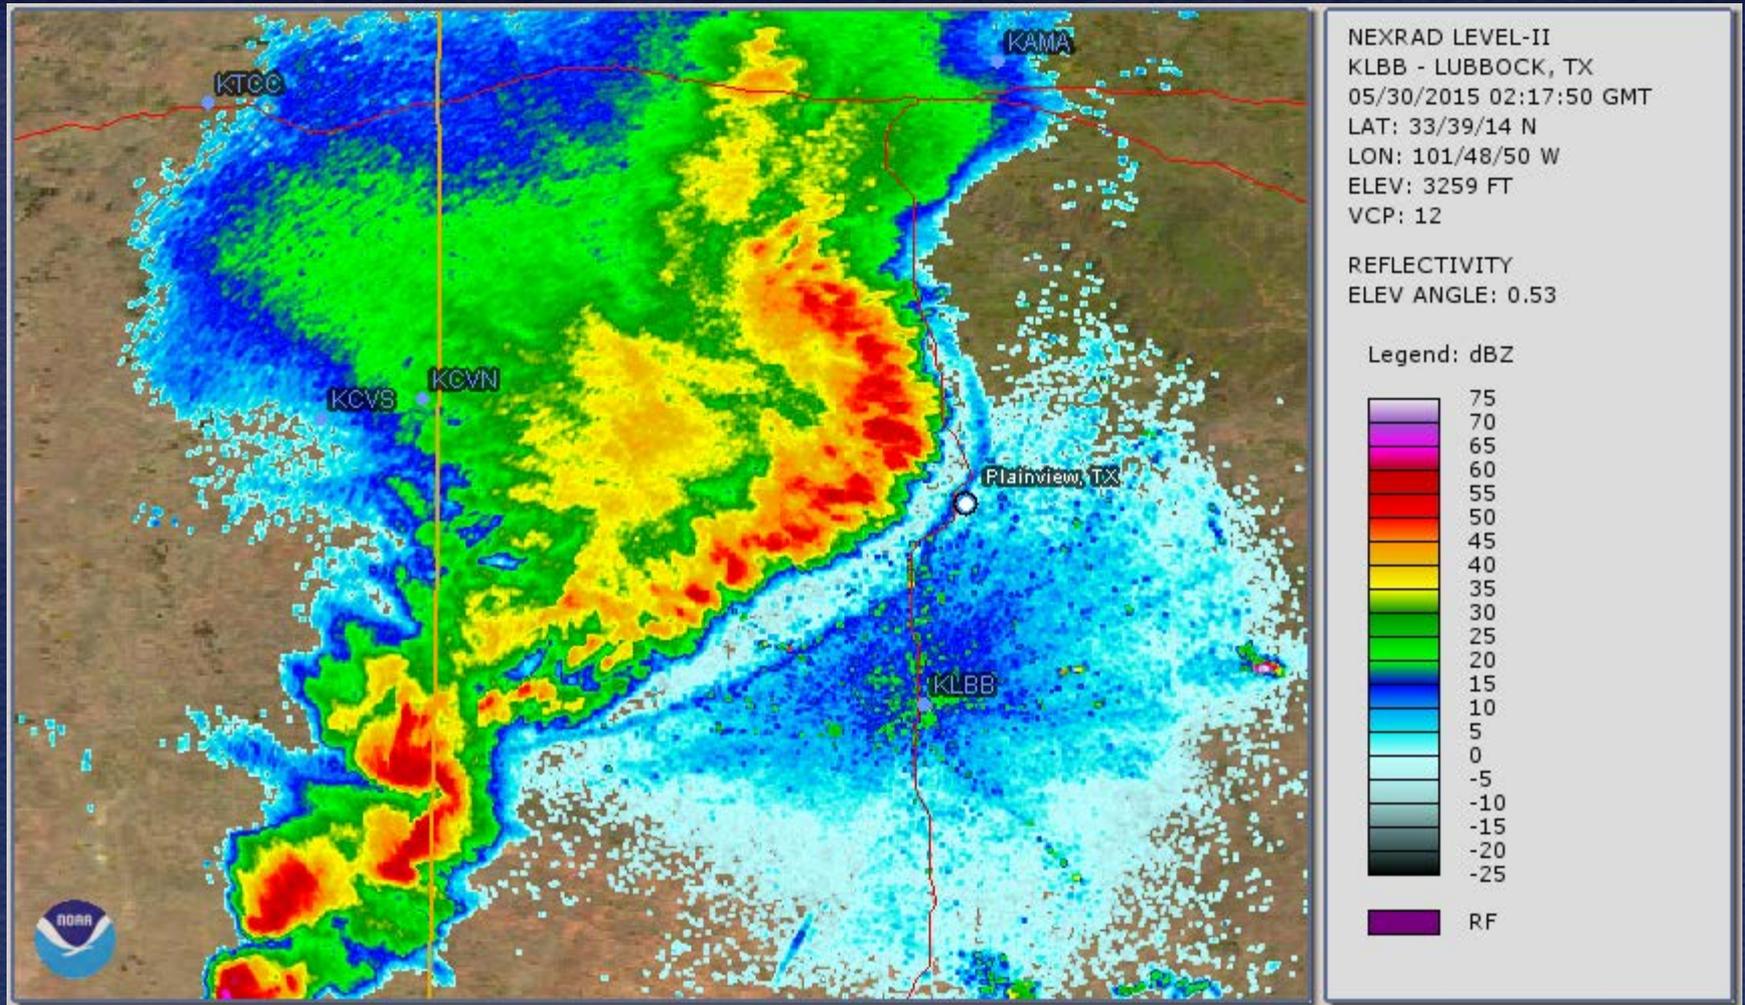
- KLBB WSR-88D 0.5° base reflectivity image at 0217Z

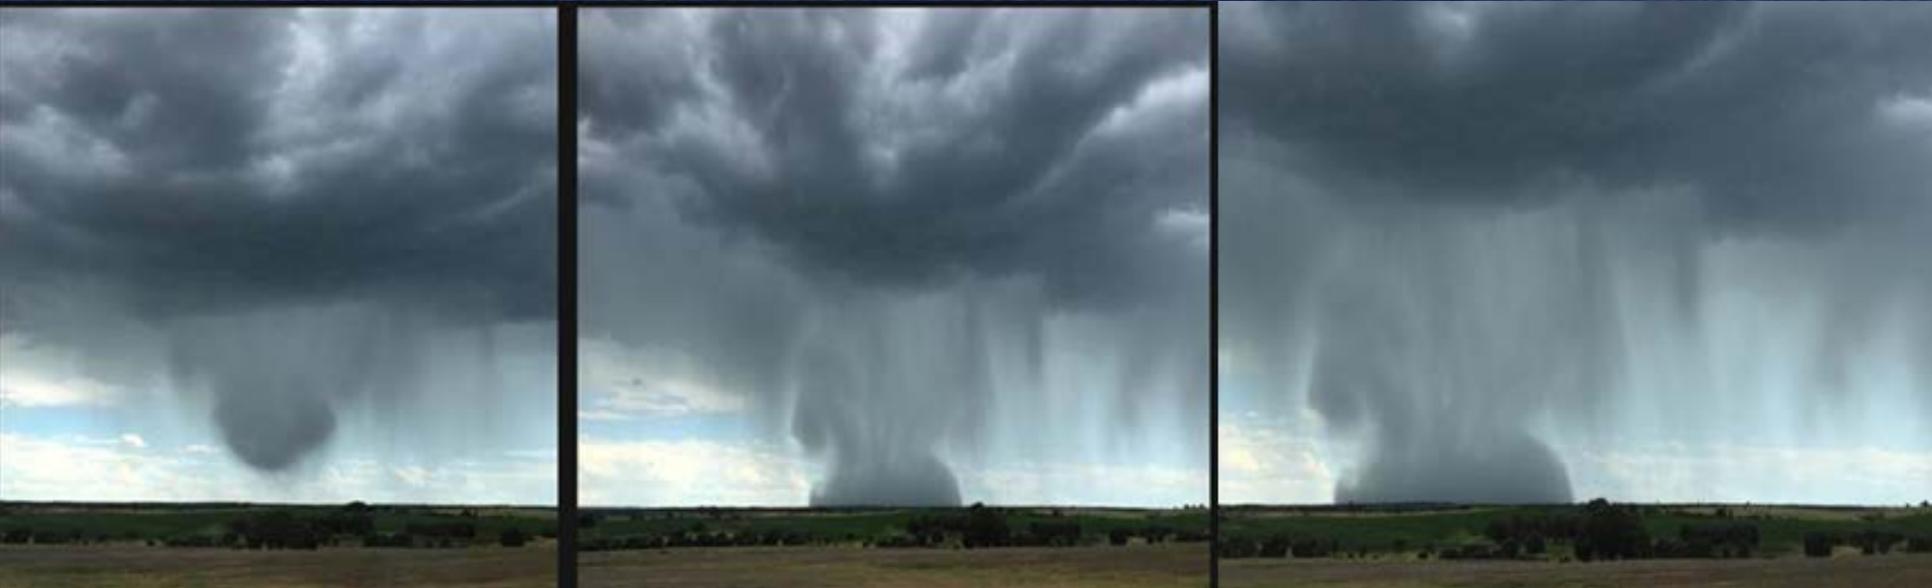
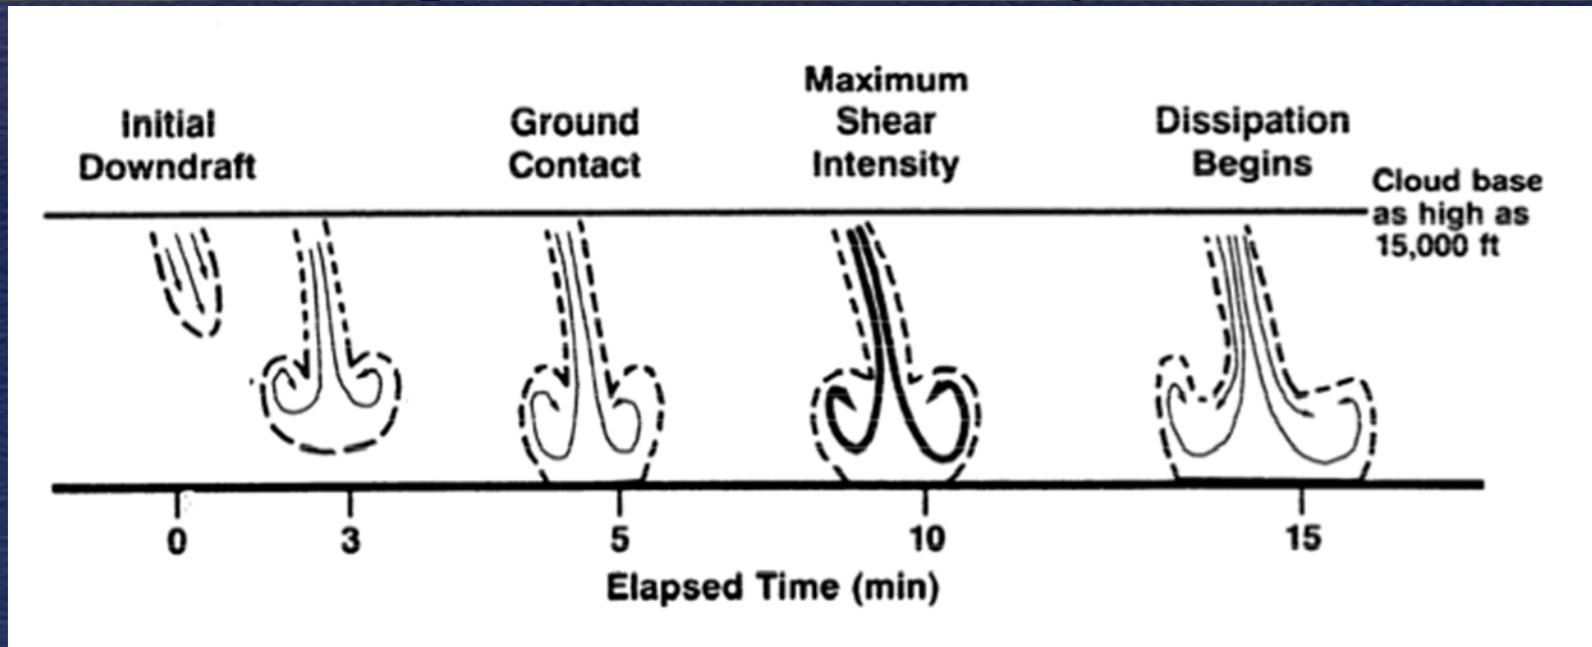
Downdrafts can exceed 6,000 FPM

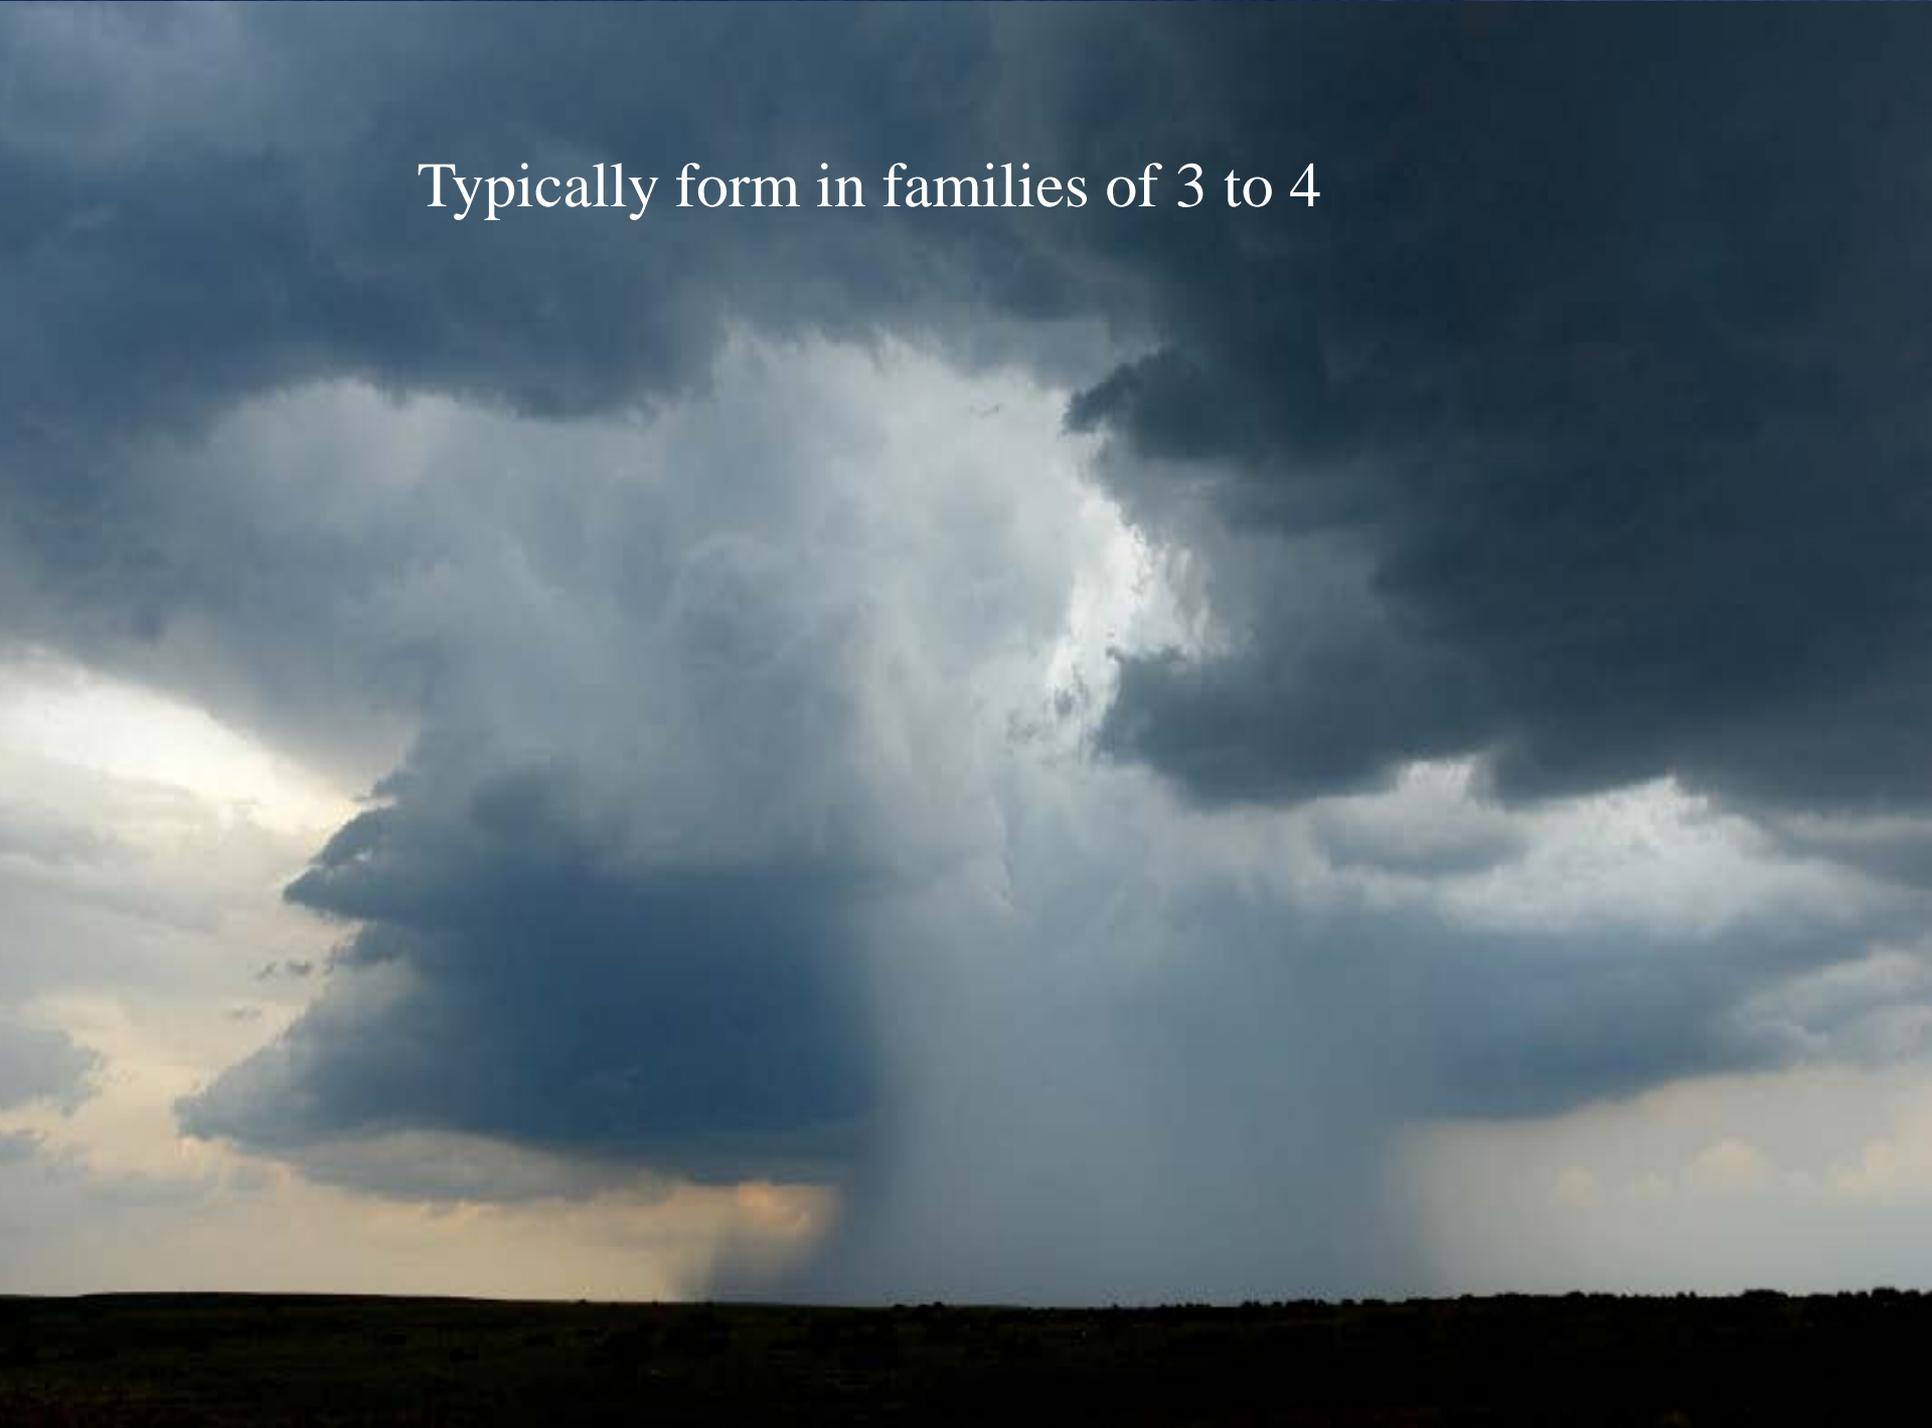
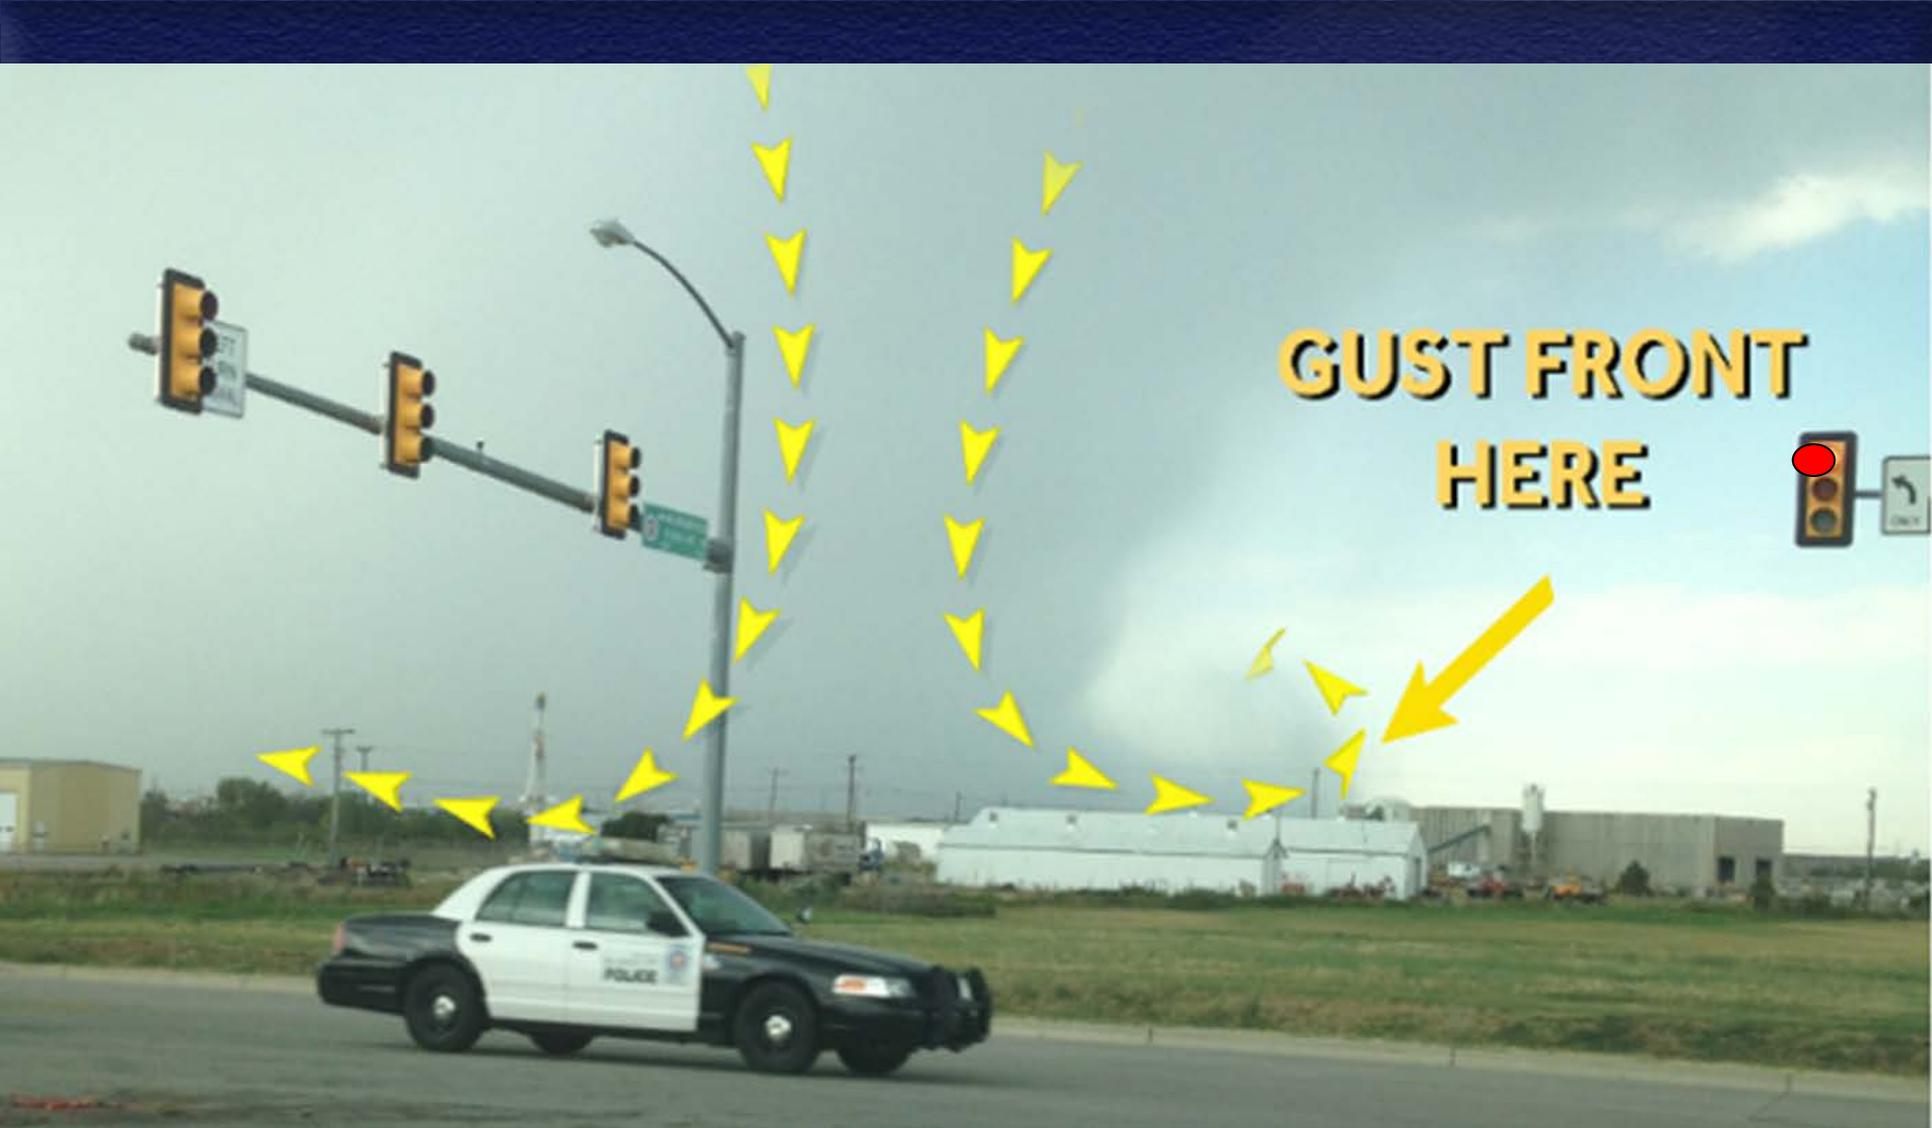
Typically form in families of 3 to 4

**GUST FRONT
HERE**

Sign posts in the sky!

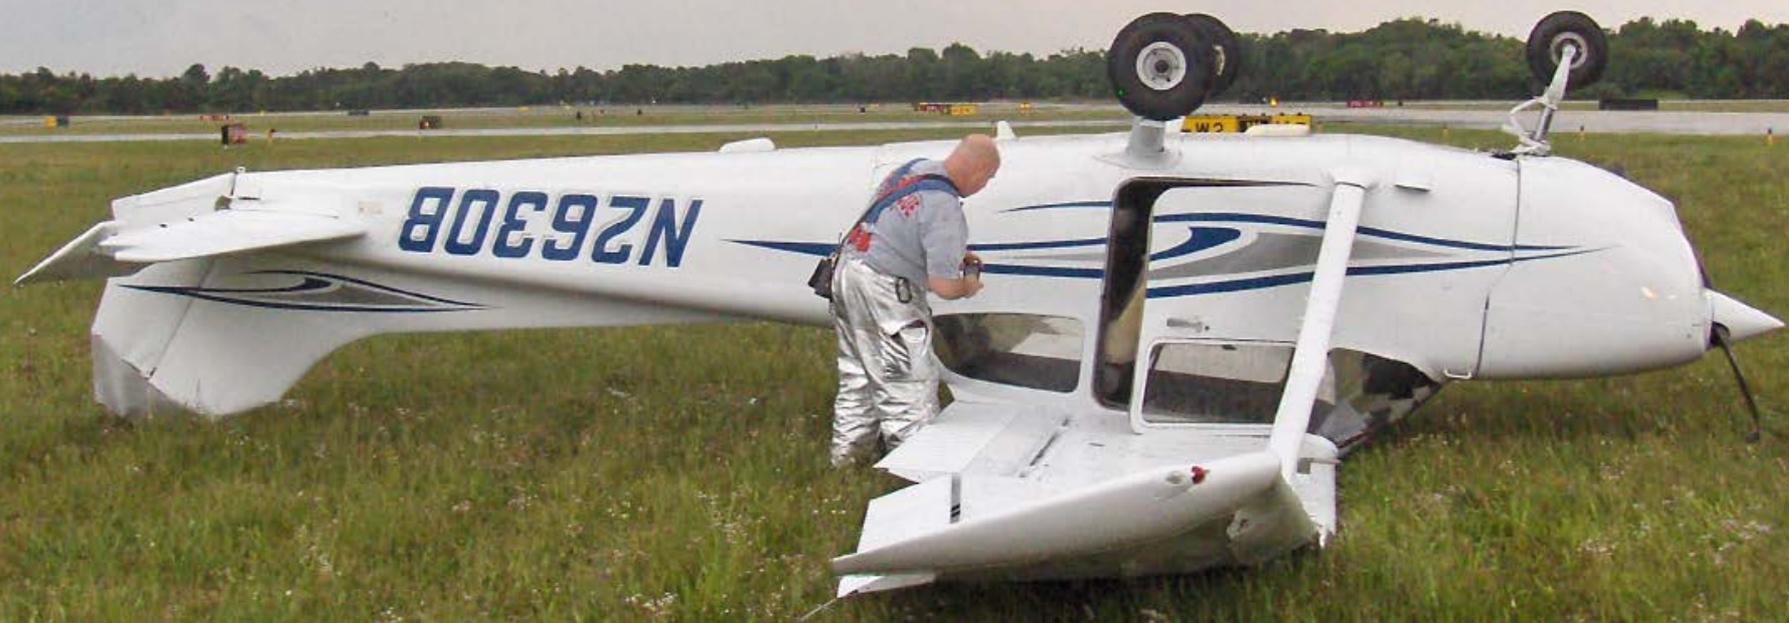
- Part 91 instructional flight
- Aircraft just landed, clearing active runway when thunderstorm impacted the field
- Aircraft flipped over inverted, substantial damage
- ATC indicated **microburst alert** with winds surges at 48 knots gusts 64 knots
- Substantial damage
- 2 shaken but uninjured pilots
- NTSB limited investigation

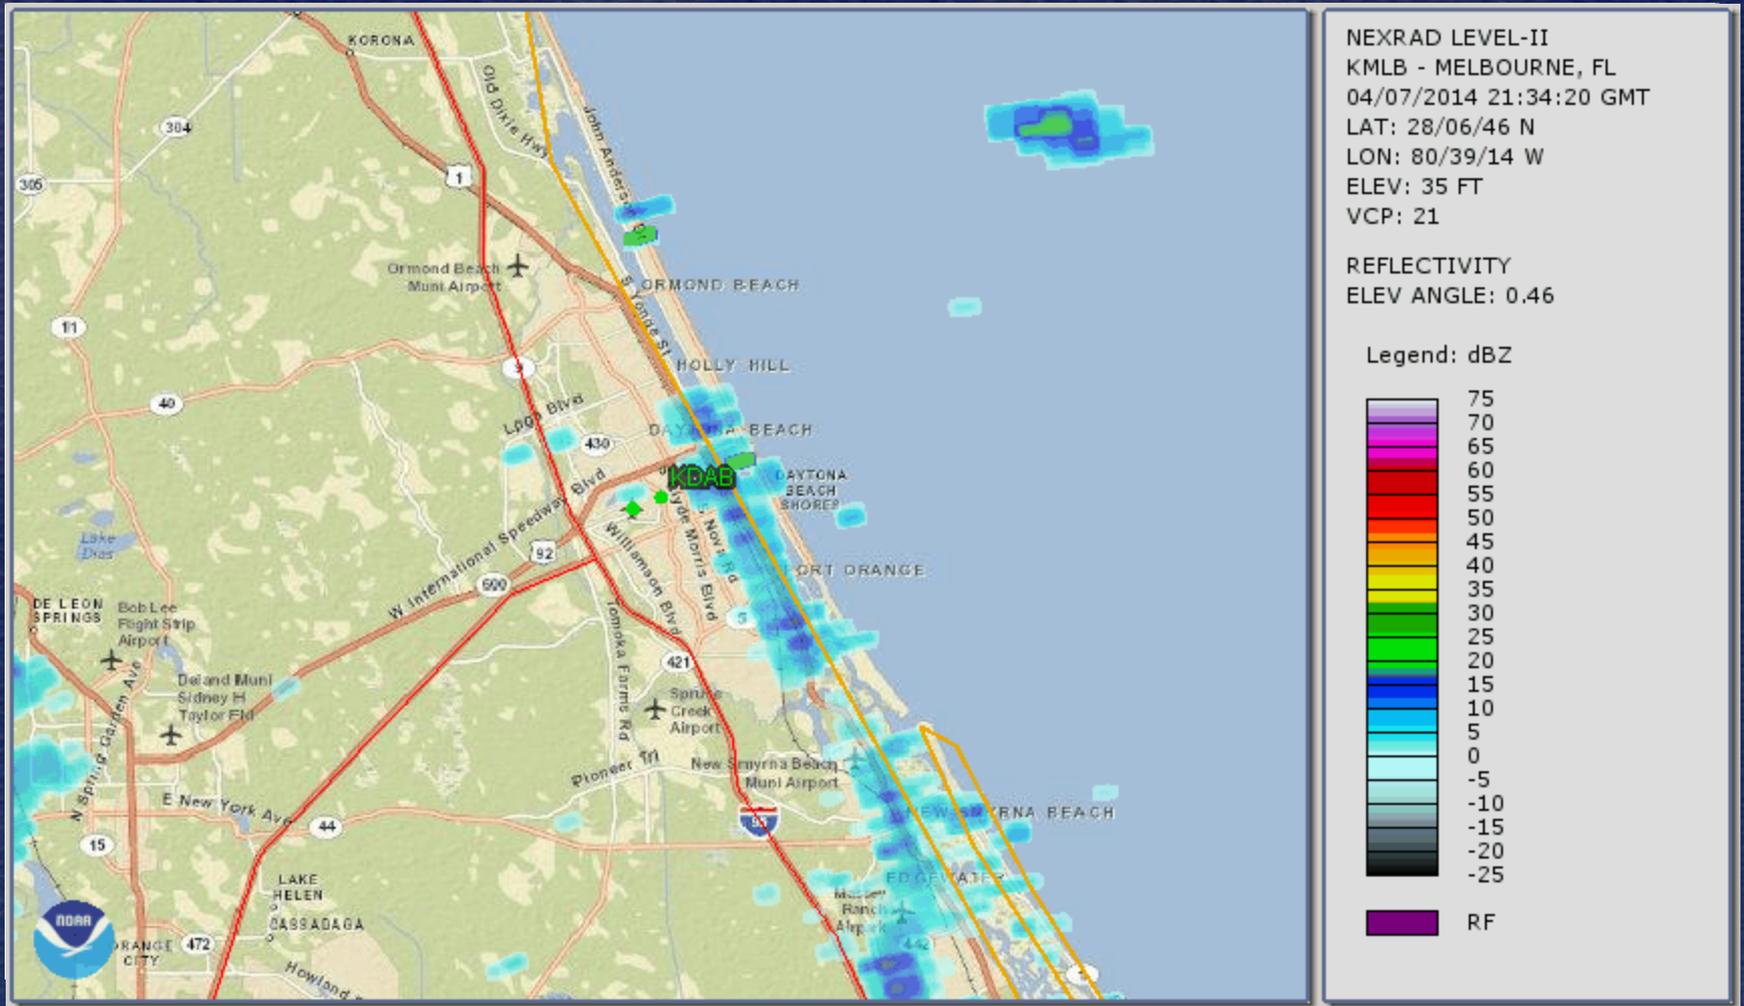
ERA14CA184 – Daytona Beach, FL WSR-88D Radar Animation

81 Steady-state multicellular/supercell type thunderstorm
