NTSB National Transportation Safety Board

General Aviation Weather Related Accidents

Donald Eick (“Ike”)

NTSB Senior Meteorologist

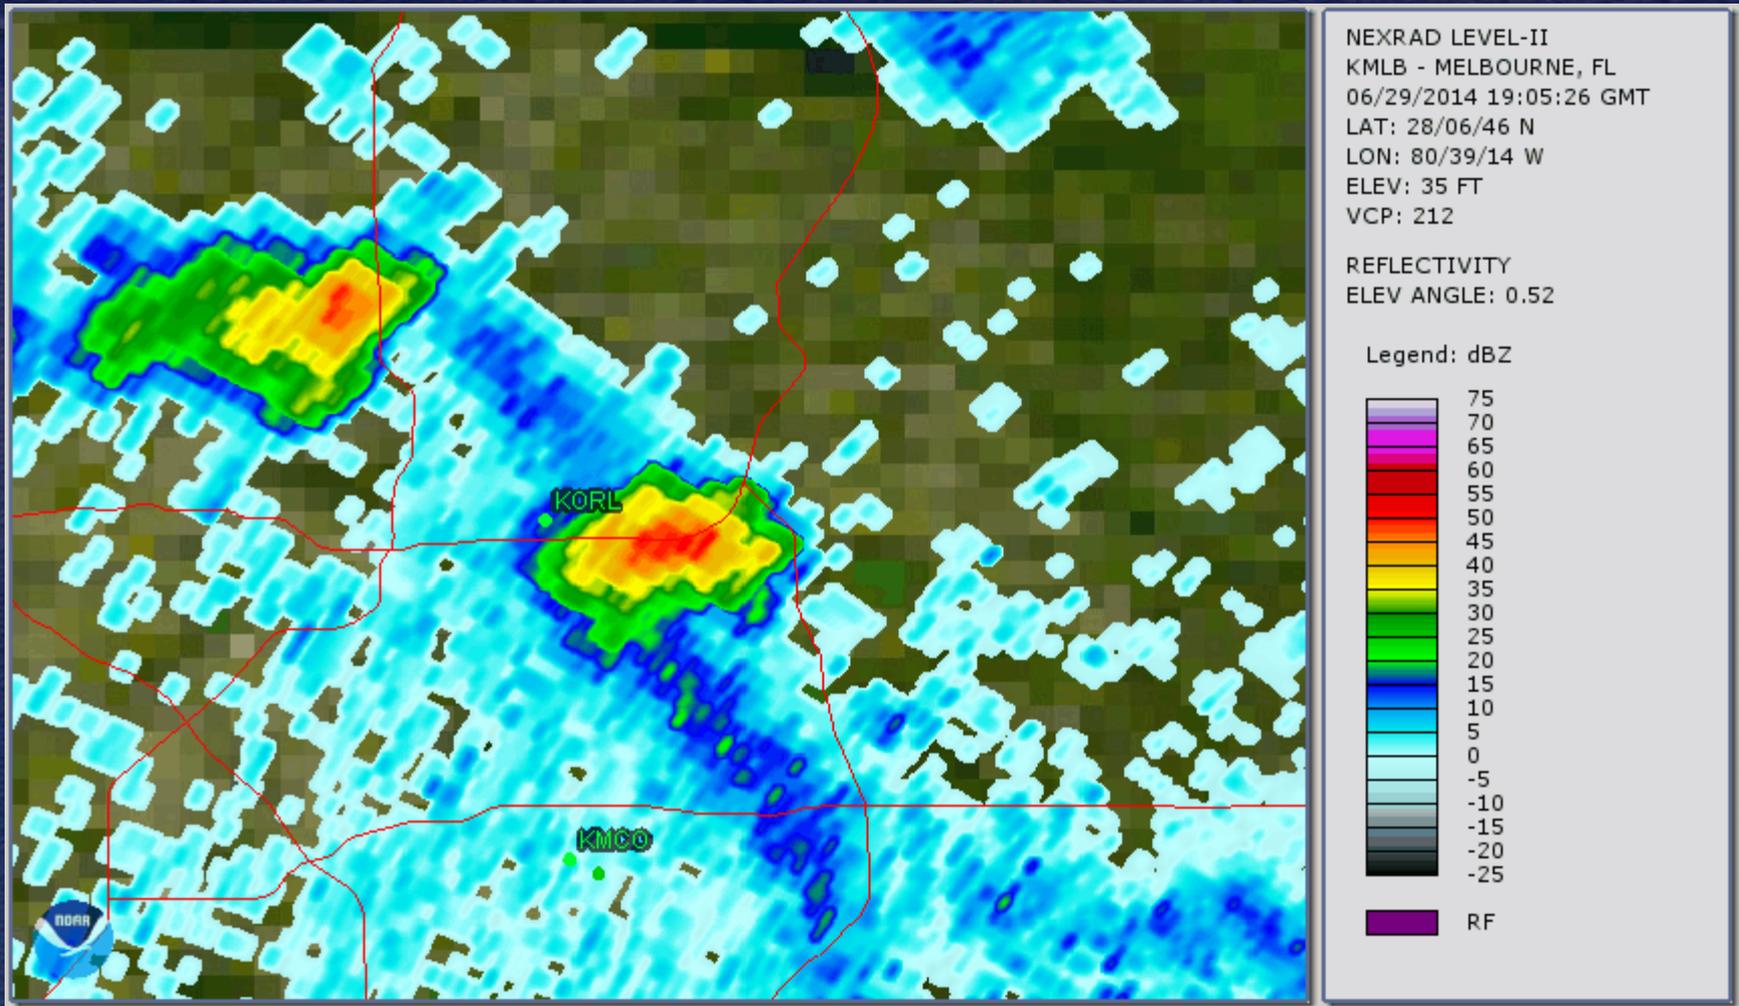
ERA14CA317 – Orlando, FL

- KMLB WSR-88D base reflectivity image at 1527 EDT
- Pulse thunderstorm – short lived microburst storm

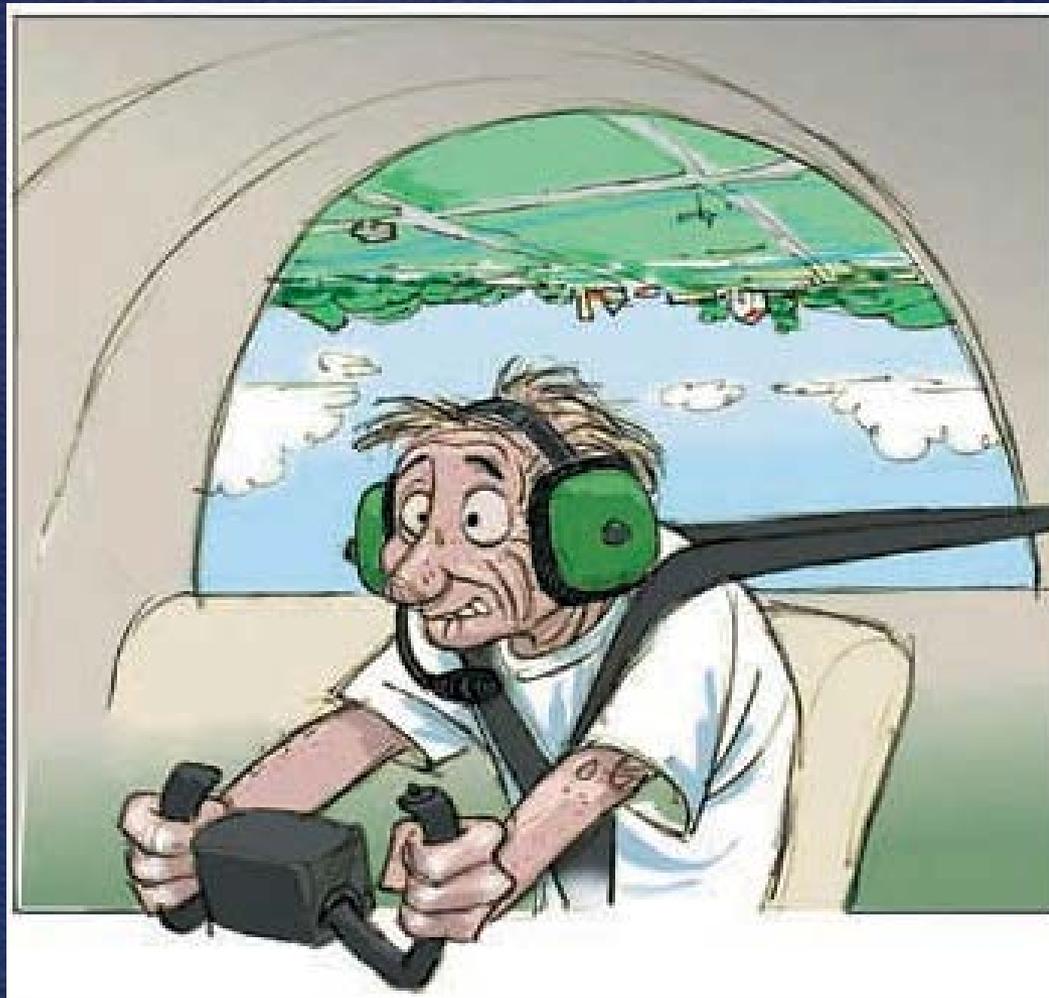
Convectively Induced Turbulence (CIT)

All thunderstorms imply severe or greater turbulence..

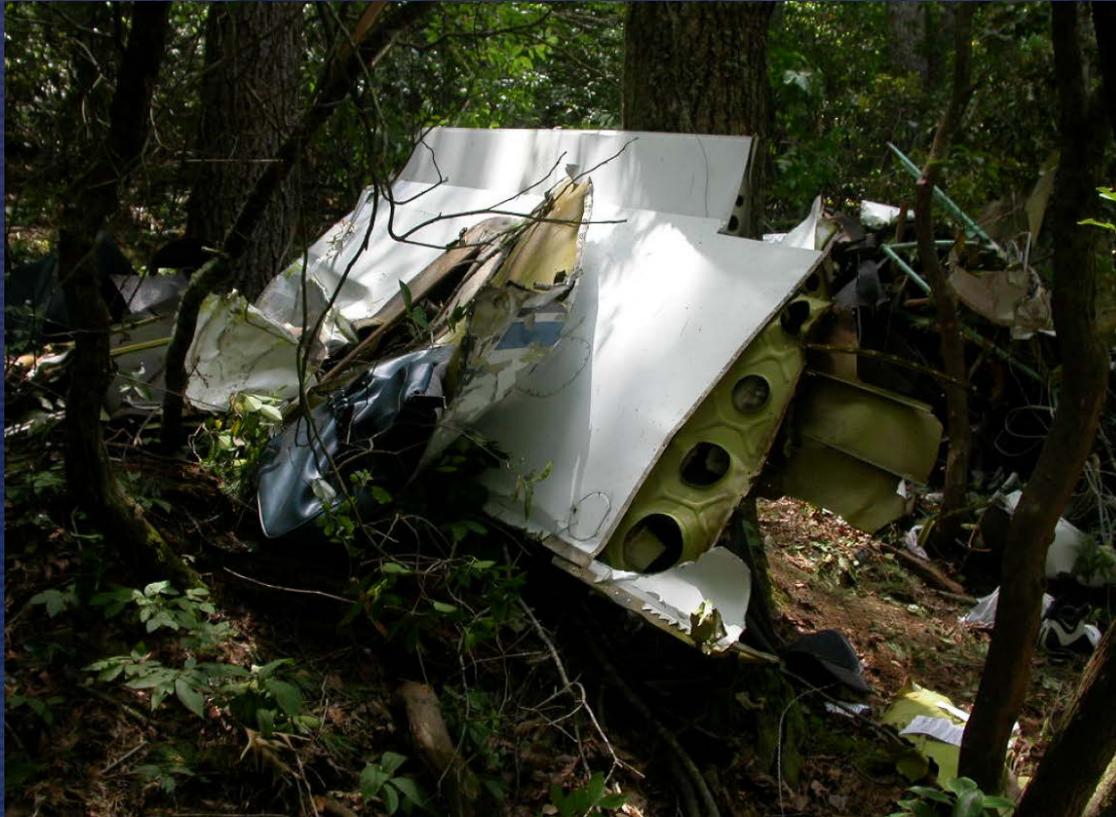
Left wing

Overstress loading on wings and tail, no indications of fatigue

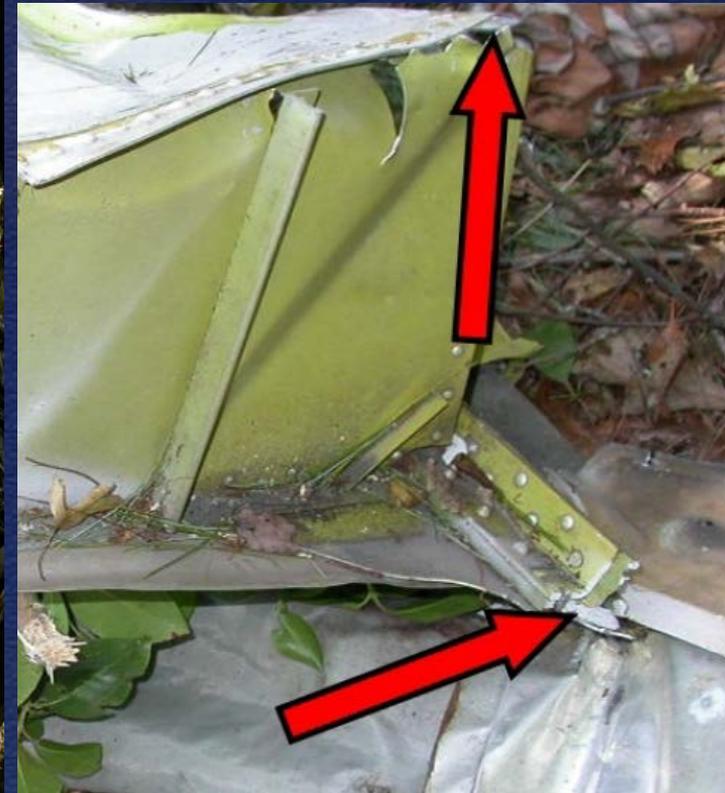
Inboard section of left wing

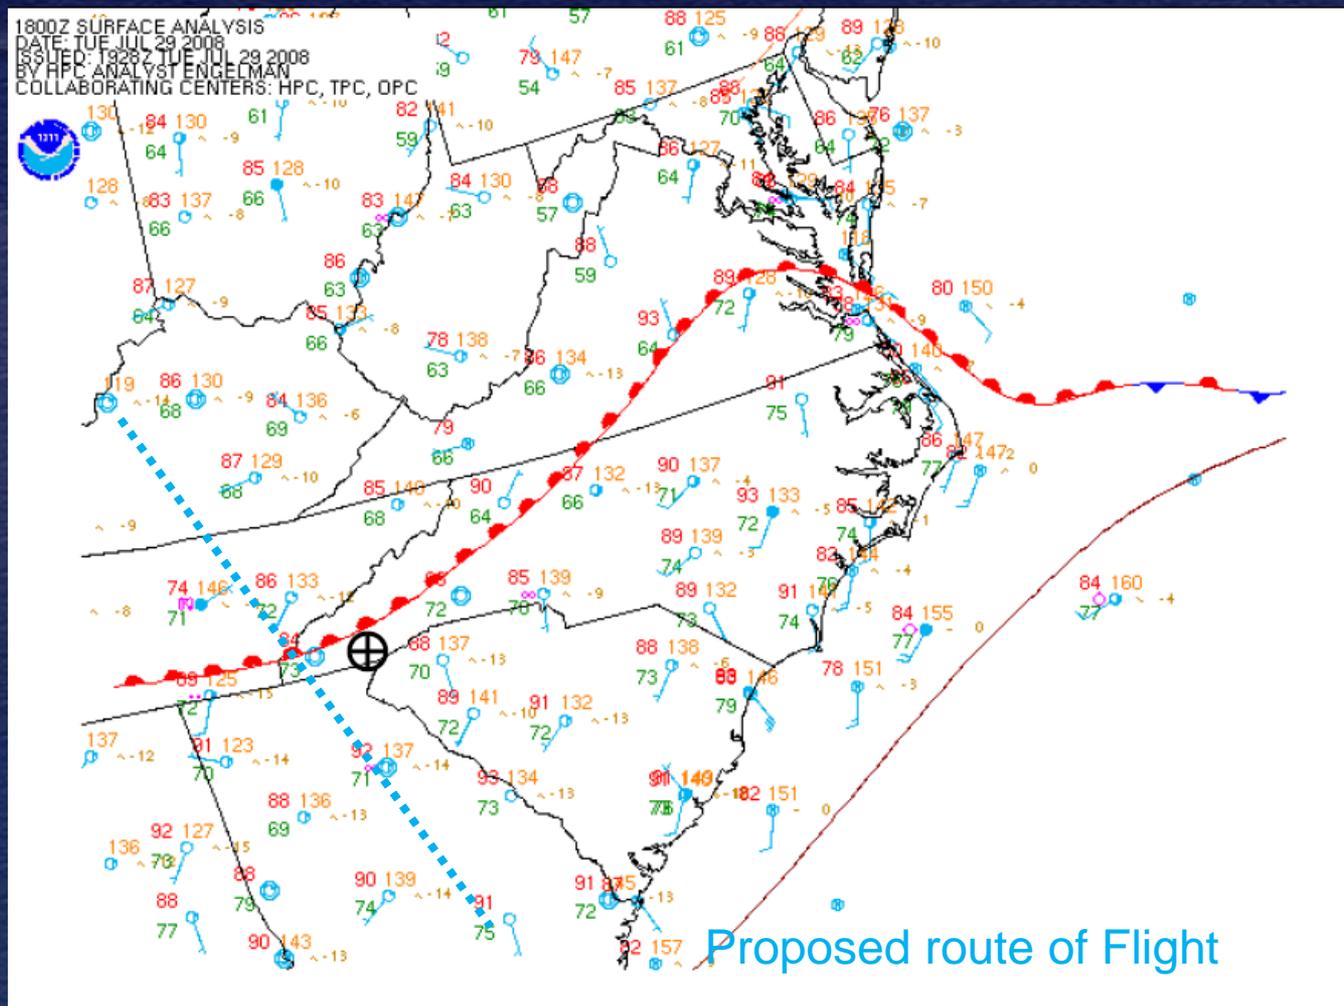
1800Z NWS Surface Analysis Chart warm front in the immediate vicinity

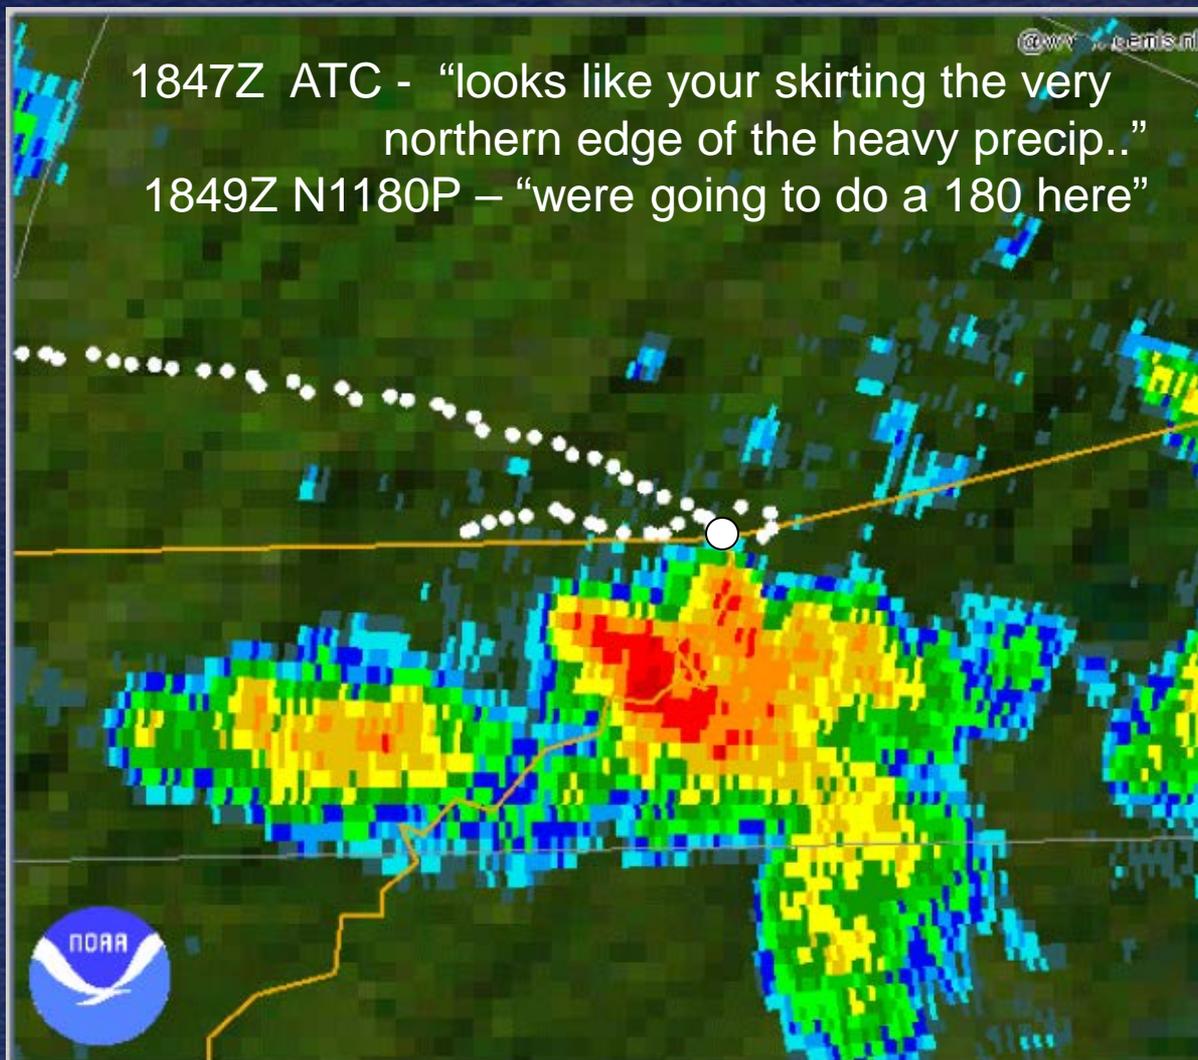
WSR-88D Base Reflectivity Imagery

NEXRAD LEVEL-II
KGSP - GREER, SC
07/29/2008 18:48:53 GMT
LAT: 34/52/59 N
LON: 82/13/11 W
ELEV: 942 FT
VCP: 12

REFLECTIVITY
ELEV ANGLE: 1.37

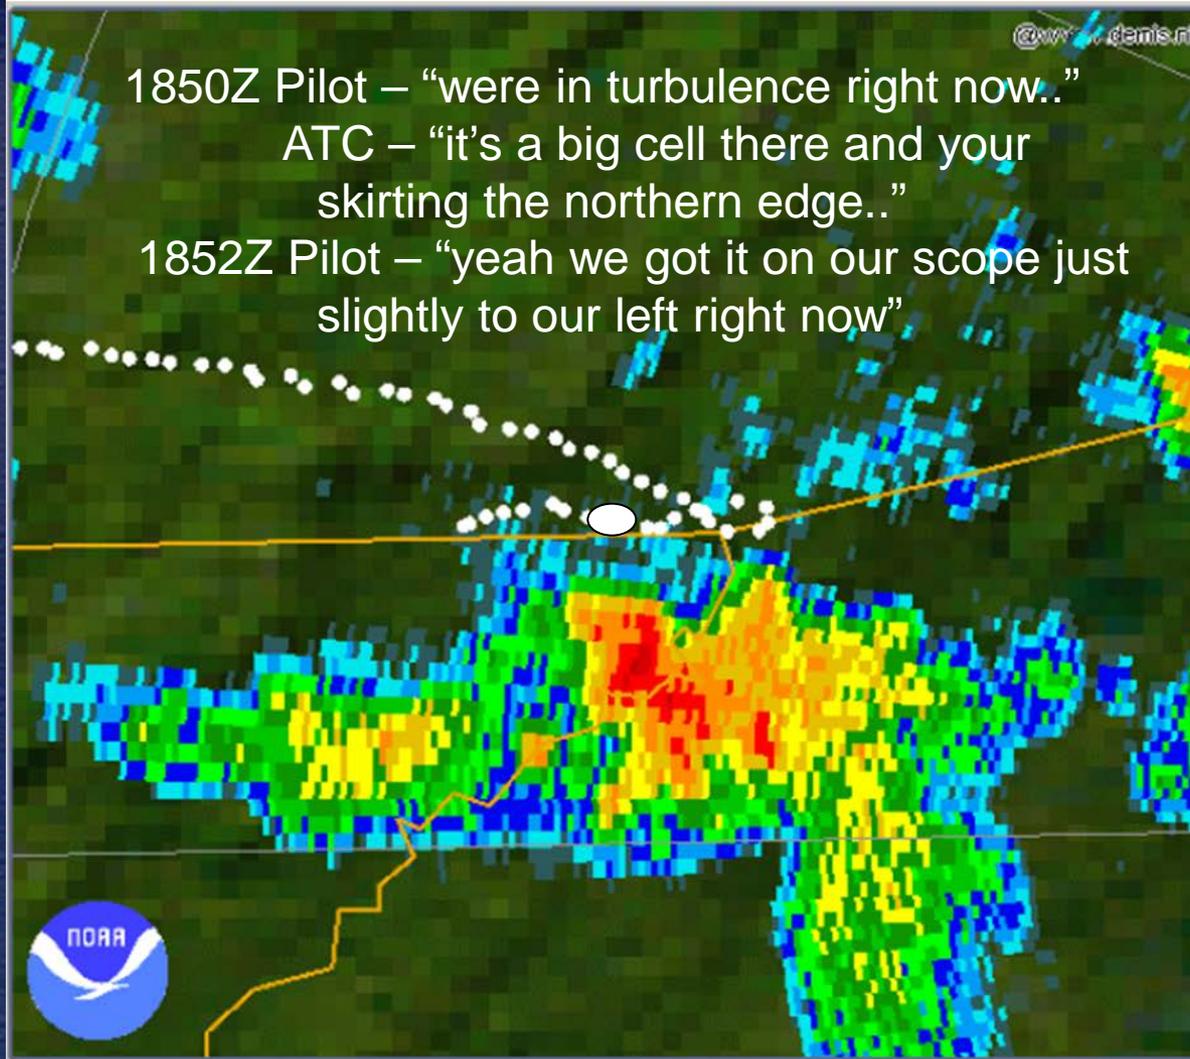
1850Z Pilot – “were in turbulence right now..”

ATC – “it’s a big cell there and your skirting the northern edge..”

1852Z Pilot – “yeah we got it on our scope just slightly to our left right now”

NEXRAD LEVEL-II
KGSP - GREER, SC
07/29/2008 18:53:14 GMT
LAT: 34/52/59 N
LON: 82/13/11 W
ELEV: 942 FT
VCP: 12

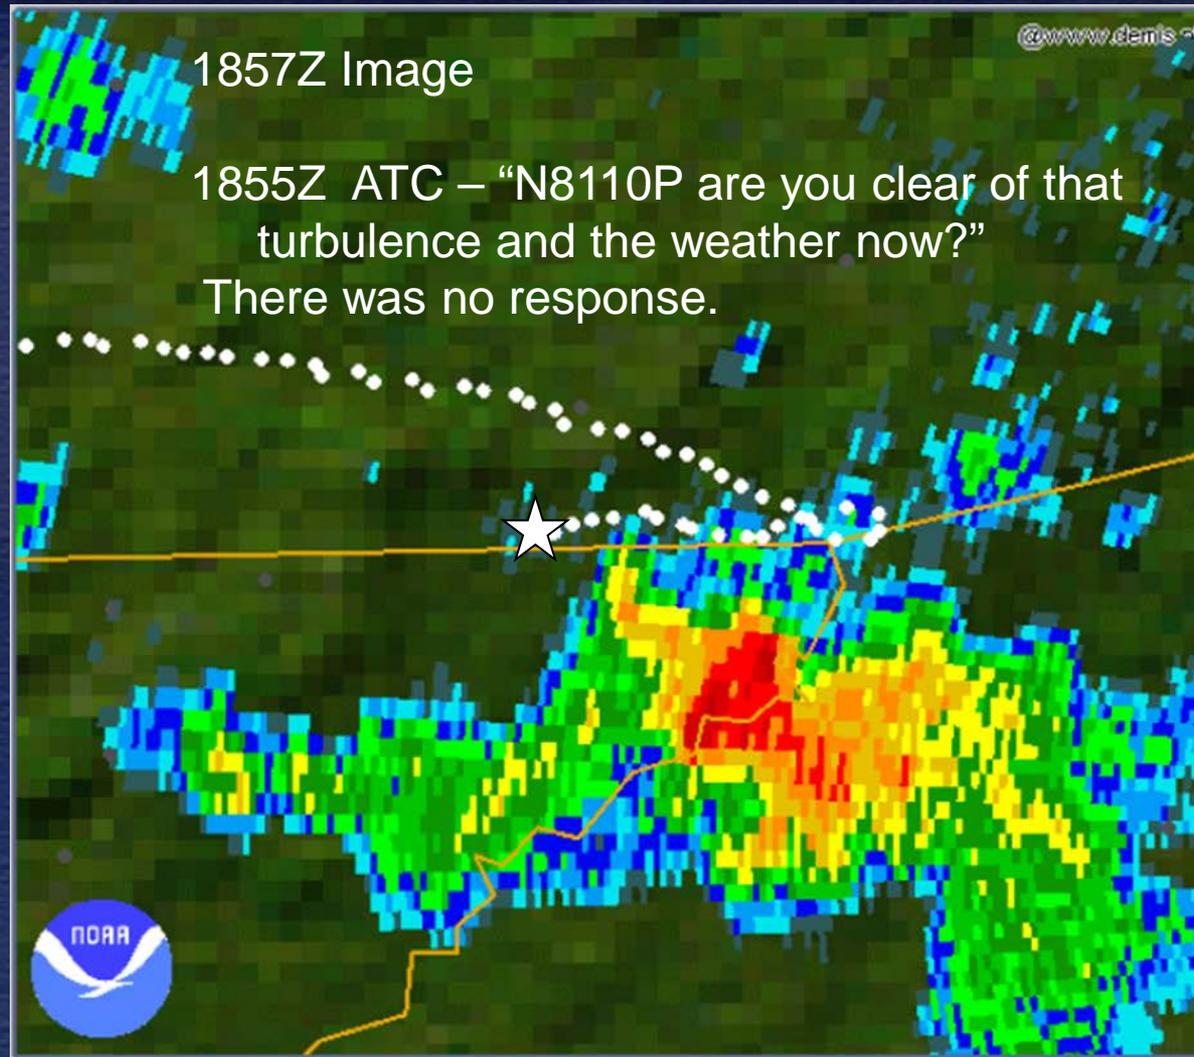
NEXRAD LEVEL-II
KGSP - GREER, SC
07/29/2008 18:57:33 GMT
LAT: 34/52/59 N
LON: 82/13/11 W
ELEV: 942 FT
VCP: 12

REFLECTIVITY
ELEV ANGLE: 1.37

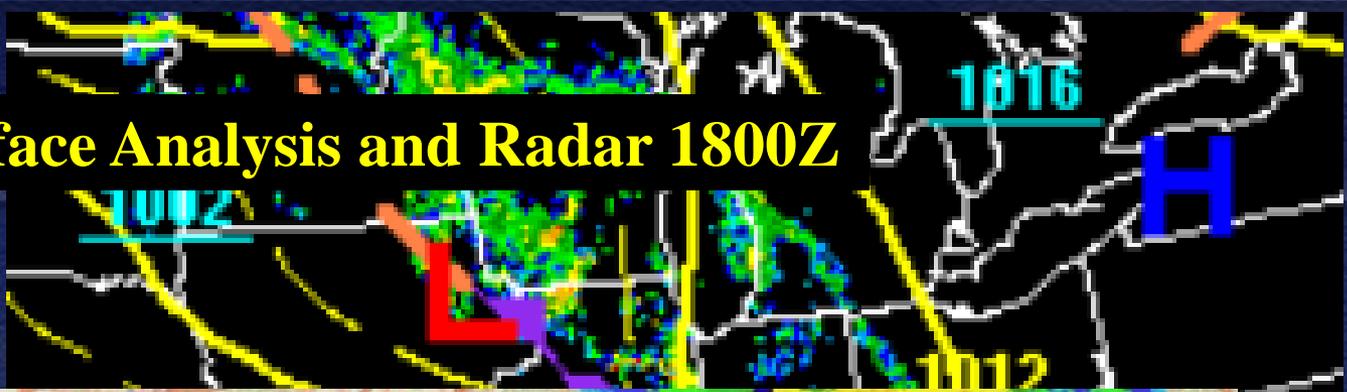
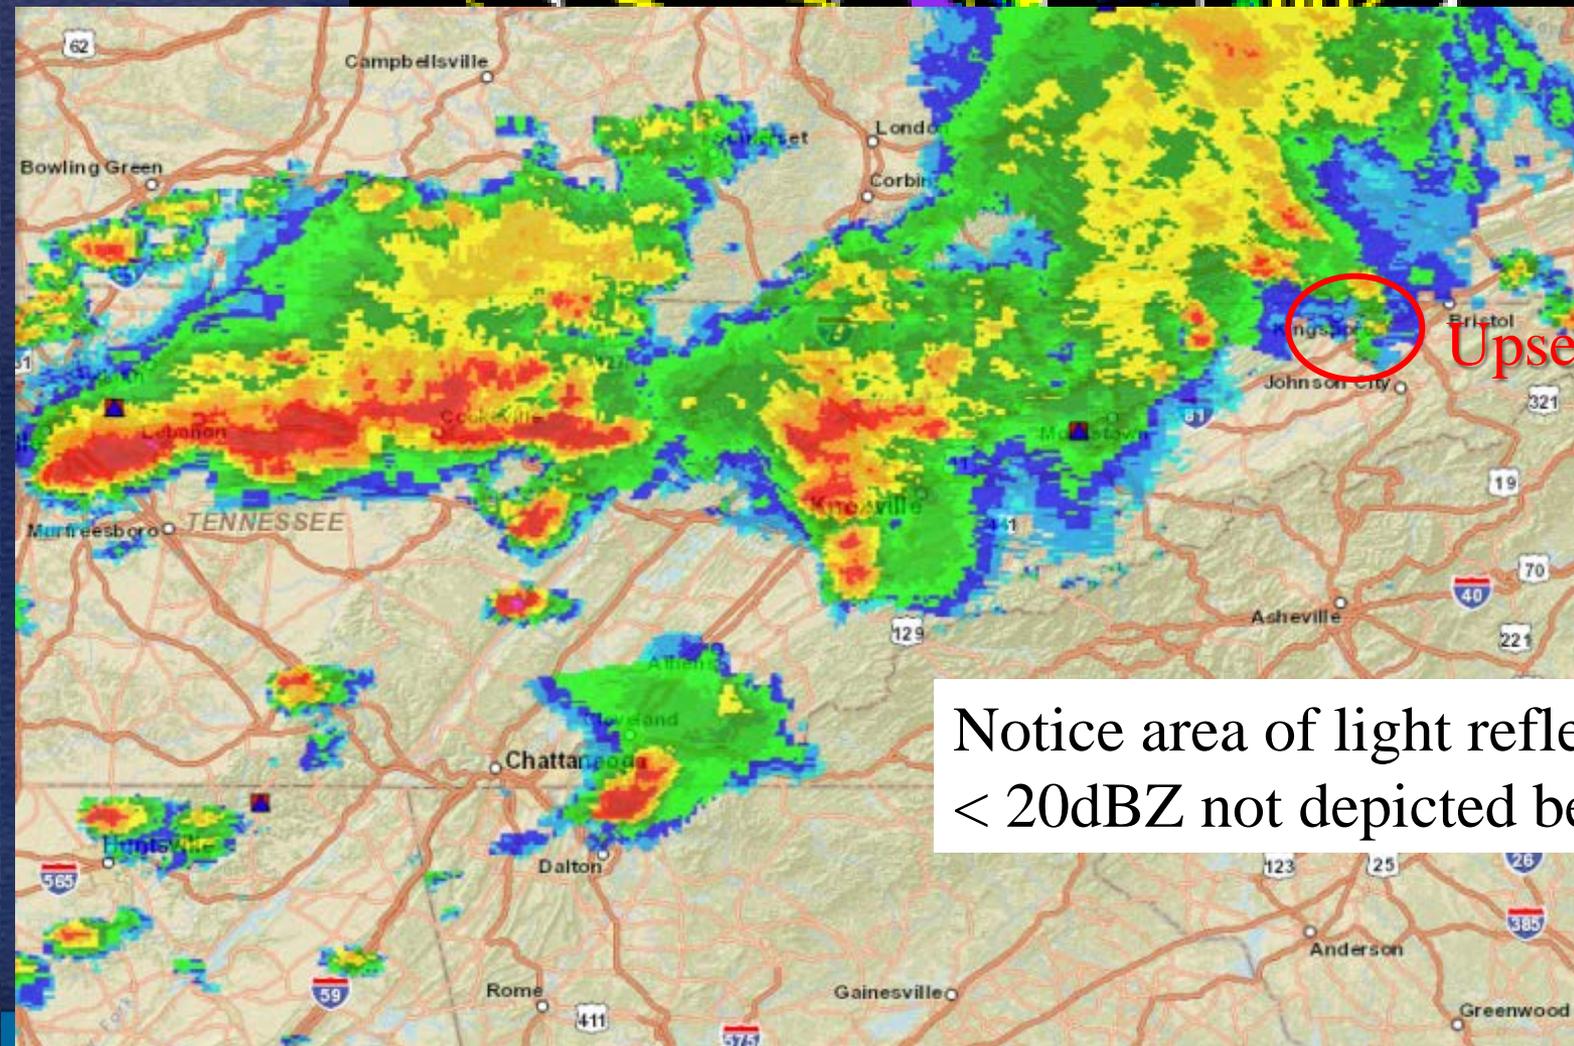
Surface Analysis and Radar 1800Z

Notice area of light reflectivity's < 20dBZ not depicted before

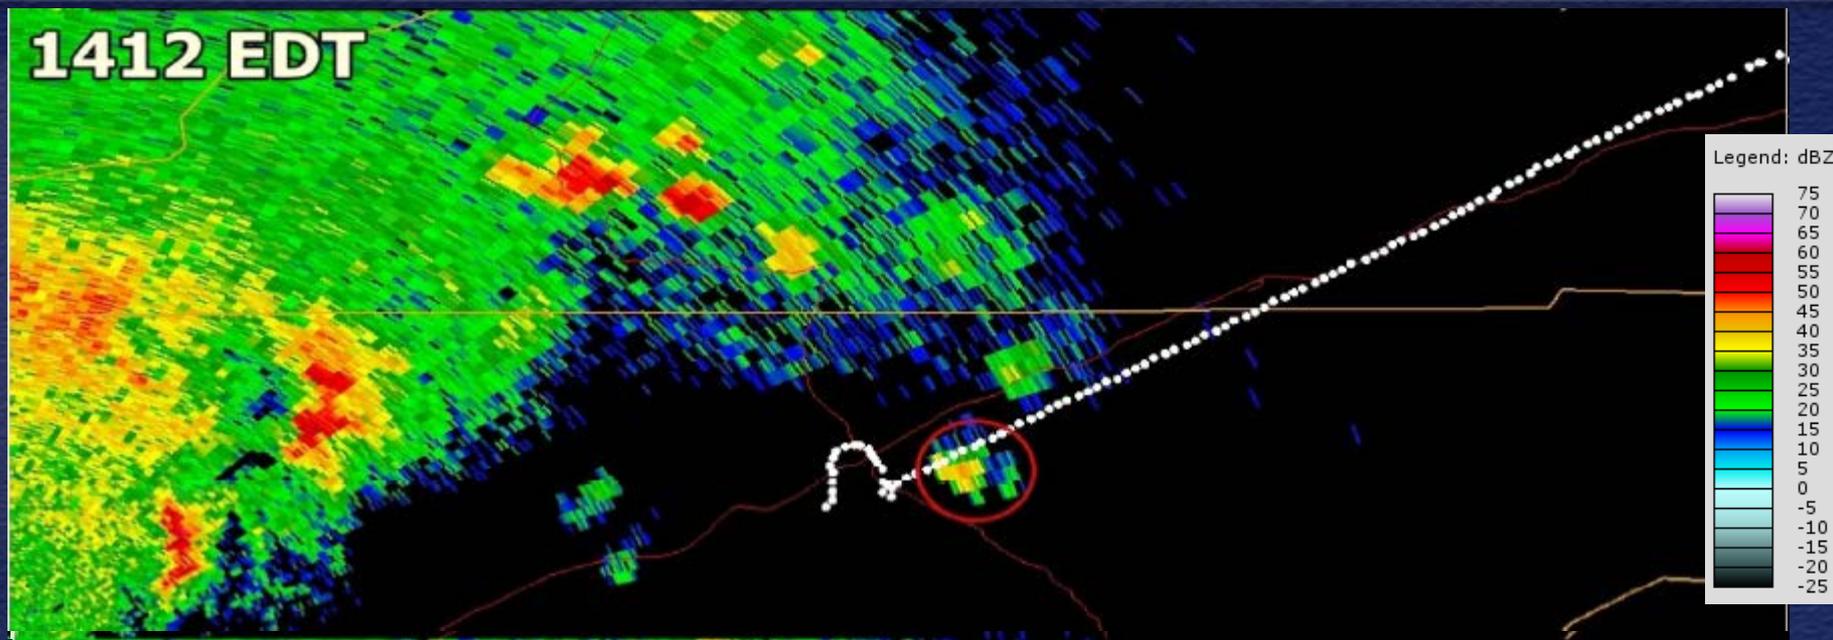
Echoes at 3.4° scan aircrafts altitude; echoes <15 dBZ not shown
FL200 -8° C

- 1400:00 – N15L reports in FL200 IMC painting cell off 1 o'clock position
- 1405:50 – N15L “going down, going down..”
- 1406:01 – N15L “un control..,we had, a we had emergency..”
- 1407:26 – N15L “we just had some major issues there, we got to deviate, we may have control issues” 8,000 ft

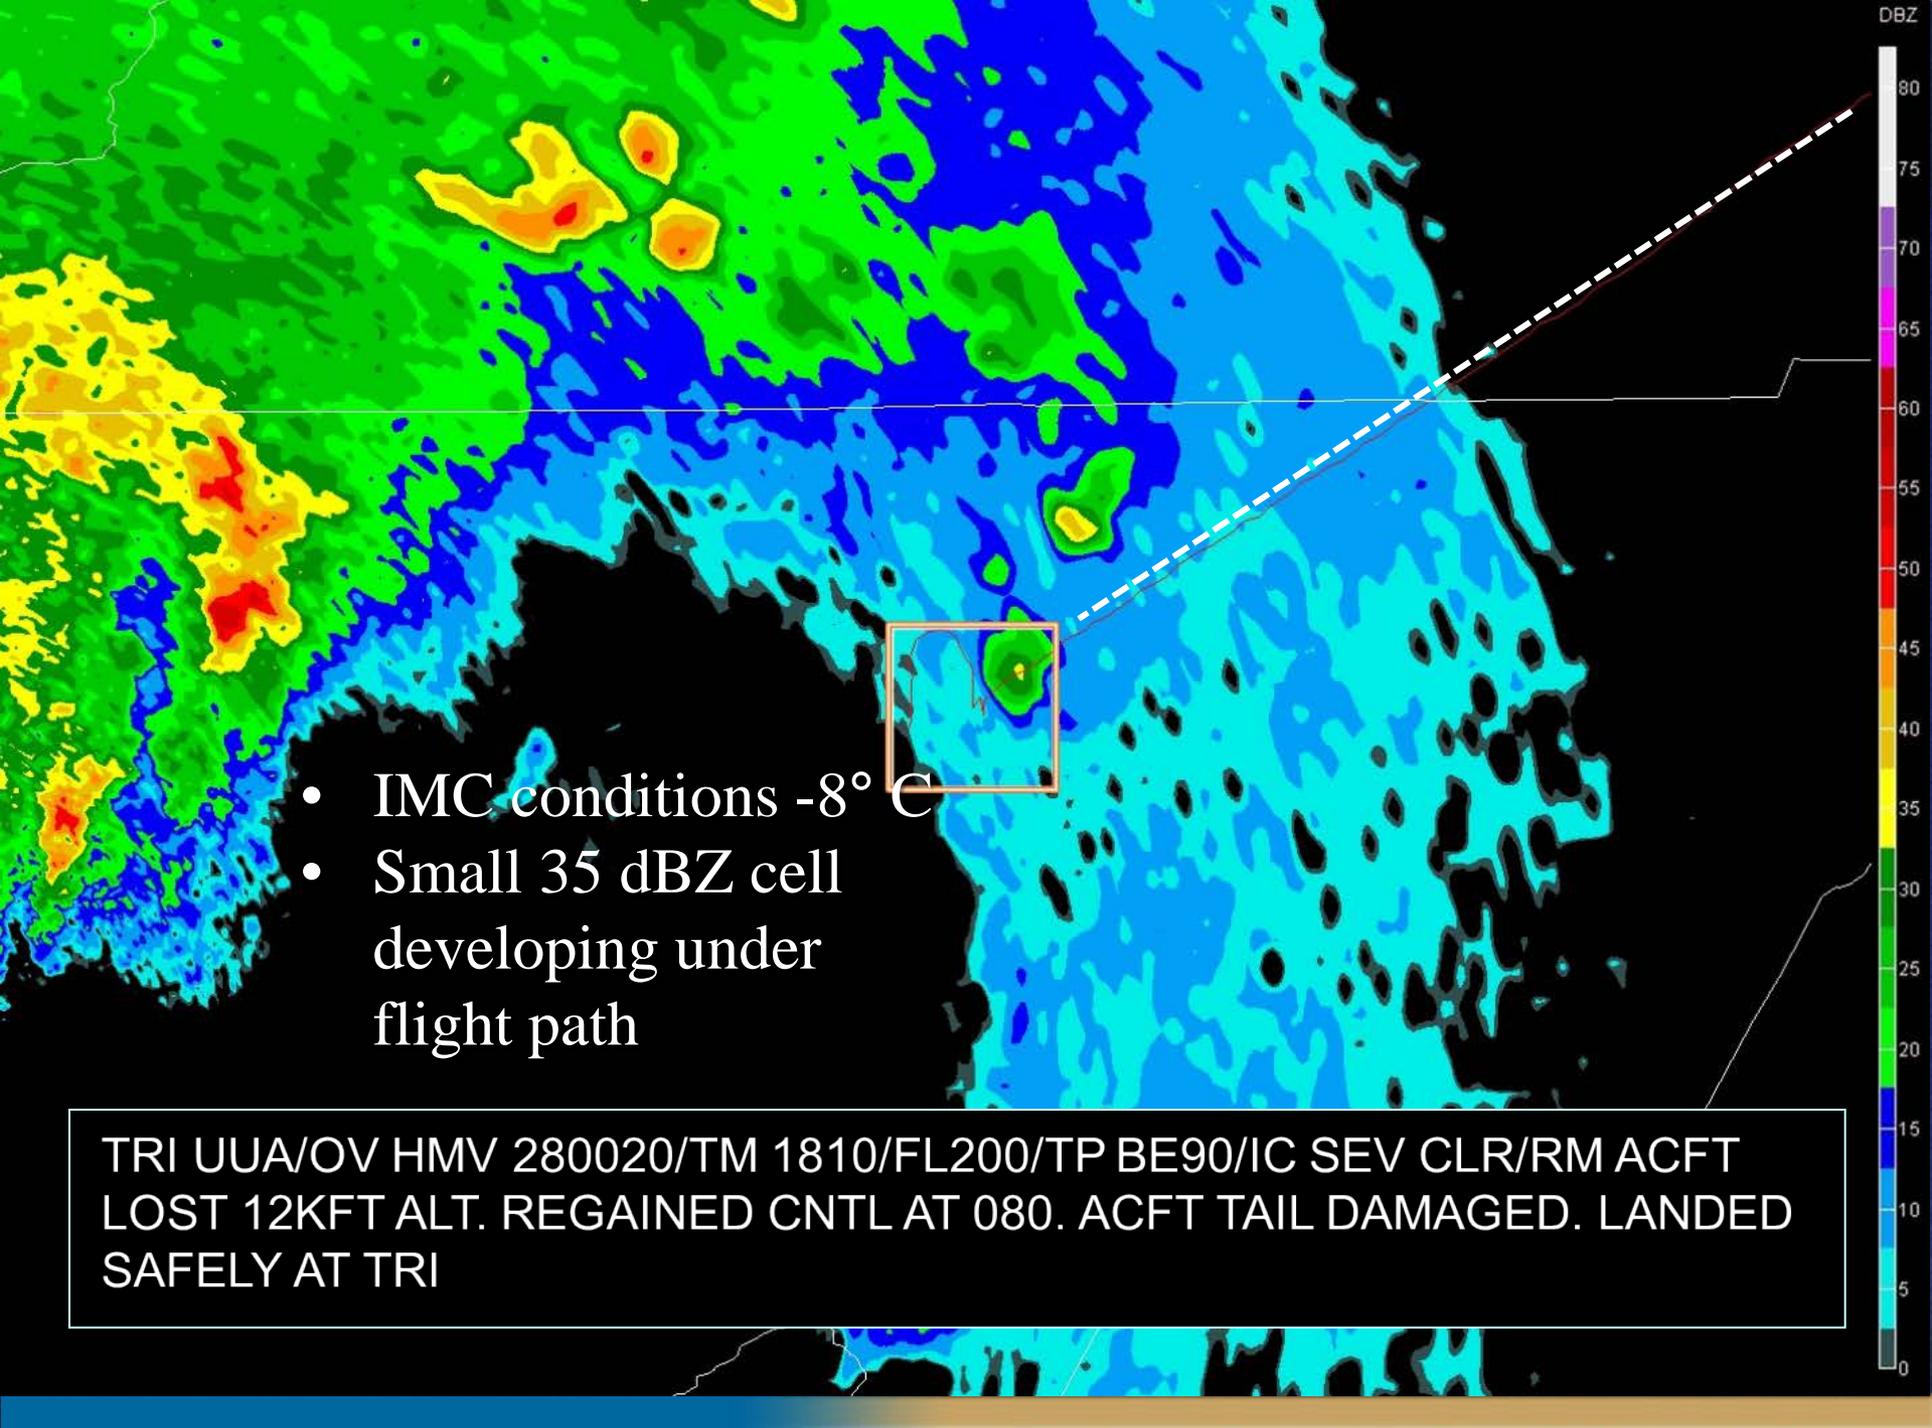
- IMC conditions -8°C
- Small 35 dBZ cell developing under flight path

TRI UUA/OV HMV 280020/TM 1810/FL200/TP BE90/IC SEV CLR/RM ACFT
LOST 12KFT ALT. REGAINED CNTL AT 080. ACFT TAIL DAMAGED. LANDED
SAFELY AT TRI

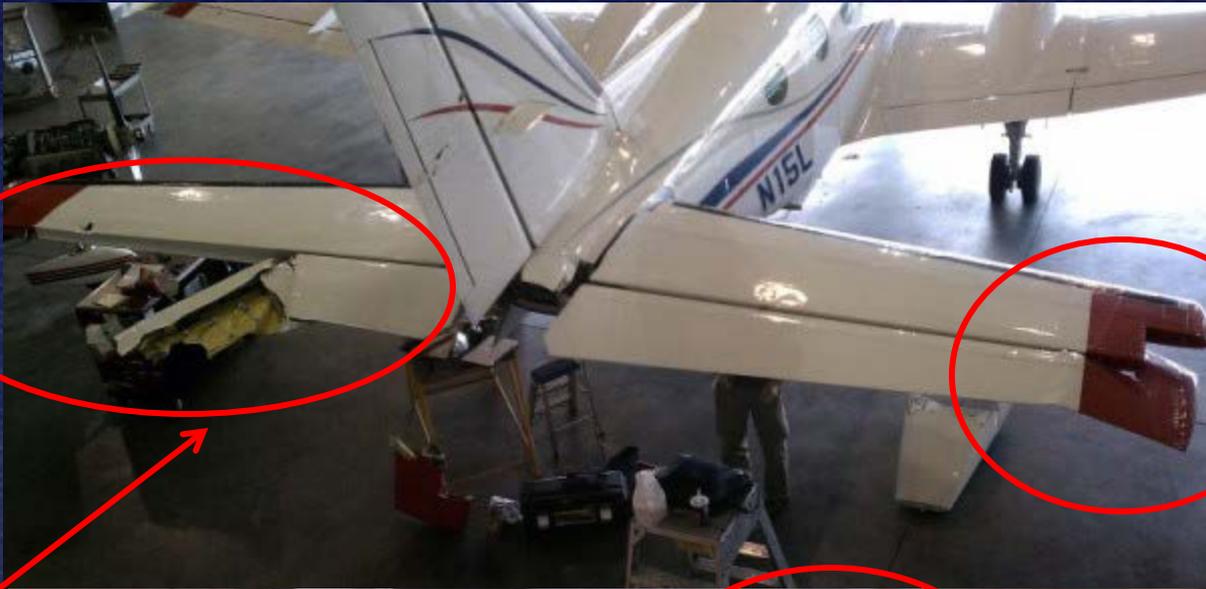
**Missing
elevator**

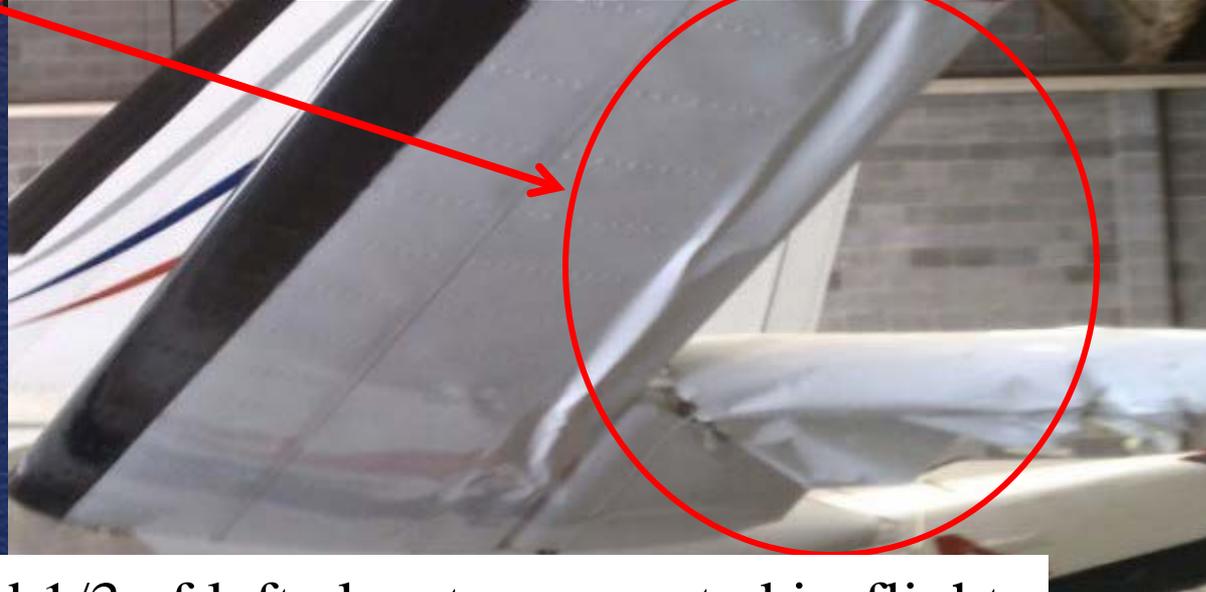
Damage

Outboard 1/3 of left elevator separated in-flight
Right elevator deformed downward

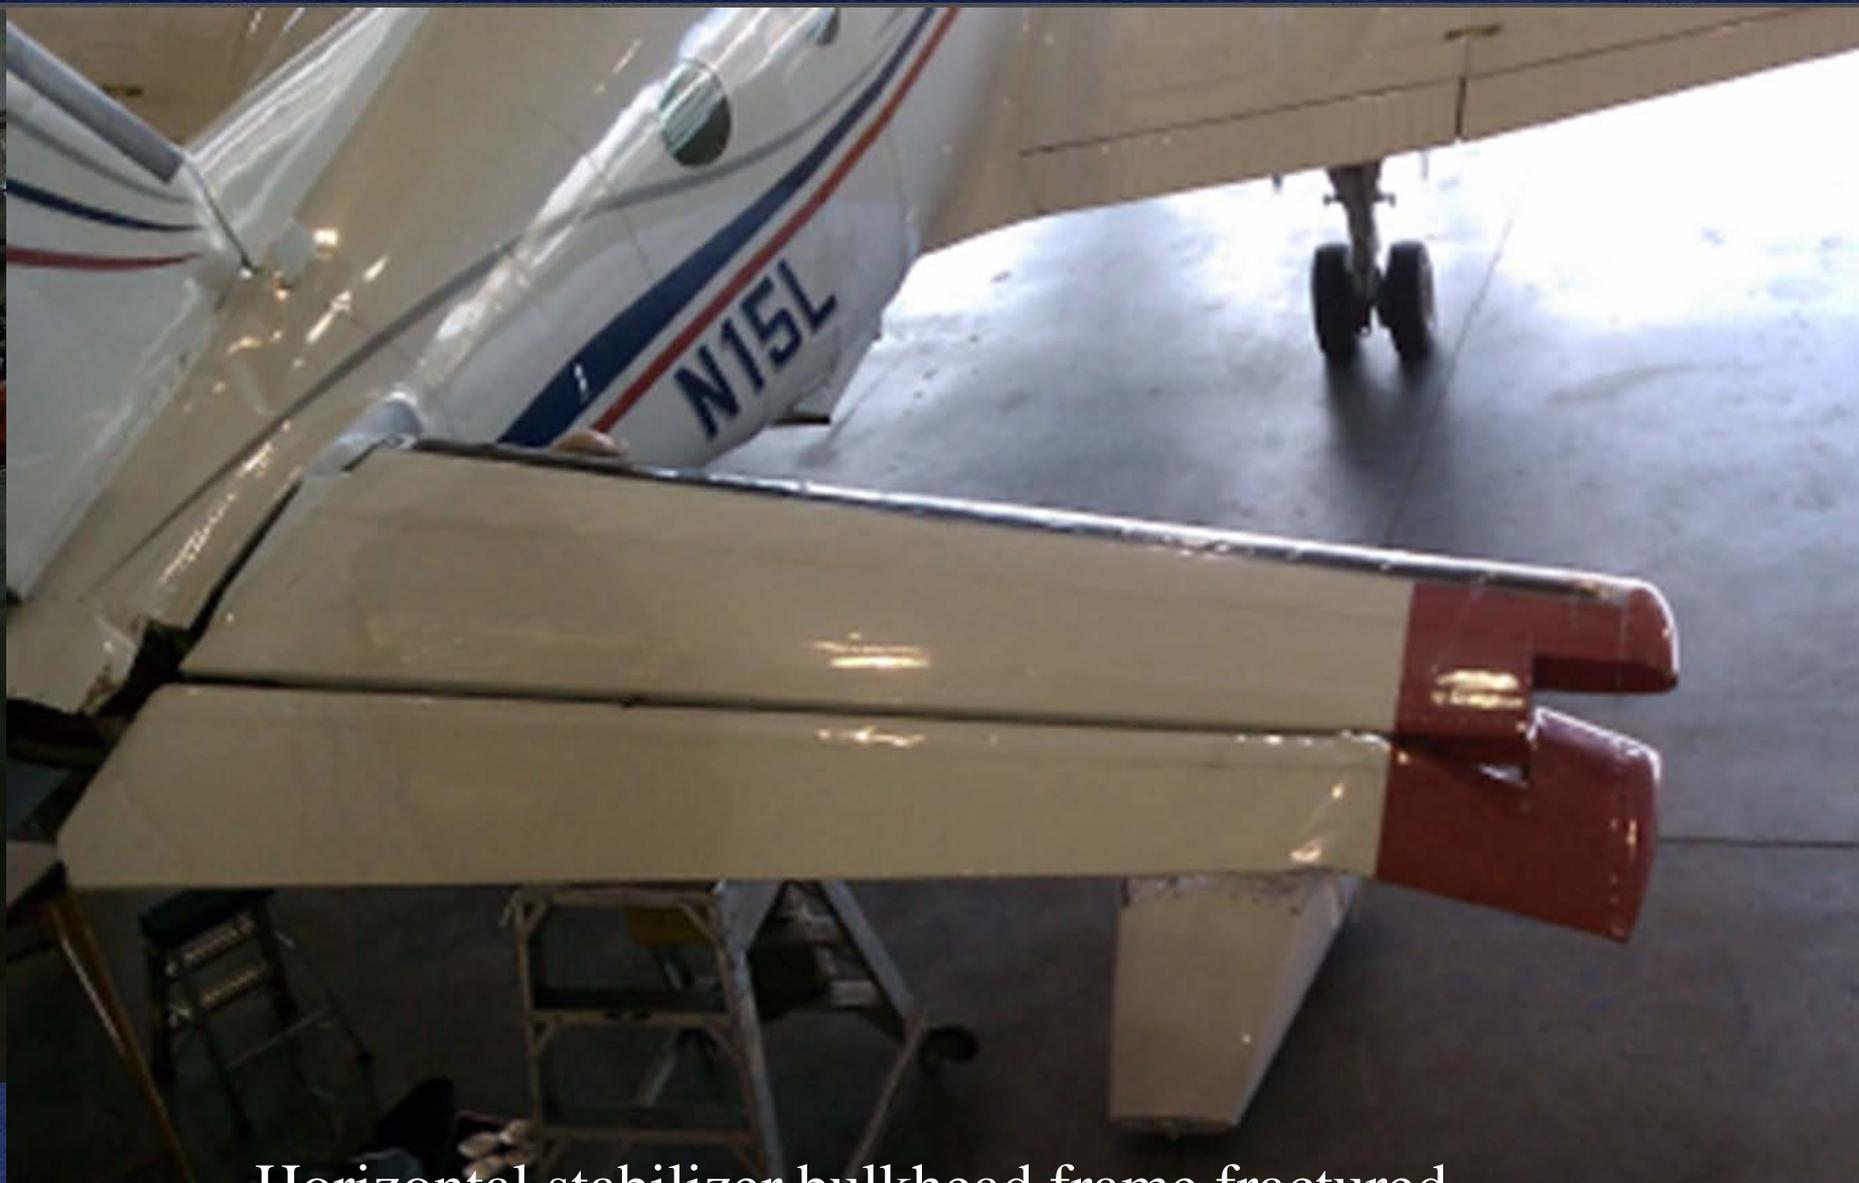
Horizontal stabilizer bulkhead frame fractured
and aft airframe deformed in several areas

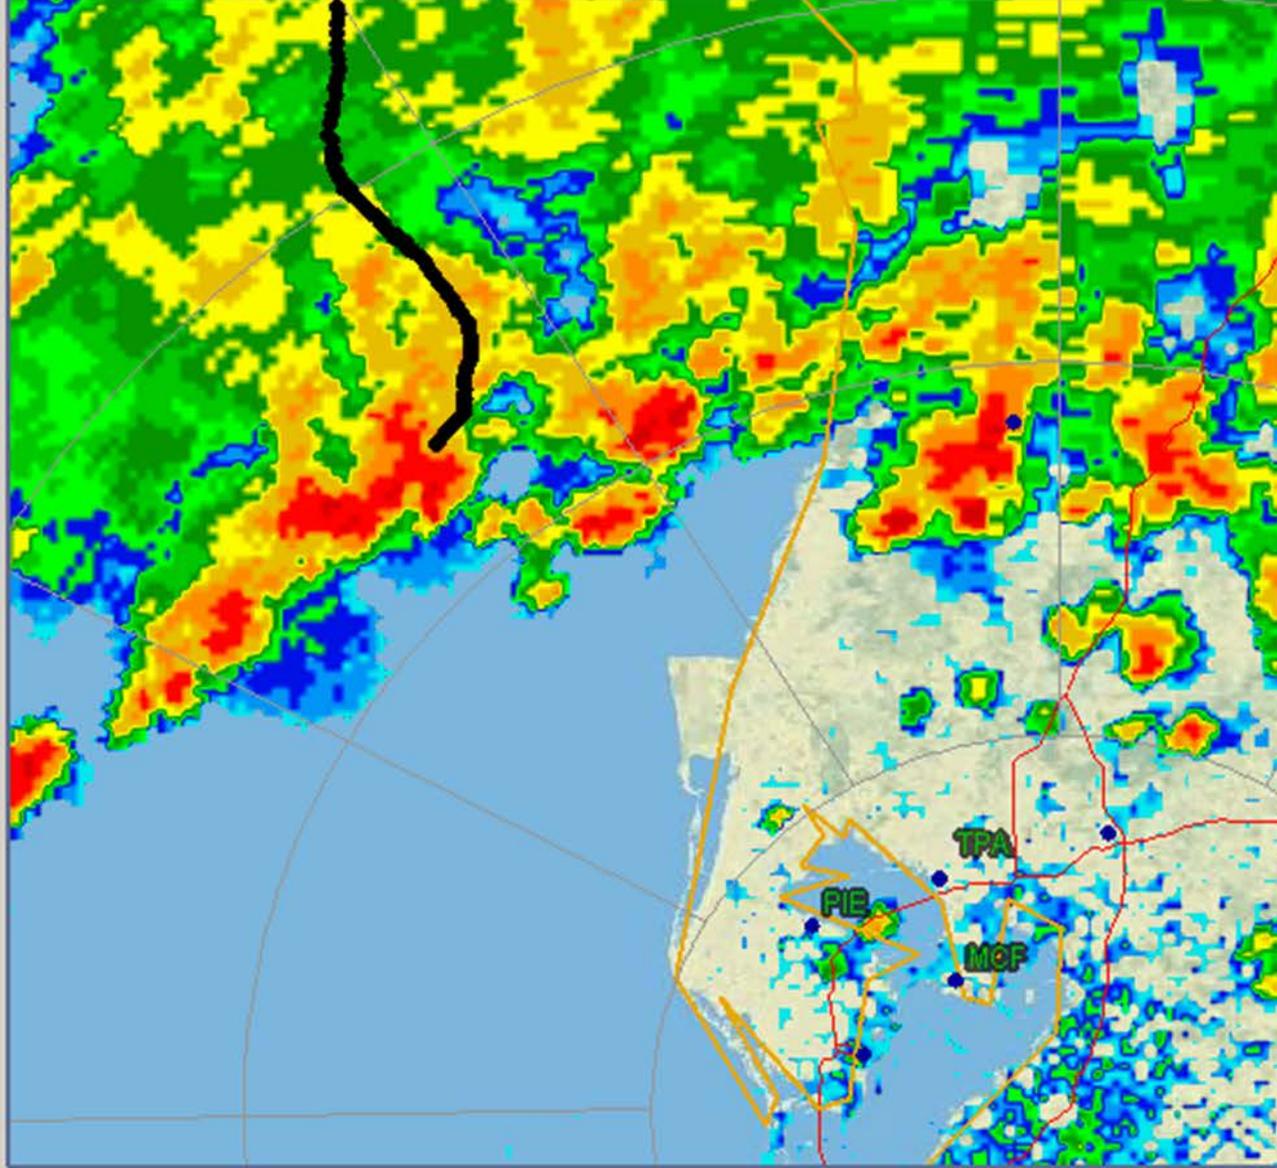
NEXRAD LEVEL-III
COMPOSITE REF. 124NM
KTBW - TAMPA, FL
07/08/2009 18:48:18 GMT
LAT: 27/42/17 N
LON: 82/24/07 W
ELEV: 122 FT
MODE/VCP: A / 211

MAX: 59 dBZ
BOT: 0 KFT
TOP: 0 KFT
