NTSB National Transportation Safety Board

General Aviation Weather Related Accidents

Donald Eick (“Ike”)

NTSB Senior Meteorologist

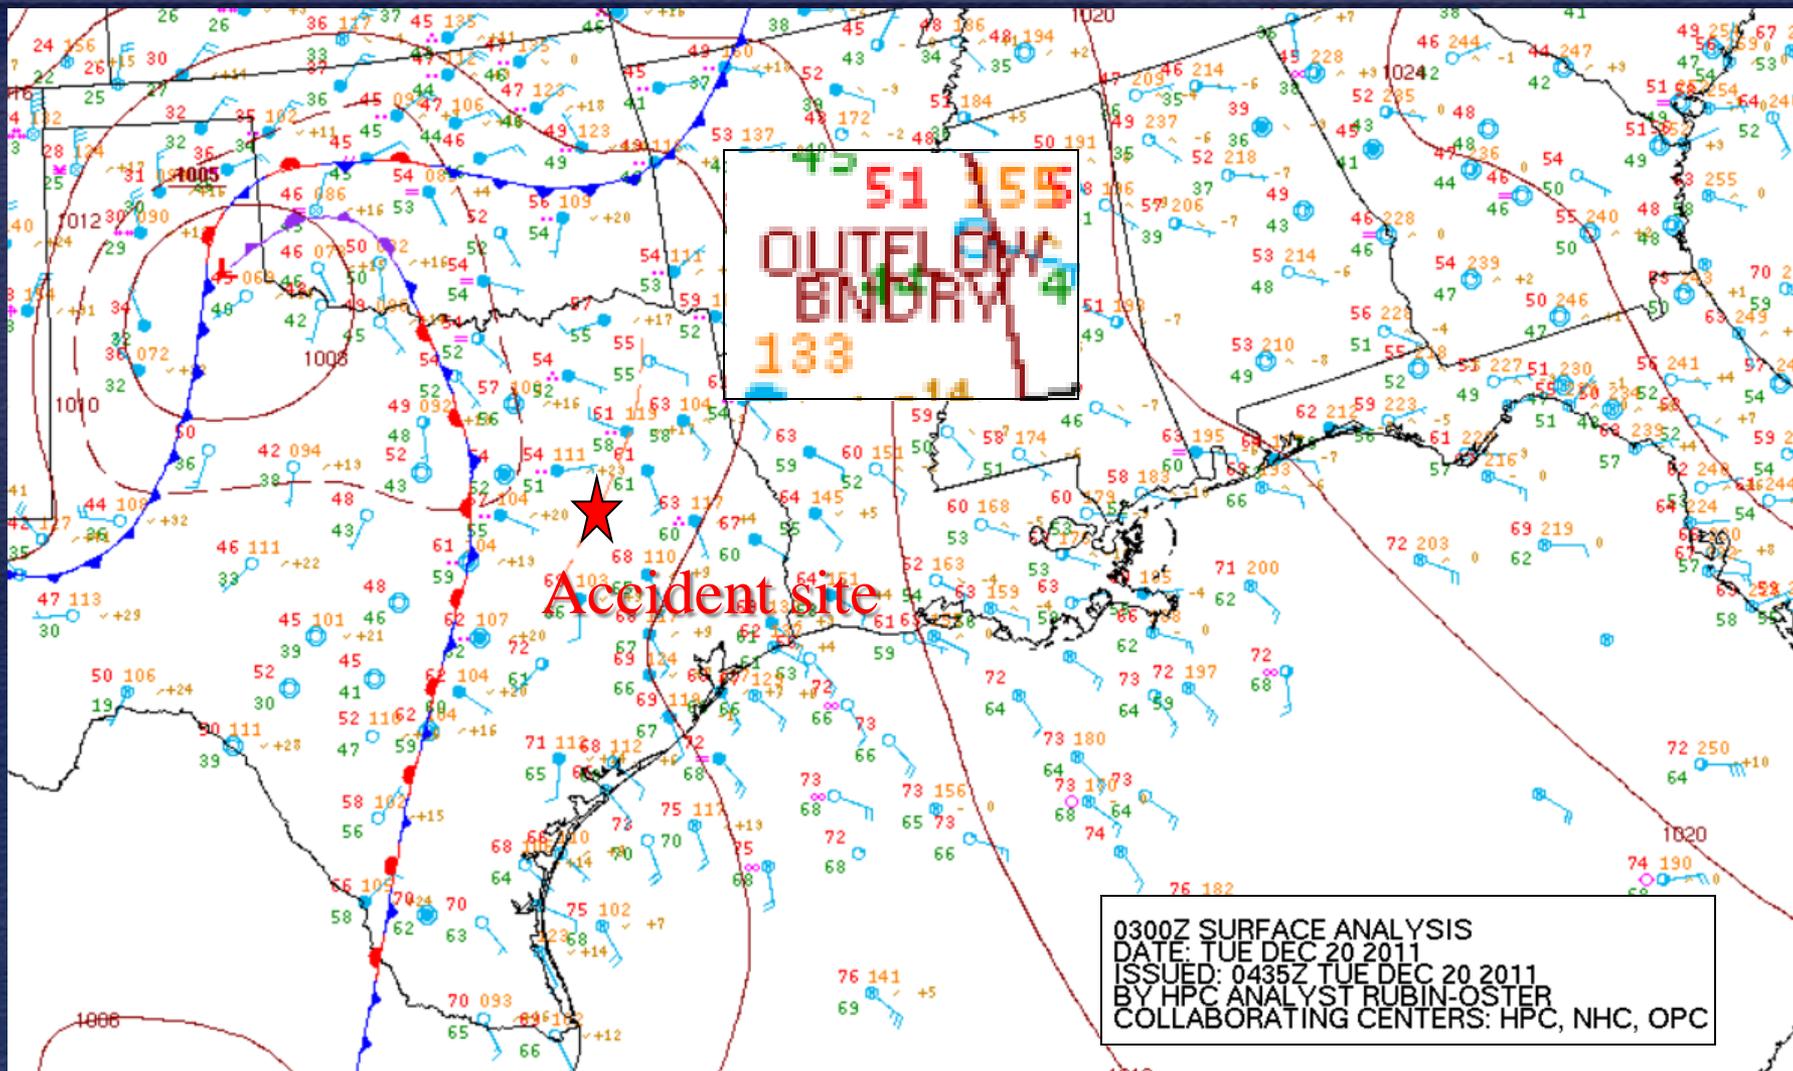
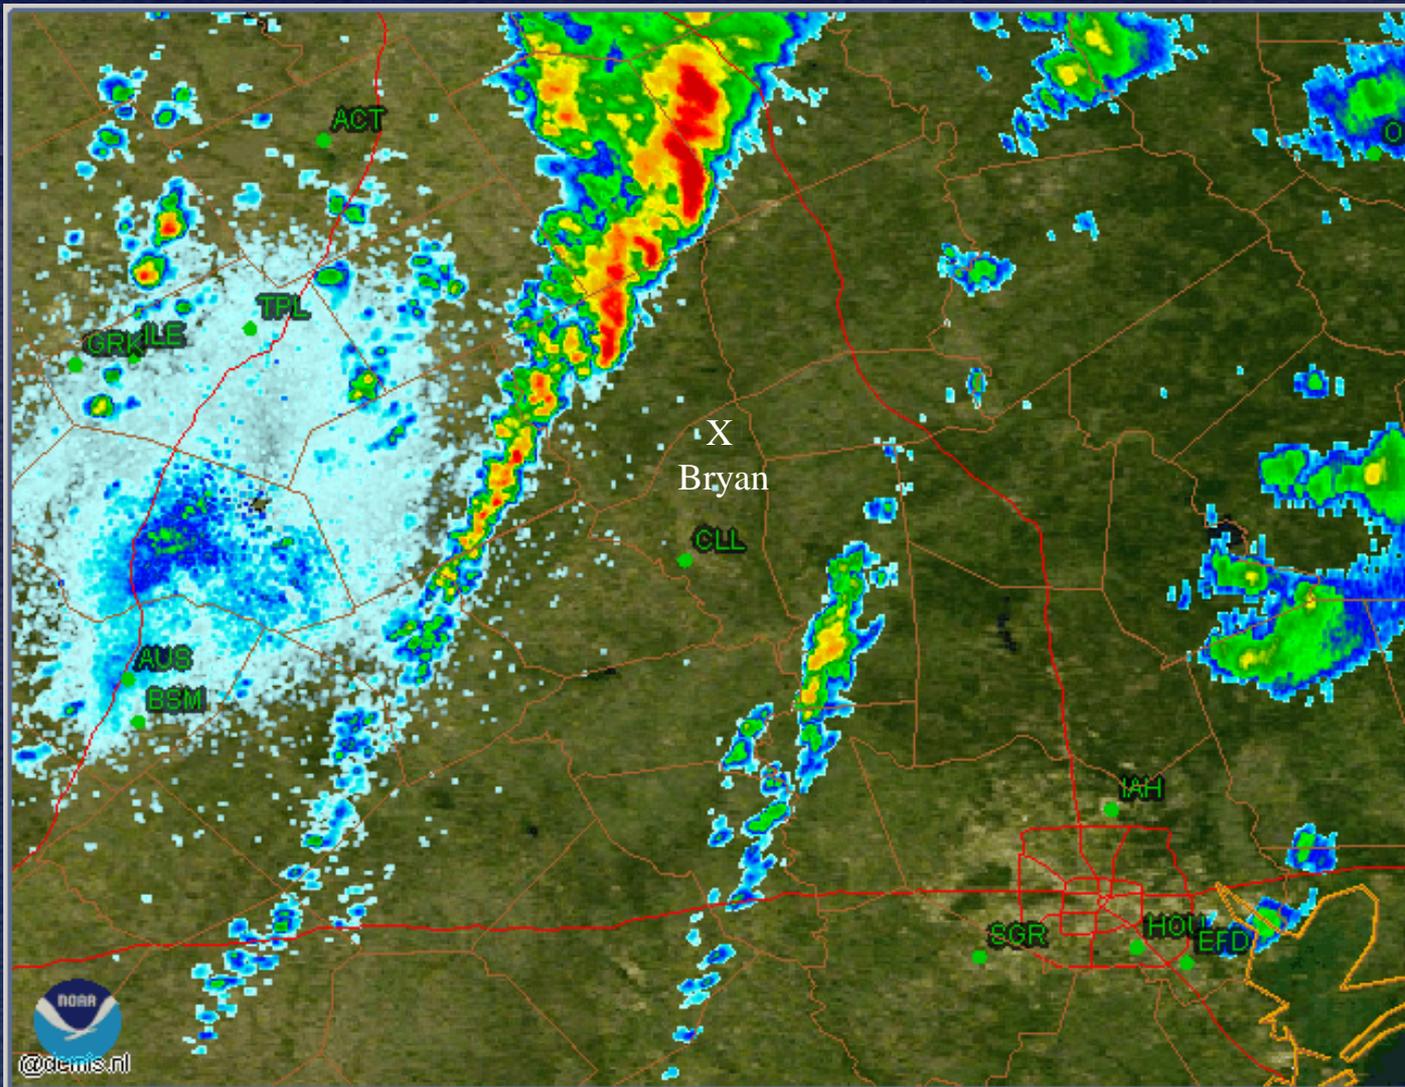
NEXRAD LEVEL-II
KGRK - FORT HOOD, TX
12/20/2011 02:00:45 GMT
LAT: 30/43/19 N
LON: 97/22/58 W
ELEV: 538 FT
VCP: 12

REFLECTIVITY
ELEV ANGLE: 0.98

Fort Hood WSR-88D NEXRAD animation

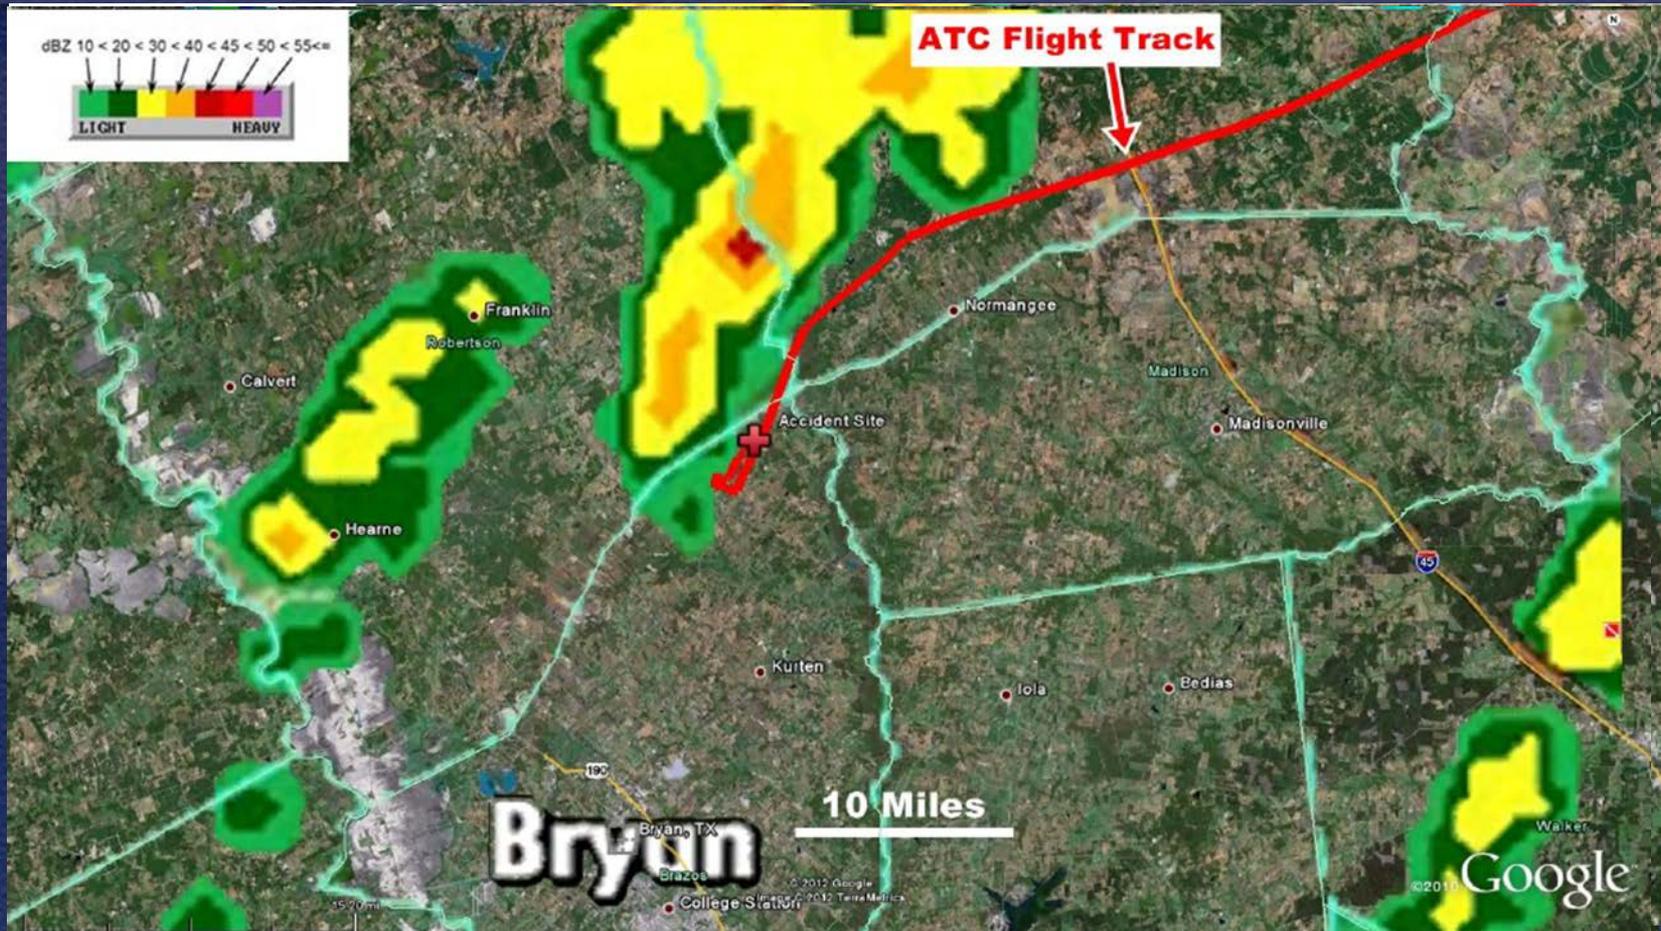
XM Satellite images 2130-2145 CST

The actual age of the NEXRAD image in the mosaic can exceed the age indicated in the cockpit by 15-20 minutes.

- The time between when the radar gathered the data and the time stamp can be up to 20 minutes in extreme situations – **not real time!**
- The time stamp only says the time from which the radar mosaic graphic was created...NOT how old the radar data actual is!
- Unless you have Airborne Weather radar and/or Stormscope – assume your display is old or lags multiple scans

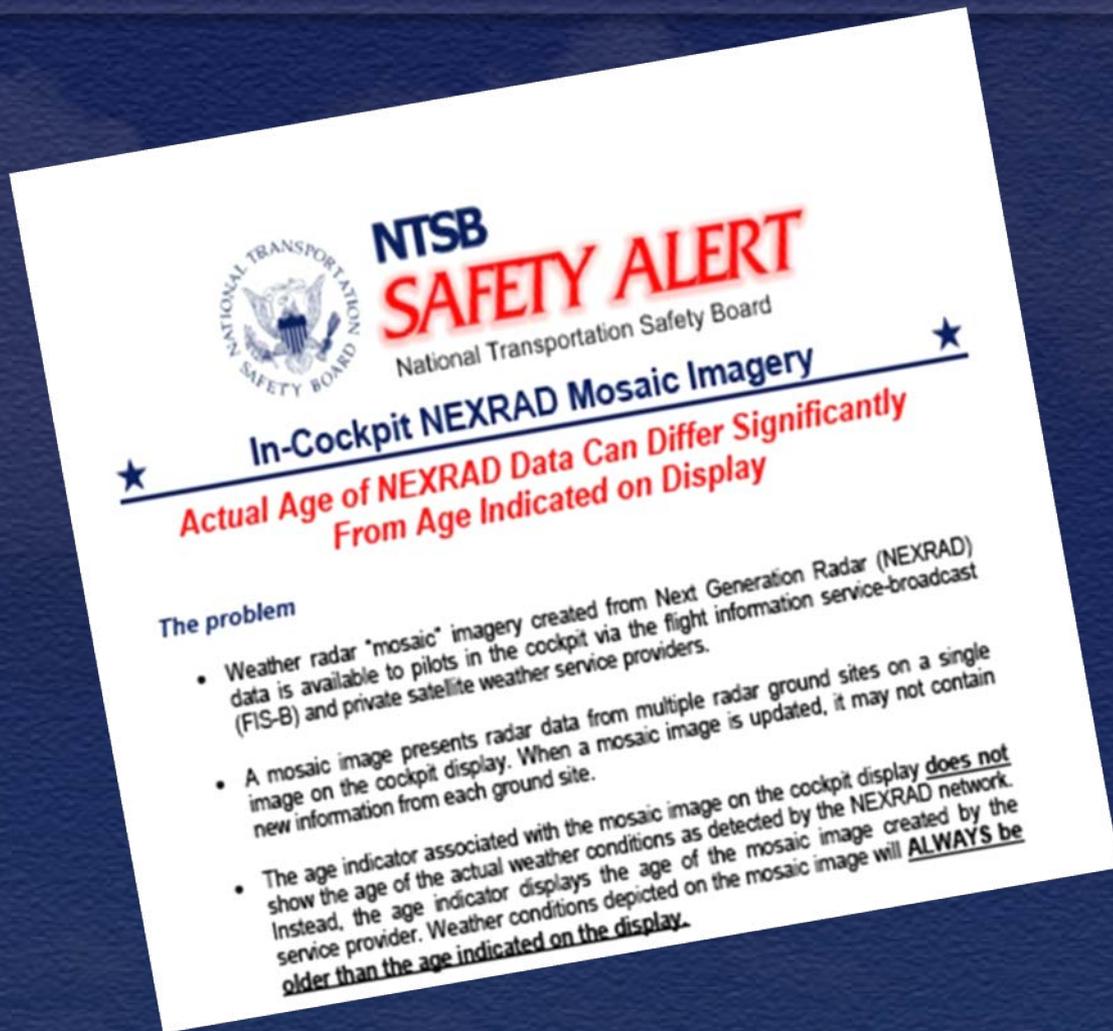
NTSB Safety Alert - NEXRAD

NEXRAD mosaic shows where weather was, not where it is!

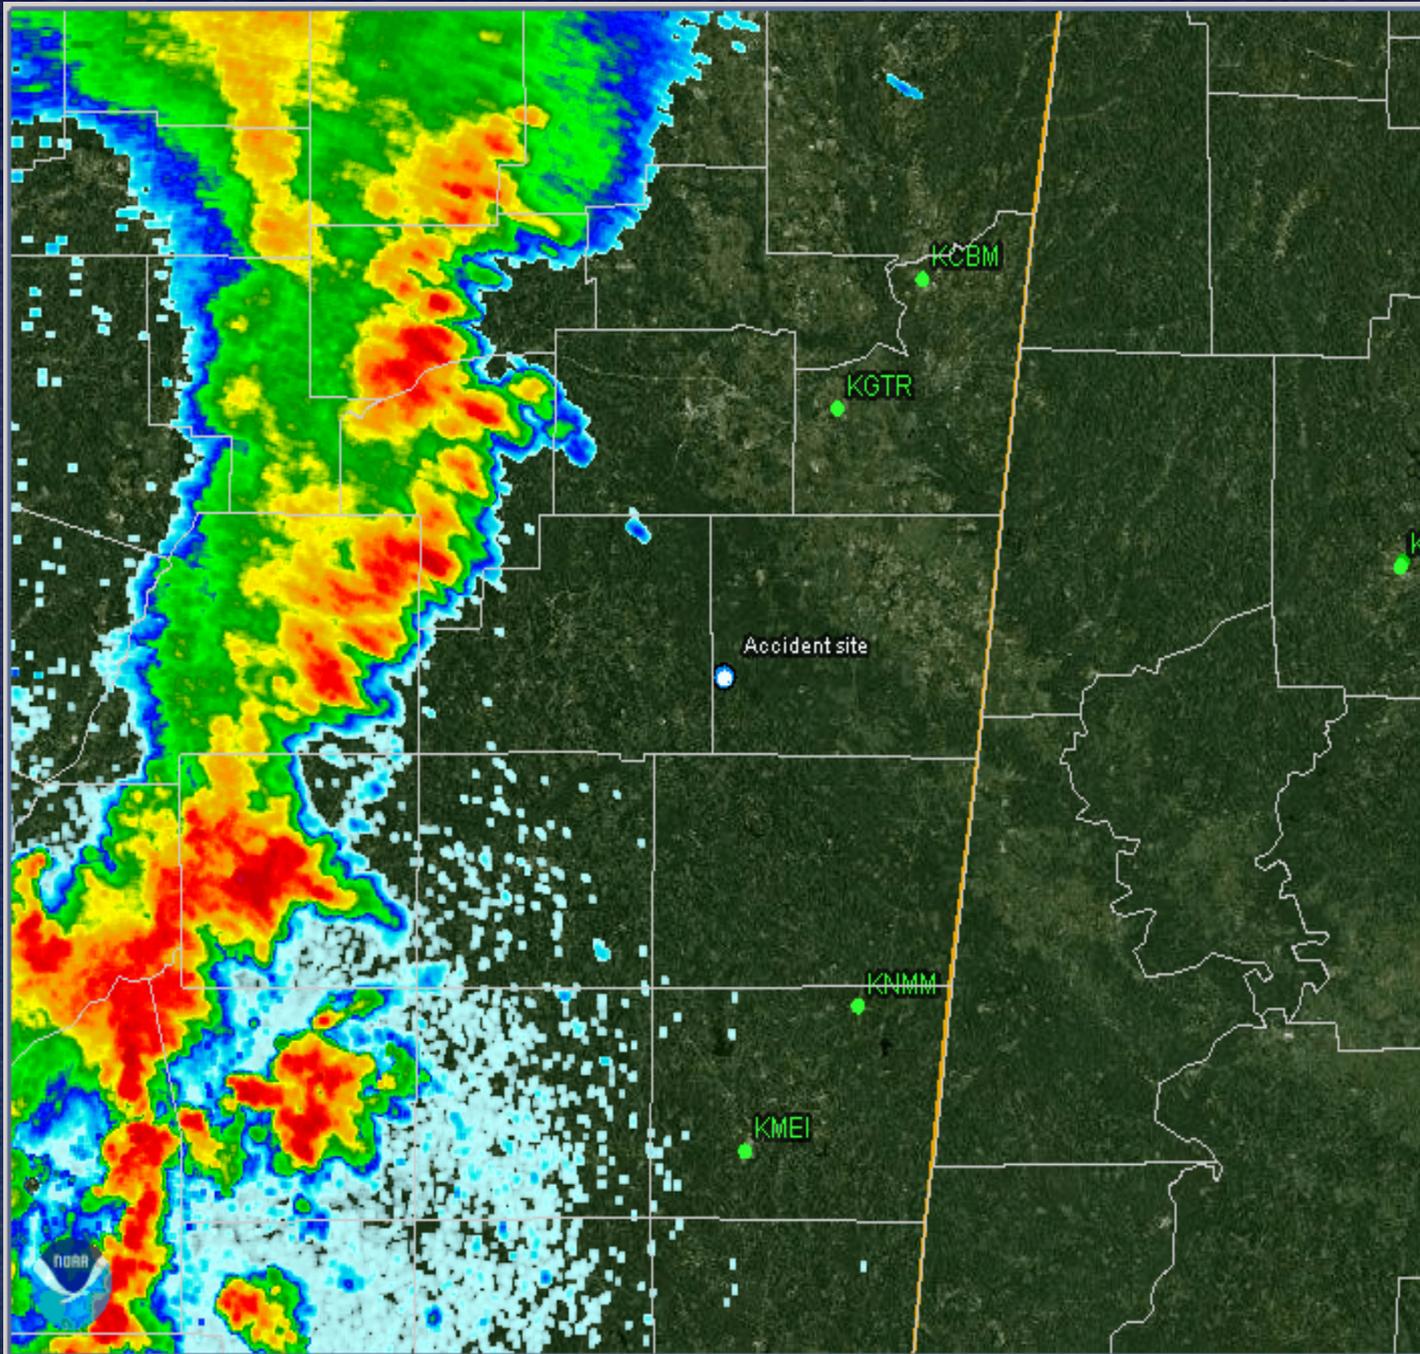
NEXRAD LEVEL-II
KDGX - JACKSON/BRAN., MS
05/31/2012 21:04:24 GMT
LAT: 32/16/48 N
LON: 89/59/02 W
ELEV: 609 FT
VCP: 212

REFLECTIVITY
ELEV ANGLE: 0.50

- While attempting to deviate around an area of extreme precipitation at FL120, aircraft experienced an in-flight breakup and crashed 15NM SW of Macon, MS.
- Witnesses reported high winds and lightning present at the time of the accident
- Convective SIGMET for AREA SEV TS, tops FL450, Hail 2”, Wind gusts 60KT

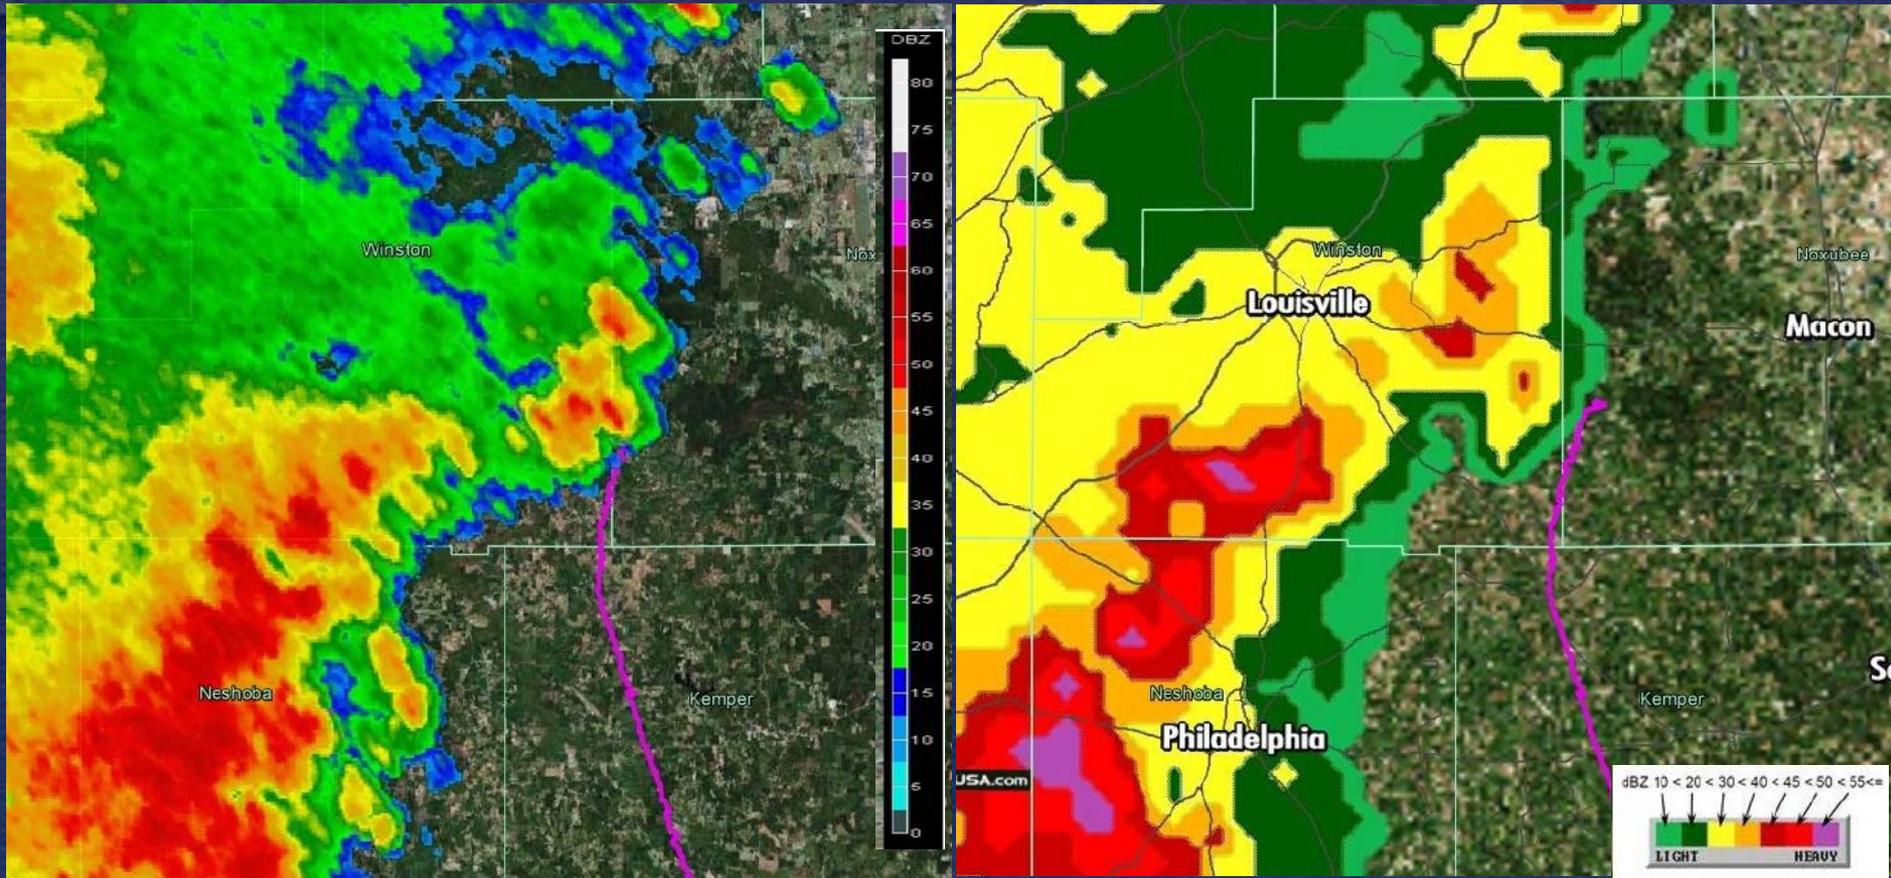
ERA12FA376 – Macon, MS

Comparison of NWS WSR-88D and XM WX Satellite Radar images at 1655 CDT
Note different color scales
