## RNAV (GPS) Y RWY 18

PICAYUNE MUNI (MJD)

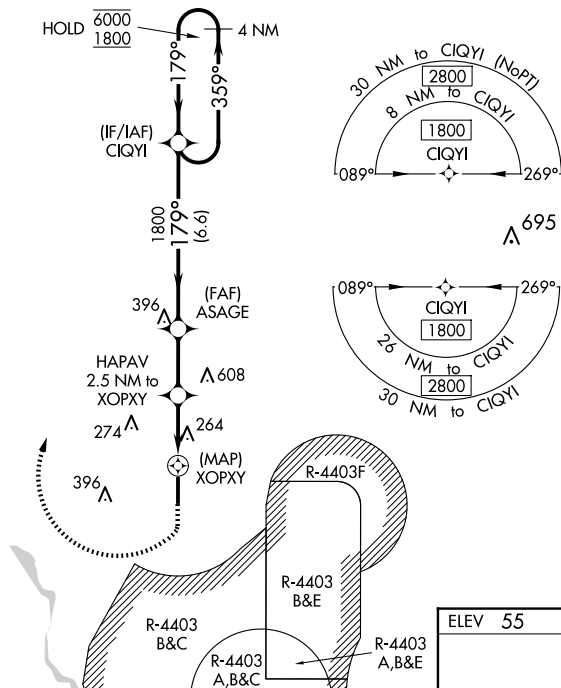
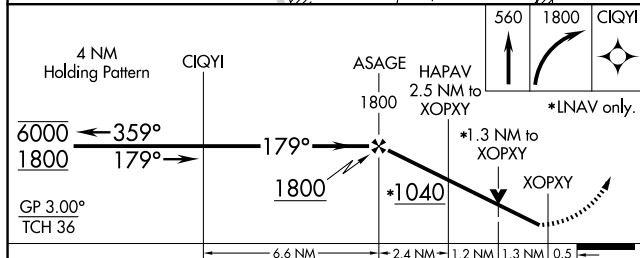
**MISSED APPROACH:** (Do not exceed 185K) Climb to 560 then climbing right turn to 1800 direct CIQYI and hold.
