RNAV (GPS) Z RWY 18

PICAYUNE MUNI (MJD)

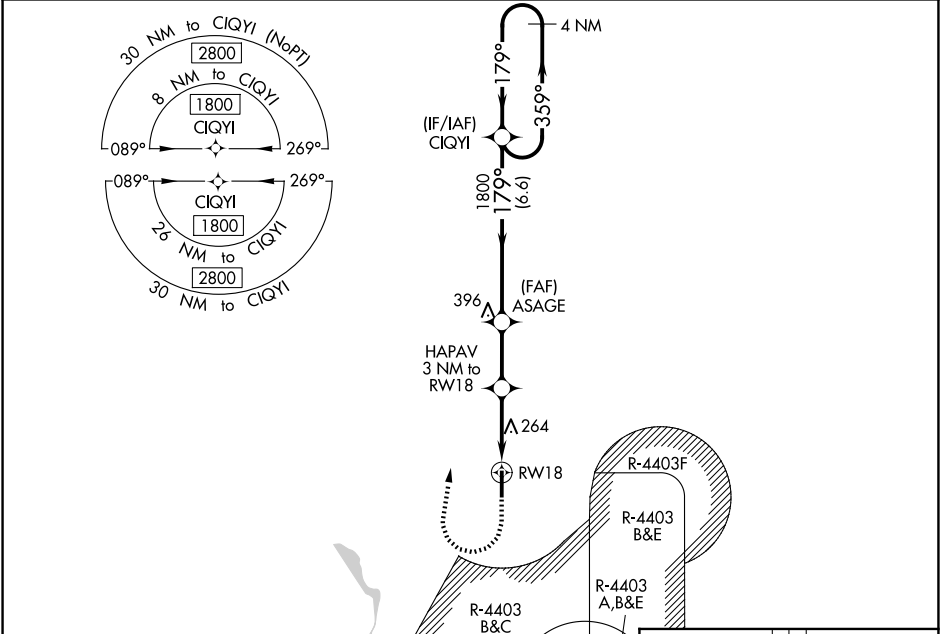
**MISSED APPROACH:**  
Climb to 1200, then climbing right turn to 1800 direct CIQYI and hold.

| | | ELEV 55 | | TDZE 55 | |
| | | 179° | | 81 | |
| | | 5000 X 75 | | 36 | |
| | | MIRL Rwy 18-36 0 | | | |
| | | 4 NM Holding Pattern | | ASAGE 1800 | |
| | | 1800 ← 359° → 179° → 1800 | | HAPAV 3 NM to RW18 | |
| | | GP 3.00° TCH 36 | | *1.3 NM to RW18 | |
