| WAAS<br>CH <b>93601</b><br><b>W20A</b> | APP CRS<br><b>206°</b> | Rwy Ldg<br>TDZE <b>955</b><br>Apt Elev <b>957</b> |

**RNAV (GPS) RWY 20**  
DAYTON/WRIGHT BROTHERS (MGY)

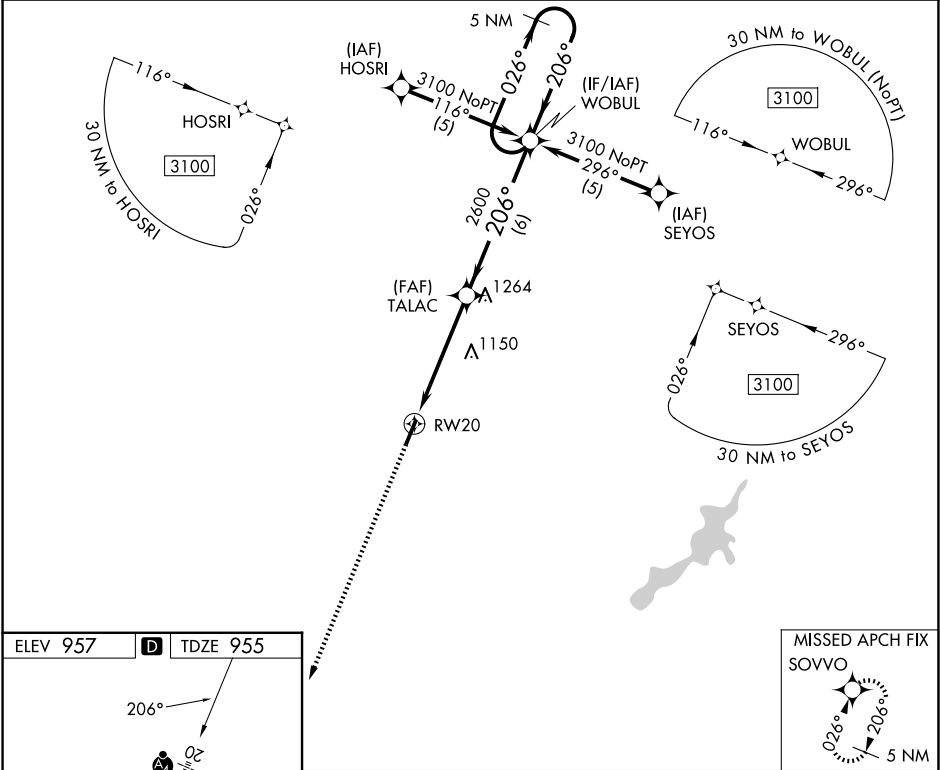
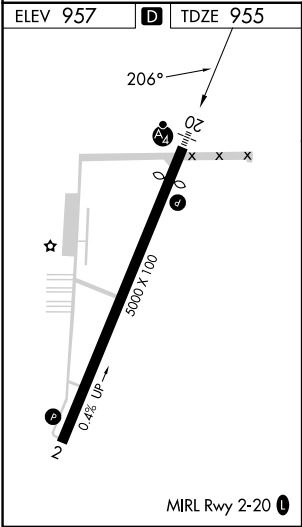
| RNP APCH:<br><div><div>▼ Inoperative table does not apply. When local altimeter setting not received, use James M Cox Dayton Intl altimeter setting and increase all DAs/MDAs 60 feet and Circling Cat C/D visibility ¼ SM. Rwy 20 helicopter visibility reduction below ¾ SM NA. VDP NA when using James M Cox Dayton Intl altimeter setting.</div><div>▲</div></div> | MALS<br> | MISSED APPROACH:<br>Climb to 3100 direct SOVVO and hold. |

3100

SOVVO

Holding Pattern

WOBL

TALAC

GP 3.00°

TCH 40°
