**G. FAA Anchorage Terminal Area Airspace and Procedures  
Feasibility Study**

# *Anchorage Terminal Area Airspace and Procedures Feasibility Study*

May 2019

Version 2.0

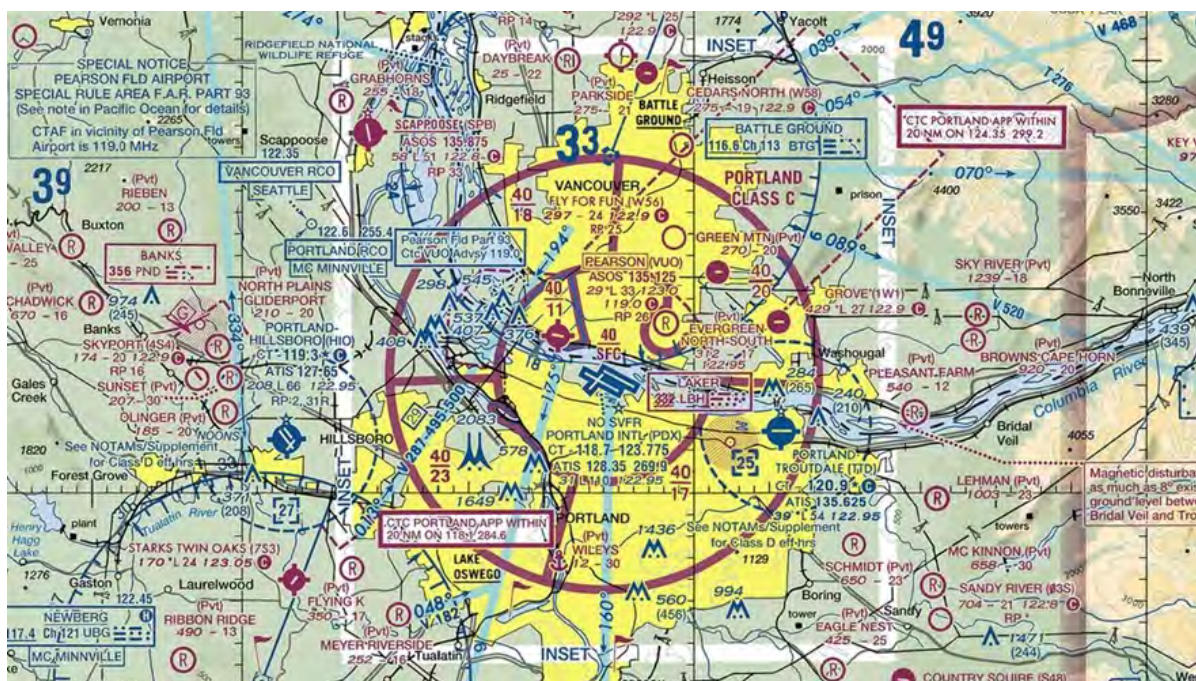
Figure 3: PDX sectional chart depiction with VUO Part 93 note

- c. Figure 3 (following page) is a sectional chart excerpt of Portland International Airport (PDX) in Portland, Oregon, with Pearson Airport (VUO) located just north of PDX. In this case, there is a note on the sectional chart indicating VUO has associated Part 93 airspace. The intent is to prompt pilots to research the special rules associated

with VUO prior to arriving or departing. The incorporation of a similar note on the Anchorage Sectional may help local Anchorage area pilots also.

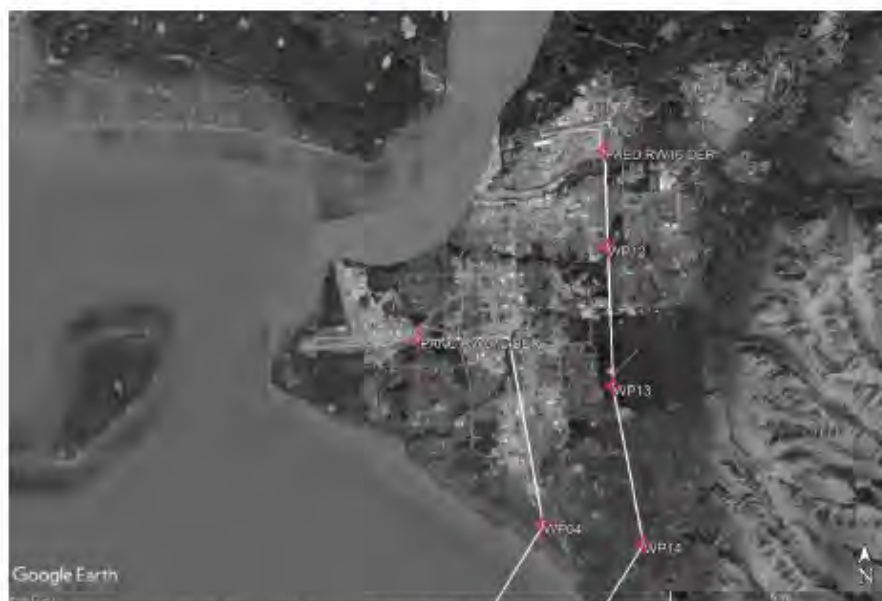
*ANC departures and missed approach RWY7L with EDF missed approach RWY16.*
