# Continued Airworthiness Assessment Methodology: Lessons Learned

## Executive Summary

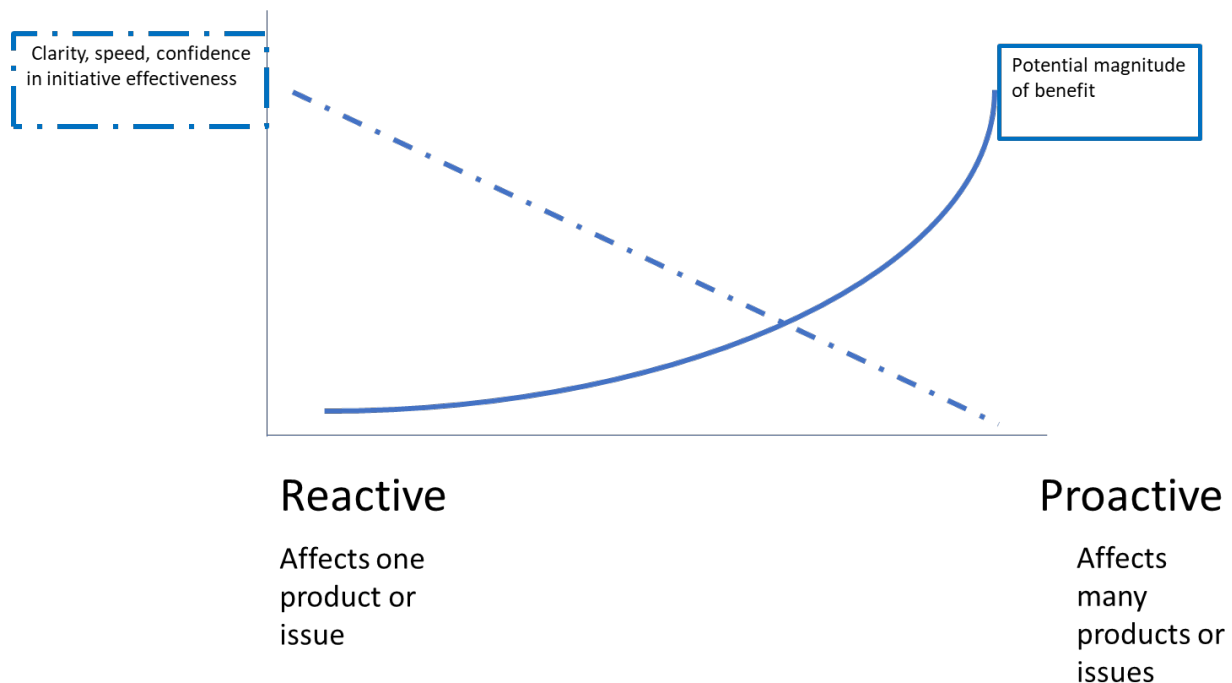
Figure 1 Continuum of Safety Initiatives

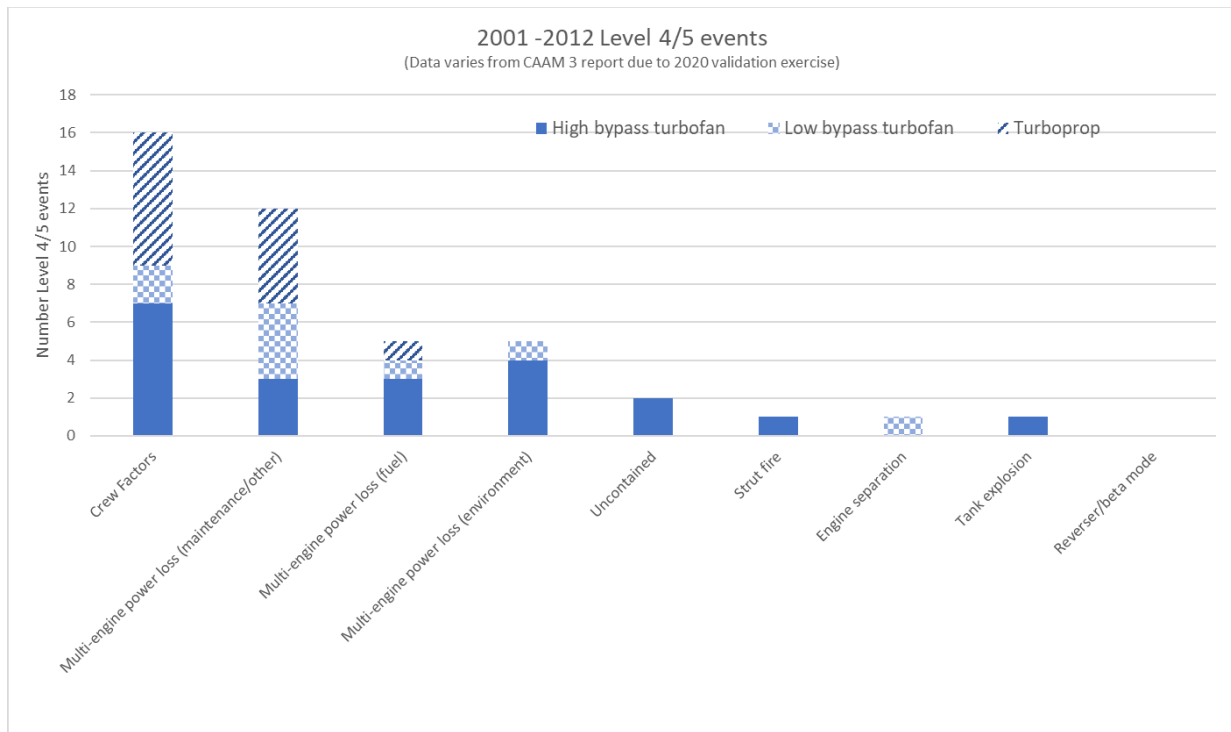
**Figure 2 Event causal factors**

The greatest contribution to level 4/5 events (fatality/ serious injury, hull loss, complete sustained power loss in flight) was crew factors; either crew incorrect operation of the propulsion system, or difficulties in recognizing a propulsion system malfunction and responding in accordance with standard procedures. Other key contributions were multi-engine power loss due to maintenance or other operational factors, due to fuel exhaustion or contamination, or due to environmental causes. It should be noted that the multi-engine power loss events did not always result in hull loss or fatalities.

Engine uncontained release of high energy fragments, fires, engine separation and tank explosion were smaller contributors.

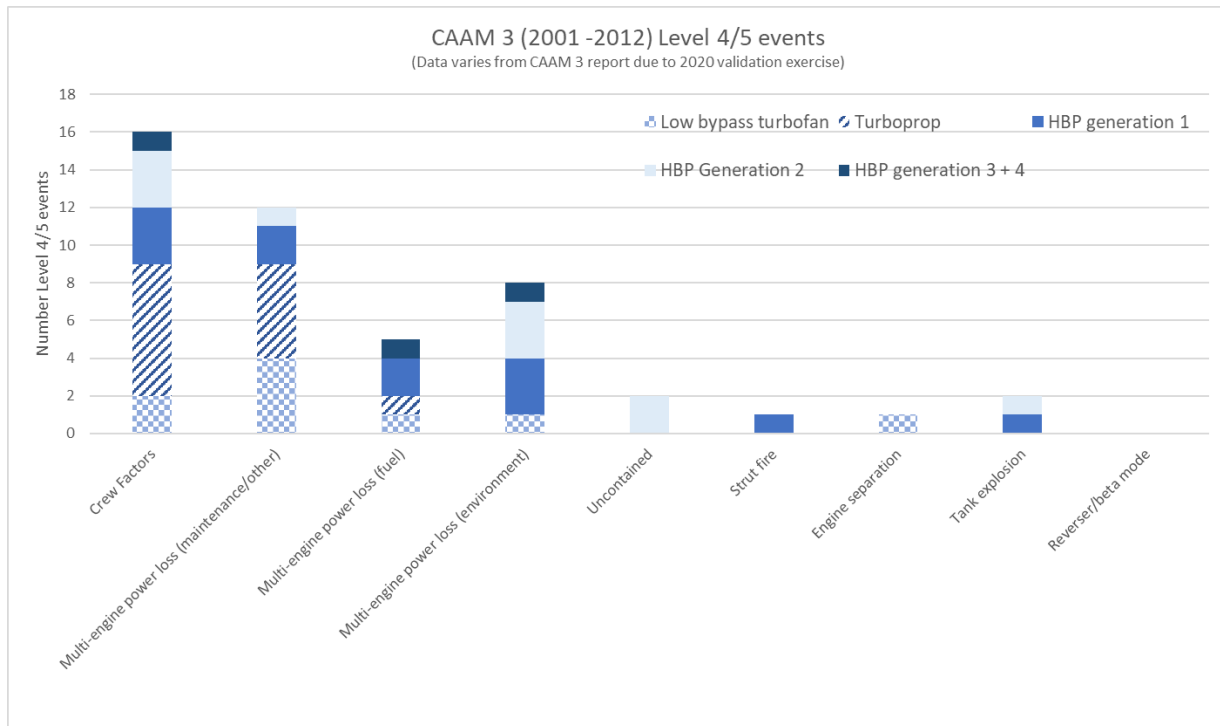
**Figure 3** Distribution of events by generation

The 1<sup>st</sup> Generation High Bypass Ratio (HBPR) engines were designed in the mid-late 1960's and early 1970's. These engines were the successors to the Low Bypass Ratio (LBPR) architecture and installations that had their origins in the 1950's and 1960's. As the 1<sup>st</sup> Generation HBPR engines have matured in service the original operators of this equipment have modernized with newer 2nd/3rd/4th generation HBPR powered airplanes. These 1<sup>st</sup> Generation HBPR engines have continued in service, but have now changed ownership (in many instances multiple times) from the original operators that utilized the equipment.

The HBPR 1<sup>st</sup> Generation CAAM level 4/5 events are not product specific, but rather the majority can be addressed by corrective actions that are broader in scope such as Maintenance awareness, Crew training, etc. This is also the case with the low bypass fleet. A parallel can be drawn between the fleet utilization of the low bypass and the high bypass generation 1 fleets, as low bypass equipment goes out of service and is replaced by generation 1 high bypass products. At this point in the life cycle, the HBPR 1<sup>st</sup> Generation and LBPR fleets should be treated similarly with respect to the recommended corrective actions and methods to deploy those to help further retire risk from the fleet.

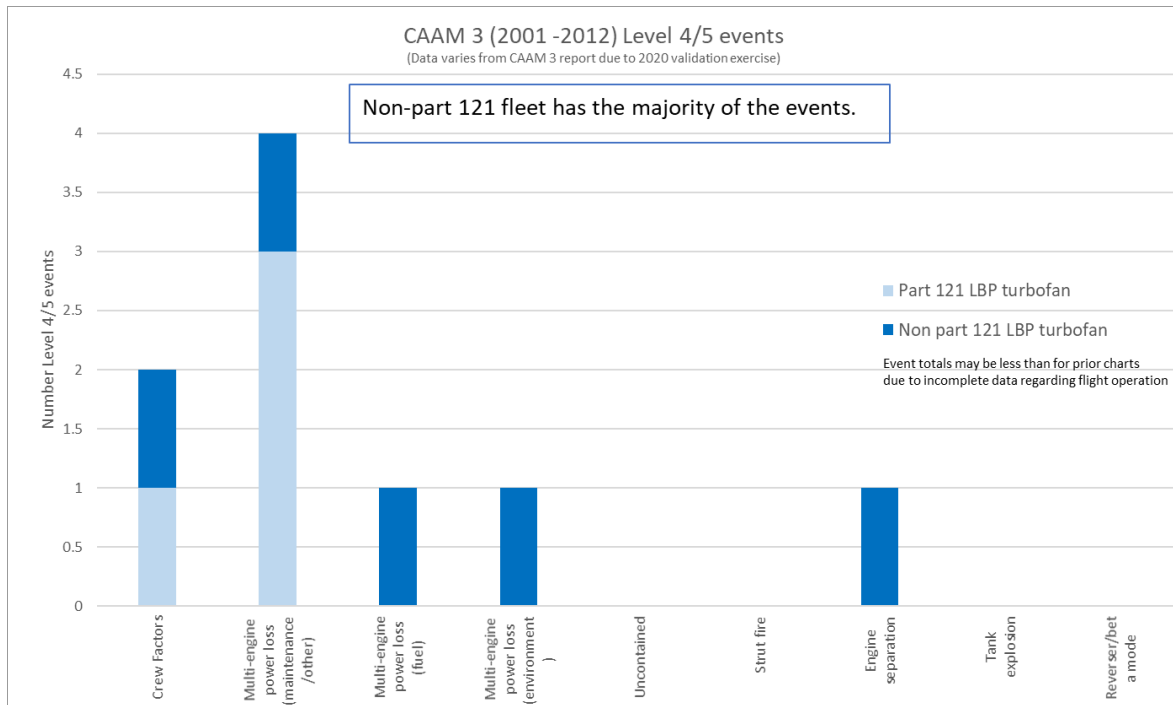
Figure 5 Low bypass turbofans: Flight operating rules

Stratifying the data by the type of operation revealed a marked difference between Part 121 operators and other operations<sup>1</sup>, for the events with multi-engine shutdown due to maintenance and other operational factors. This is especially notable given the large fleets and high usage of Part 121 operators. It is likely that as the older high bypass turbofan fleet transfers into less structured operations – the non-Part 121 operators and current operators of low bypass ratio turbofans - this risk area (multi-engine shutdown due to maintenance/operational considerations) will grow. The team recommends additional support be provided to low-resource or low-experience operators.
