AC NO: 20-59

MAINTENANCE INSPECTION NOTES FOR CONVAIR MODELS 240 AND
600/240D; MODELS 340/440 AND 640/340D/440D SERIES AIRCRAFT

1. **PURPOSE.** This handbook describes maintenance inspection notes which
can be used for the maintenance support of certain structural parts
of Convair 240 and 600/240D; Models 340/440 and 640/340D/440D series
aircraft. *
2. **DESCRIPTION.** Maintenance on the wing, fuselage, and empennage struc-
ture is reviewed with a view toward supplementing information current-
ly available.
3. **HOW TO GET THIS PUBLICATION.**
 - a. Order additional copies of this publication from:

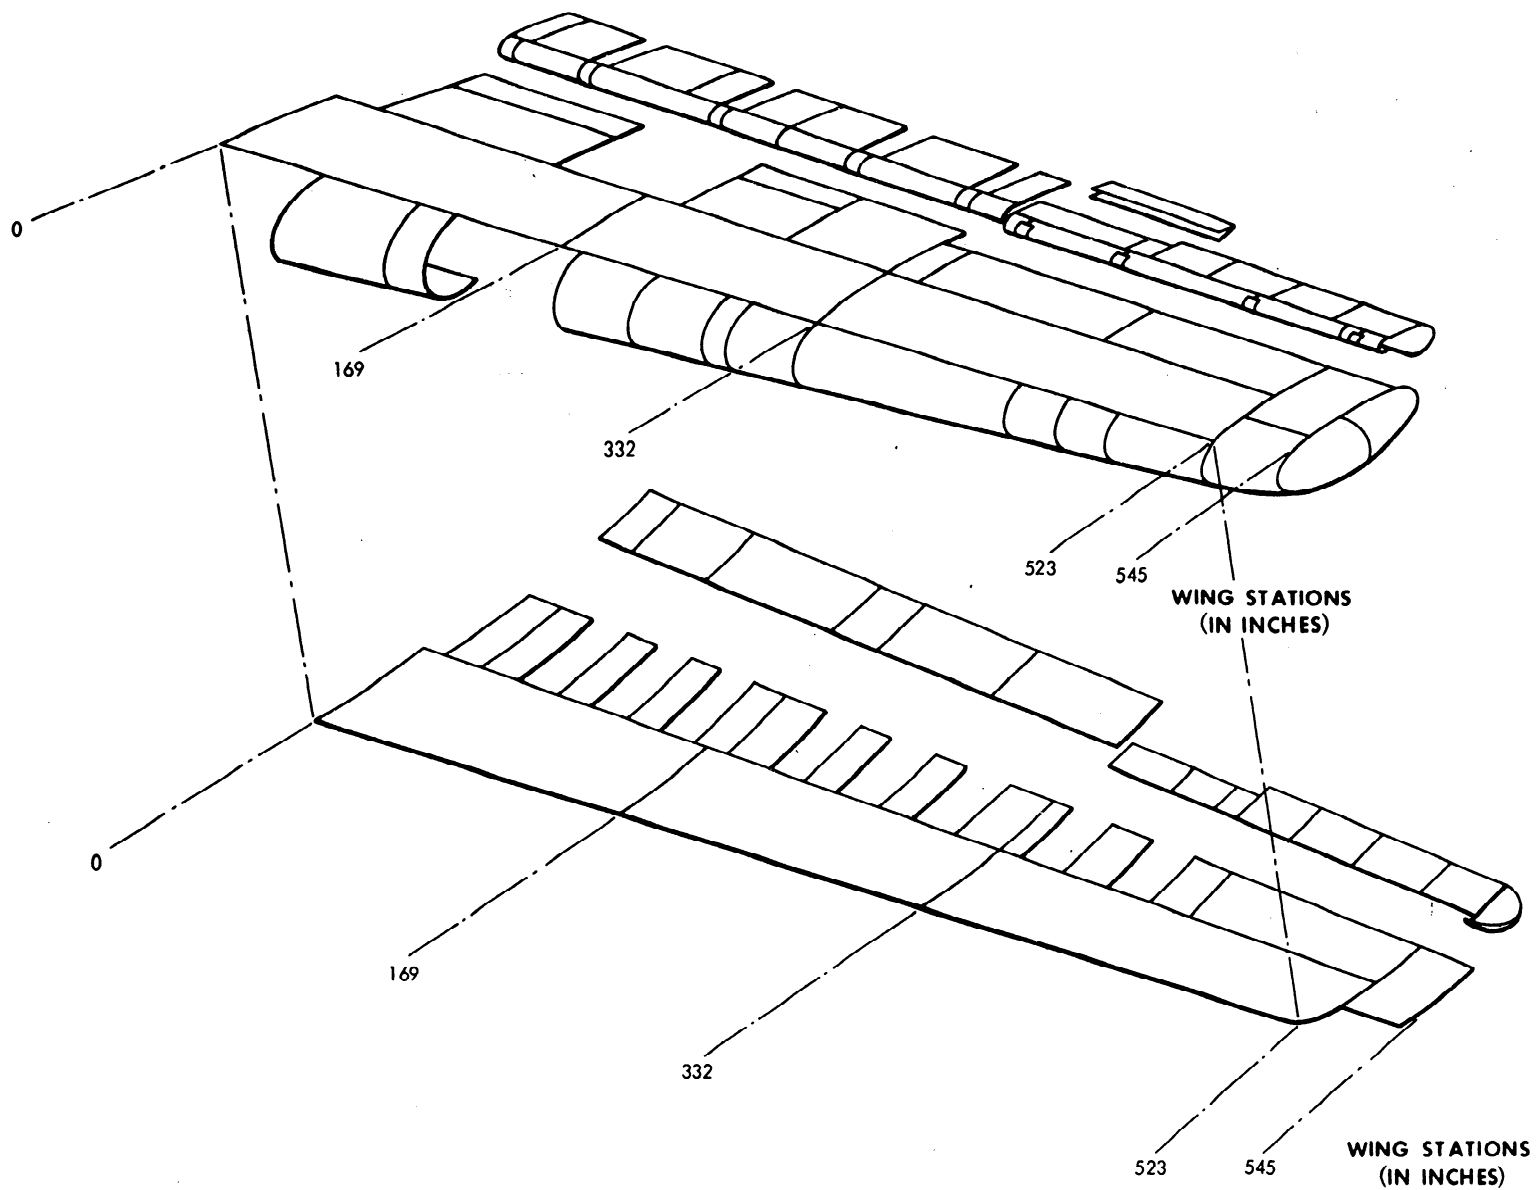
FIGURE A-1. WING STATIONS

The wing, fuselage, and empennage station diagrams included in this document were developed for the CV-340 aircraft and are used as a general reference only. Several models of each of these aircraft were manufactured and have different station locator numbers based on the particular configuration. Since the defect areas generally apply to all models of both aircraft, the referenced area can be compared with a similar area and locator on the appropriate station diagram for the particular model of aircraft.

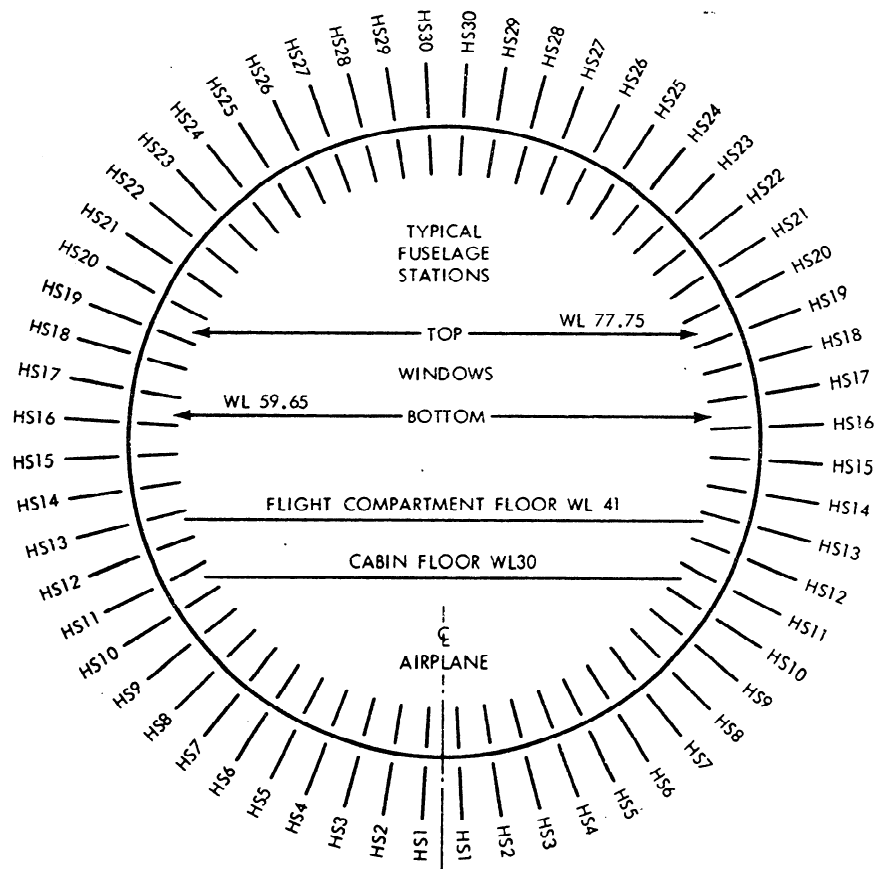
FIGURE B-5. FUSELAGE STRINGER DIAGRAM

1. HS INDICATES POINT ON LINE OF STRINGER HEEL.
2. ALL STRINGERS ARE MADE FROM STANDARD ROLL-FORMED SECTIONS Y36 OR Y34, OF 24ST ALCLAD MATERIAL.
3. STRINGERS AT POSITIONS 19 L/R CABIN SECTION ARE REVERSED.
4. STRINGERS AT POSITIONS 17 L/R AND 29 L/R TAIL SECTION ARE REVERSED.
