Mr. Brandon Roberts
Executive Director, Office of Rulemaking

On behalf of the Emergency Evacuation Standards Aviation Rulemaking Committee (ARC), we are pleased to provide you with the attached Evacuation ARC report and its 27 recommendations covering airplane design and certification standards, operational and training requirements as well as airport rescue and firefighting.

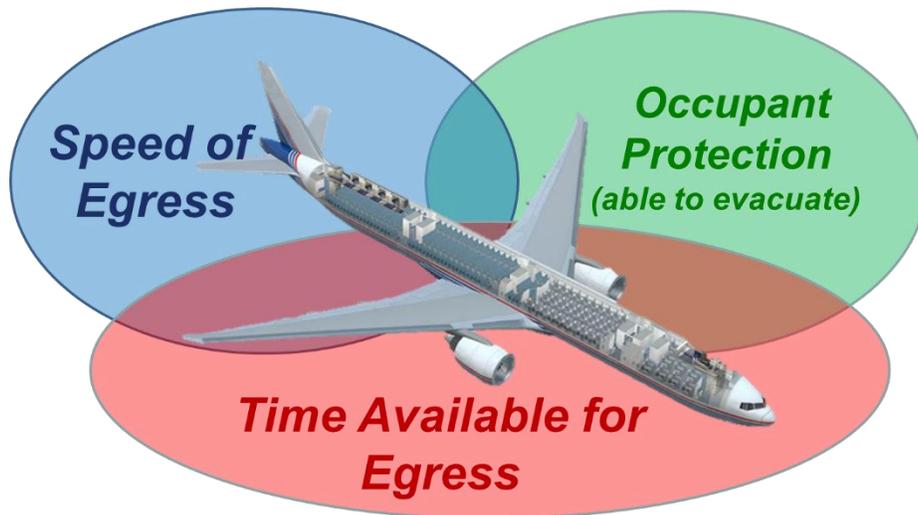
Figure 1

There are numerous regulatory requirements and associated guidance that address evacuation safety. Each of the requirements is independent. For example, the number of passengers is limited by the type and number of exits, regardless of how many passengers might evacuate in a given time. The requirements are summarized in Appendix 2, but are generally in one of three categories:

- Provide the ability to evacuate
- Provide as much time as possible for egress
- Be able to egress as fast and safely as possible

Requirements intended to protect occupants are those that apply to crashworthiness of seats, restraints, and design of the interior. Requirements intended to extend the time available for evacuation are those that apply to materials flammability and aircraft buoyancy in a ditching. Requirements intended to make egress as fast and safe as possible are those that apply to emergency exits, egress paths between each seat and emergency exits, egress assist means and emergency lighting, as well as the training and operational procedures of crewmembers. In addition, there is a requirement to show that, under specific conditions, an airplane can be

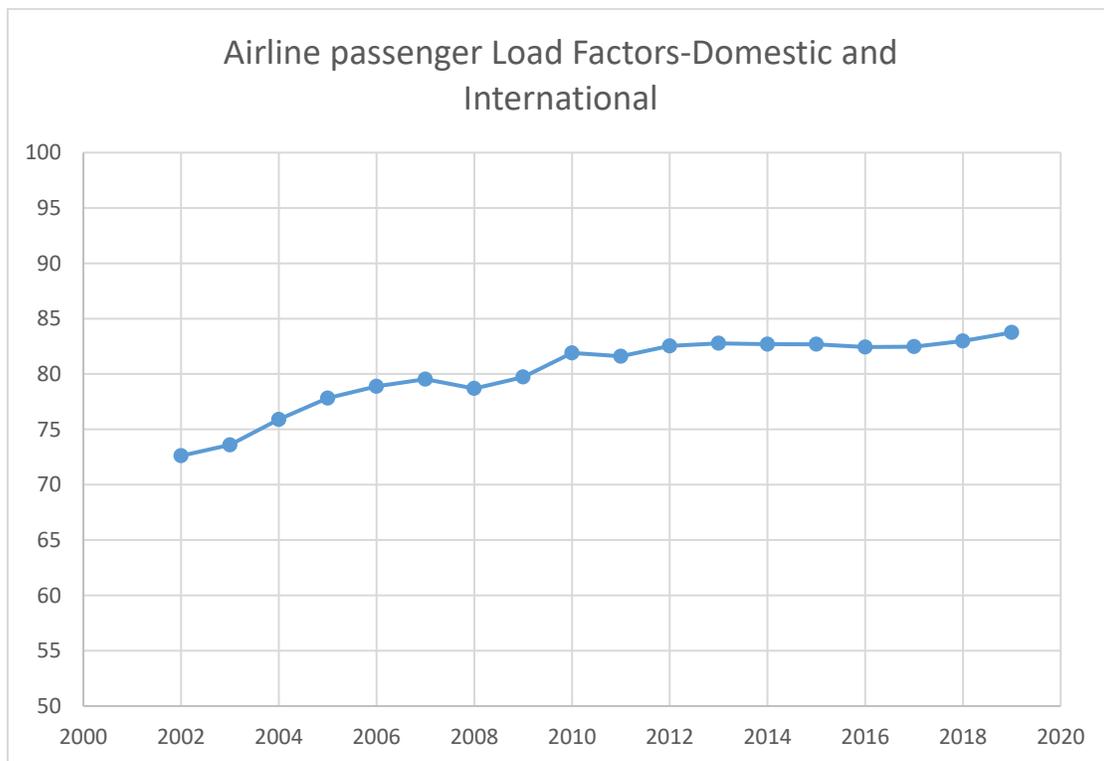
Figure 2⁴

The ARC expressed concern that passenger load factors were increasing, so the success of emergency evacuations in years past might not be relevant if more people had to evacuate from the same airplanes. The Bureau of Transportation Statistics (BTS) maintains data on passenger load factors over time. The previous ten years of BTS load factor data is shown in Figure 2.
