# **Task Assignment**

Aviation Rulemaking Advisory Committee; Transport Airplane and  
Engine Issues--New Tasks

ACTION: Notice of new task assignments for the Aviation Rulemaking  
Advisory Committee (ARAC).

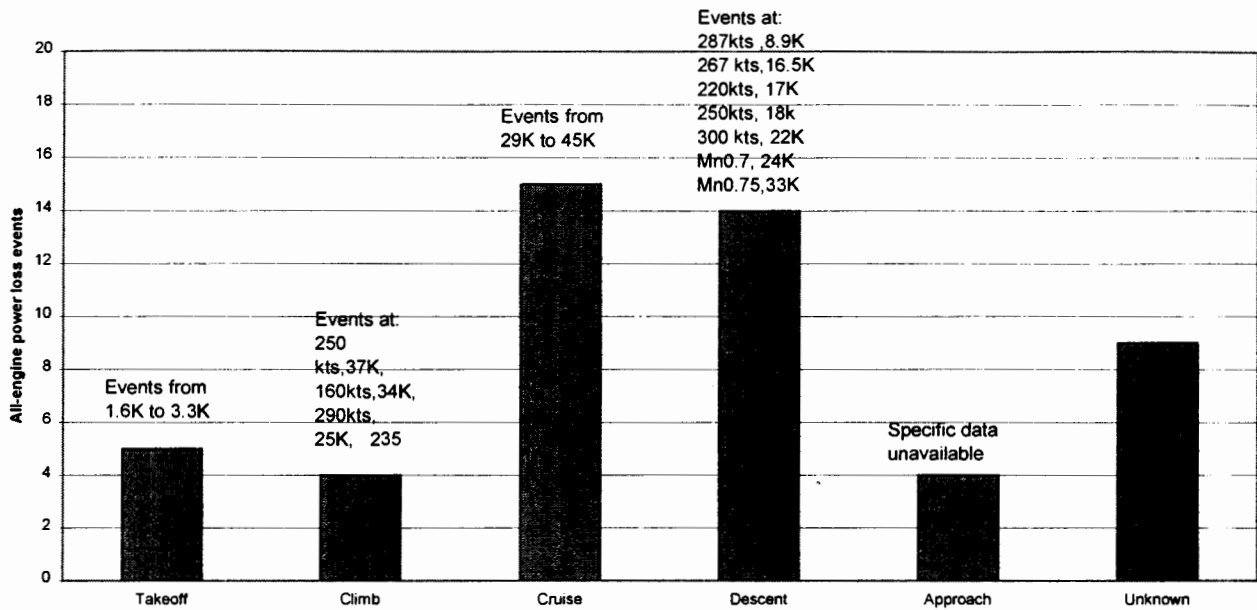
**CHART 2**  
**Commercial Transport Fleet All-Engine Power Loss Events, by Flight Phase**  
**1960-1996**

**Majority of events occur at high/intermediate altitudes. Low altitude/low airspeed/low power scenario (condition 4) represents no events/ a very small proportion of events**

The flight conditions specified in the AC do not reflect the flight conditions at which the majority of all-engine power losses have historically occurred, according to this database. Specifically, condition 4 (low power, below 10,000 ft, 1.45 V<sub>stall</sub>) reflects a more severe condition than has been documented for an all-engine power loss in the commercial transport fleet. It is proposed that the requirement of section 7, condition 4, for an initial airspeed of 1.45 V<sub>stall</sub> be changed to permit a higher initial airspeed such as 250 kts.

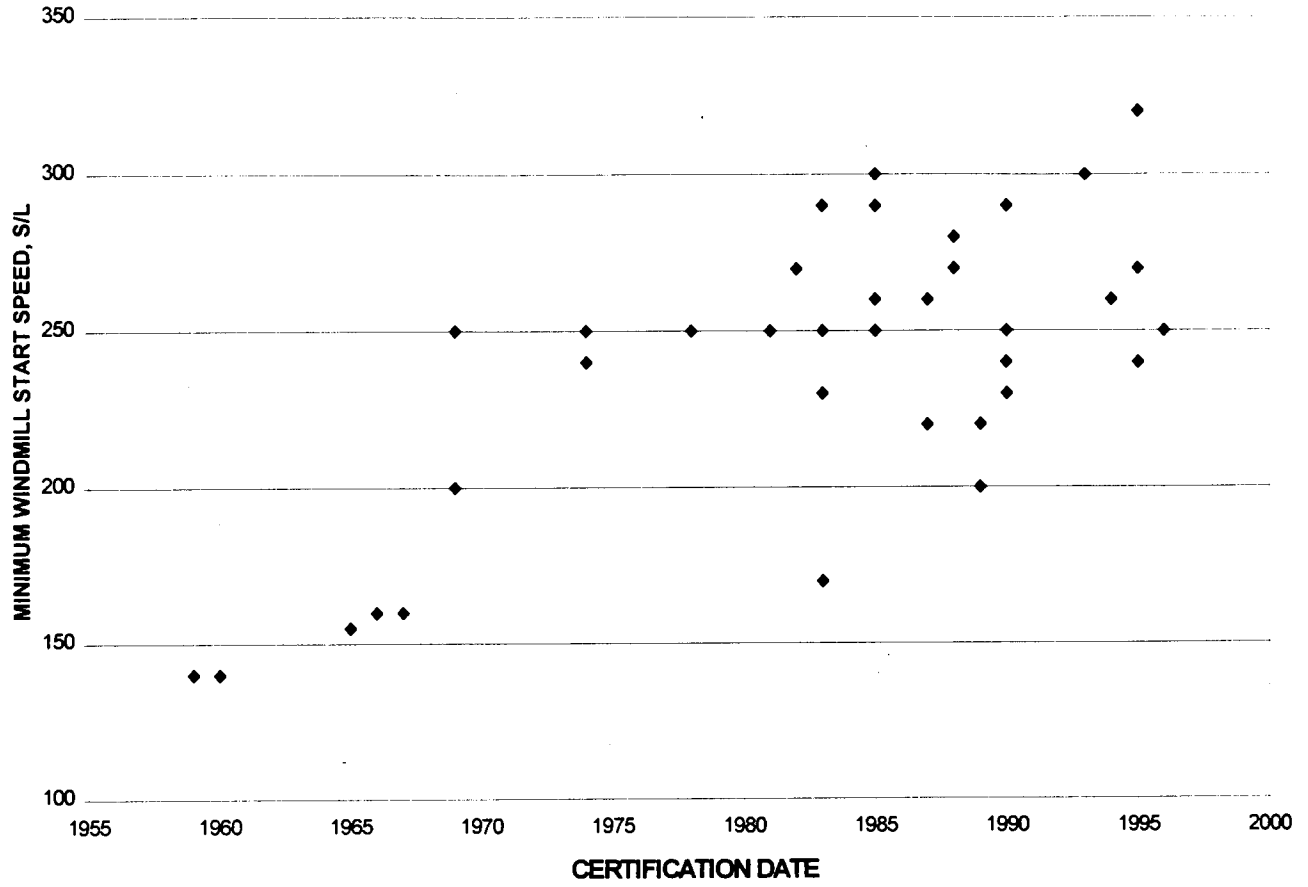
Chart 3  
Certified Windmill Start Envelopes

Chart 3 shows the minimum windmill start airspeed as a function of aircraft certification date. Half of the engine/airframe combinations currently in service are capable of windmill start, S/L, at 250 knots. Therefore a reasonable criterion for maintaining the current safety standard would be 250 knots rather than 1.45 V<sub>stall</sub>. The following wording change is proposed to Section 7, condition 4:
