**THE FORTY-SEVENTH MEETING OF THE
INFORMAL PACIFIC ATC CO-ORDINATING GROUP (IPACG/47)**

**THE THIRTY-FOURTH MEETING OF THE
IPACG FANS INTEROPERABILITY TEAM (IPACG FIT/34)**

**Federal Aviation Administration (FAA) Central Reporting Agency (CRA)
Problem Report (PR) Briefing**

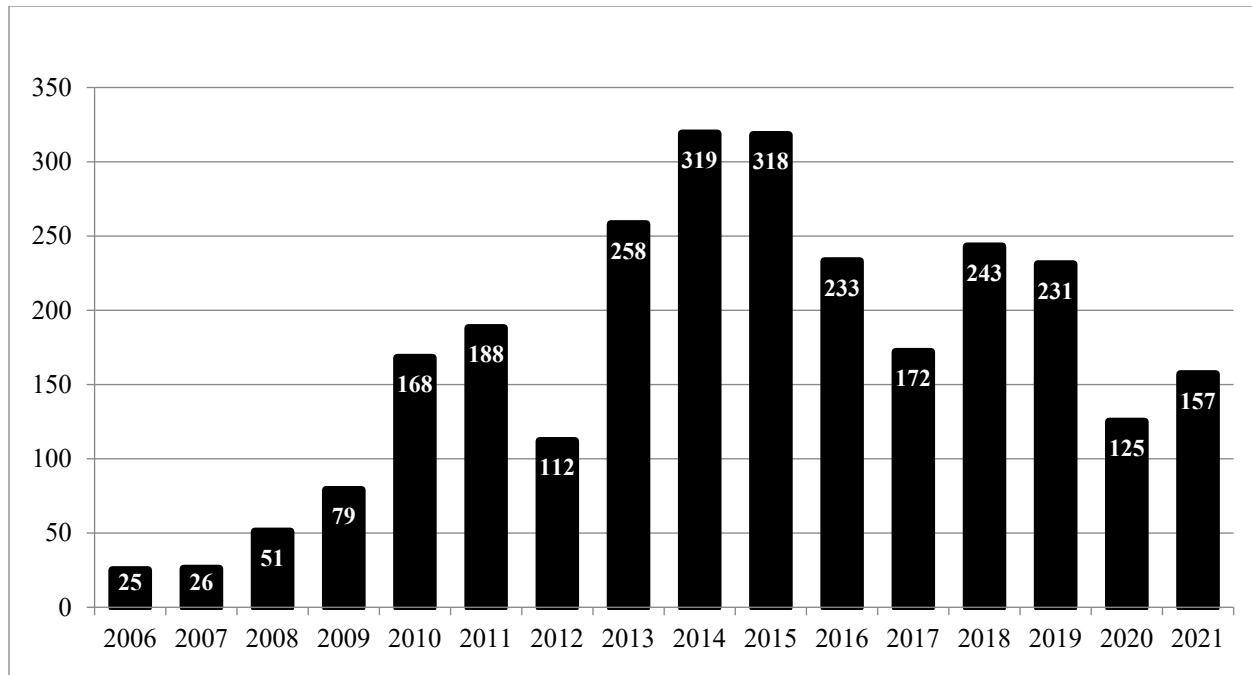
- 1.3. Figure 1 illustrates the total number of PRs submitted per calendar year starting in 2006.

Figure 1 PRs Per Year
