AERONAUTICAL CHARTING MEETING
Instrument Procedures Group
Meeting 22-01 – April 25-26, 2022

FAA Control # 22-01-365

Subject: As Charted, Teardrop Course Reversals Lack Pilot Guidance on How to Fly the Reversal

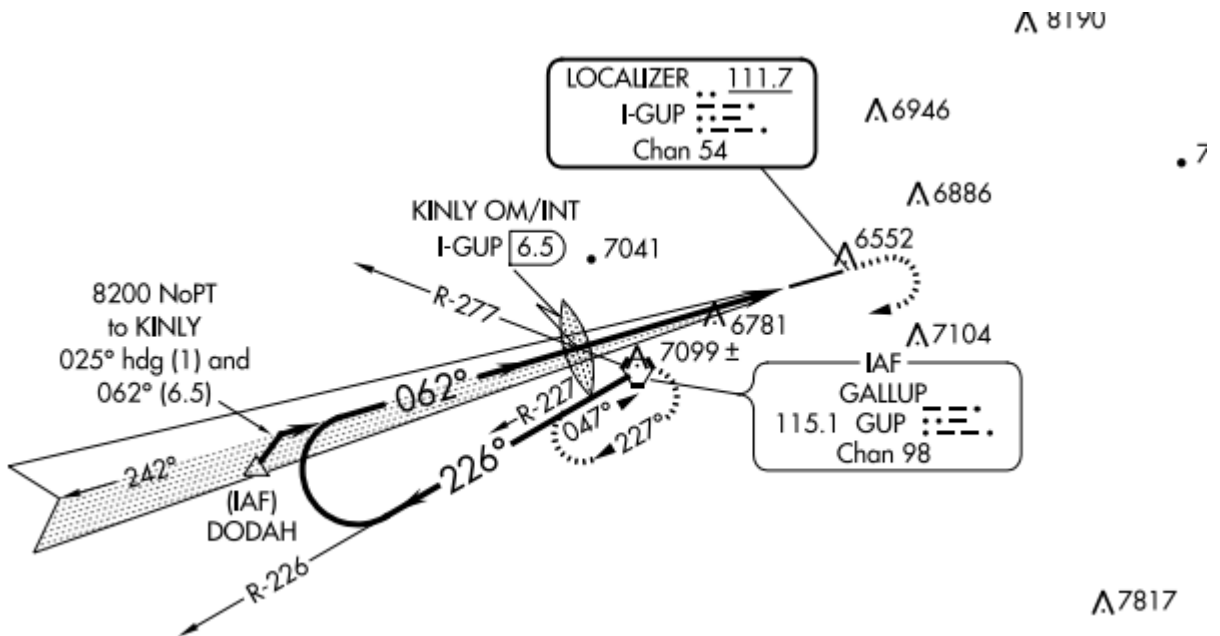
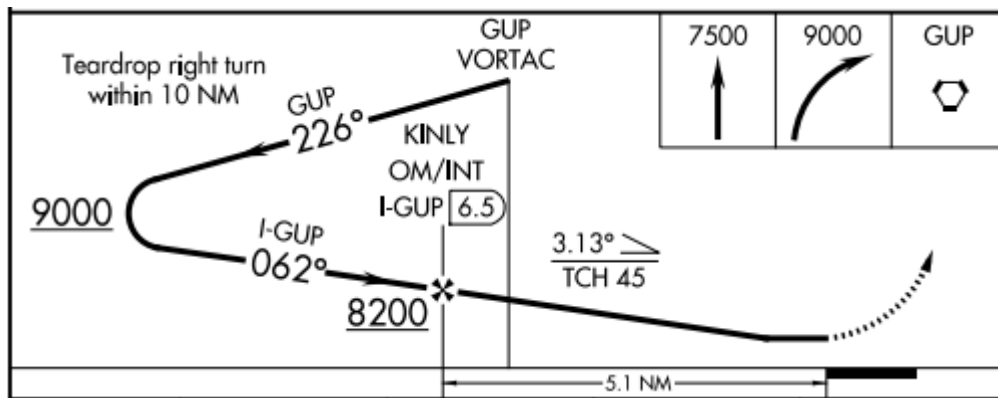
Here is a teardrop course reversal (excerpted from GUP LOC 6, Appendix A has full procedure):

The FAA publishes extensive pilot guidance on other course reversals; namely procedure turn, hold-in-lieu of procedure turn, and DME arcs. However, there is no substantial guidance on how to fly a teardrop. Ask most pilots “how to” and they will respond, “standard rate turn,” which is incorrect.

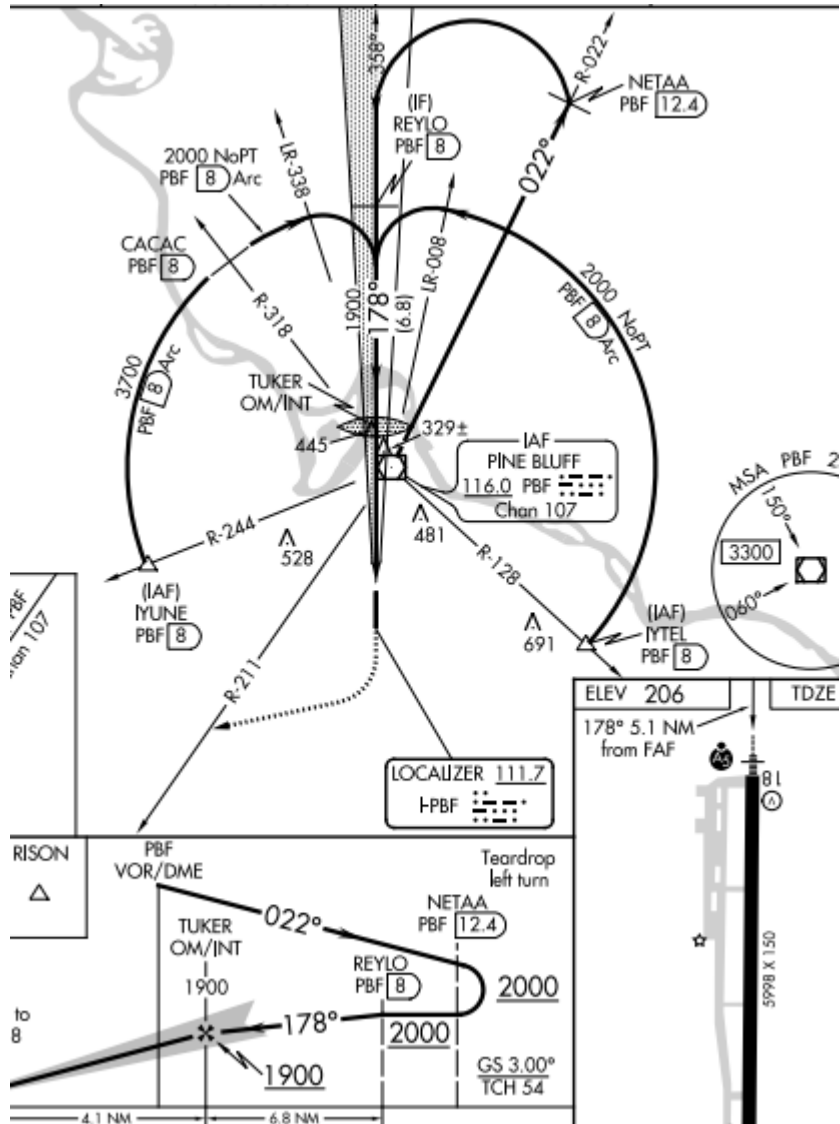
Problems may result from lack of guidance; for example, in PBF (full chart in Appendix A), there is no profile view “remain within” distance note for the teardrop. Without this note, the turn from NETAA to intercept the final is technically unbounded as there is no way to follow the depicted semicircle (when flying the approach with conventional navigation).
